# Unconsented operations in Chichester Harbour SSSI

Unit 3 Tournerbury Woods

20<sup>th</sup> September 2022

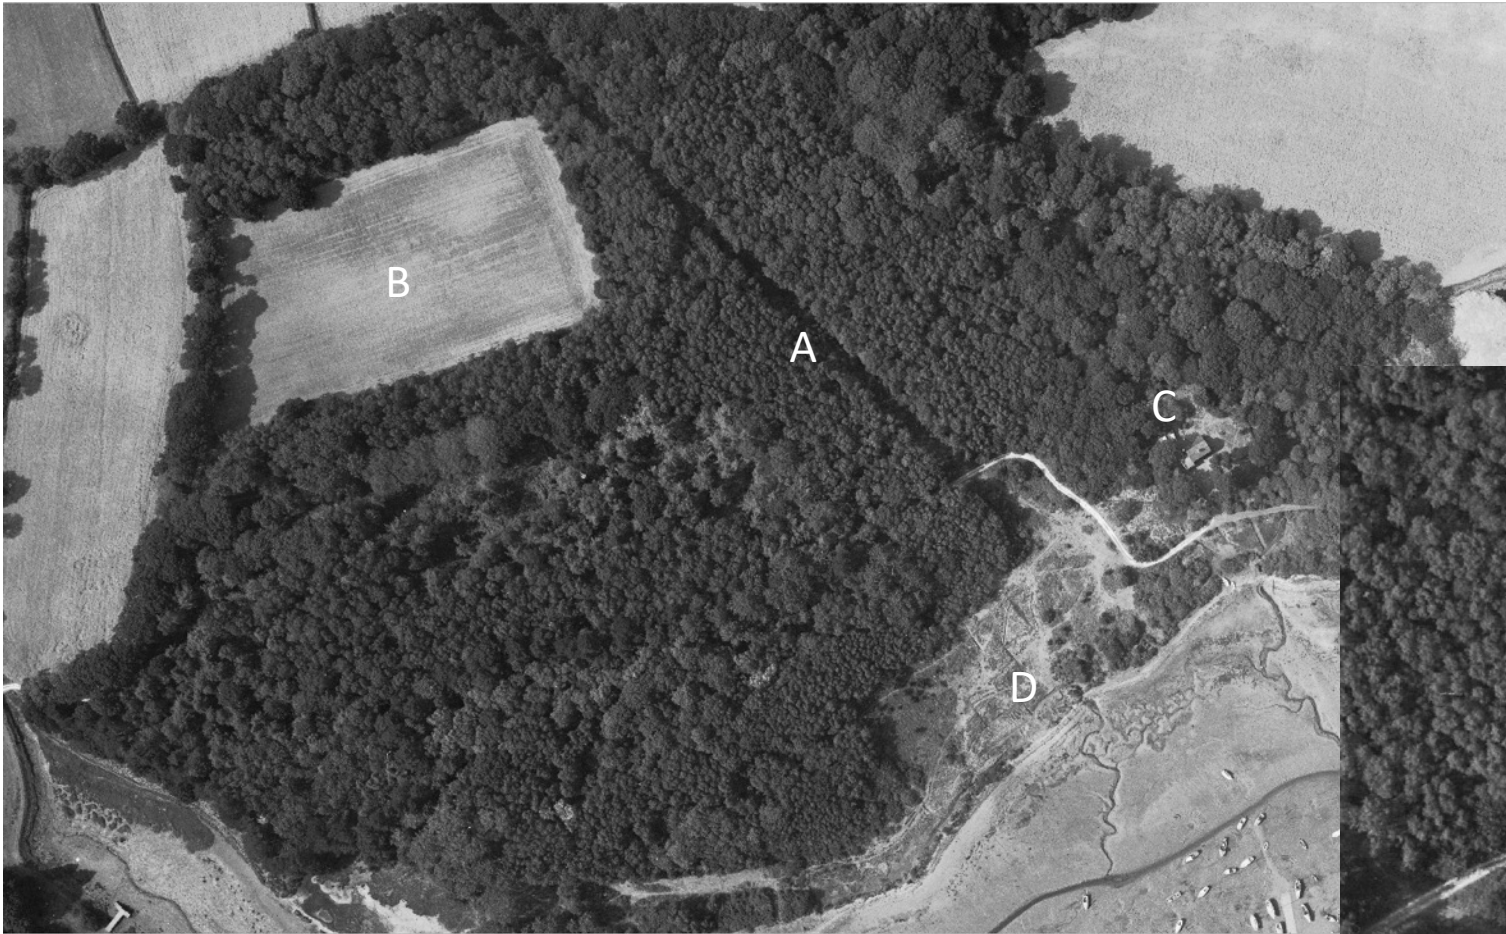
# Timeline of development 1976

- Tournembury Woods 6 yrs after 1970 designation
- Long ride cut for electricity cable (A)
- No lake in woods; Wood Field (B) clear of trees
- Woods Cottage (C) surrounded by trees
- Low, flat, open back beach area along creek (D) later subject to dumping

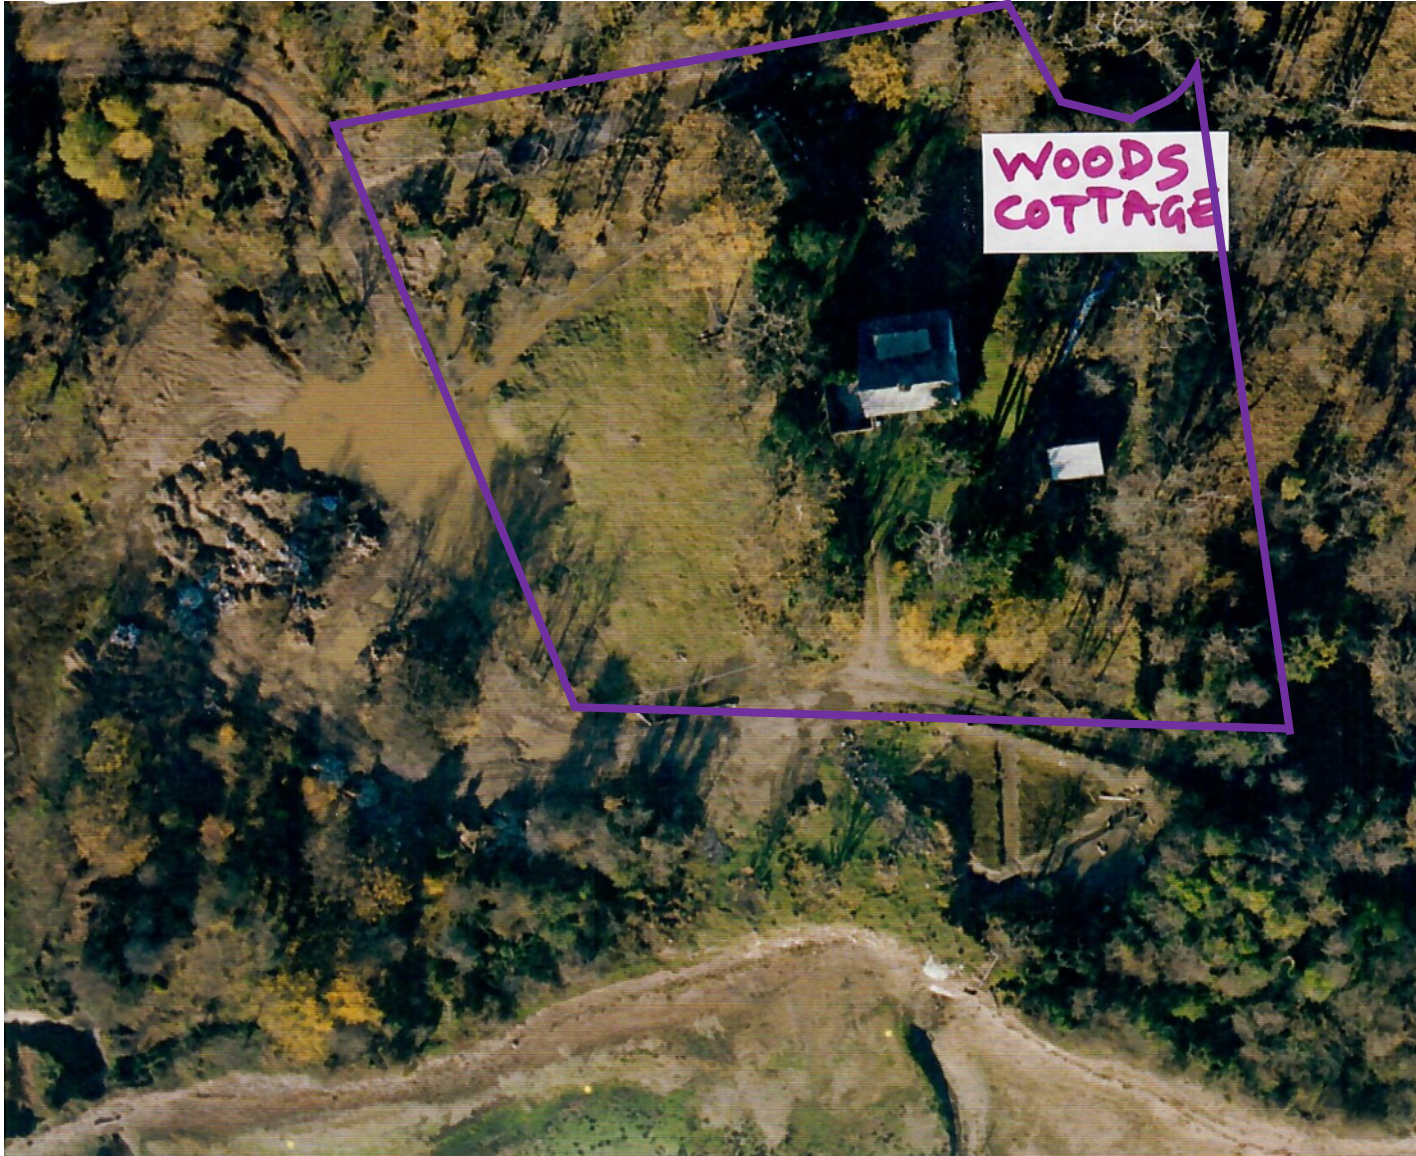
# Timeline of development 1996-97

- Privately commissioned aerial photo from December 1996, four months before the SMS
- Dumping of waste material is clearly visible outside the boundary of the domestic curtilage
- The landowner/ Havant acknowledge that SSSI regulations apply outside the curtilage in map

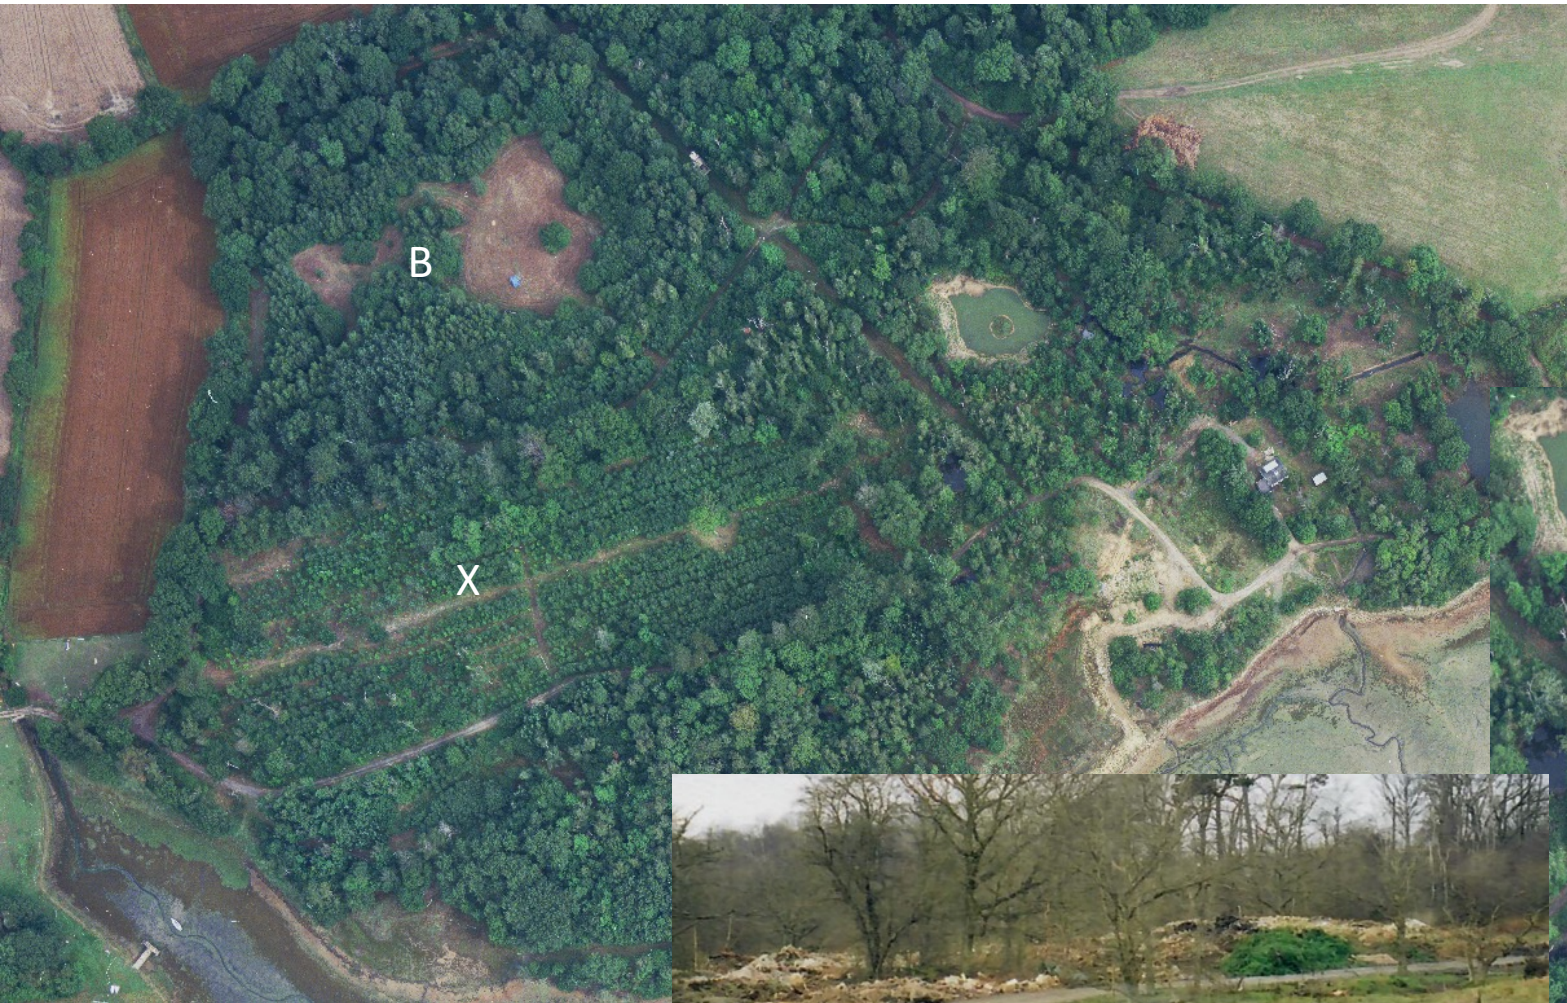
# Timeline of development 1999

- 2 years after SMS agreement with Nat Eng
- Extensive damage X in 1987 storm replanted
- Lake excavated in wood since 1981
- Wood Field B infilled by new tree growth
- Woods Cottage trees significantly thinned
- Large dump of rubble SW of Woods Cottage outside domestic curtilage

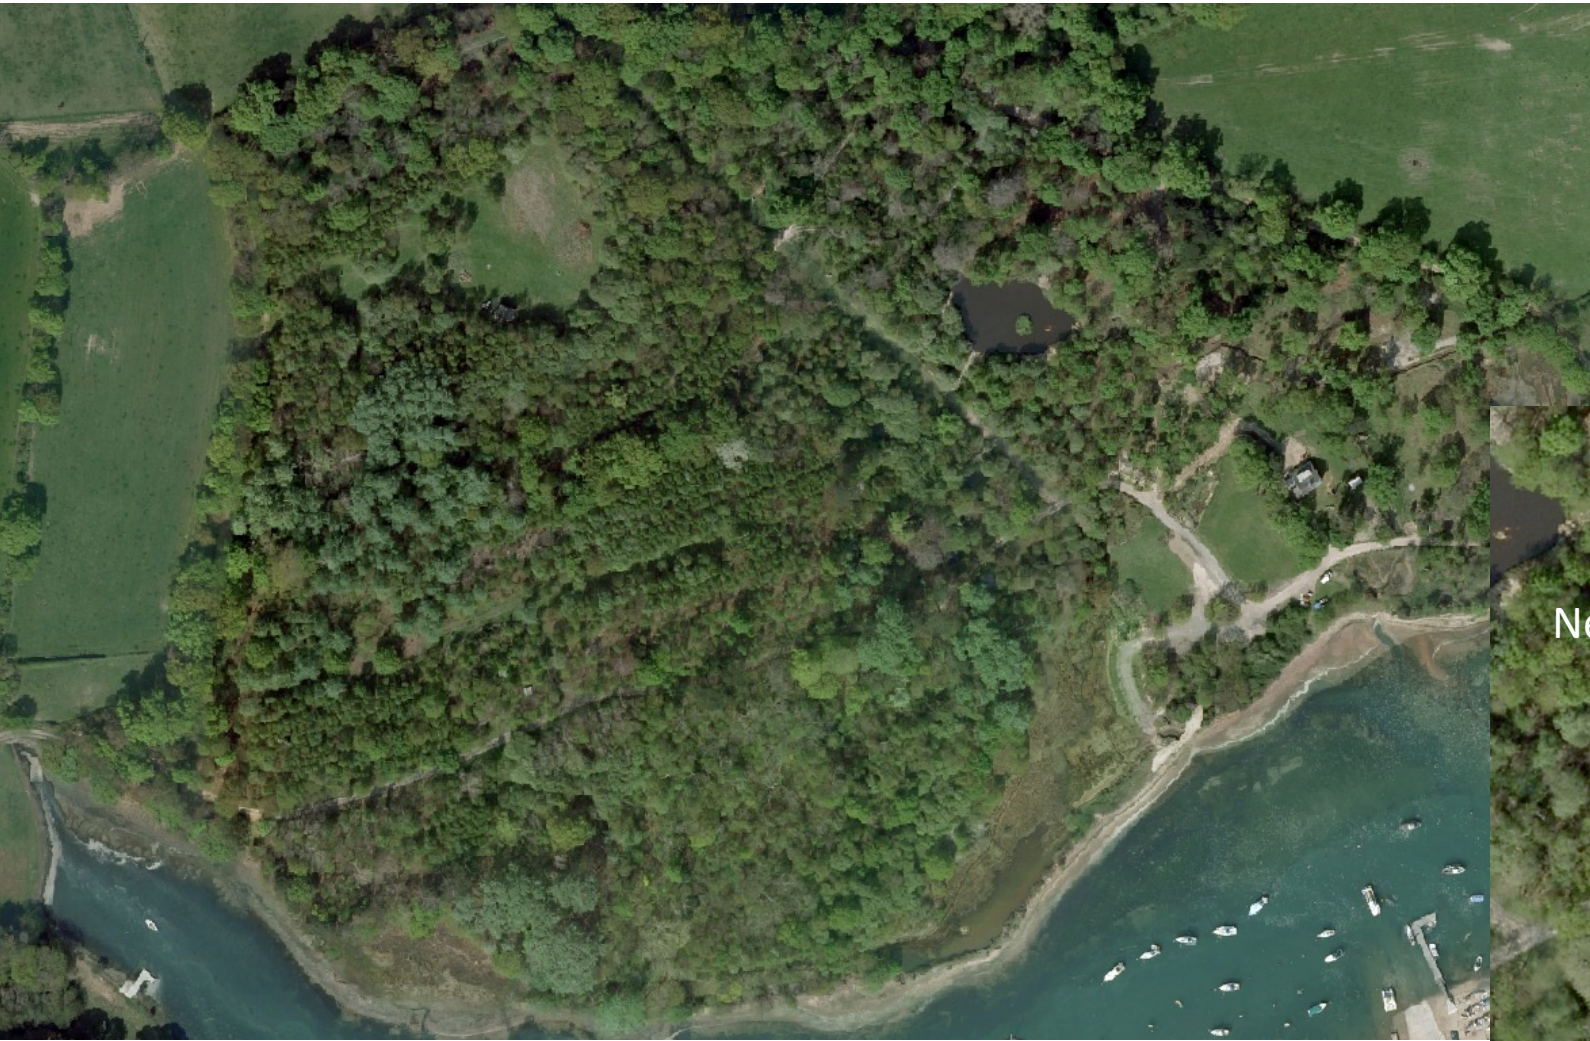
# Timeline of development 2007

- Electricity cable ride growing over
- Wood Field mostly infilled by new growth
- 2 new lawns laid on rubble by Woods Cott
- Dumping new rubble NW of Woods Cottage
- 2 ponds of 100 sq. m have been infilled
- Trees have disappeared in Woods Cott area

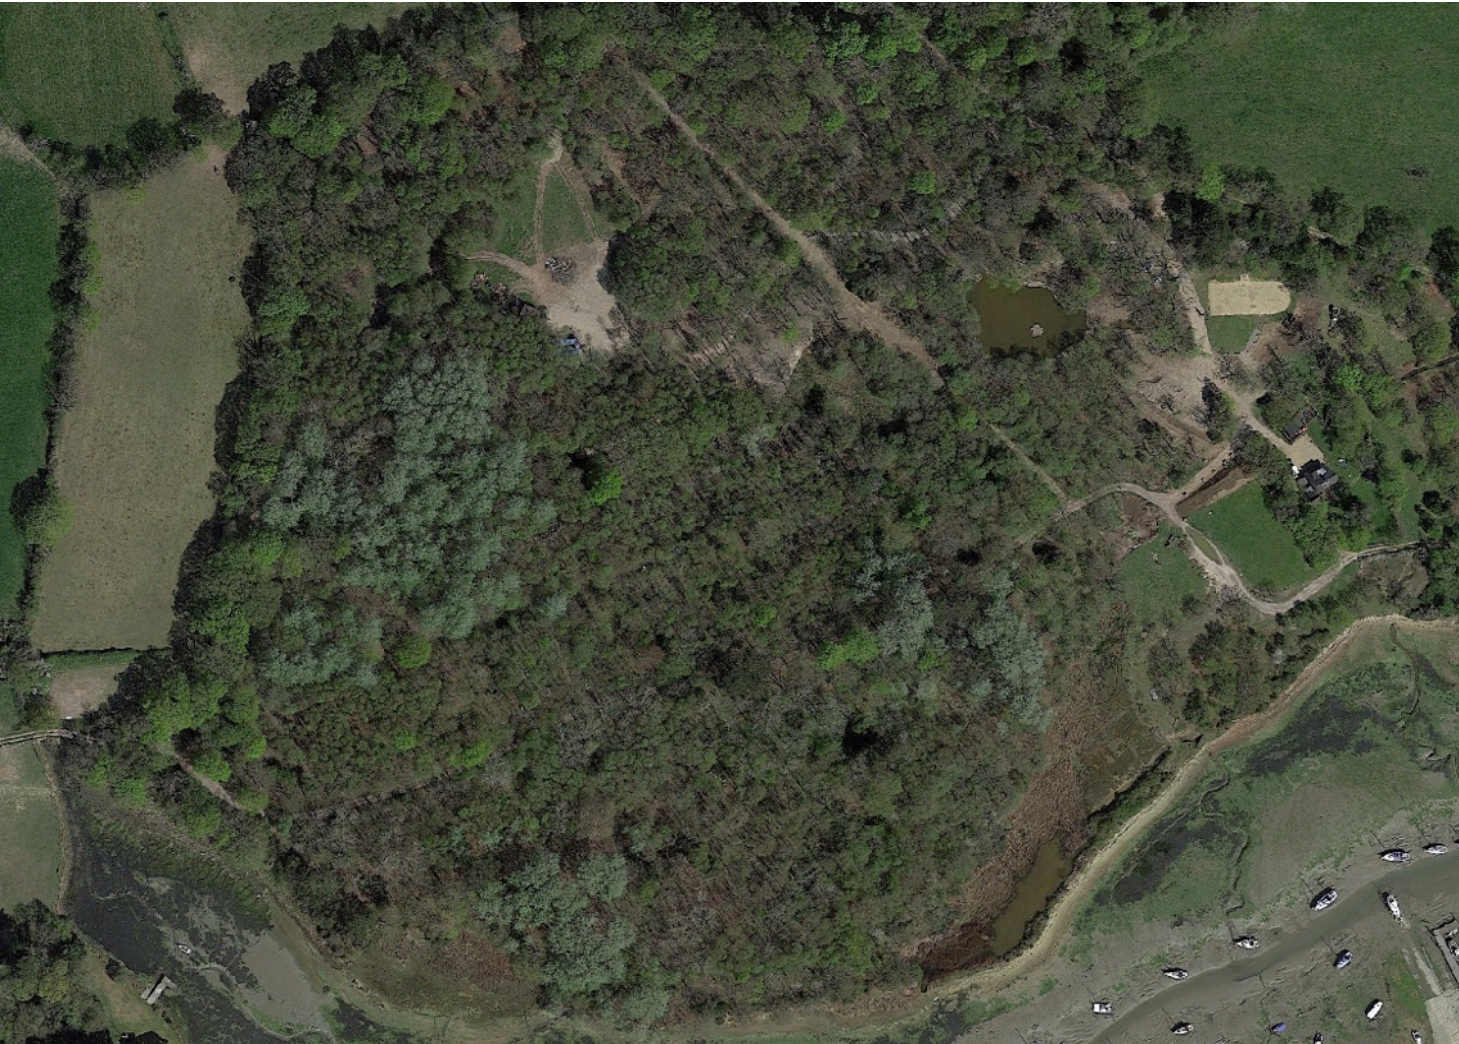
# Timeline of development 2015

- Large pond infilled N of Woods Cottage
- Dumping new rubble NW of Woods Cottage
- 80m of watercourse infilled under car park
- Two ponds 16 & 85 sq. m have been infilled
- Foundation for new marquee
- Bulldozed bank W of car park / N of lawn
- All outside domestic curtilage

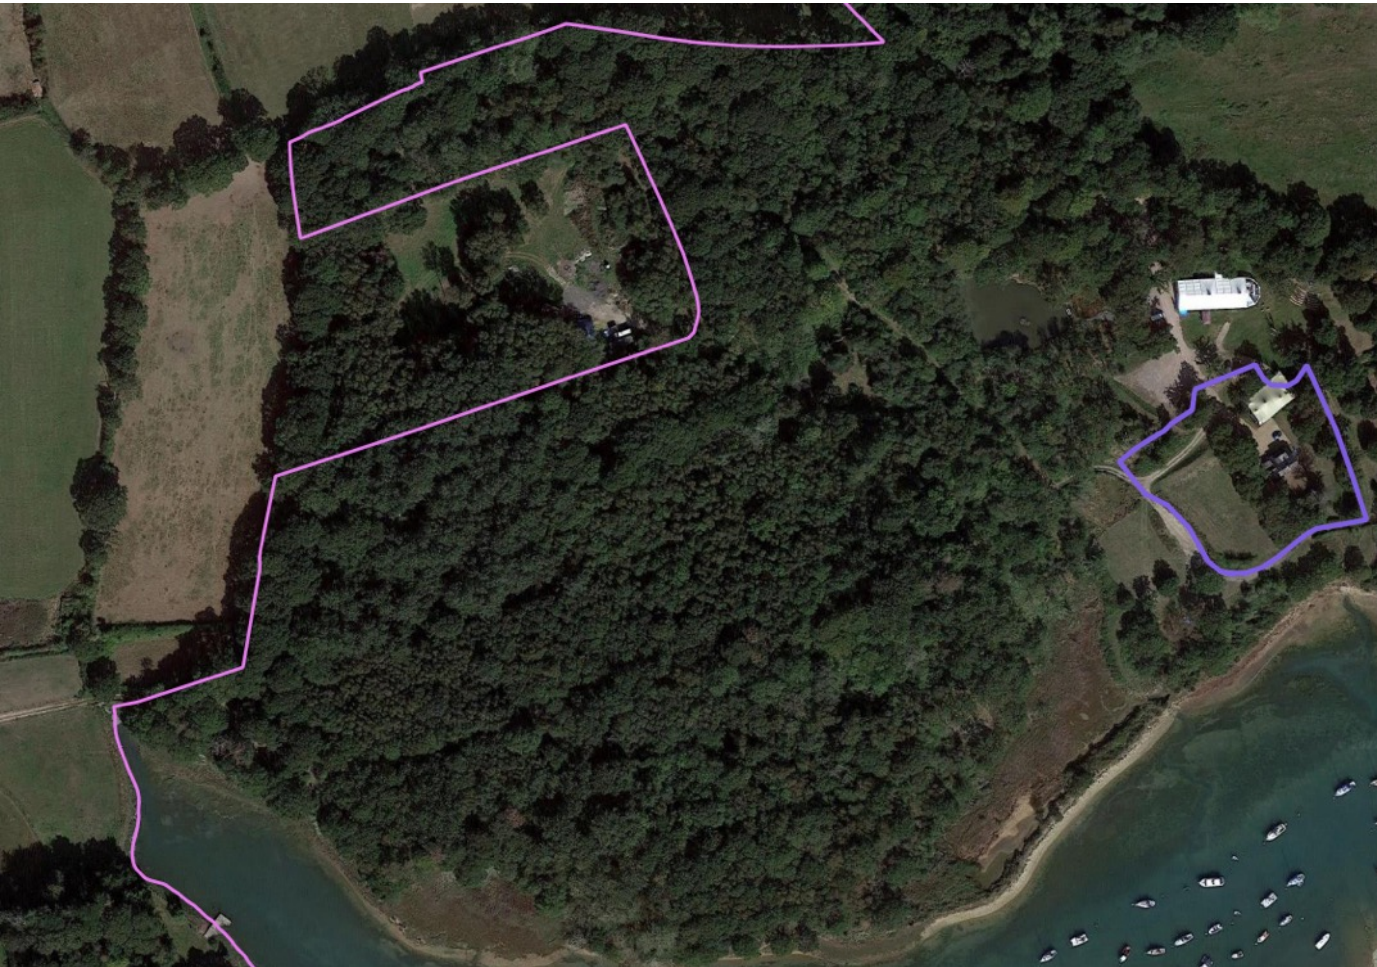
# Timeline of development 2019

- Marquee erected and reinforced as permanent structure
- New deck structure erected over former pond
- Extensive camping areas laid out in woods
- Domestic curtilage shown in purple
- SSSI boundary in pink- Tournurbury inside

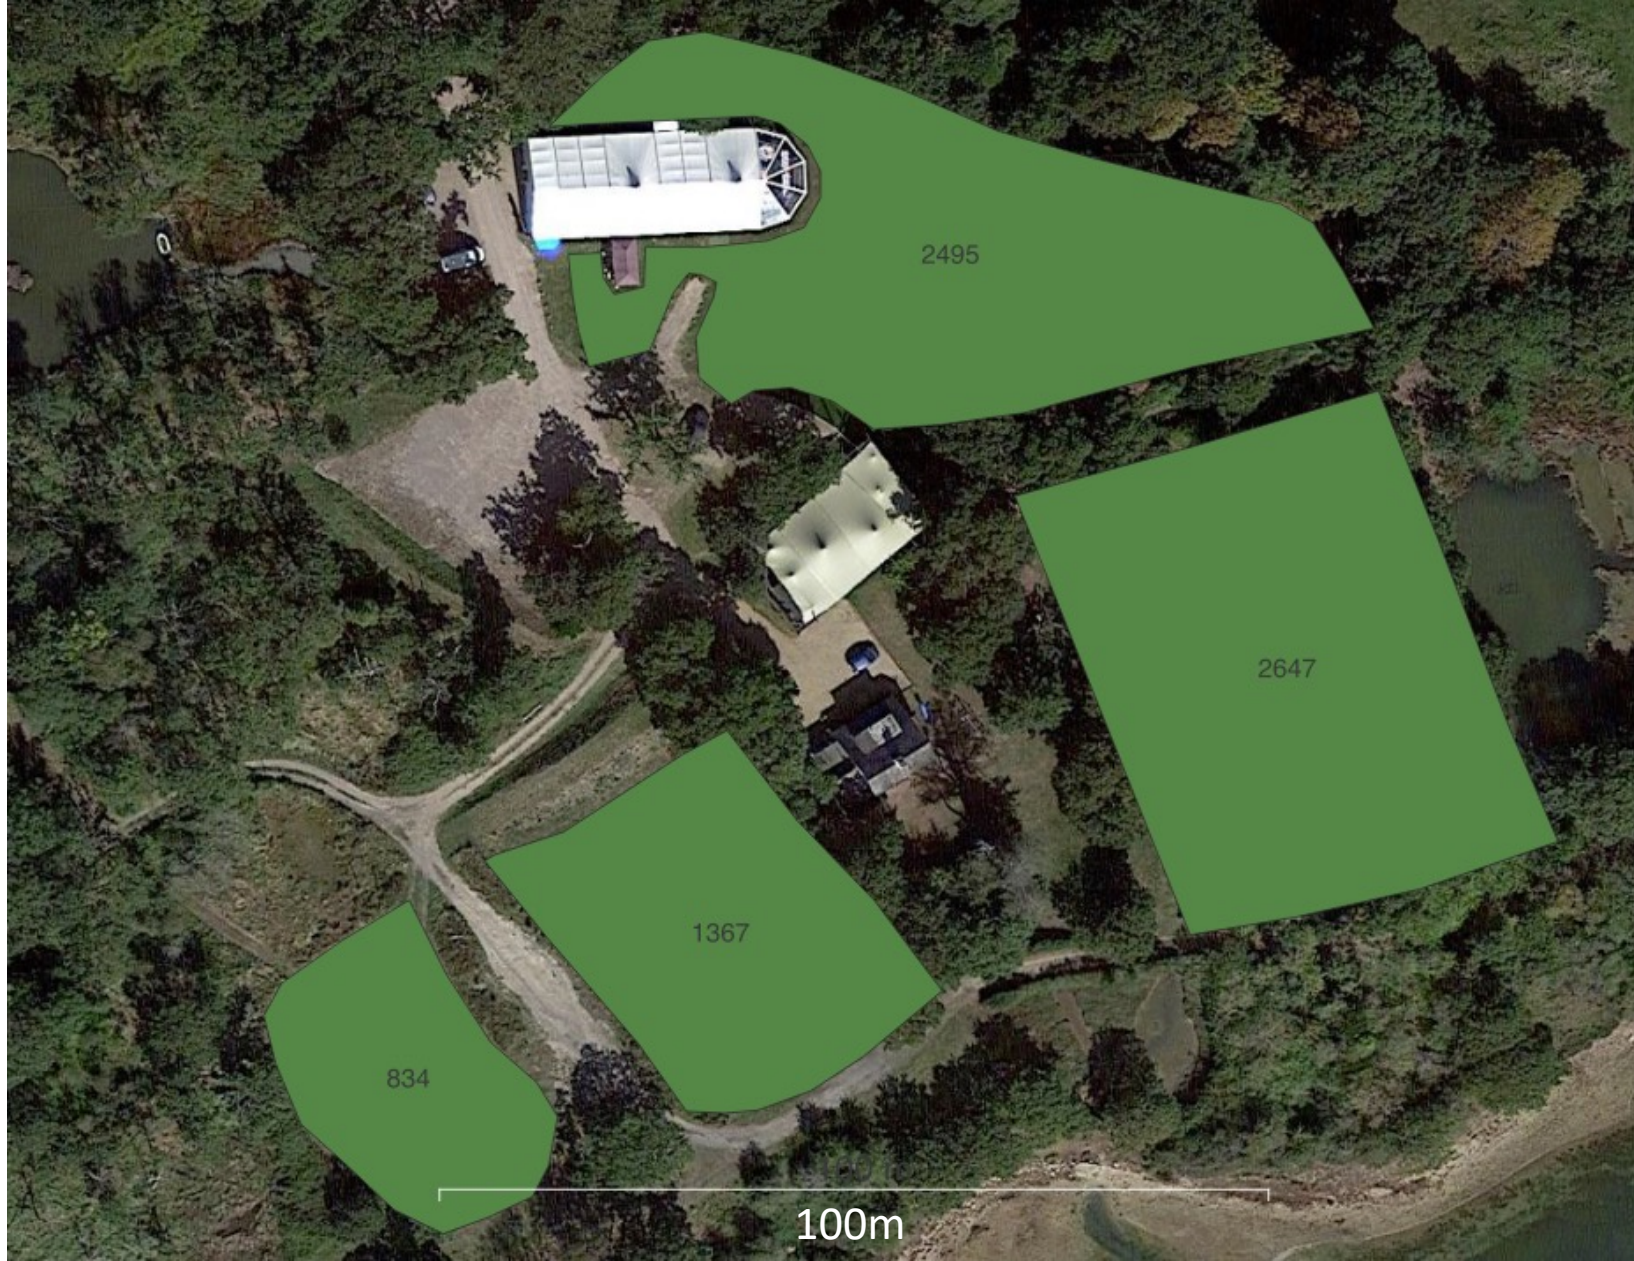
# ORNEC 1 & 5: cultivation/ mowing

Lawns area labelled in m2 shown left over 2019 satellite image

Lawns 1367 & 834 were created by tipping builders waste to raise the surface level and covered in imported earth, then seeded in: 1999 (lawn 834); and 2001-2 (lawn 1367)

Lawn 2495 was created by spring 2015 when the Marquee base was already in place.

**NO NATURAL ENGLAND CONSENT**

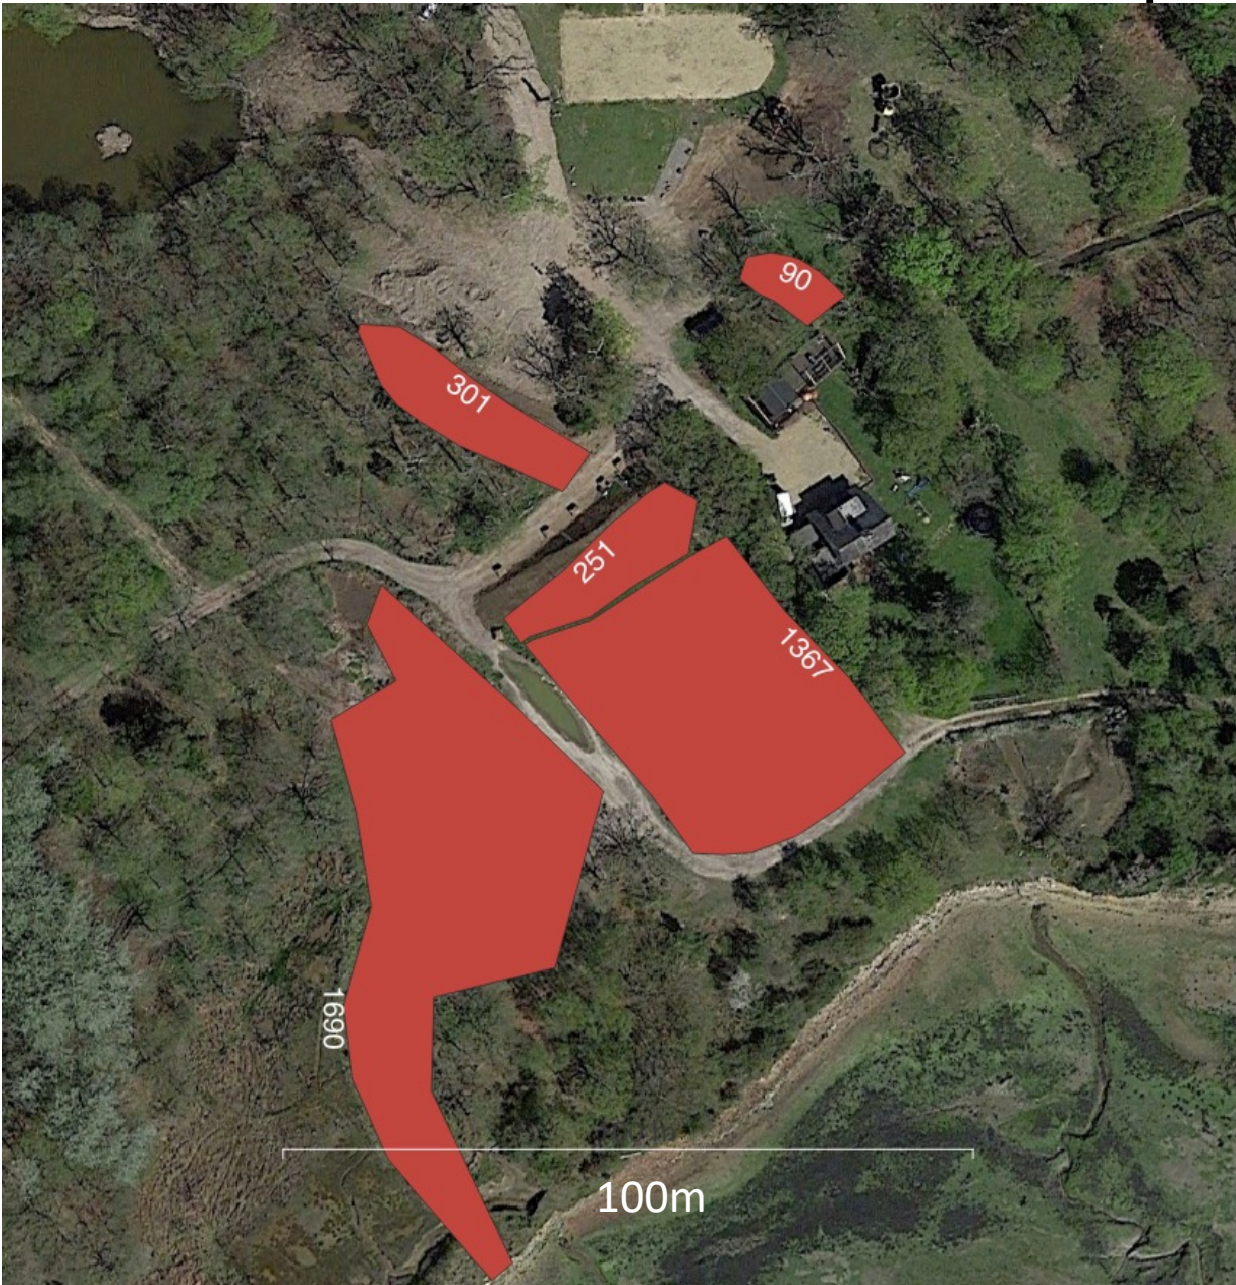
# ORNEC 8 & 21: dumping of materials

Earthworks area labelled in m2 shown left over 2015 satellite image showing gravel spreading under way

The earthworks in the map left were created by dumping builders’ rubble, covering it with earth and seeding it on the following dates:

- 1690 between 1999 and 2002
- 1367 is a raised lawn created in 2001/2
- 251/ 301 and 90 were created in spring 2015 when the marquee base was already in place

The dimensions of these earthworks are also visible in EA LIDAR DTM data. Dated ground photos also used to validate.

**NO NATURAL ENGLAND CONSENT**

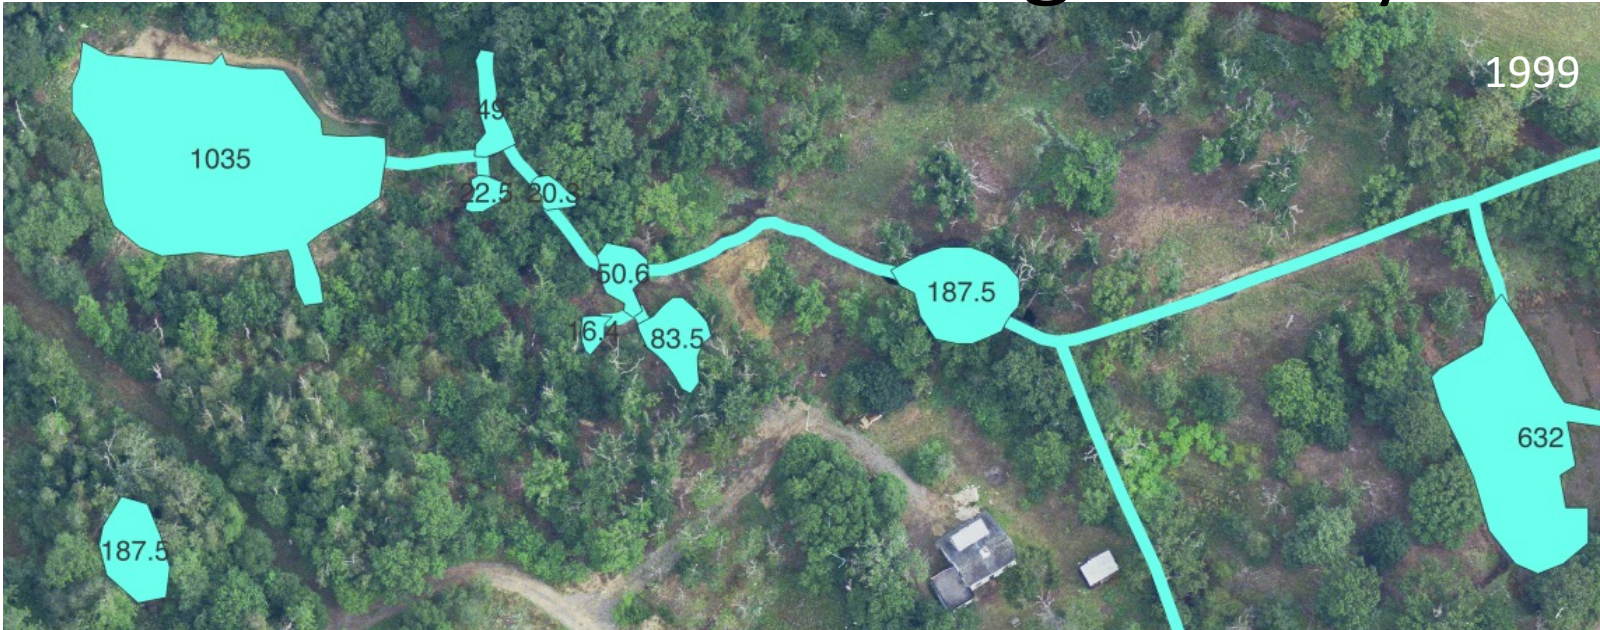
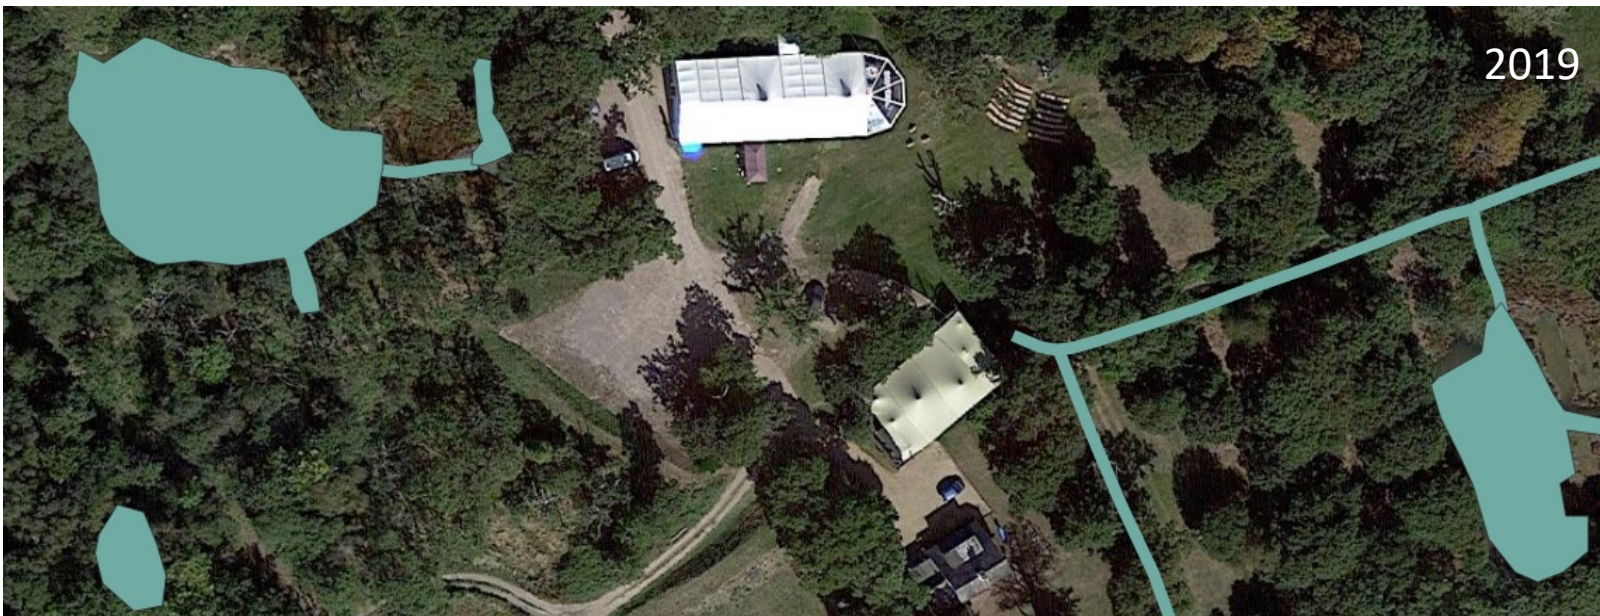
# ORNEC 18: Infilling of... dykes...ponds

Comparing waterbodies and watercourses clearly shown on 1999 satellite images with what can be seen in the 2019 image shows:

- watercourses 80m long have been infilled
- pools totaling 380 sq. m have been infilled

The infilling work was undertaken between 2013 and spring 2015.

NO NATURAL ENGLAND CONSENT

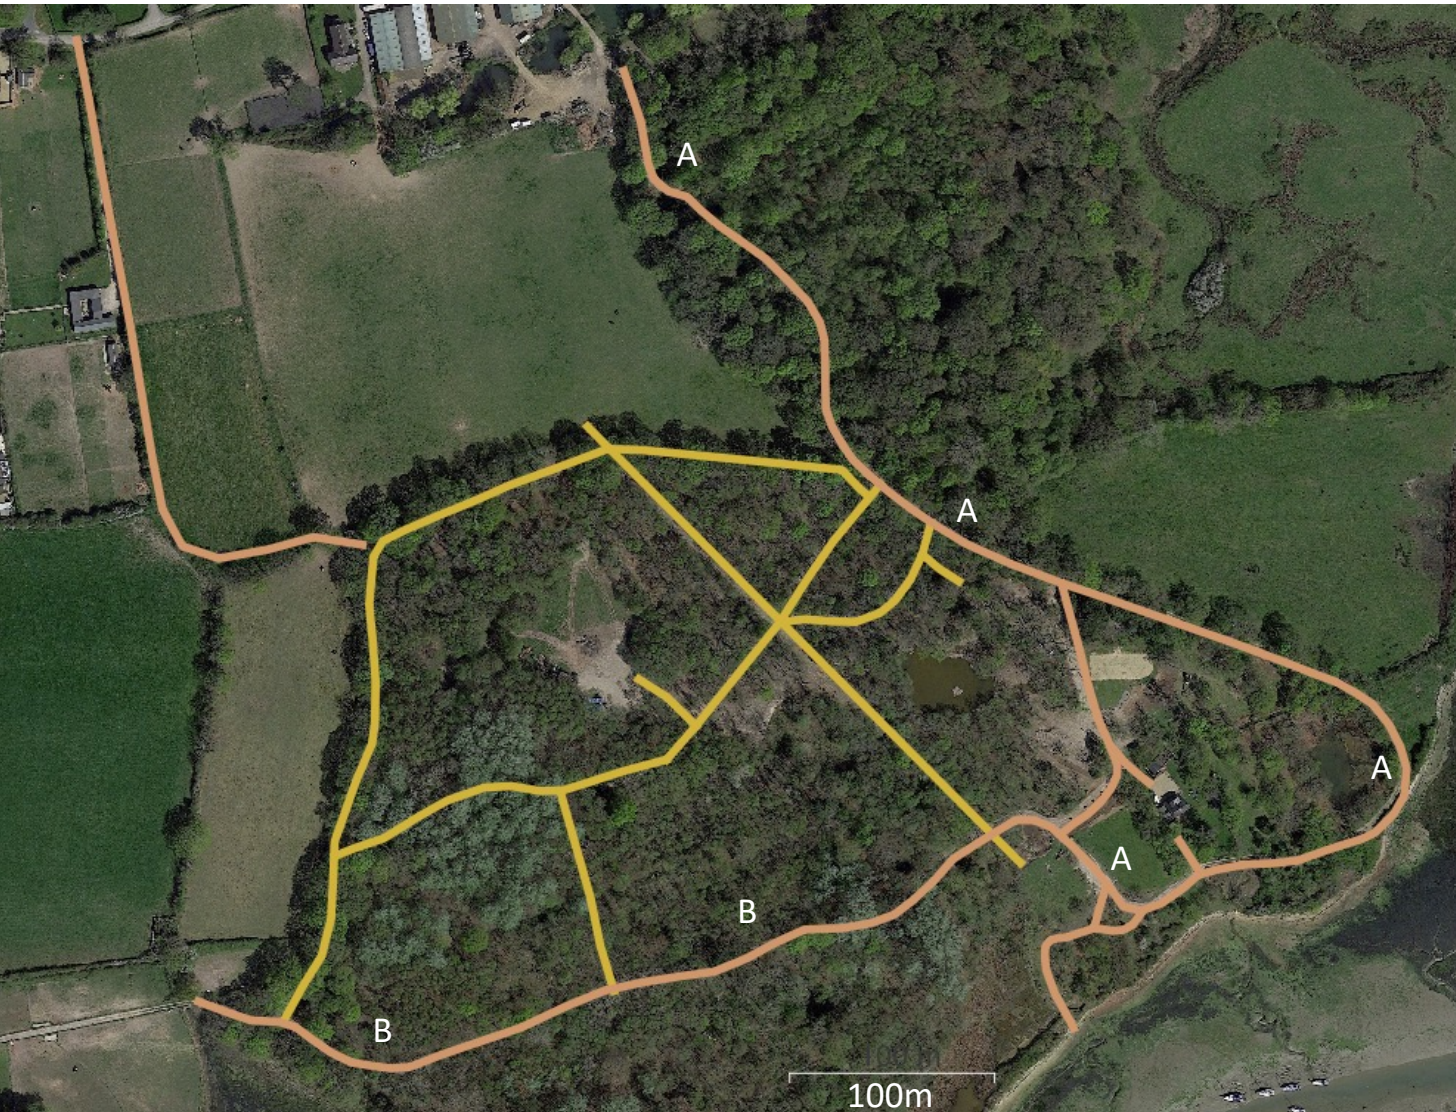
# ORNEC 25: construction

1997 SMS says: “Woodland tracks: these are mainly earth tracks and where waterlogging and rutting occurs, limited infilling with rubble is acceptable... Gradual change or upgrading of tracks is not acceptable from a nature conservation point of view”

Map left shows current tracks: orange are upgraded gravel tracks in breach of the SMS , yellow are mainly earth tracks. 2015 satellite image.

Track marked ‘A’ from Tournurbury Farm to Wood Cottage was upgraded throughout its length in summer 2001, a distance of 804m in total. Track B is also an upgraded gravel track 460m long.

NO NATURAL ENGLAND CONSENT

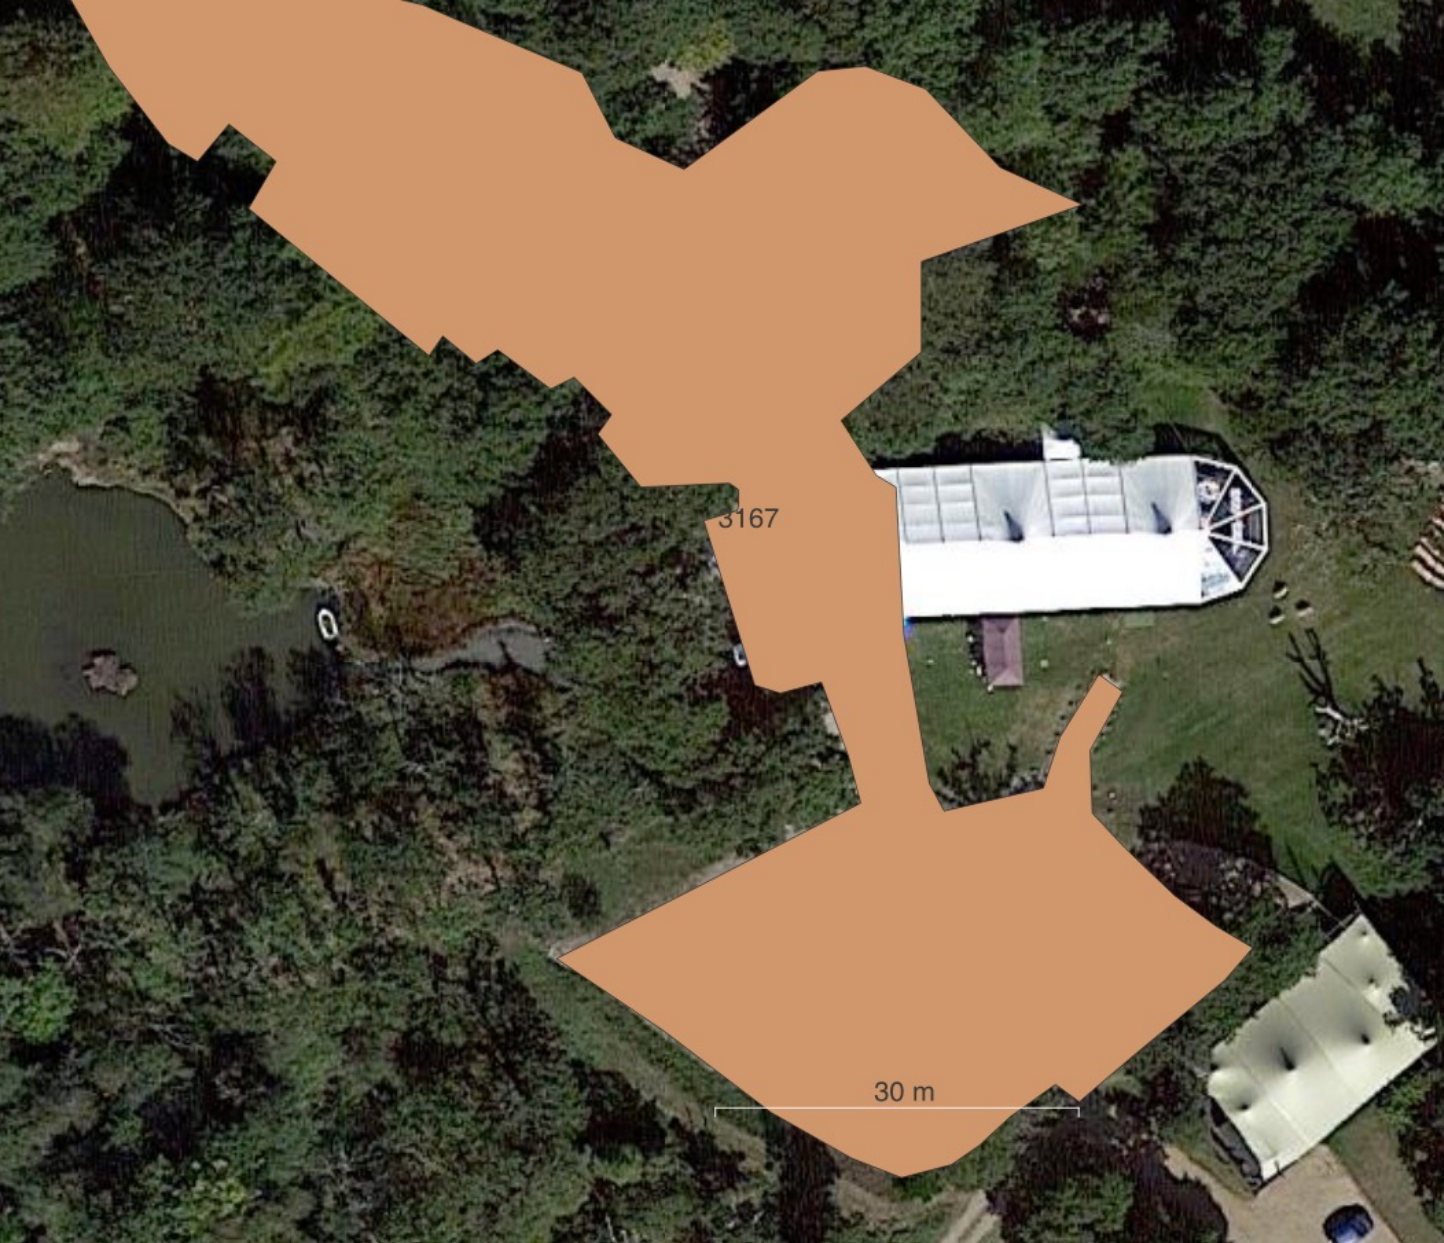
# ORNEC 25: construction

The gravel area of 3167 sq m has been created by importing scalpings to make a large car park between 2013 and spring 2015

Gravel parking area labelled in m2 shown left over 2019 satellite image.

Tournerbury Estate planning submission says that they have spaces for parking by 124 vehicles.

NO NATURAL ENGLAND CONSENT

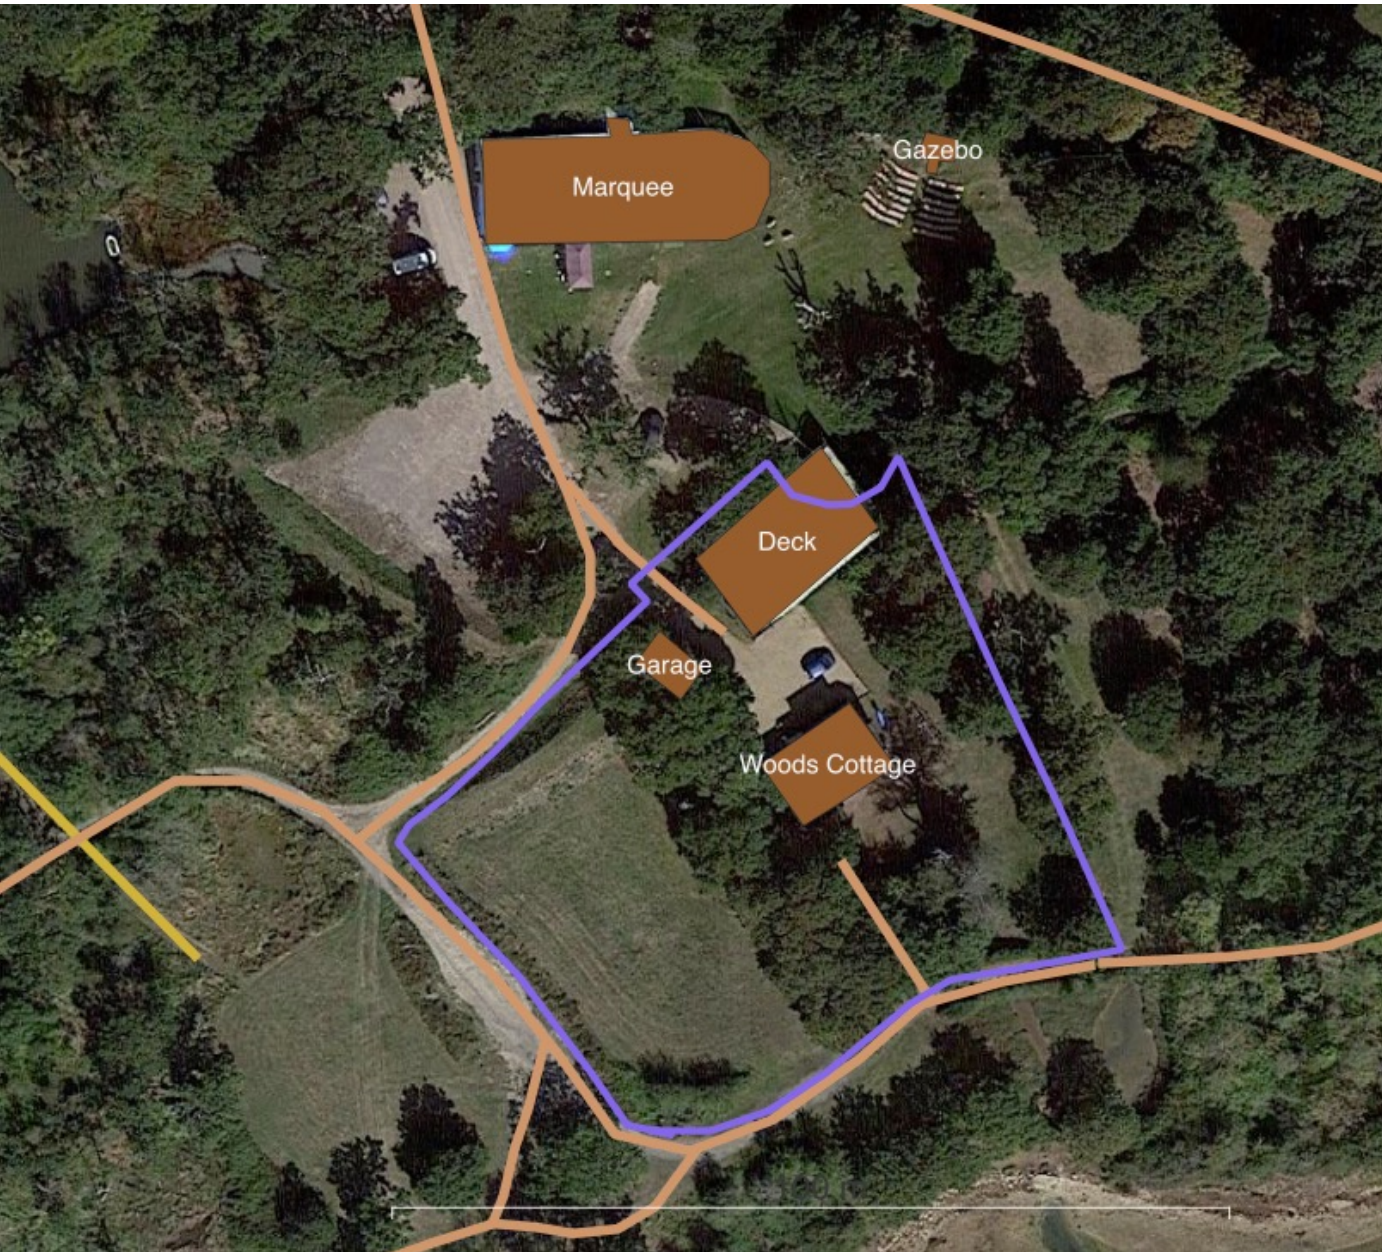
# ORNEC 27: Erection of structures

Buildings on wedding site shown left over 2019 satellite image. Purple area is domestic curtilage of Woods Cottage.

The marquee is a permanent structure with internal steel reinforcements. Photos available on the planning portal show this. The gazebo is also a permanent structure. The SMS does not consent these structures.

The deck area extends outside the domestic curtilage into an area of an infilled pond

**NO NATURAL ENGLAND CONSENT**

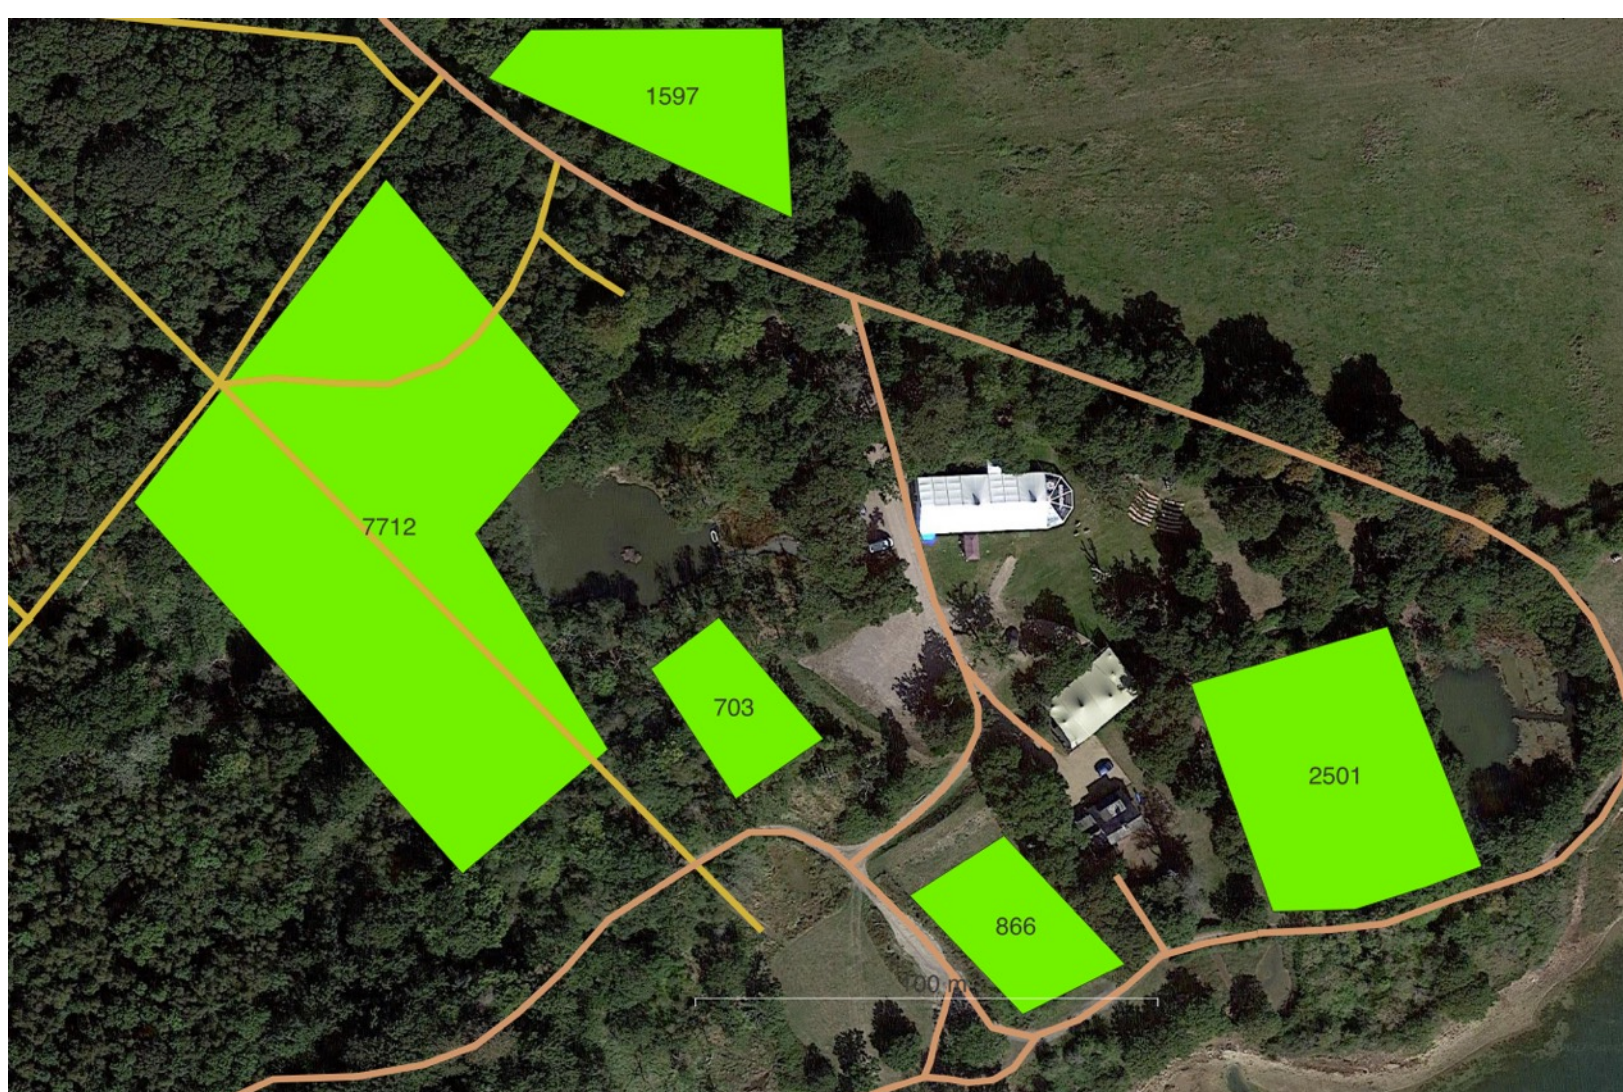
# ORNEC 27: Erection of structures

Camping areas shown at the left from Tournerbury planning submission over 2019 satellite image are used by overnighting guests at weddings.

The total area covered by camping pitches is 13379 sq. metres within the SSSI.

NO NATURAL ENGLAND CONSENT
