Portsmouth City Council

# Bunting Gardens, Waterloooville

Phase 2 Geo-environmental Factual and Interpretive Report

305258-R01 (01)

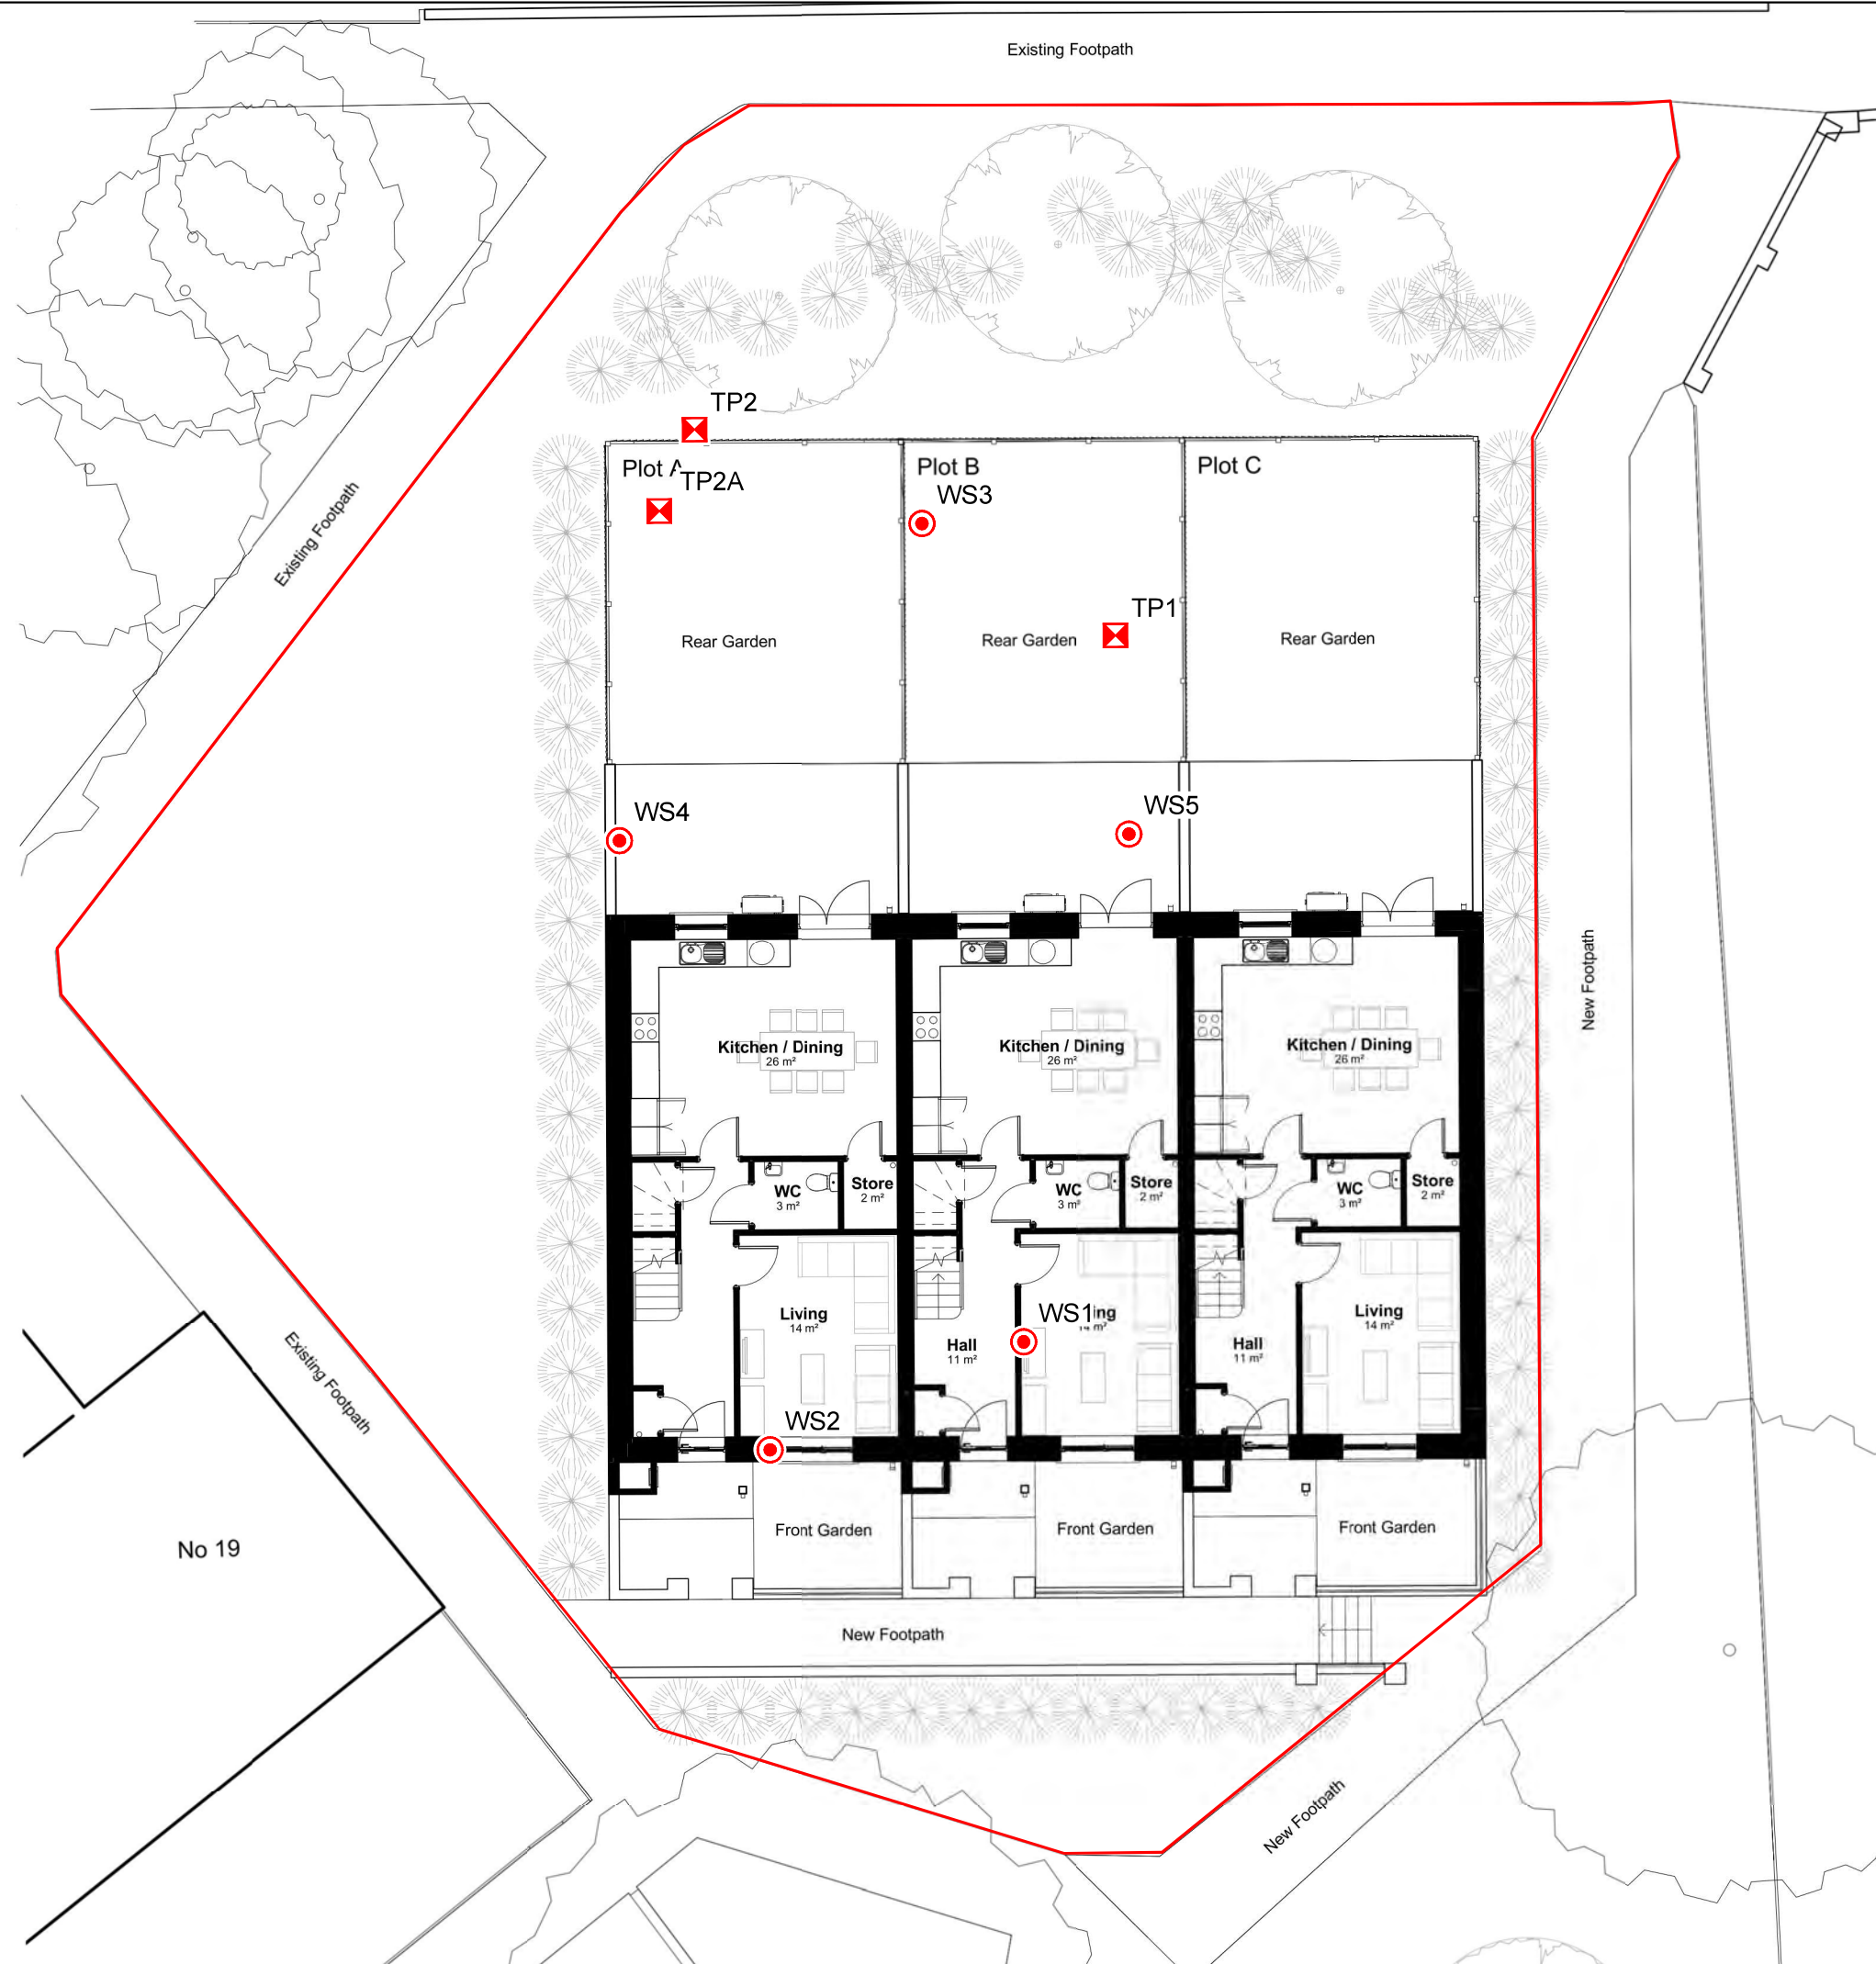
### **FIGURE 3 EXPLORATORY HOLE LOCATION PLAN**

- Site boundary
- Trial Pit Location
- Window Sample Location

Details of the investigation locations, installations and rationale are presented in Table . 3No. machine excavated pits were dug to a maximum depth of 2.60m bgl to facilitate infiltration testing and 5No. window sample boreholes were drilled to a maximum depth of 4.00m – 5.00m bgl with 3no. boreholes installed with a combined gas and groundwater monitoring well complete with a flush cover. An exploratory hole location plan is shown on **Figure 3**.
