Hampshire Homes Group

# Land at 31a North Street, Emsworth

Preliminary Risk Assessment

Project no. 305019

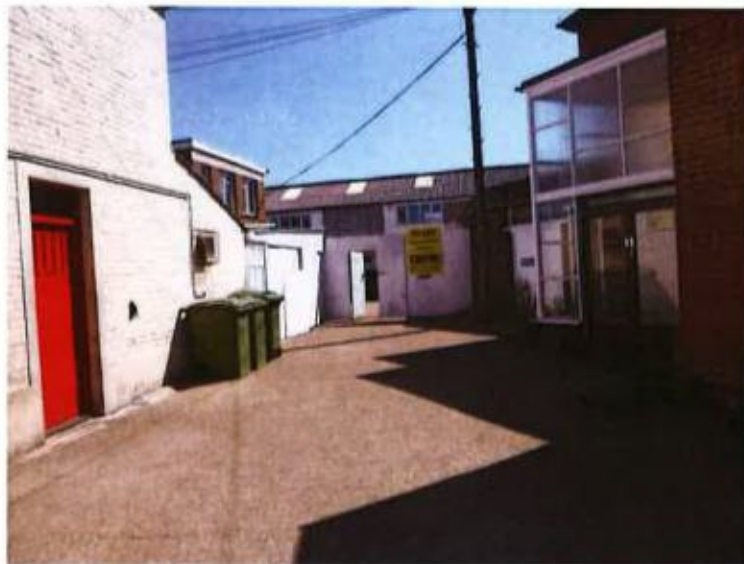
| Description:<br>View of the site entrance from North Street | |

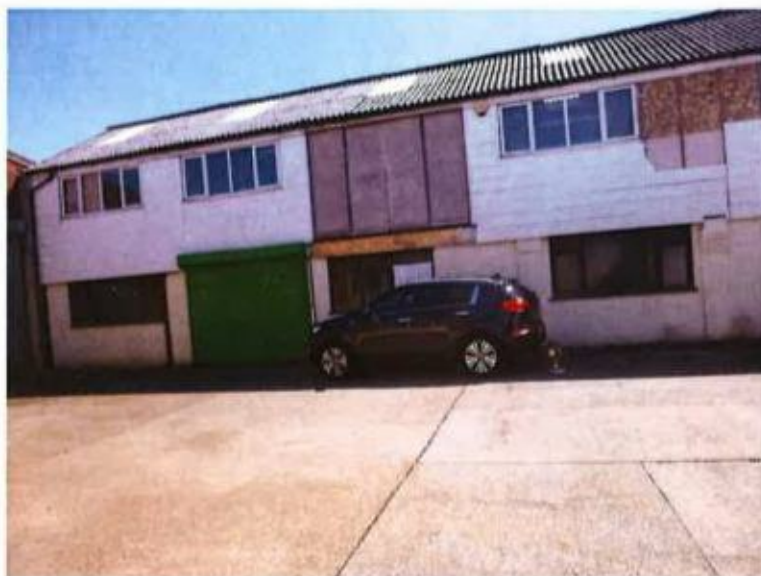
| Photo No.<br>2 | Date:<br>23/07/2018 |

| Description:<br>View of the central hardstanding area and the building along the eastern boundary | |

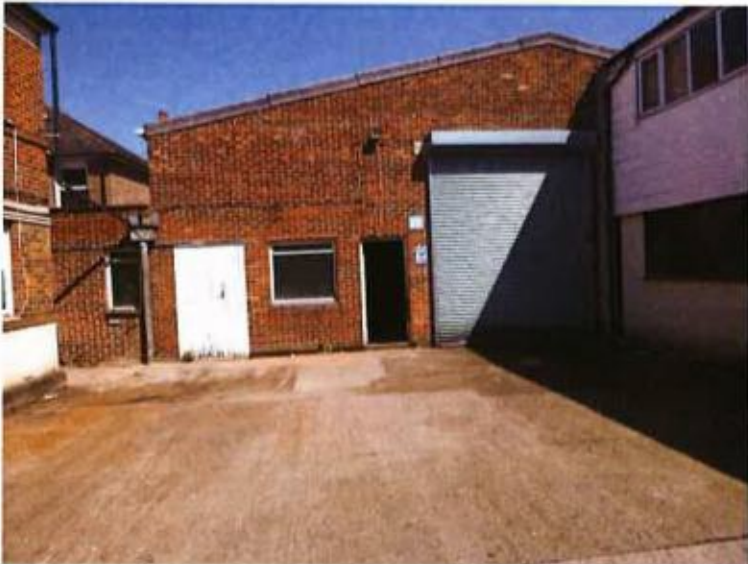
| Photo No.<br>3 | Date:<br>23/07/2018 | |

| Description:<br>View of the warehouse/workshop in the north of the site plus the remaining hardstanding courtyard | | |

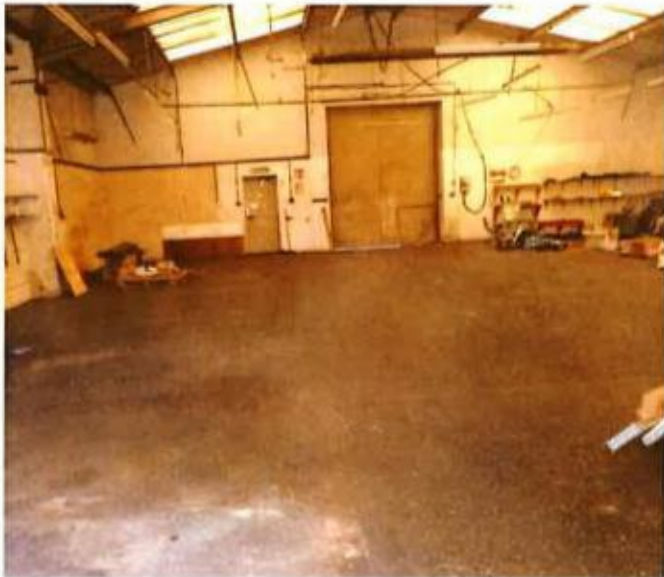
| Photo No.<br>4 | Date:<br>23/07/2018 | |

A number of vehicle parts were noted within the workshop, suggesting some vehicle maintenance has been carried out on site. No evidence of fuel or waste storage was noted. Areas of the workshop floor were noted to be stained with substances likely associated with the vehicle parts.

| Description:<br>View inside the workshop, showing minor staining on the hardstanding floor and vehicle parts in the north eastern corner | | |

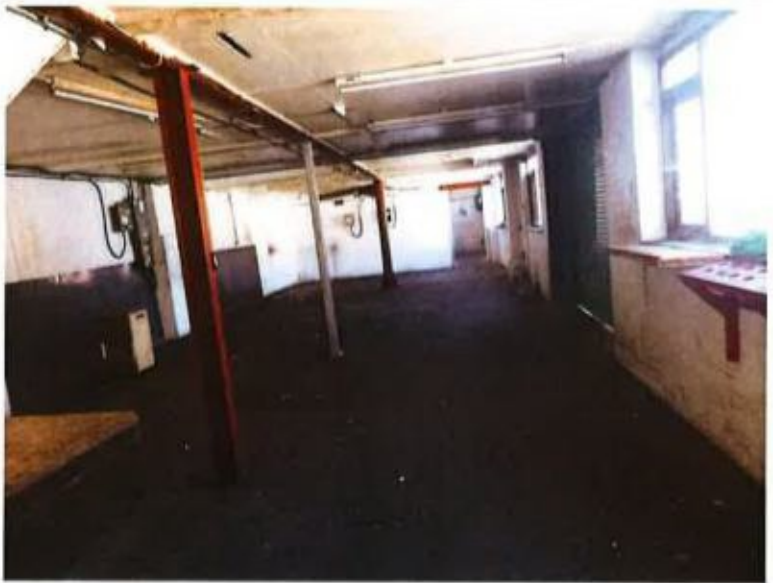
| Photo No.<br>5 | Date:<br>23/07/2018 | |

| Description:<br>View showing the ground floor of the workshop adjoining office block along the eastern boundary | | |

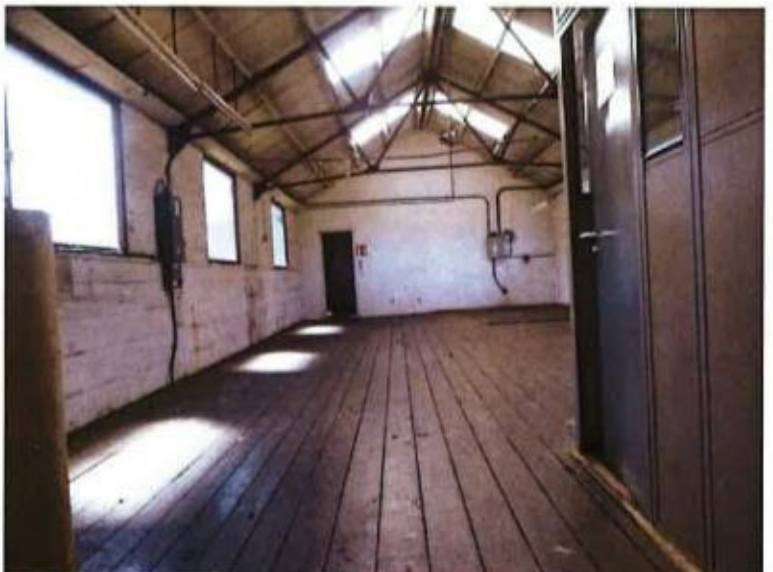
| Photo No.<br>6 | Date:<br>23/07/2018 | |

| Description:<br>View of the first floor of the workshop adjoining office block along the eastern boundary | | |

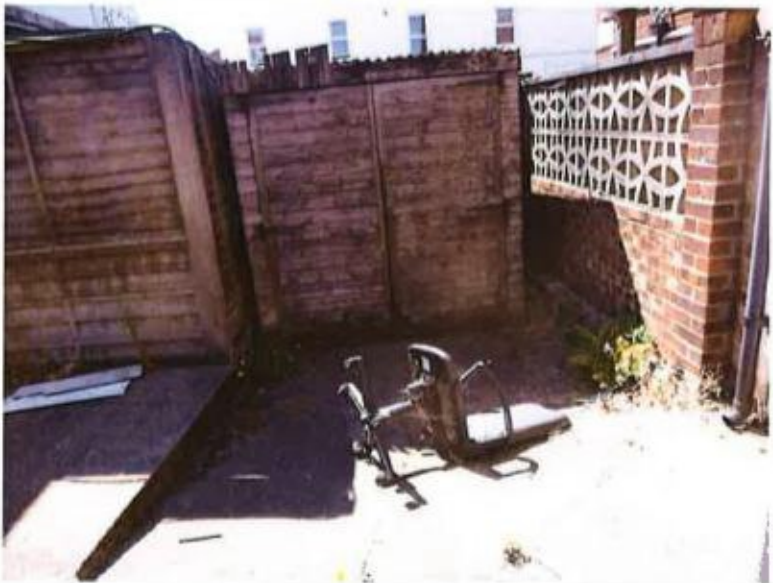
| Photo No.<br>7 | Date:<br>23/07/2018 | |

| Description:<br>View showing the shed in the south of the site and the level change noted in the site walkover. | | |

| Features | Description | Photo no. | Map ref. |
|---|---|---|---|
| j) Note any abrupt changes in ground level. Is there evidence of Made Ground/fill on site<br><i>May indicate that minerals have been worked in surface excavations. May indicate cut and fill.</i> | Level change to shed as previously noted. | | |

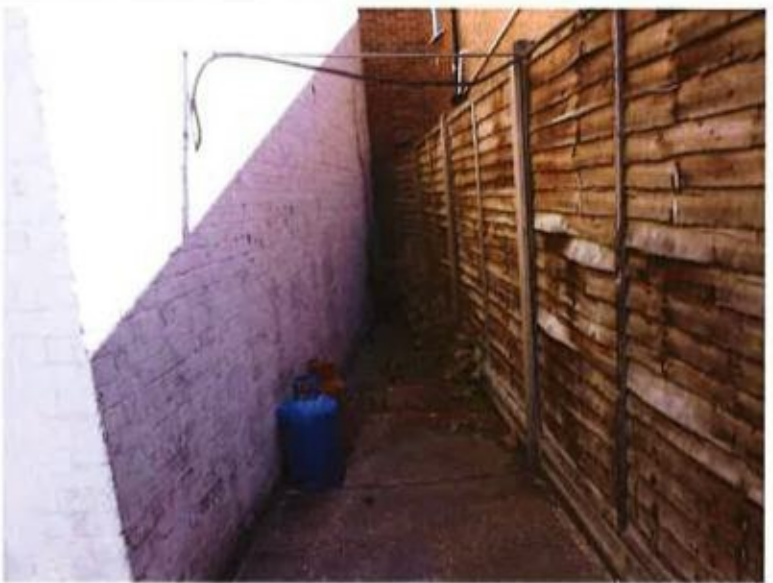
| Photo No.<br>8 | Date:<br>23/07/2018 | |

| Description:<br>View showing the butane bottles to the south of the commercial building in the east of the site. | | |

| Features | Description | Photo no. | Map ref. |
|---|---|---|---|
| r) Describe storage of fuels and chemicals. Are there any drums/containers (if yes, describe quantity, full/empty, stored on hardstanding/softstanding, banded)?<br><i>Is there evidence of underground fuel tanks (if yes, describe locations, how many, volumes, bunding, used/disused, condition)?</i> | Site heating run off mains gas. Hot water heated electrically using wall mounted heaters. No access to office to confirm.<br>2 gas bottles noted within east of site to side of warehouse unit. | | |
