WSP Environmental Ltd was instructed by Jones Lang LaSalle to undertake a Phase I Environmental Assessment of Langstone Technology Park, Havant, Hampshire, PO9 1SA, UK. The report highlights environmental considerations, predominantly with respect to ground conditions, and is required as part of the proposed purchase of the freehold interest in the site. Please refer to Appendix F for WSP's Methodology and Limitations.

# SITE BUILDING PLAN

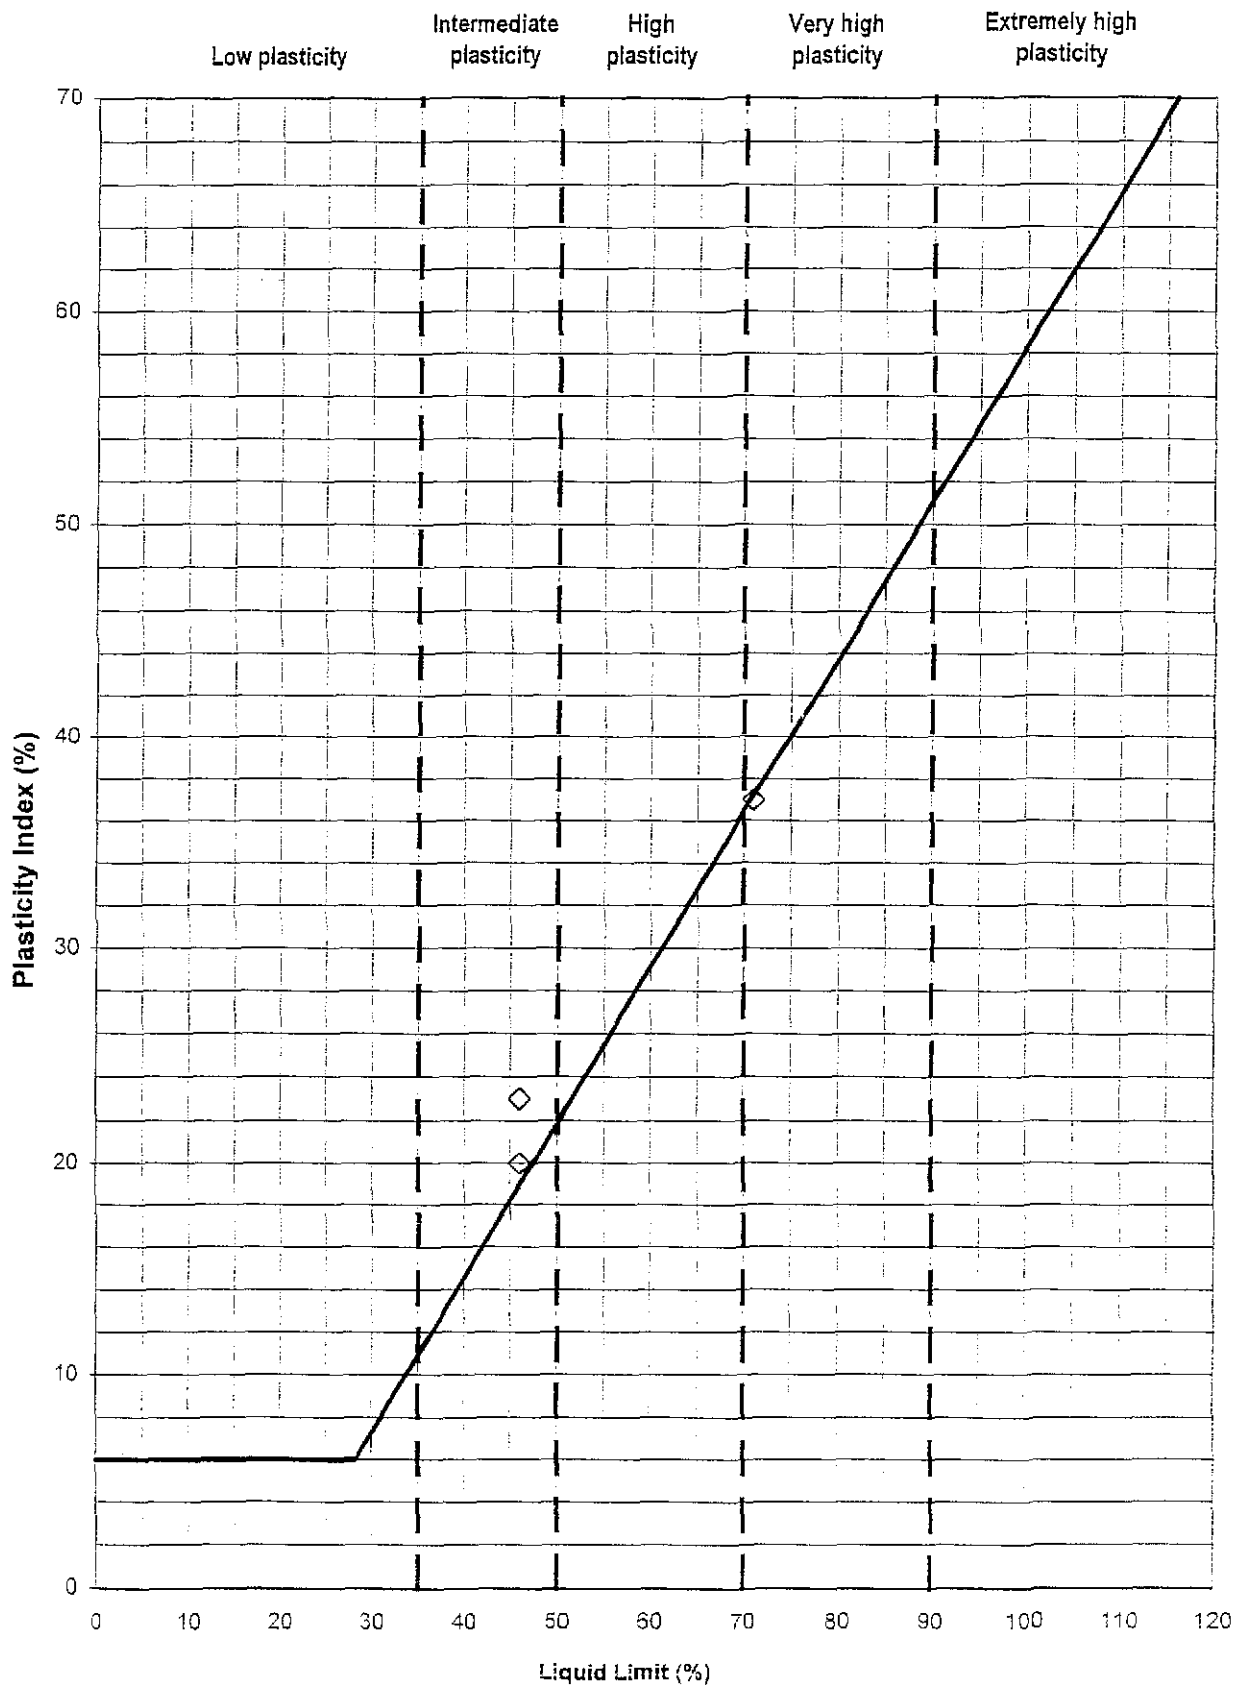
Figure: 13

## PLASTICITY CLASSIFICATION CHART

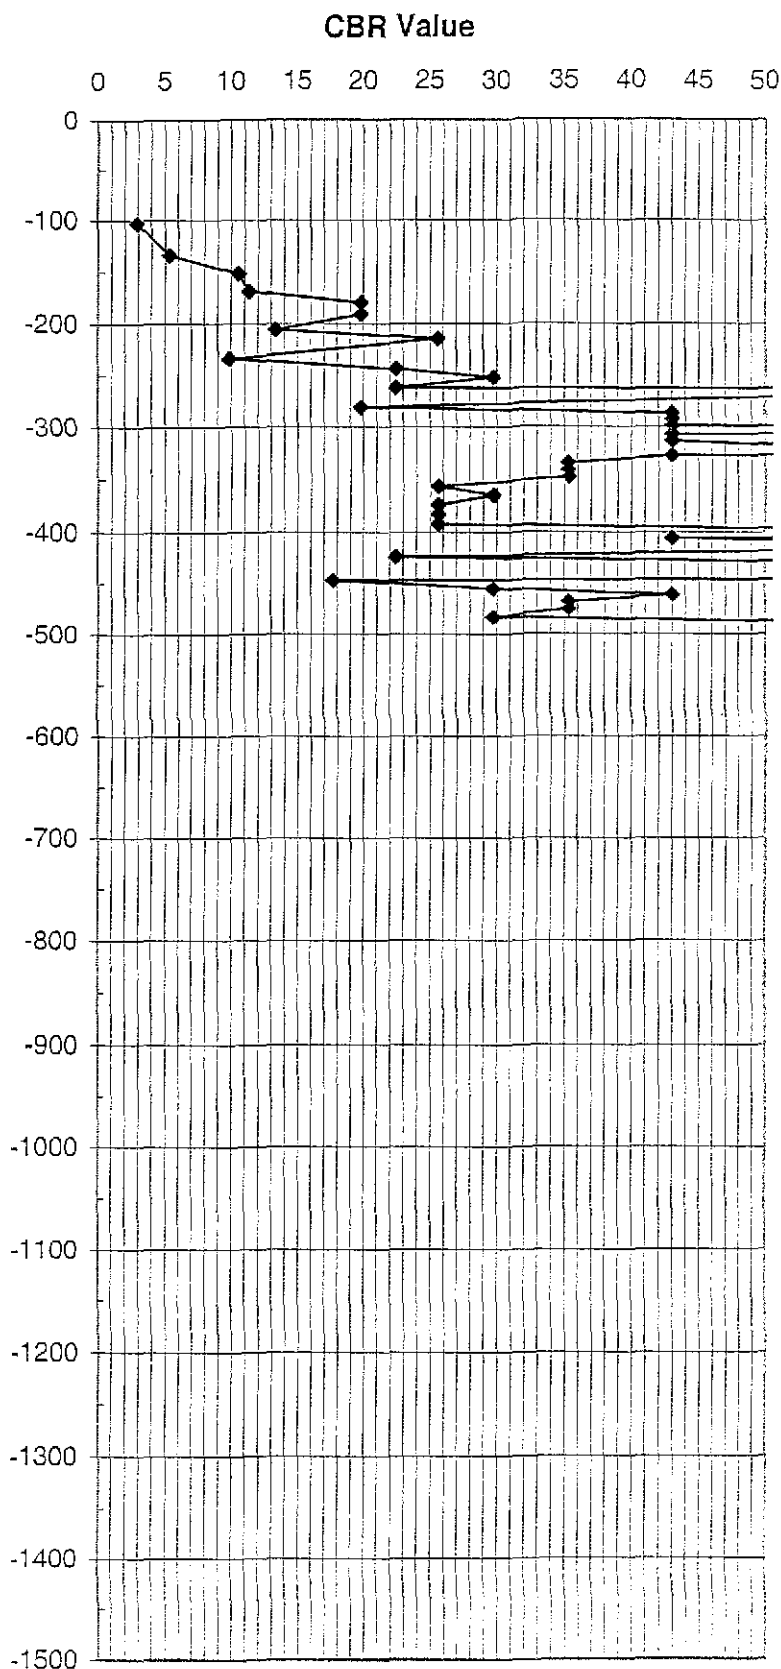
Test complete to 500mm depth.

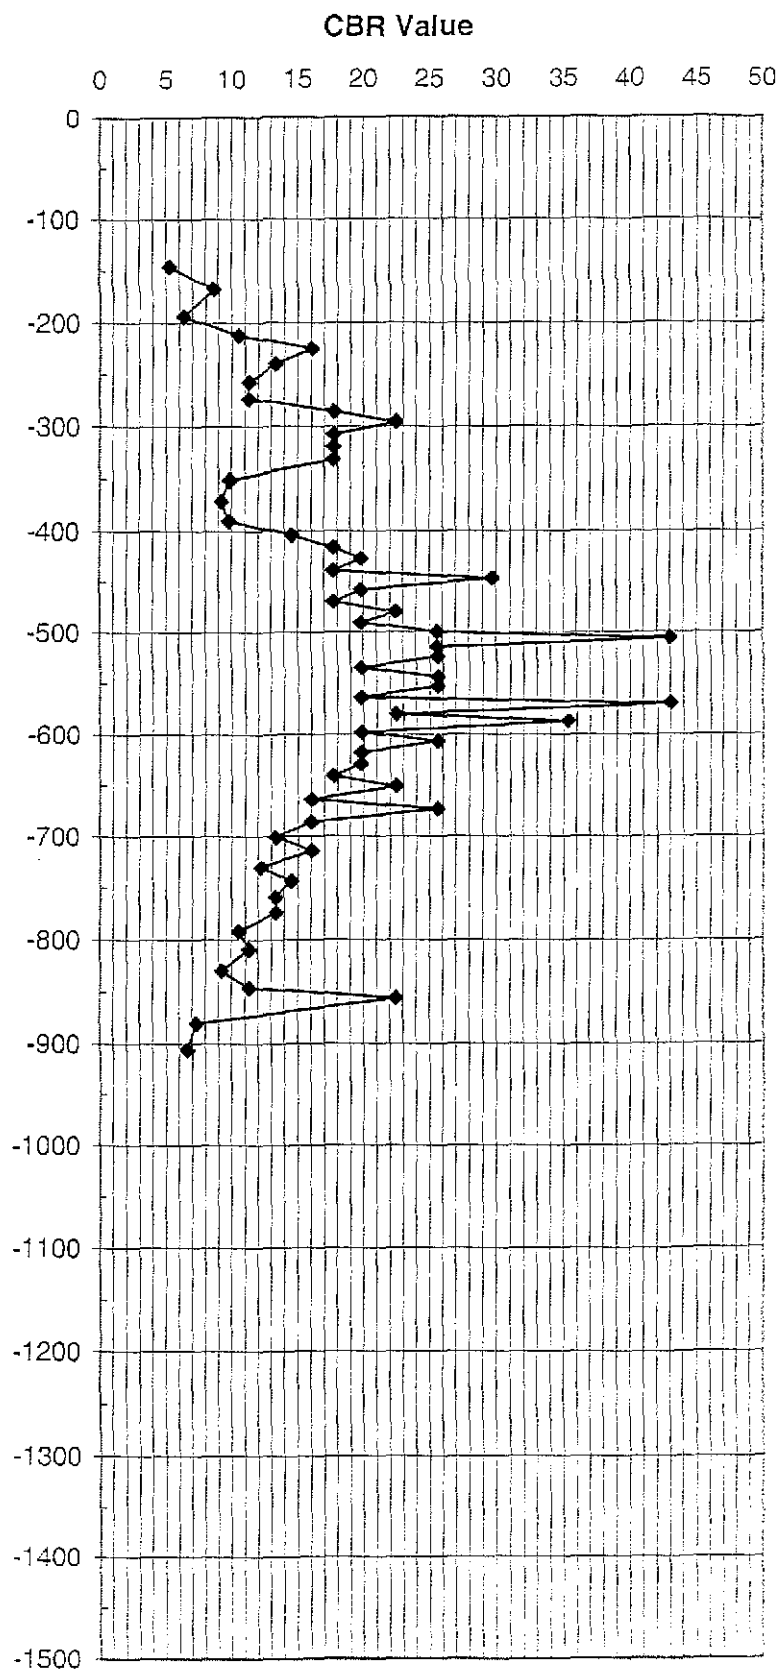
Test complete to 906mm depth.

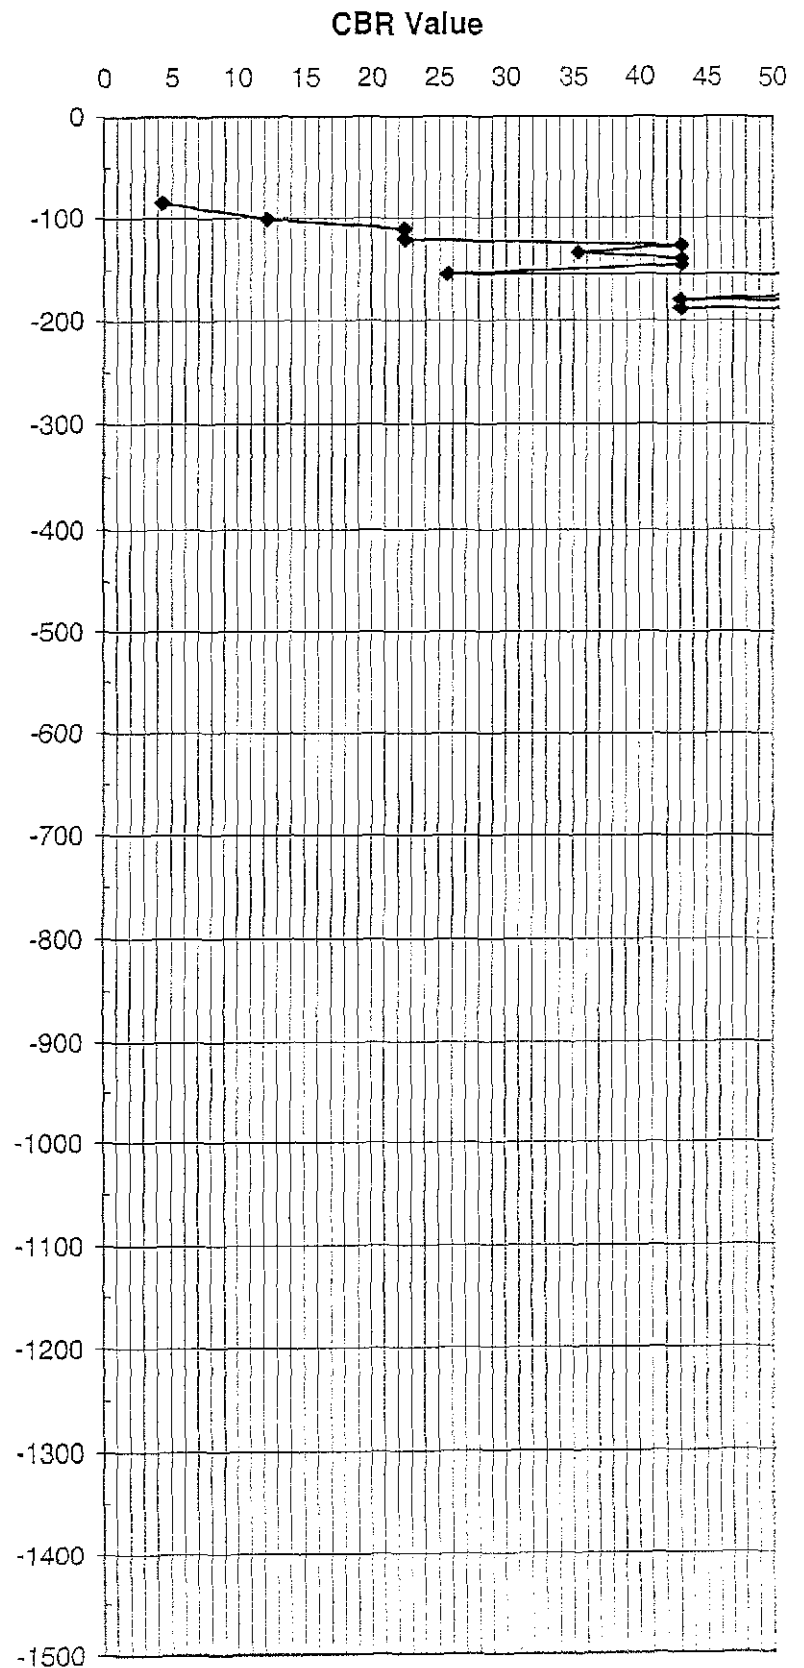
Test refusal at 213mm depth due to flint fragments.

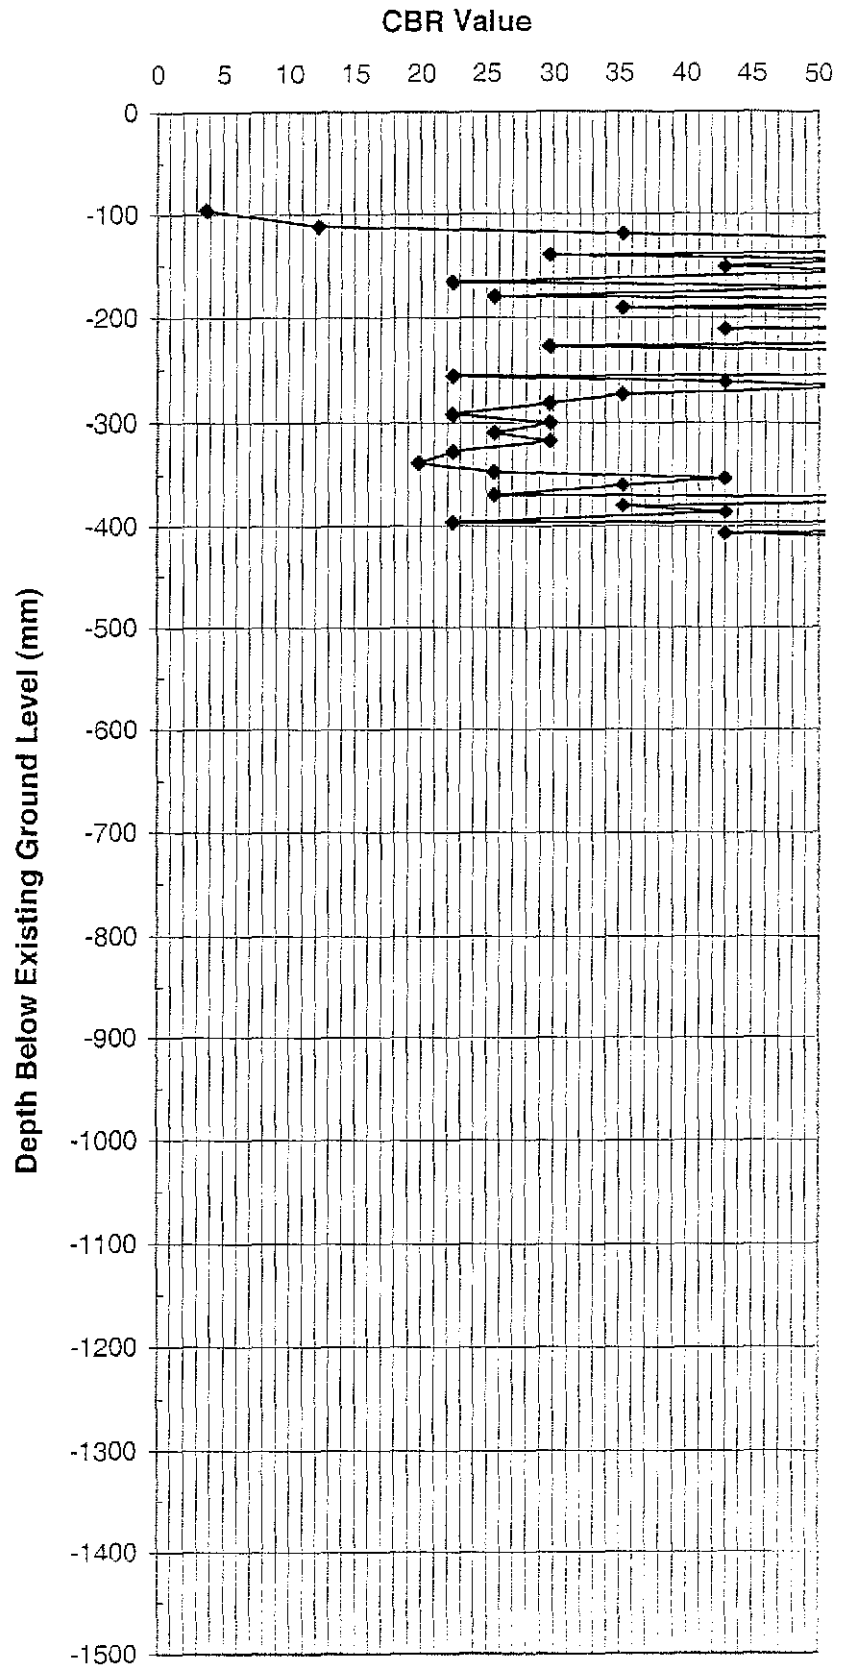
Test complete to 532mm depth.

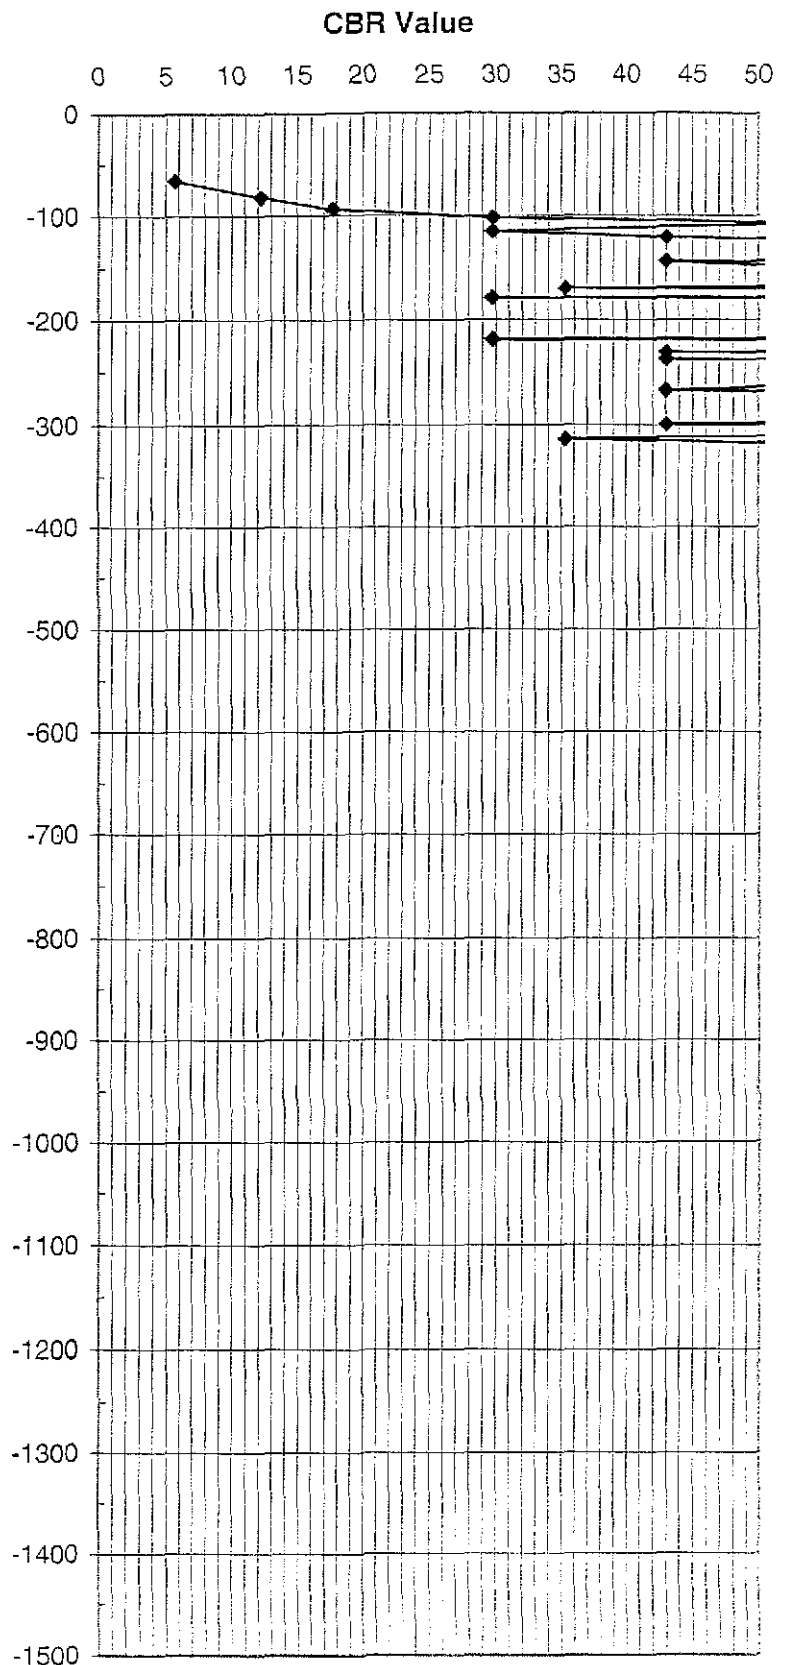
Comments: Test refusal at 331mm depth due to flint fragments.

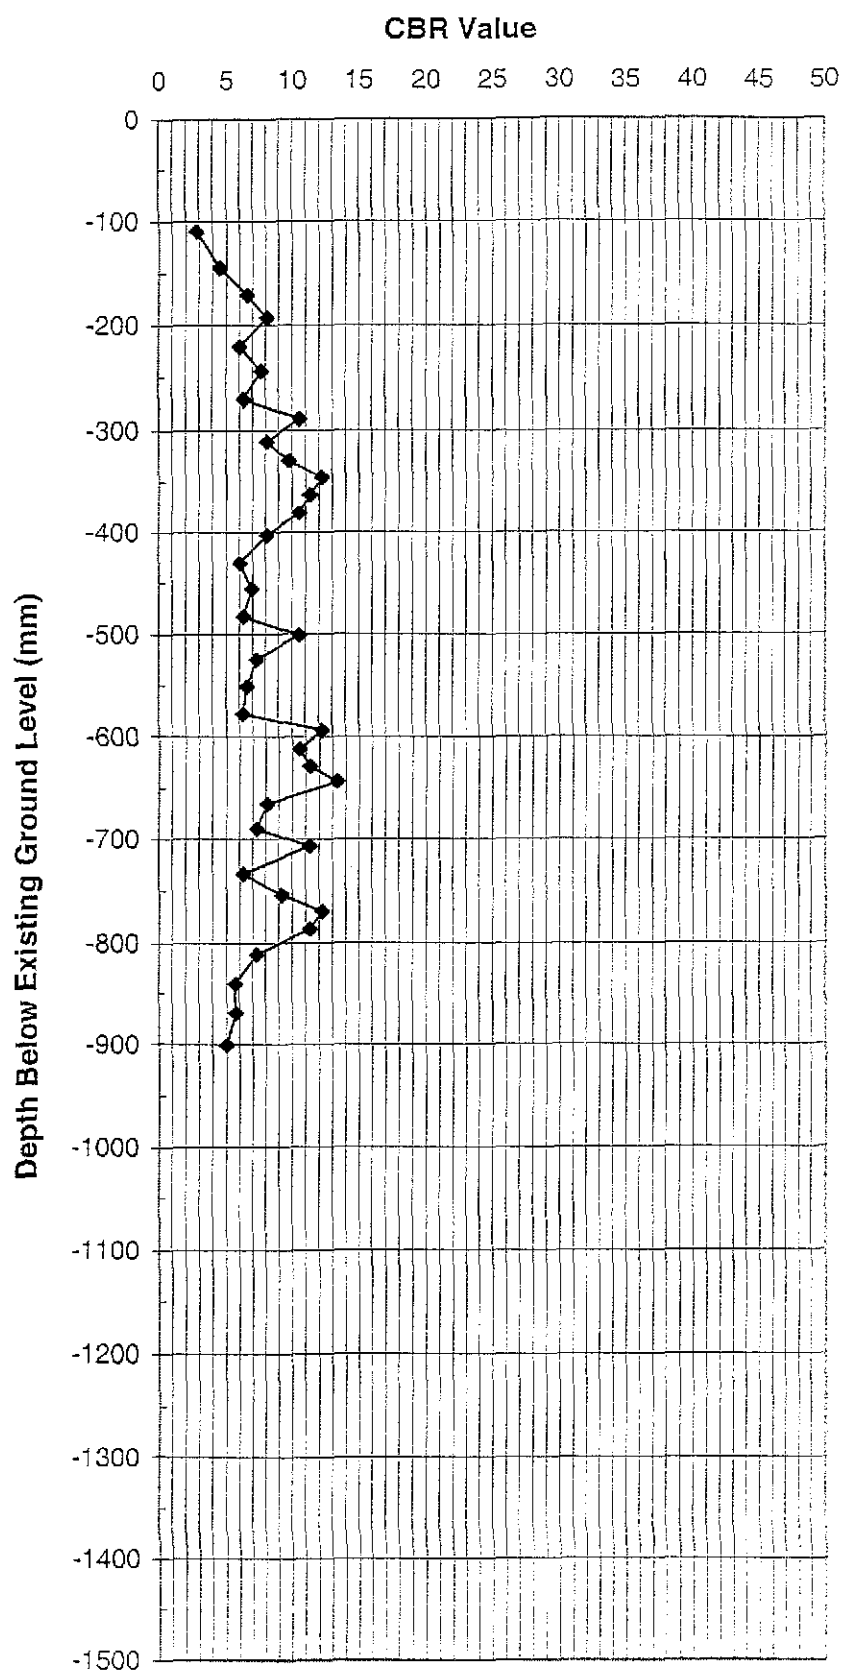
Test complete to 901mm depth.

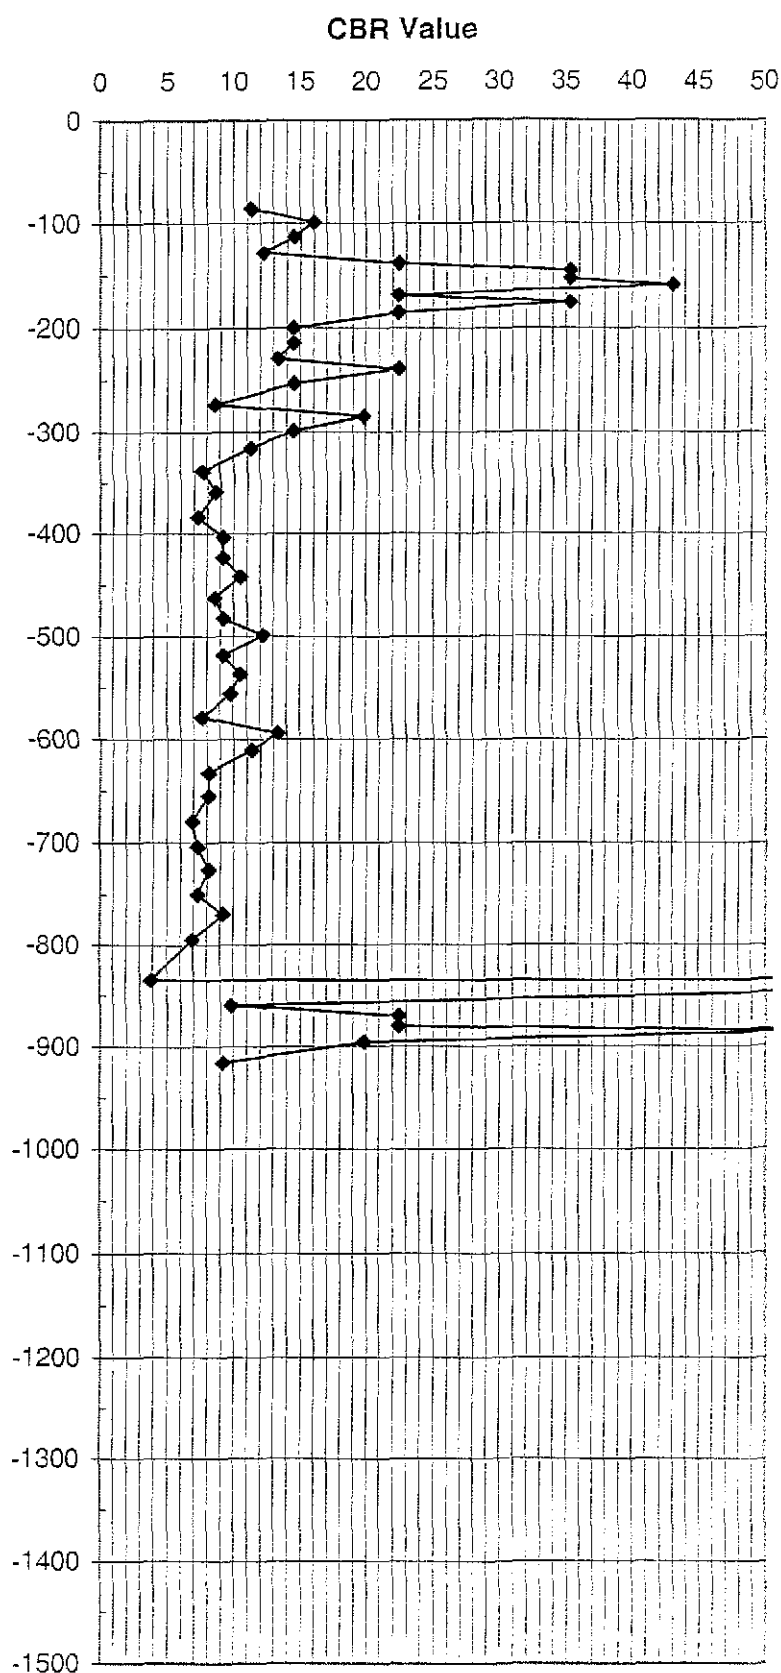
Test complete to 936mm depth.

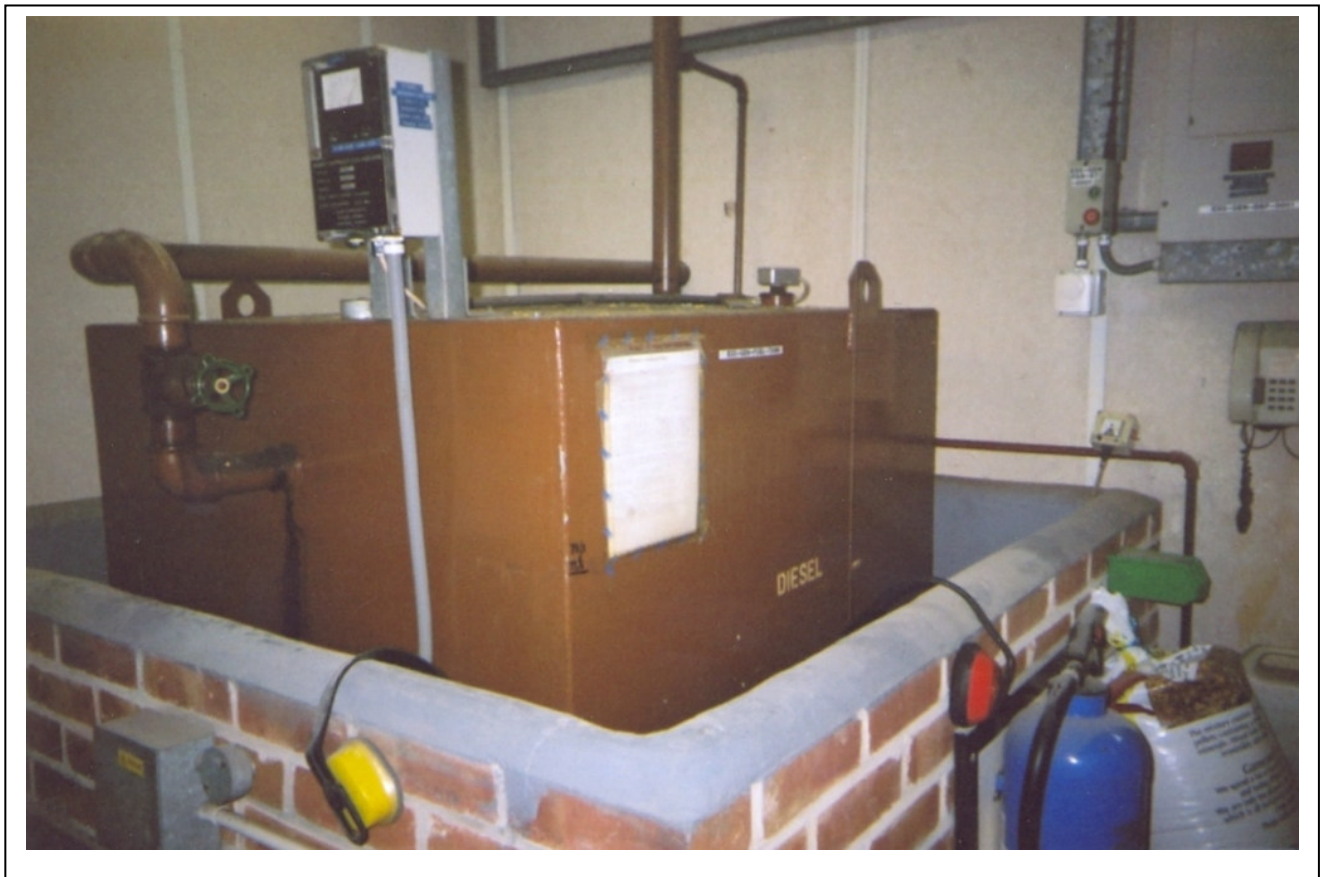
PLATE 2:

- The site representative stated that there are no below ground storage tanks and no evidence of such tanks was noted during the site reconnaissance.
- An above ground diesel tank was observed to be in use within the essential services back up generator house located between Building 3000 and 4000. The tank capacity was approximately 2000 litres and was noted to be contained within a brick bund in good repair. The onsite representative reported that a previous assessment had confirmed the bund as being greater than 110% of the tanks capacity. The fill point for the tank was observed to the exterior of the Building, no staining was observed upon the good quality hardstanding within the room or around the fill point. See Plate 2 within Appendix B

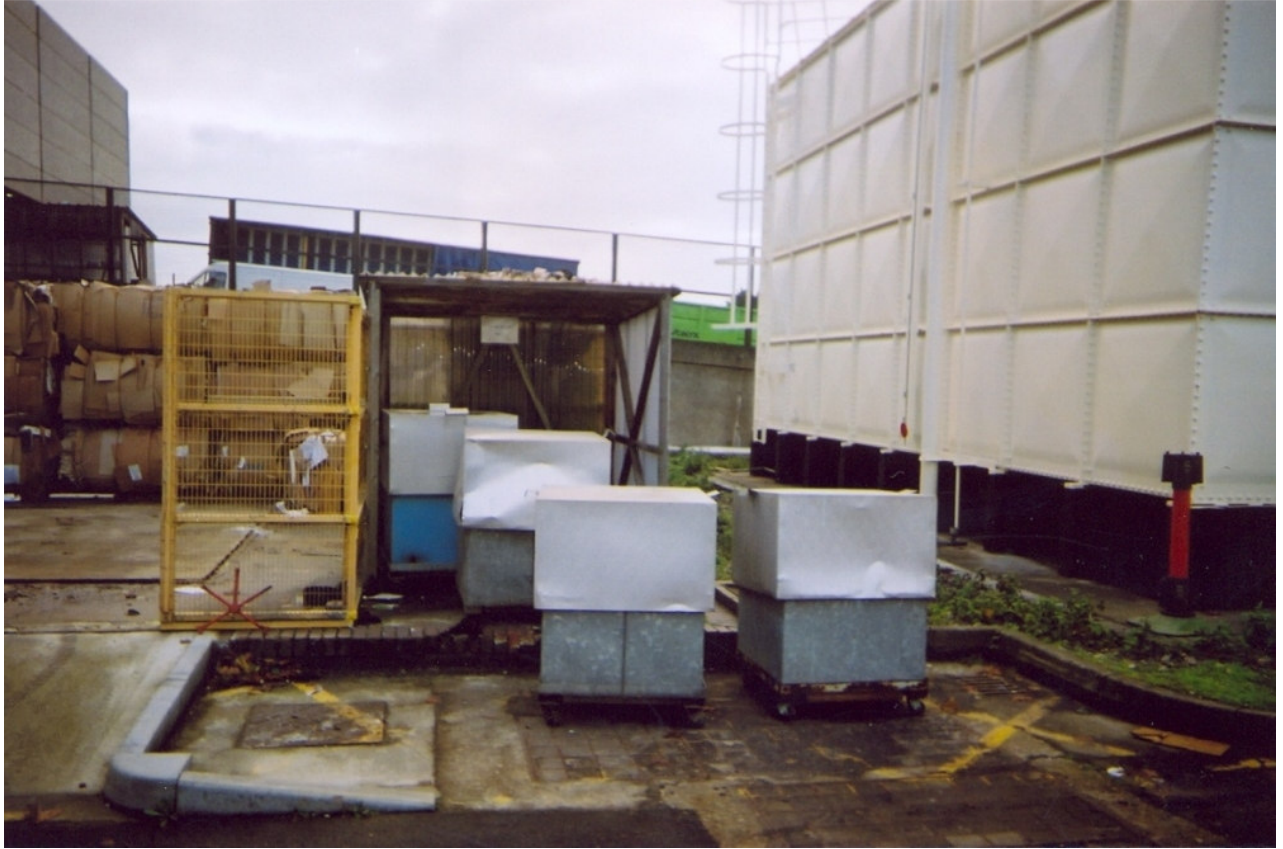
PLATE 3:

- A number of full and part used 250 litre diesel drums were observed on site, however, all were contained within mobile bunds See Plate 3 within Appendix B
