# **Frontier Estates**

## **Infiltration Test Report**

**The Cowplain School  
Hart Plain Avenue  
Waterlooville  
Hampshire  
PO8 8RY**

**Report No: 21.02.014a  
August 2021**

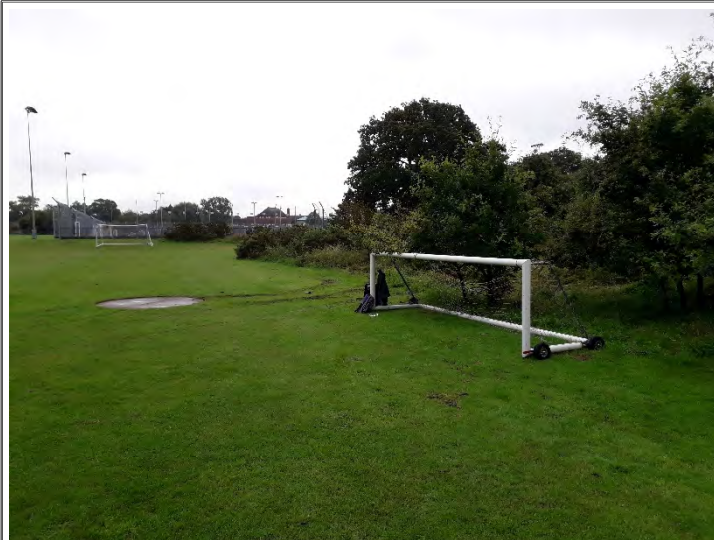
Towards the site from the west (near to TP01)

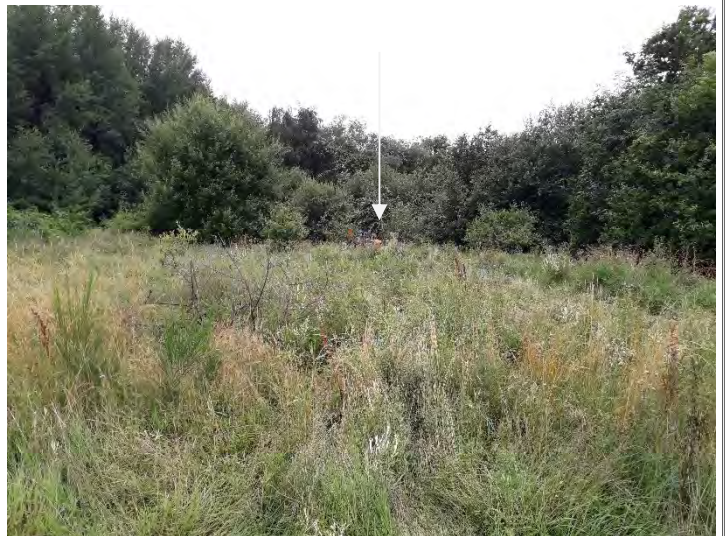
Trial pit TP02 was at a lower elevation, located towards the bottom of the basin-like feature on the site and this may account for the absence of the Head deposits there.

Towards the site from the south (and TP02, arrowed)

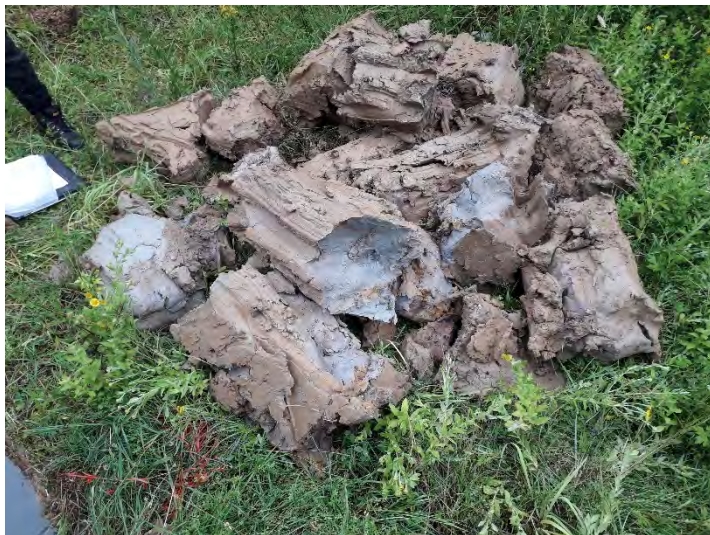
London Clay was encountered to the base of both trial pits (from depths of 0.75m in TP01 and 0.05m in TP02) and comprised stiff, fissured, brown and orange-brown, veined blue-grey, clay.

Typical clay arising

The low permeability clay soils encountered strongly indicates that conventional soakaways will not be viable and that an alternative form of drainage will have to be adopted.

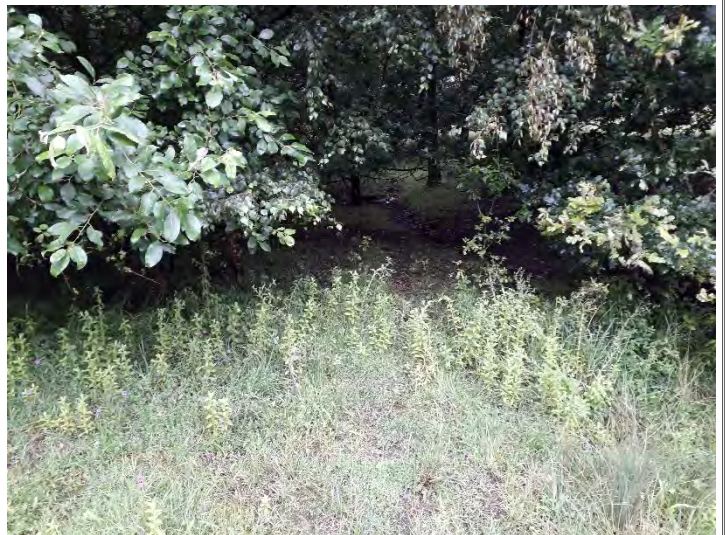
The site contains a manhole above a concrete chamber that is connected to evident ditches at surface. The precise location of this chamber and the direction of the ditches were not readily determinable due to the dense vegetation. Internal inspection of the chamber was not attempted, but it appeared to be typical of those above soakaways.

Existing ditch leading to possible soakaway chamber

It may be beneficial to undertake further investigation of the suspected soakaway installation within the site.

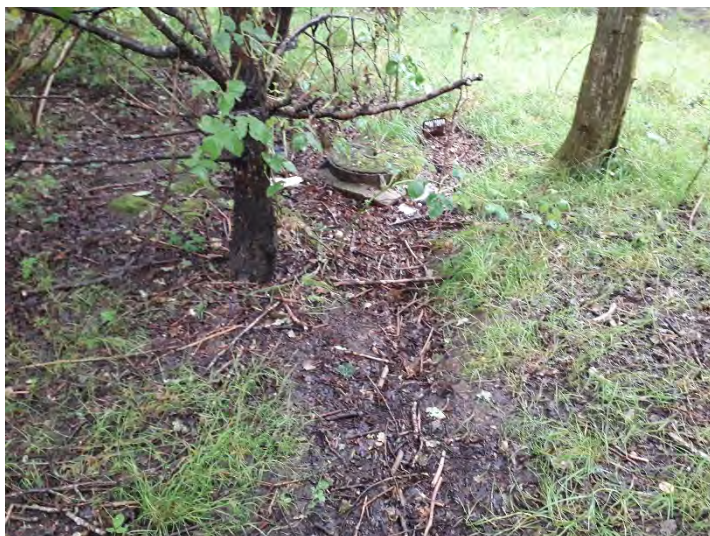
Possible soakaway chamber
