# Langstone Park, Masterplan

## Land Quality Assessment

Project Ref: **13023**

Report Ref: **13023/AB/LQA**

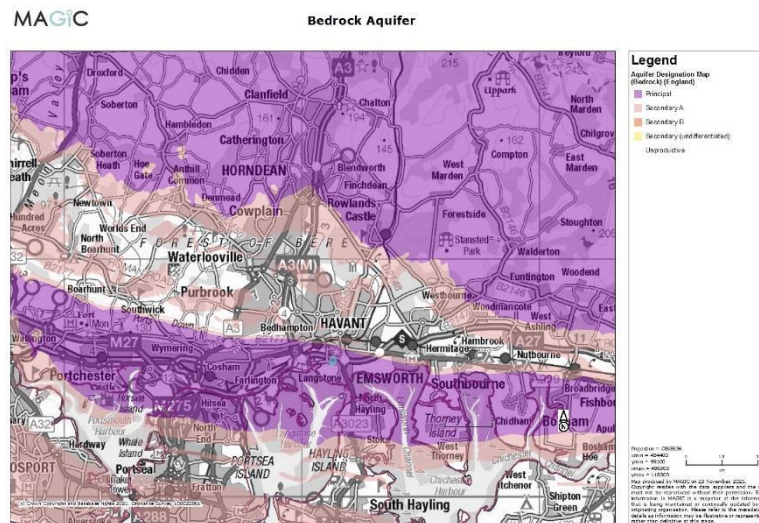
Figure 1. Aquifer Designation Map

BGS information suggest that the superficial strata is classified as a Secondary A Aquifer and the solid strata is classified as a Principal Aquifer.

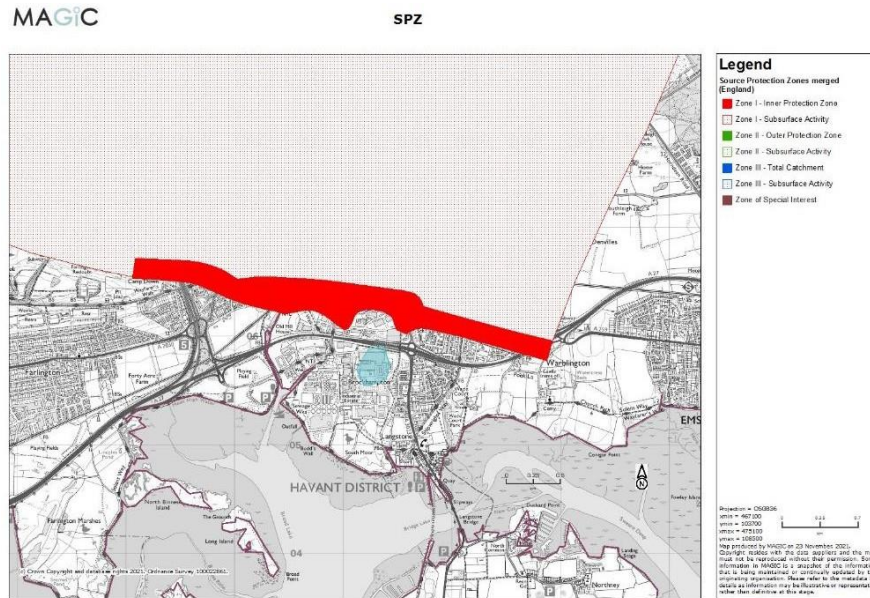
Figure 3. Source Protection Zones

The Environment Agency's (EA) source protection zones (SPZ) map indicate that the site does not fall within any SPZ category.

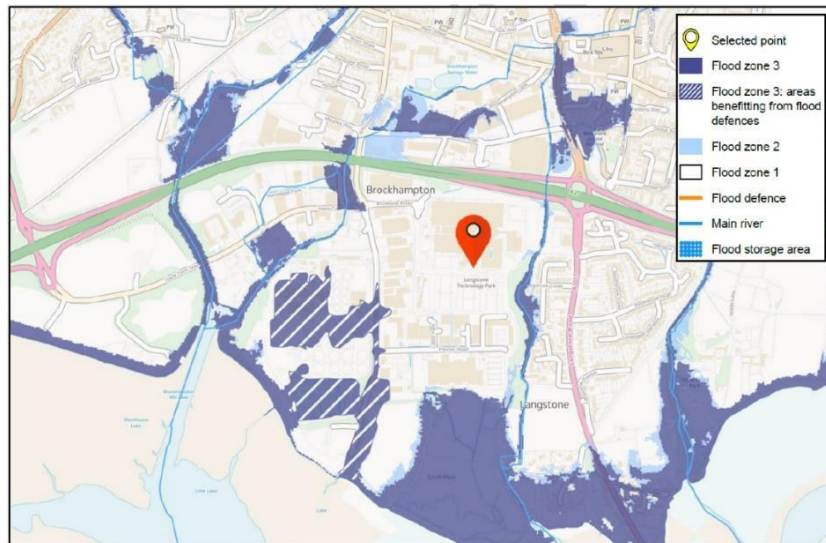
Figure 5. Environment Agency Flood Zone Map

The EA's Flood Map – shown in figure 5, indicates the site is largely in flood zone 1, having less than 1 in 1000 annual probability of river or sea flooding. Figure 5 also shows the Mill Stream (located east of the site) as being potentially prone to flooding since this is shown to be within Flood Zone 3. However, it is known that raised earthworks exist between the site wide development and the Mill Stream which is believed to have been built to offer protection from flooding.

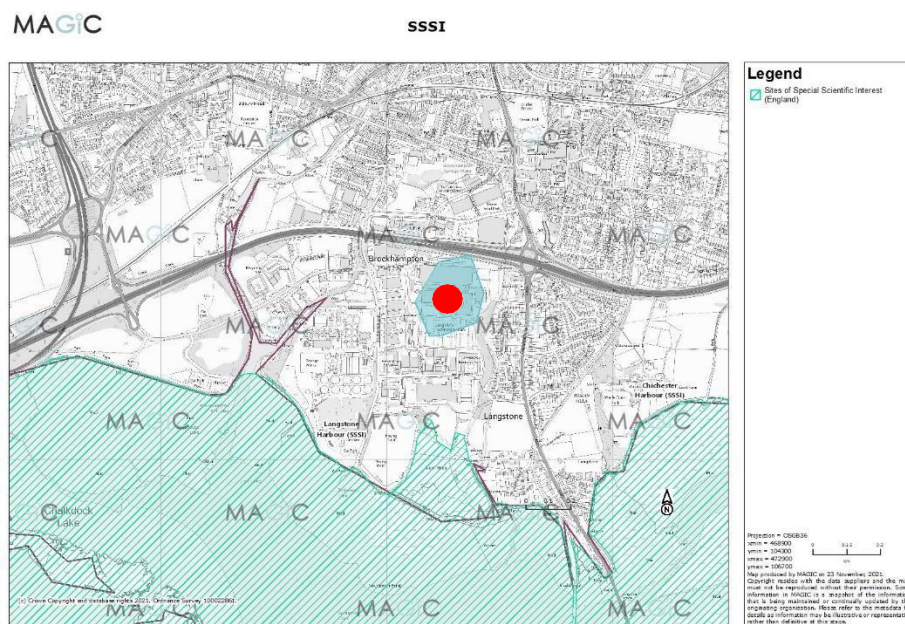
Figure 6. Sites of Specific Scientific Interest (SSSI)

No national or internationally designated sensitive land uses such as sites of special scientific interest (SSSI) were noted within 200m of the site boundary.

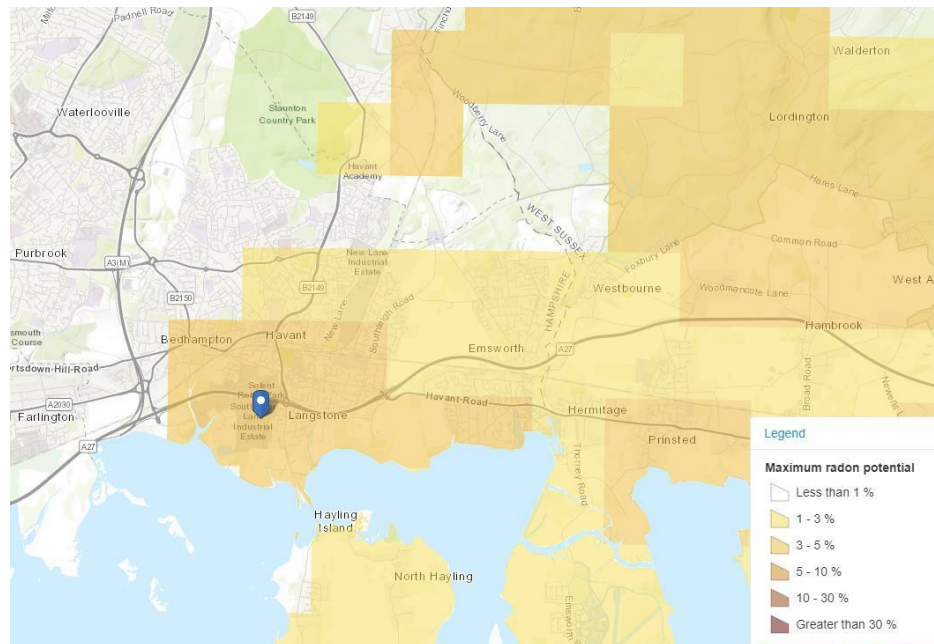
*Figure 7. UK Maps of Radon*

The environmental database report indicates that the site is located within an area of elevated radon potential as defined by the Documents of the National Radiological Protection Board (Radon Atlas of England and Wales, NRPB-W26-2002). Maximum radon potential is 3-5%, and therefore the risk of significant ingress of radon into structures on-site is considered medium and as such radon protective measures are considered necessary.

The Radon Guidance on protective measures for new dwellings indicates that the site is located within an area where between 3% and 5% of homes are above the National Radiological Protection Board (NRPB) recommended action level.

It is recommended that a site-specific radon risk assessment be obtained.

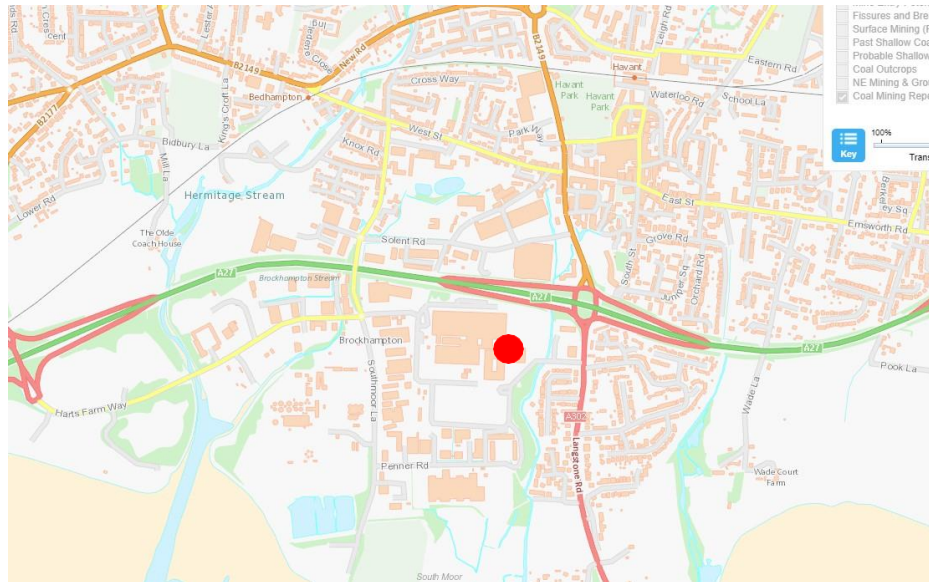
*Figure 8. Coal Mining Reporting Area Map*

The Coal Authority's standing advice indicates that the site is located off the coalfield and not within the Cheshire Brine Compensation District.

According to Coal Authority records, the site is not located within an area which may be affected by coal mining activity. The BGS consider that 'no hazard' is present at the site with regard to 'non-coal' mining (underground) and there are no recorded mineral sites within 500m.
