# Dunsbury Park Plots 500-502

## Ground Investigation Report

*For Portsmouth City Council*

*Doc ref:* 19453-HYD-XX-XX-RP-GE-1004

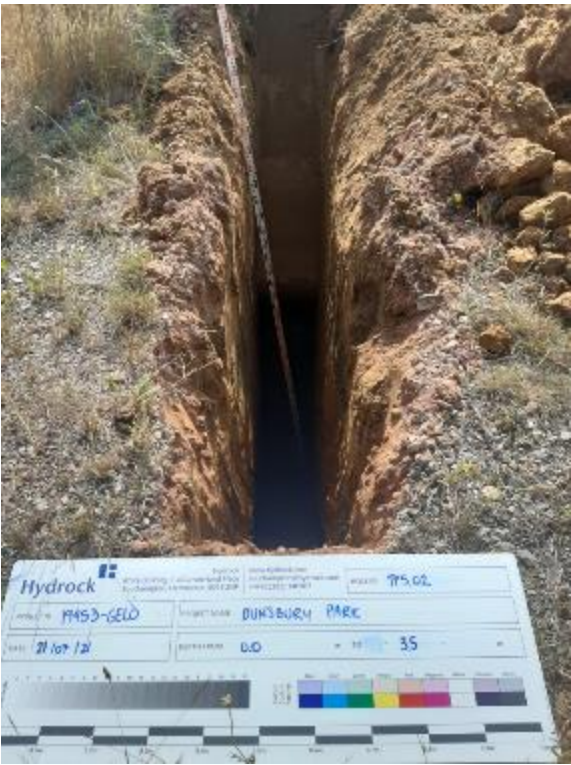
| <b>Site Investigation<br/>Photograph 23</b> | |

| <b>Description:</b> SA101 – backfilled with pipework and gravel for infiltration testing. | | |

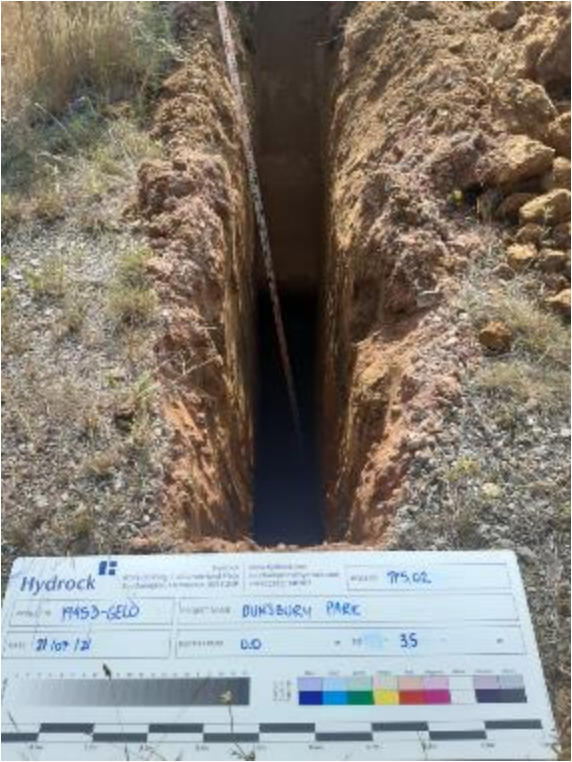
| <b>Site Investigation<br/>Photograph 23</b> | |

| <b>Description:</b> SA101 – backfilled with pipework and gravel for infiltration testing. | |
