# Stage 1 Road Safety Audit

Redlands Lane, Emsworth

## Proposed Walking and Cycling Improvements to Redlands Lane

Report Ref: 21025-3

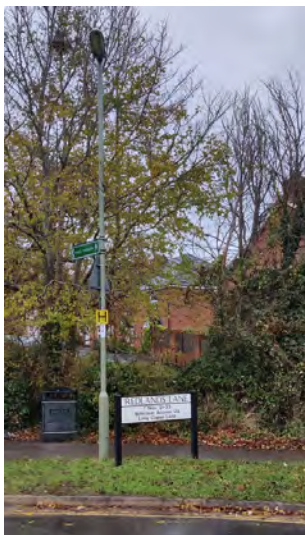
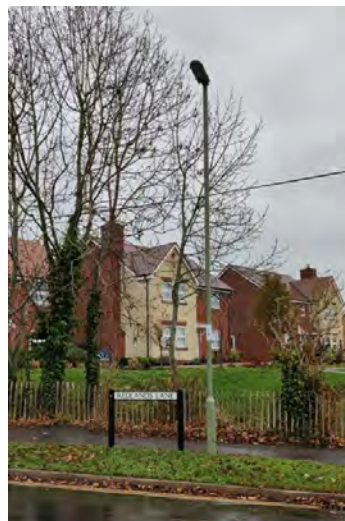
| <b>Location:</b> | Redlands Lane junctions with Birch Tree Drive |
| <b>Summary:</b> | Existing lighting columns and road name plates are situated within the proposed shared footway / cycleway |
| <p>The scheme includes the provision of a minimum 3 metre wide shared footway / cycleway on the eastern side of Redlands Lane, between its junctions with Birch Tree Drive. In order to accommodate the widening associated with the proposed shared footway / cycleway, the existing verge is to be utilised, where existing lighting columns and road name plates are present. In order to negotiate along the shared footway / cycleway in these locations, wheelchair / pushchair users may be required to enter into the carriageway where full height kerbs are present, to negotiate around the lighting column and/or road name plates, potentially resulting in vehicle to pedestrian collisions or fall.</p> | |

| It is recommended that the existing lighting columns and road name plates are relocated accordingly. | |

Accepted – At the detailed design stage existing lighting columns and road name plates will be relocated accordingly.

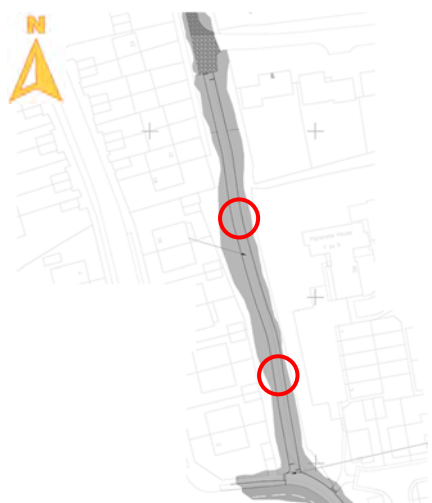
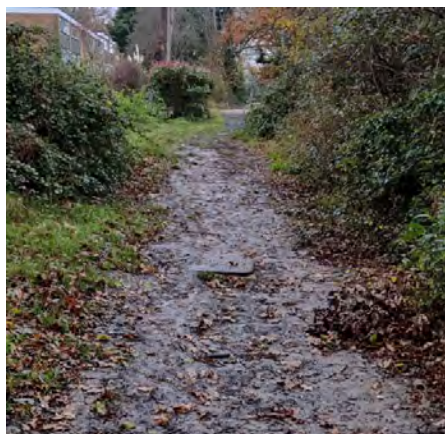
**Location:** Redlands Lane

**Summary:** Existing unmade track accommodates utility covers

Various utility covers are present within the existing unmade track along Redlands Lane, along the route where it is proposed to provide the traffic free section of the 3 metre wide shared footway / cycleway. The utility covers appear to be set at a level above the top of the existing track. The Audit Team have concerns that the covers will protrude above the level of the proposed footway / cycleway, which will be a trip hazard leading to personal injuries.

It is recommended that all cover levels are adjusted appropriately.

Accepted - At the detailed design stage all cover levels will be adjusted appropriately.

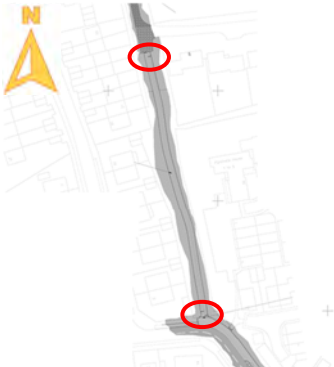
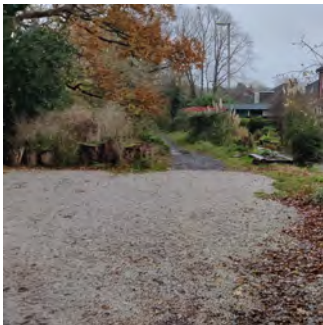
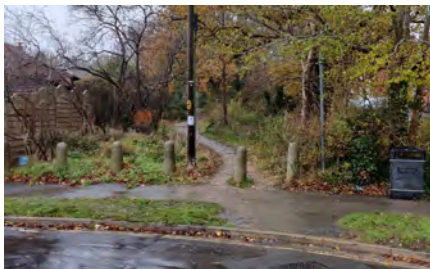
| <b>Location:</b> | Redlands Lane - proposed staggered barriers |
| <b>Summary:</b> | Cyclists could bypass staggered barriers |
| <p>The scheme includes the provision of staggered barriers at the northern and southern section of the traffic free section of the proposed shared footway / cycleway. The vegetation adjacent to the proposed staggered barriers appears sparse and/or grassed, resulting in gaps. There is a risk a cyclist could bypass the staggered barriers, fail to stop in time and enter into the carriageway, into the path of an approaching vehicle, which could lead to vehicle to cyclist collisions or heavy vehicle braking and loss of control type collisions.</p> | |

| It is recommended that suitable measures are implemented either side of the proposed staggered barriers in order to prevent cyclists from by-passing the staggered barriers. | |
| Accepted – At the detailed design stage suitable measures will be implemented either side of the proposed staggered barriers in order to prevent cyclists from by-passing the staggered barriers. A note has been added to drawing ITB13525-GA-103 Rev C. | |

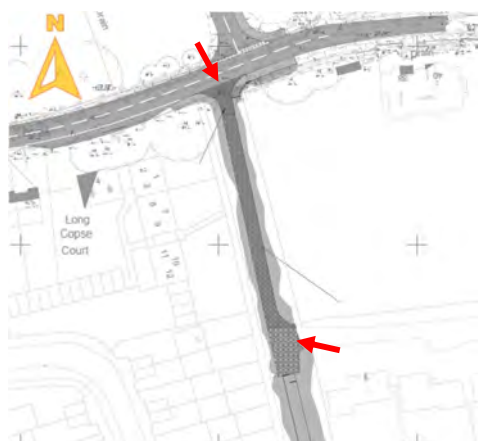
| <b>Location:</b> | Redlands Lane |
| <b>Summary:</b> | Lack of advance warning of the potential for pedestrians to be present in the carriageway |
| <p>The scheme drawing provided with the Audit Brief indicates that the northern section of Redlands Lane is to continue to operate as a shared carriageway between vehicles and pedestrians / cyclists. At this stage, the Audit Brief does not include details of the</p> | |

proposed signage. A lack of advance warning for vehicles approaching the shared surface could result in drivers not being made aware pedestrians could be present in the carriageway. This could lead to heavy braking and rear impact collisions, loss of control type collisions or vehicle to pedestrian collisions.

It is recommended that advance warning is provided on the approaches to the shared surface to inform drivers of the potential for pedestrians to be present in the carriageway.

Accepted - At the detailed design stage advanced warning signs will be provided on approach to the shared surface section in order inform drivers of the potential for pedestrians. A note has been added to drawing ITB13525-GA-103 Rev C.

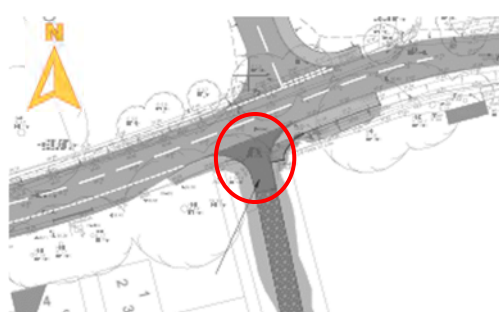
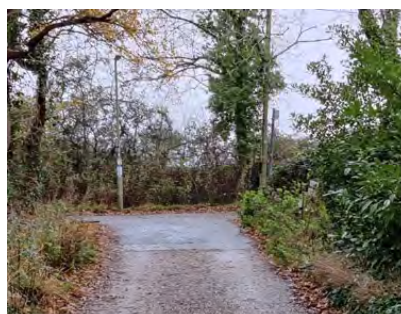
Redlands Lane junction with Long Copse Lane

Lack of on-carriageway measures to inform drivers of the change in carriageway to a shared surface

The scheme drawing provided with the Audit Brief indicates that the northern section of Redlands Lane is to continue to operate as a shared carriageway between vehicles and pedestrians / cyclists, however, it is unclear if any on-carriageway change in surface materials are to be provided at the junction to inform drivers of the change in carriageway to a shared surface. A lack of a suitable on-carriageway warning for drivers entering the shared surface could result in drivers being unaware that pedestrians may be present in the carriageway ahead. This could lead to inappropriate vehicular speeds and vehicle to pedestrian collisions.

It is recommended suitable measures are provided to highlight the change in nature of the carriageway to a shared surface.

Accepted - At the detailed design stage suitable measures will be provided to highlight the change in nature of the carriageway to a shared surface. A note has been added to drawing ITB13525-GA-103 Rev C which is supplemented by a surface change provided at the point Redlands Lane meets Long Copse Lane – this shown on the updated drawing.

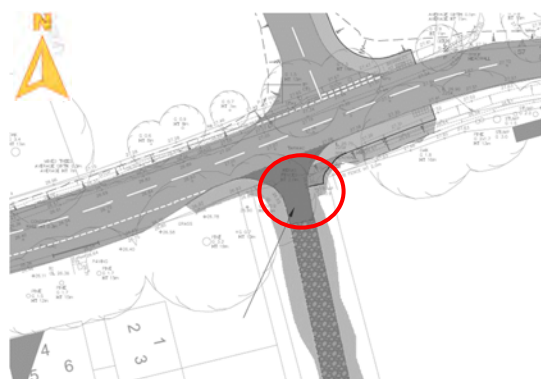
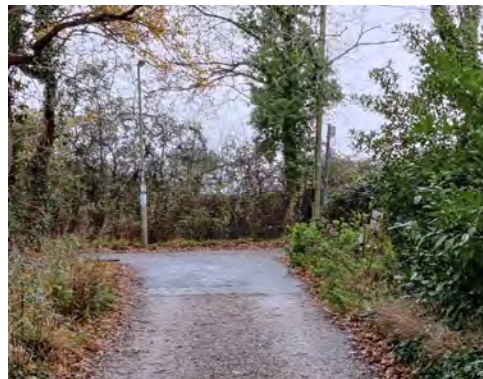
Redlands Lane junction with Long Copse Lane

Lack of suitable transition to shared carriageway from footway

The scheme drawing provided with the Audit Brief indicates that the northern section of Redlands Lane is to continue to operate as a shared carriageway, with pedestrians and vehicles sharing the carriageway on an equitable basis. The proposed footway is shown to wrap around the corner radius and terminate on Redlands Lane. No level access between the proposed footway and shared surface carriageway is illustrated on the scheme drawing. Full height kerbs will be an obstruction for pedestrians and could lead to trips, falls and personal injury. Furthermore, it is unclear if suitable measures will be provided to ensure users will be informed of the change in route characteristics. Insufficient advance warning could lead to users, including the visually impaired, stepping into the carriageway and into the path of vehicles, resulting in vehicle to pedestrian / cycle collisions.

It is recommended that the edge of carriageway where users transition from the footway to the carriageway is not formed with kerbs in excess of 6mm and that suitable measures

are provided on approach to the shared carriageway to ensure that footway users are made aware of the change in route characteristics.

Accepted – A dropped kerb has been shown on drawing ITB13525-GA-103 Rev C and at the detailed design stage it will be ensured that the transition from the footway to the carriageway is not formed with kerbs in excess of 6mm. In addition, advanced warning signs will be provided on approach to the shared surface section in order to ensure that footway users are made aware of the change in route characteristics.

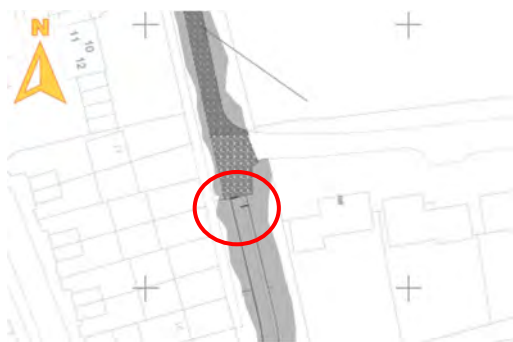
Redlands Lane

Lack of suitable transition to shared carriageway from proposed shared footway / cycleway

The scheme drawing provided with the Audit Brief indicates that the northern section of Redlands Lane is to continue to operate as a shared carriageway, with pedestrians and vehicles sharing the carriageway on an equitable basis, however, it is unclear if suitable measures will be provided at the point where the shared footway / cycleway transitions to the shared carriageway. Insufficient advance warning could lead to users, including the visually impaired, stepping into the carriageway and into the path of vehicles, resulting in vehicle to pedestrian / cycle collisions.

It is recommended that suitable measures are provided on approach to the shared carriageway to ensure that users are made aware of the change in route characteristics.

Accepted - At the detailed design stage advanced warning signs will be provided on approach to the shared surface section in order inform users of the change in route characteristics. A note has been added to drawing ITB13525-GA-103 Rev C.

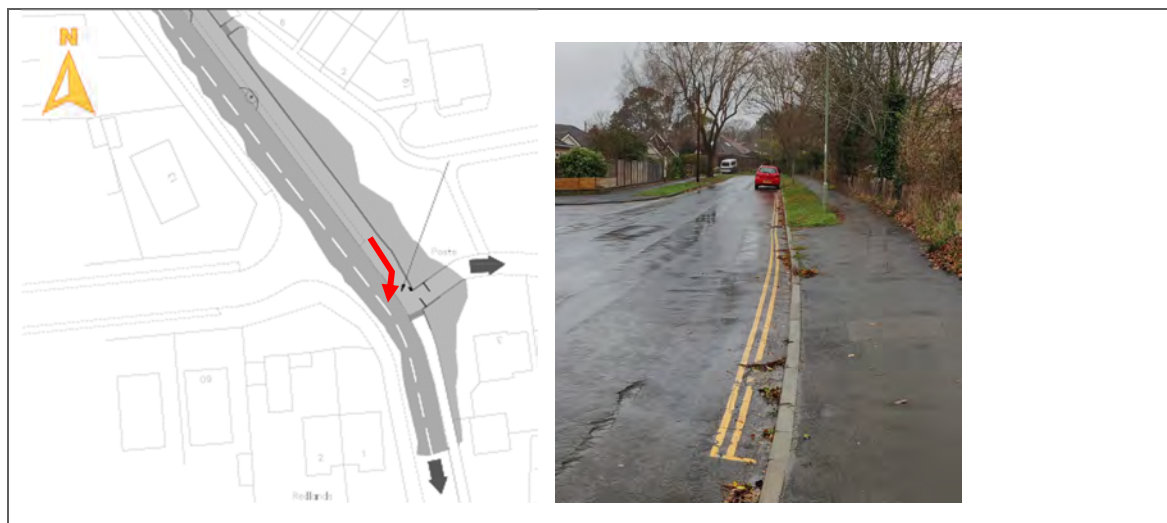
Proposed shared footway / cycleway onto Redlands Lane

Cyclists could enter the carriageway without stopping / looking properly

The scheme includes the provision of a minimum 3 metre wide shared footway / cycleway on the eastern side of Redlands Lane, between its junctions with Birch Tree Drive. At its southern point, a dropped kerb is proposed to enable cyclists to transition from the shared footway / cycleway to the live carriageway on Redlands Lane. There is a risk cyclists travelling south along the shared footway / cycleway looking to enter onto Redlands Lane could do so without giving due care and consideration to vehicles travelling on Redlands Lane. Cyclists entering into the carriageway without giving way could result in vehicle to cyclist collisions.

It is recommended that cyclist giveaway markings are provided prior to the point where cyclists transition from the shared footway / cycleway onto the live carriageway on Redlands Lane.

Accepted – Drawing ITB13525-GA-103 Rev C has been updated to include cyclist give way markings prior to the point where cyclists transition from the shared footway / cycleway onto the live carriageway on Redlands Lane.

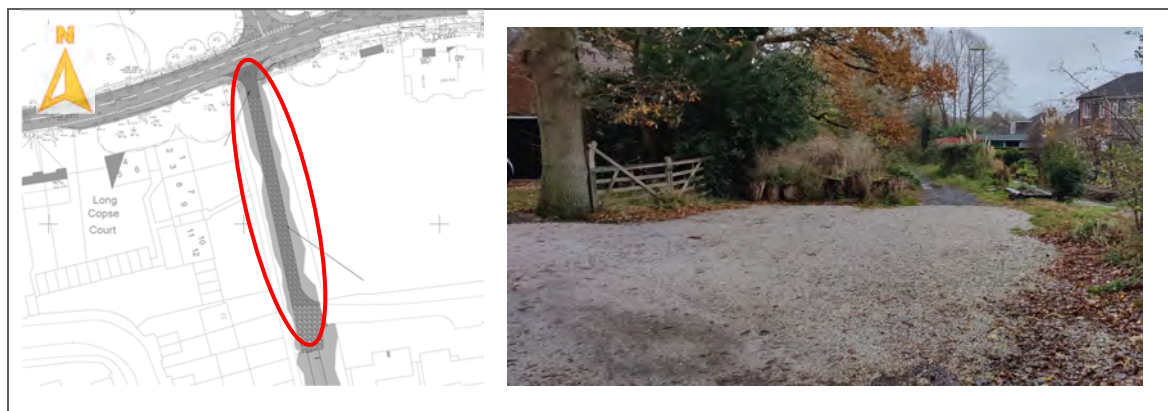
| <b>Location:</b> | Redlands Lane |
| <b>Summary:</b> | Uneven surface could result in trips and falls |
| <p>The scheme includes the widening and resurfacing of the existing unmade track on Redlands Lane. The scheme drawings provided with the audit brief indicate the existing surface on the northern section of Redlands Lane, which provides vehicular access to the recently constructed 1-4 Paddocks Copse residential development, is to remain as per existing. The existing surface along the northern section of Redlands Lane appears to be made of gravel and sand. At the time of the site visit, large sections of the existing gravel and sand surface appeared to be loose and unstable under foot. There is a risk users, particularly perambulators and wheelchair users, will be unable to safely negotiate the existing gravel surface, resulting in becoming stuck or trips and falls leading to personal injury.</p> | |

| It is recommended it is ensured an appropriate surface is provided. | |

Accepted – At the detailed design stage it will be ensured that an appropriate surface is provided. A note has been added to drawing ITB13525-GA-103 Rev C.

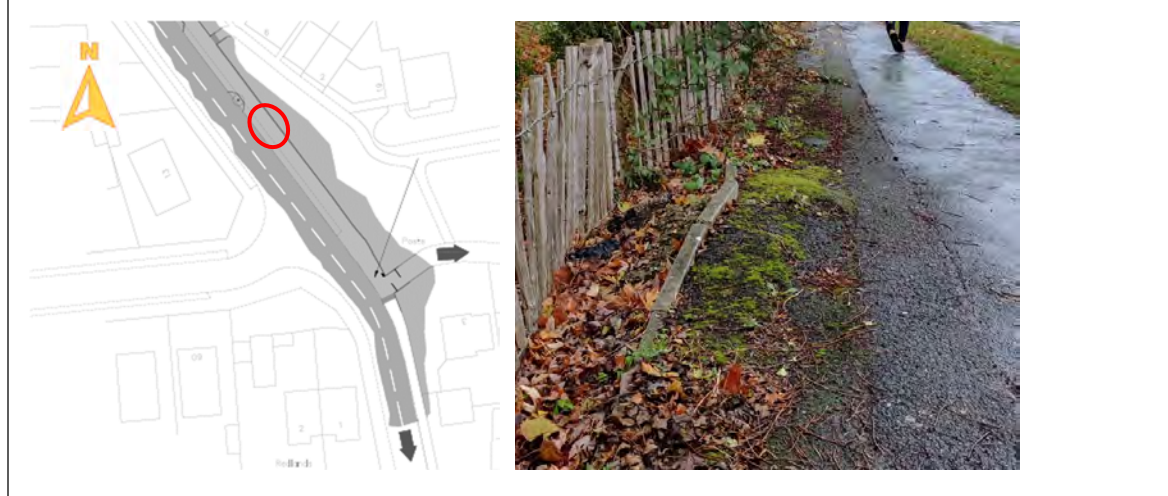
Redlands Lane

Broken / uneven surface could result in trips and falls

The scheme includes the provision of a minimum 3 metre wide shared footway / cycleway on the eastern side of Redlands Lane, between its junctions with Birch Tree Drive. Along the southern section, an area of the footway appears uneven. The resultant uneven surface could give rise to trips and falls, particularly involving the visually impaired and infirm.

It is recommended that the proposed shared footway / cycleway allows for a smooth even surface.

Accepted - At the detailed design stage it will be ensured that an appropriate surface is provided. A note has been added to drawing ITB13525-GA-103 Rev C.

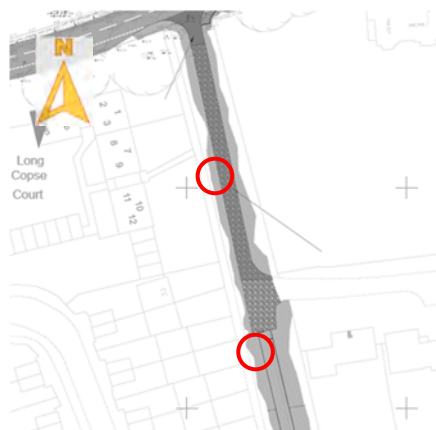
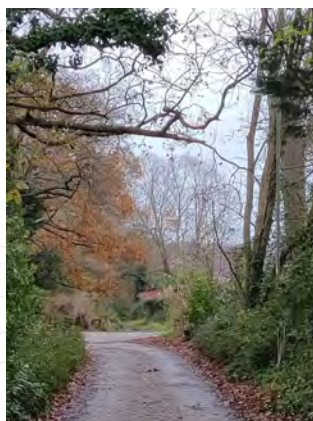
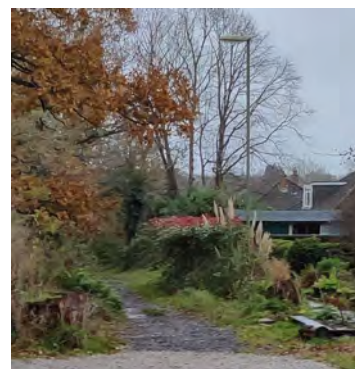
**Location:** Redlands Lane

**Summary:** Pedestrians may not be seen during the hours of darkness

A number of lighting columns are present along the northern section of Redlands Lane. Existing vegetation was observed to obscure the illumination levels of the existing lighting columns. Whilst vehicles are driven during the hours of darkness with head lights illuminated, drivers may not become aware of the presence of pedestrians at a safe distance, which could give rise to vehicle to pedestrian / cyclist collisions. Furthermore, tree canopies and overgrown vegetation are present along Redlands Lane which would generate shadows, restricting clear visibility of pedestrians negotiating along Redlands Lane.

It is recommended that a suitable level of street lighting is provided and that vegetation is maintained clear of any lighting.

Accepted - At the detailed design stage a lighting strategy and design will be provided. A note has been added to drawing ITB13525-GA-103 Rev C.
