## **Southampton Archaeology Unit Report 1489**

### **Archaeological Evaluation on land at 5-11 East Street and 10A The Pallant, Havant, Hampshire A2021.29**

## **Report on an Archaeological Evaluation on land at 5-11 East Street and 10A The Pallant, Havant, Hampshire A2021.29**

Report number: 1489  
Site code: A2021.29  
Grid reference: 471846 106270

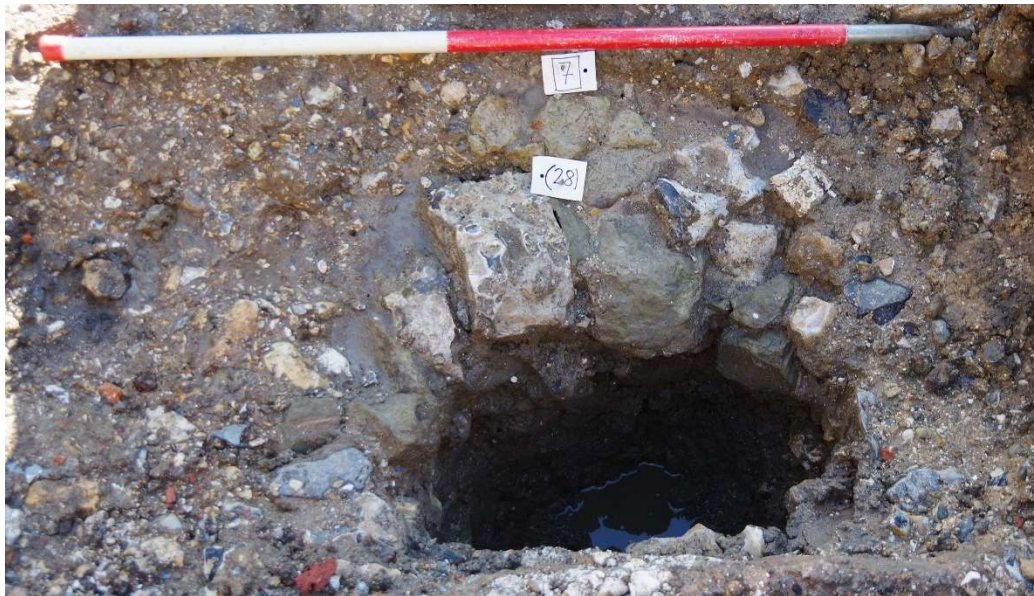
Feature 7 (fig 4) was a stone-lined well. It was sub-circular in plan with vertical sides. It was not completely excavated due to its depth. It was 0.8m long, at least 0.62m wide and 0.7m deep. It cut natural gravel and it was below post-medieval layer 6. It had three fills, 28, 29 and 8. Fill 28 was the flint and greensand lining of the well. The stones were bonded with soil. Fill 29 was the lower exposed fill. It was olive brown (2.5Y 4/4) silt clay and it was 0.52m thick. It contained a burnt flint, West Country roof slate, a sherd of a Late Medieval glazed cistern, iron slag, and bird bones. Upper fill 8 was dark greyish brown (2.5Y 4/2) silty clay loam. It was 0.25m thick and produced West Country roof slate, a Roman ceramic fragment (probably tegula), a Late Medieval roof tile, and a sherd of a Late Medieval Borderware.

**Figure 4. Plan of well 7, looking east.**

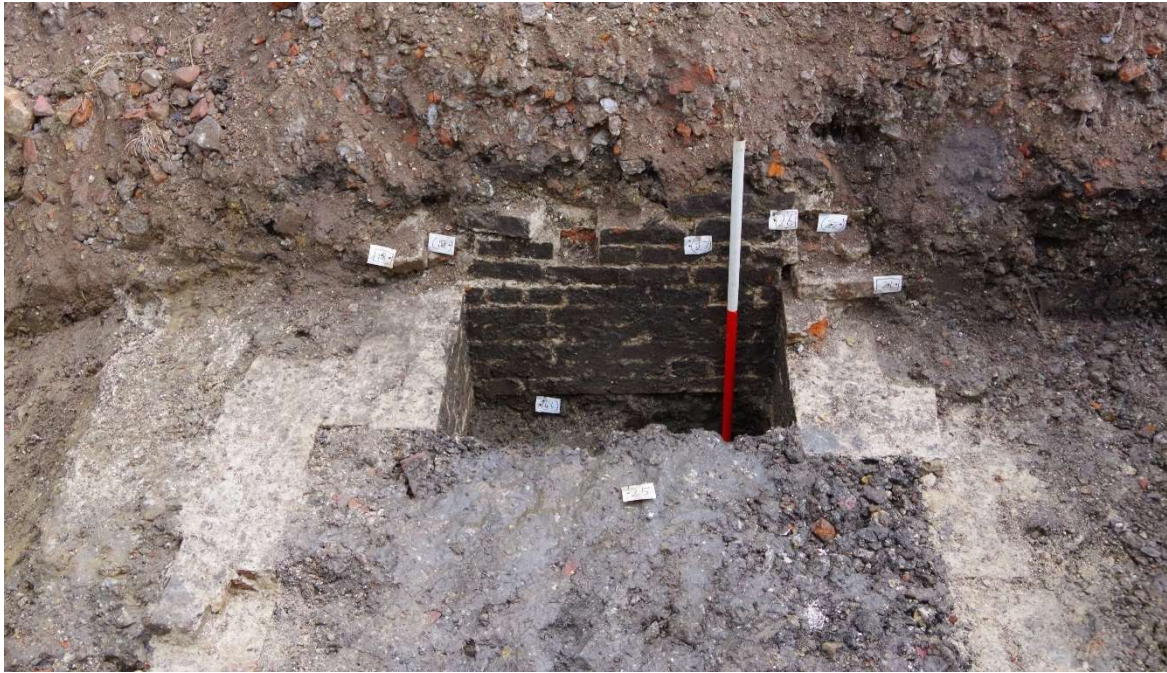
Features 18, 21 and 26 (fig 5) were the foundations trenches for walls 19, 22, and 27 respectively. These walls formed a brick-lined cesspit in the eastern part of Trench 2. Foundation trench 18 was 2m long, 0.50m wide and 0.6m deep. Wall 19 was the west edge of the cesspit. It had eight courses of red bricks bonded with lime mortar. The bricks were 227x107x57mm. Foundation trench 21 was 2.1m long, 0.50m wide and 0.8m deep. Wall 22 was the east edge of the cesspit. It had eight courses of red bricks bonded with lime mortar. The bricks were 223x96x60mm. Foundation trench 26 was 0.85m long, at least 0.1m wide and 0.68m deep. Wall 17 was the north edge of the cesspit. It consisted of red bricks bonded with lime mortar. The bricks measured 212x98x60mm. The lowest excavated fill 44 was dark yellowish brown and dark greyish brown (10YR 4/4 and 4/2) silty clay loam. Above it fill 25 was dark brown (10YR 3/3) silty clay loam. It was 0.34m thick and it contained West Country roof slate, coal, fragments of bricks and tiles, 18<sup>th</sup>-19<sup>th</sup> century pottery, glass, a galvanised iron sheet, and mammal bones.

**Figure 5 cesspit 18, 21 and 26 looking north.**

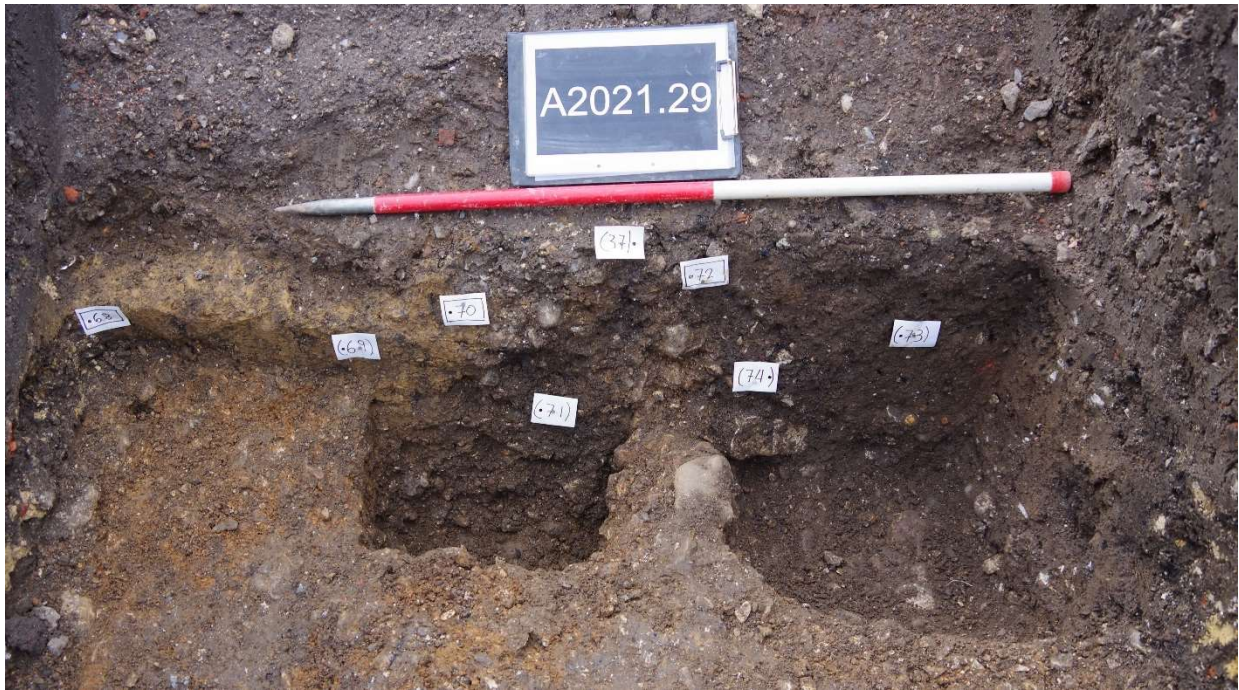
Post-hole 70 (fig 6) was situated at the south end of Trench 3. It was rectangular with vertical sides and a concave base. It was 0.40m by 0.32m by 0.50m deep. It was cut by feature 68 and it cut natural gravel 31. Fill 71 was a dark yellowish brown (10YR 3/4), silty clay loam. It contained pieces of Bembridge and Quarr stone, probably the packing material around the post.

Post-hole 72 (fig 6) was partly exposed in the southwest corner of Trench 3. It was circular in plan with gently sloping sides and a concave base. It was 0.47m in diameter and 0.45m deep. It contained two fills, 74 and 73. Fill 74 was the packing material around the post. It was dark brown (10YR 3/3) silty clay loam. The post mould was filled by 73, a dark brown (7.5YR 3/2) silty clay loam. It contained coal, a fragment of post-medieval brick, pegtile fragments, bottle glass, a copper-alloy pin, and mammal bones.

**Figure 6. North facing section of features 68, 70 and 72.**

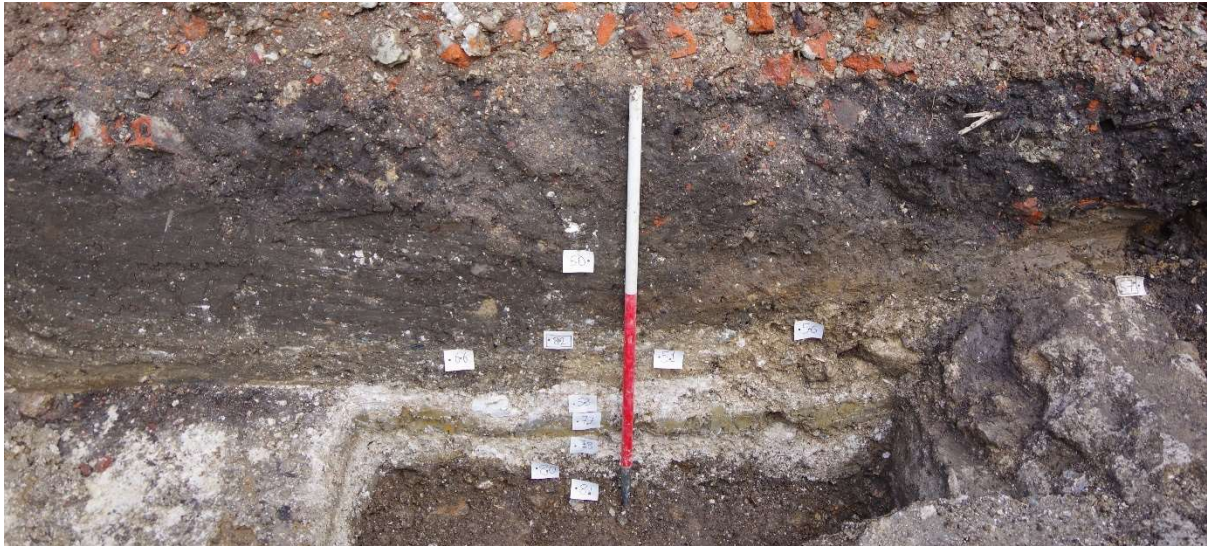
Pit 168 was excavated into the natural gravel 4 by some 200mm. The pit was then filled up with alternated layers of clay and chalk to a depth of 330mm (fig. 8). Fill 80 was an olive grey (5Y 5/2) clay. Fill 78 was grey (10YR 6/1) crushed chalk 0.10m thick. Fill 77 was olive grey (5Y 5/2) clay some 0.07m thick. Fill 53 was a deposit of white (7.5YR 8/1) chalk with patches of olive grey (5Y 5/2) clay. It was 0.10m thick. Fill 51 was pale brown (2.5Y 8/4) chalk.

**Figure 8. Sondage through the alternating layers of chalk and clay in pit 168, to the west of wall 58. Looking north.**

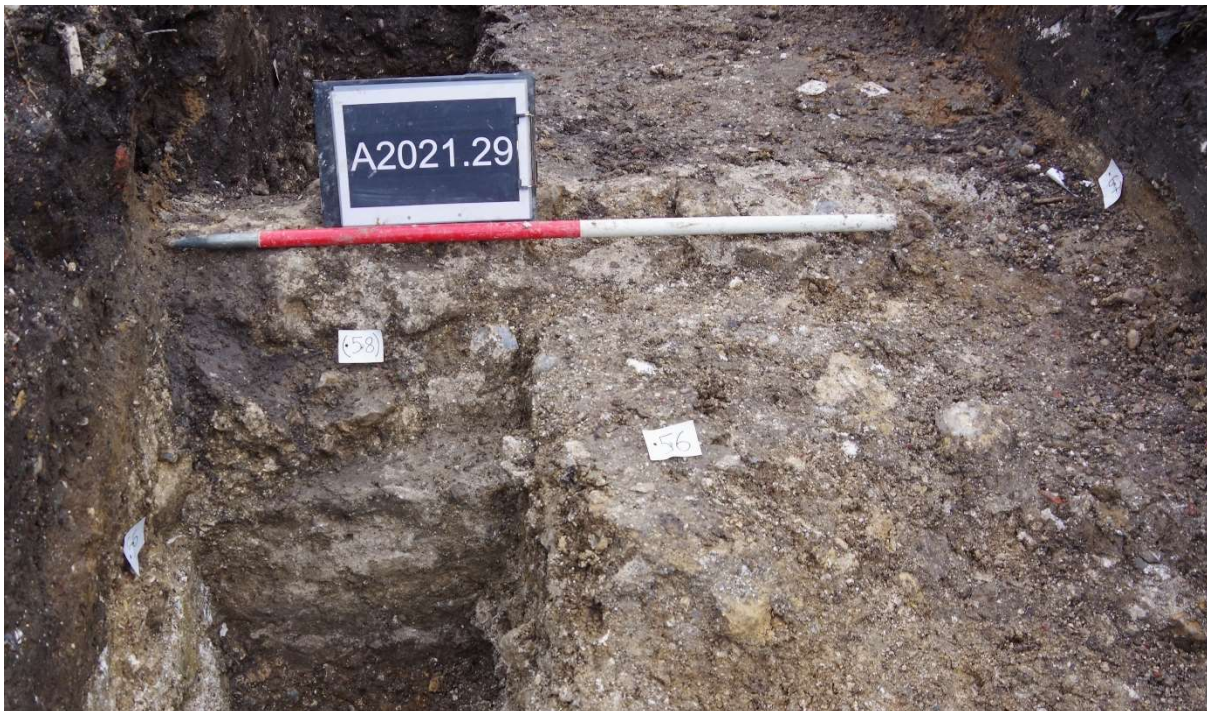
**Figure 9. West facing elevation of wall 58.**

Foundation trench 57 ran north to south. It was at least 1.5m long, 0.75m wide and 0.65m deep. It cut natural gravel 4/81, the fills of pit 168 and fill 76 of ditch 75. Wall 58 was built on the east side of the construction trench (fig 9). It consisted of layers of flint nodules and limestone rubble alternating with layers of extremely hard lime mortar. On the east side of the wall, the mortar had squeezed out from between the stones and flattened out against fills 59 and 76 of ditch 75. The edge of the construction trench was 200mm to the west of the wall allowing the builder access to the west face. After the wall was built, the gap along the west side was backfilled with 79, a brown (10YR 5/3) sandy clay loam mixed with the clay and chalk layers.

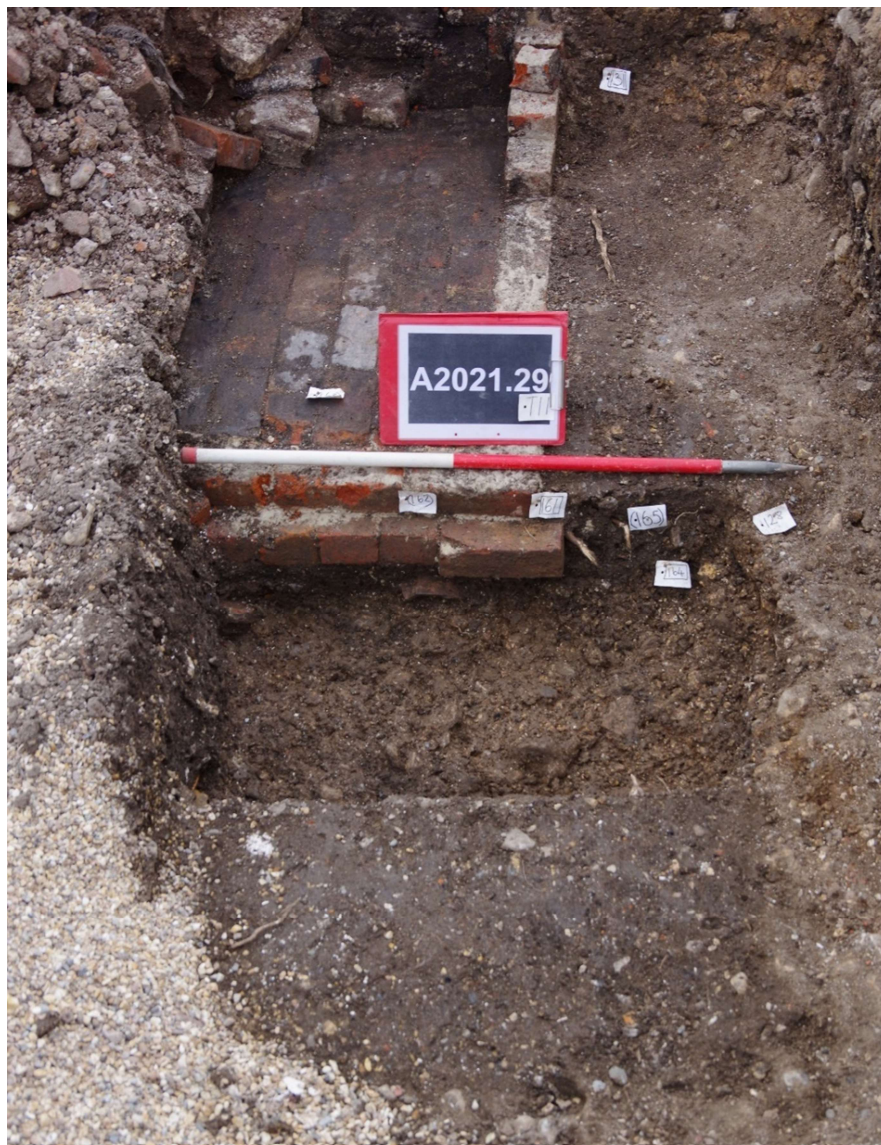
Cesspit 164 (fig 10) was situated in the northern part of Trench 11. It was 1.20m long, 1m wide and 0.22m deep.

**Figure 2. View of feature 164 looking south.**

It was rectangular in plan with almost vertical sides and a flat base. It continued beyond the eastern edge of the trench, and it was cut by feature 161. Fill 165 was a very dark brown (10YR 2/2) silty clay loam. It contained bricks, glass, iron nails, bird and mammal bones and oyster shells. The pottery included porcelain, Staffordshire salt glazed, sherds of a tin-glazed earthenware chamber pot, Verwood, redware,

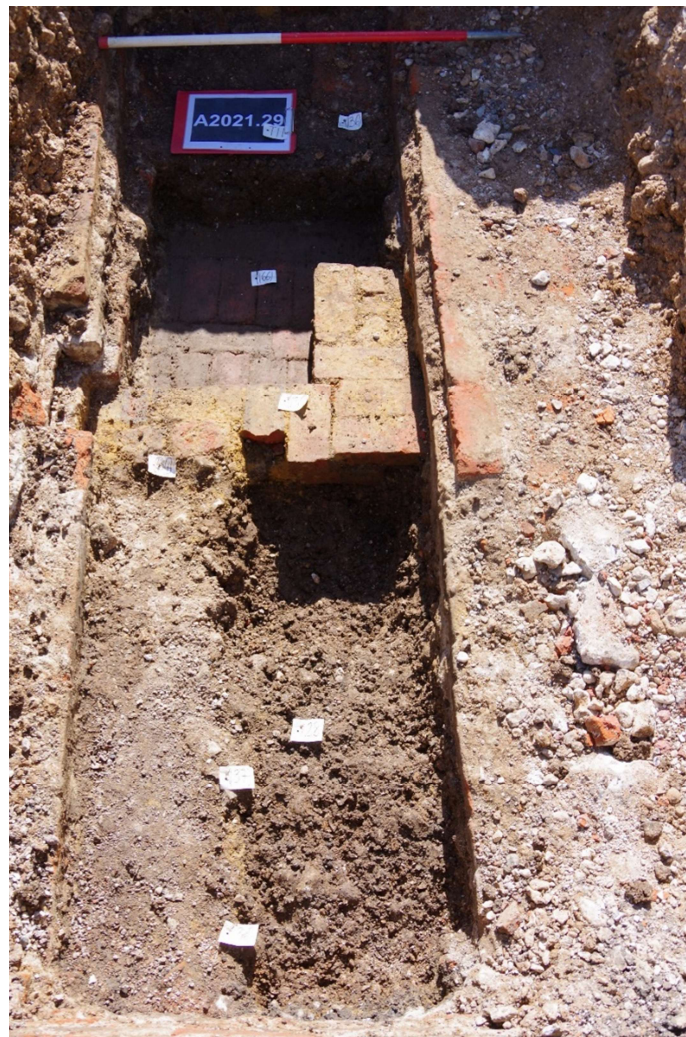
Foundation trench 131 (fig 11) was at least 3.25m long, 1.8m wide and 0.5m deep. It cut natural gravel 127/128.

**Figure 3. Features 131 and 134 looking south.**

Brick wall 132 consisted of seven courses of red bricks bonded with cement mortar. The bricks were 240mm in length, 100mm in width and 65mm in thickness. The bottom

Foundation trench 134 (fig 11) created a small almost rectangular room probably for a toilet. It was at least 1.50m long, 0.8m wide and 0.17m deep. It cut natural gravel 127/128. Brick wall 135 consisted of two courses of red bricks bonded with mortar. The bricks measured 221x100mm. The part of wall which ran north to south had a 0.60m gap. Floor 166 was 1.30m long, 0.80 wide and 0.10m deep. It consisted of red bricks with no frogs. They were 224mm in length and 98mm in width. The feature was backfilled with layer 136. It was a dark brown (10YR 3/3) silty clay. It was 0.17m thick. It contained a ceramic fragment and a sherd of Post-Medieval redware.

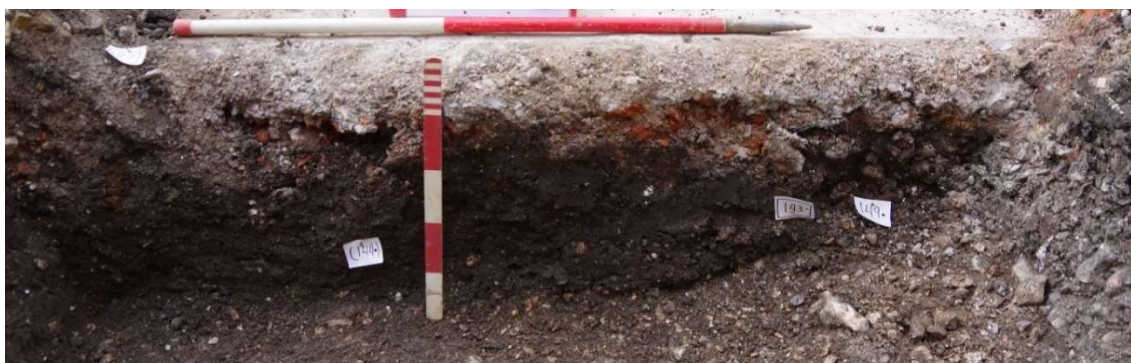
Pit 143 was situated in the southeast corner of Trench 13. It had gently sloping sides and a flat base (fig 14). It cut natural gravel 149 and it was cut by foundation trench 87. It was 1.35m long, 1m wide and 0.43m deep. Fill 144 was dark brown (10YR 3/3) silty clay loam. It produced a sherd from a Westerwald jug, a sherd of post-medieval redware and a fragment of late 18<sup>th</sup>-early 19<sup>th</sup> tobacco pipe.

**Figure 4. East facing section of pit 143.**
