# Yacht Haven Hayling Island, Hampshire

Archaeological Evaluation

Planning Ref: APP/13/00317  
Ref: 211010.03  
November 2018

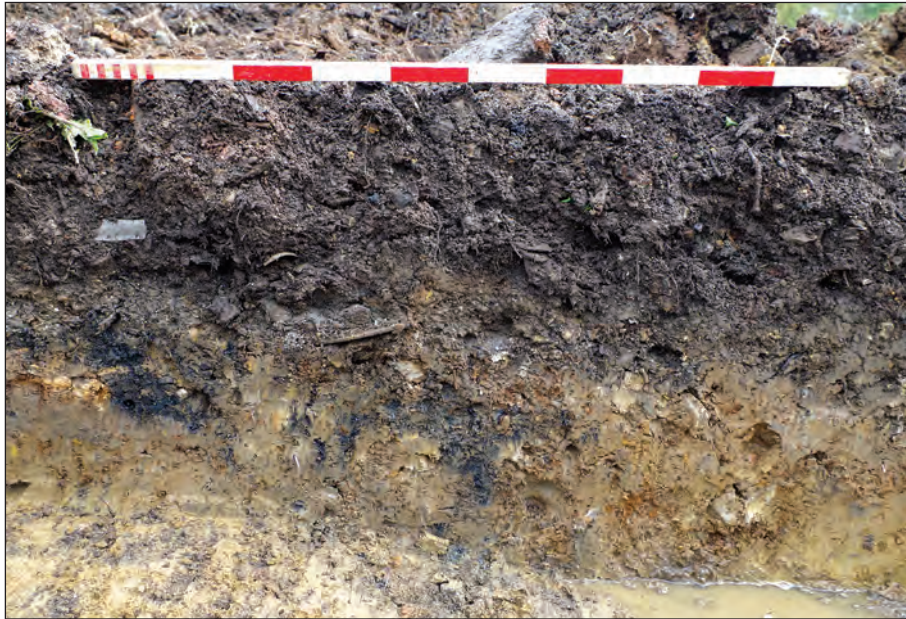
- 5.2.1 The majority of the site was covered by a thin topsoil material. Generally, very dark and humic, this topsoil is probably not of any significant age, and has formed in the period in which the boat yard has been derelict (**Plate 1**).

Plate 1: North-west facing section of Trench 1. 1 m scale.

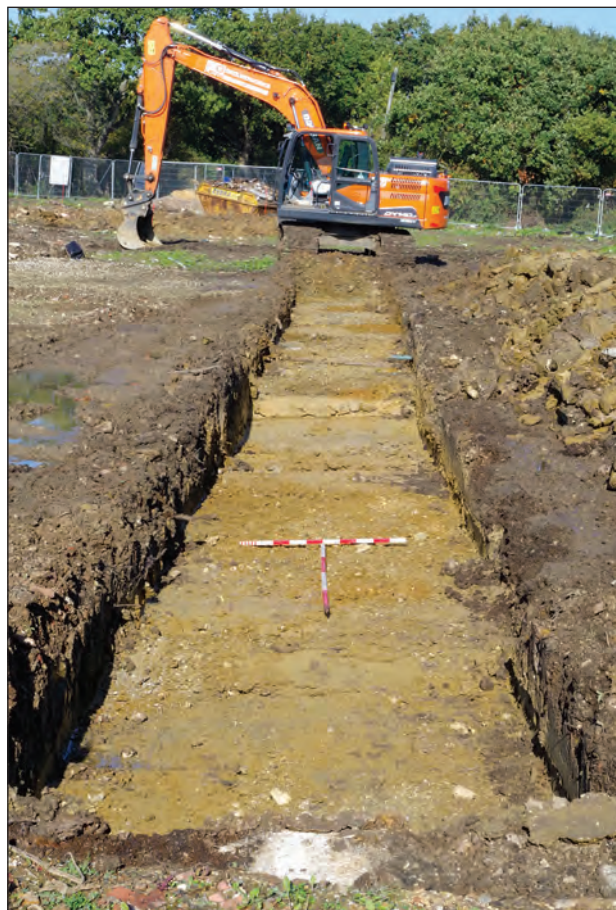
- 5.2.3 The natural geology across site varied between a silty clay and a gravelly clay, as indicated by the BGS data (**Plate 2**).
- 5.2.4 In trench 7 the natural geology was not reached. The trench was excavated to 1.2 m below ground level where the decision to cease excavation was made due to safety concerns. The material in trench 7 consisted of various layers of made ground (**Plate 3**).

Plate 2: Trench 5, viewed from the south-east. 1 m scale.

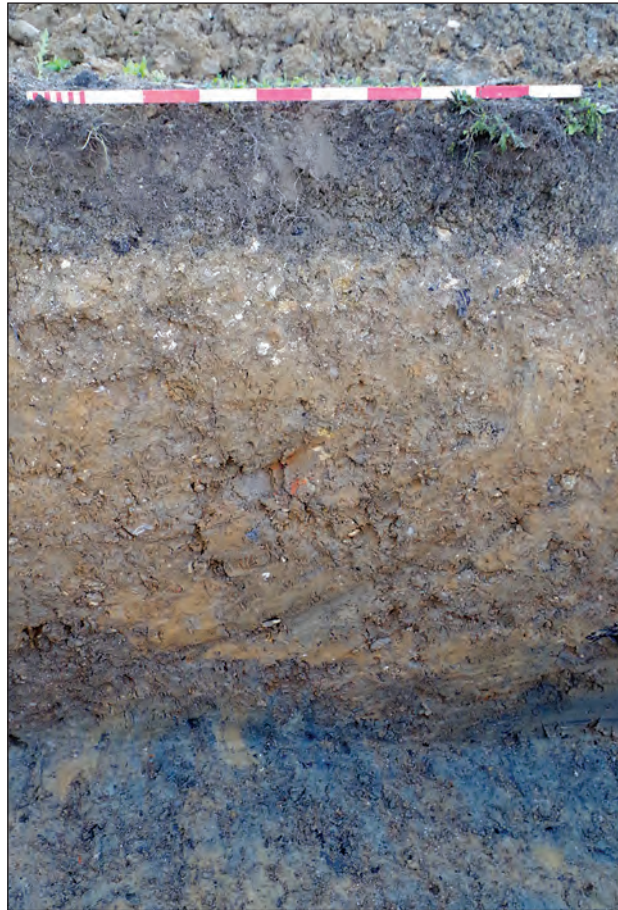
Plate 3: North facing section of Trench 7. 1 m scale.

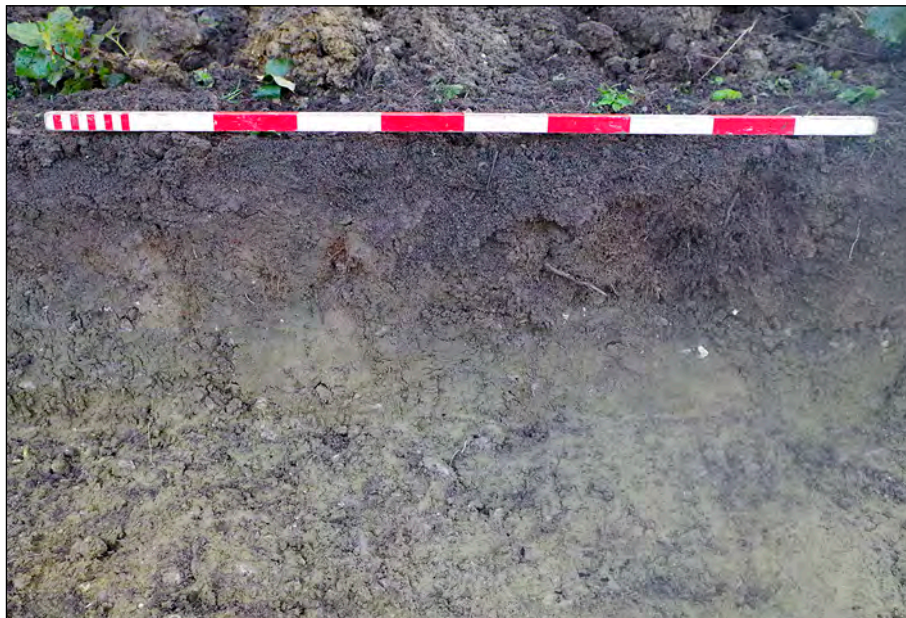
- 5.2.2 Across most of the site this topsoil overlay a made ground deposit, which varied between redeposited clay material, possibly moved from within site its self, and imported gravels (**Plate 1**). The only variations to this were trenches 5 and 6 where there was just a thin topsoil above the clay natural (**Plate 4**).

- 5.2.6 The lack of any buried soil sequences beneath the made ground deposits and the thin modern topsoil directly above the clay natural geology in trenches 5 and 6 suggests that the site had previously been stripped.

Plate 4: North west facing section of Trench 6. 1 m scale.
