# Land at Fathoms Reach, Hayling Island

## Desk Study and Ground Investigation Report

*Taylor Wimpey UK Ltd (Southern Counties)*

*Doc ref:* 16117-HYD-XX-XX-RP-GE-1000

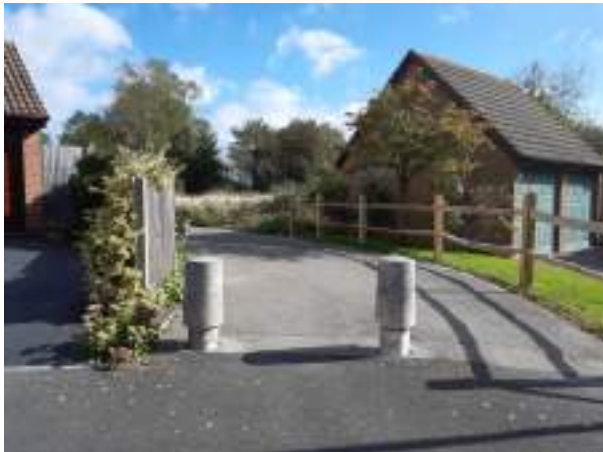
Figure 2.3: Entrance to the site via Southleigh Grove

| Item | Brief Description |
|---|---|
| Site access | The site is 175m to the east of A3023 (Manor Road). The site currently has three points of access. Vehicular access is via Southleigh Grove to the south (between concrete bollards-Fig. 2.3), with pedestrian access via Fathoms Reach to the west (Fig. 2.4), and via Manor Road next to Newtown House, also to the west (Fig. 2.5). |

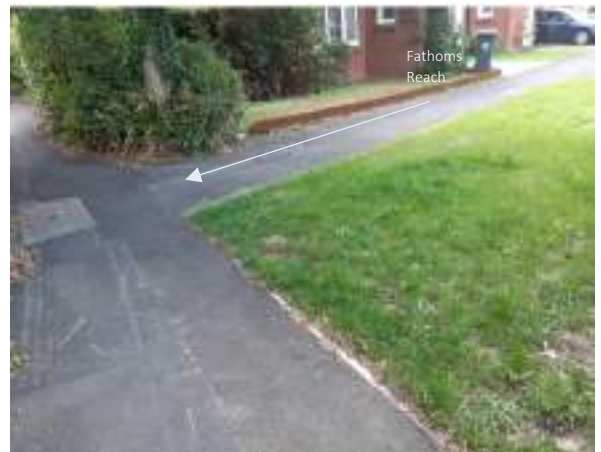
Figure 2.4: Small pedestrian entrance via Fathoms Reach.

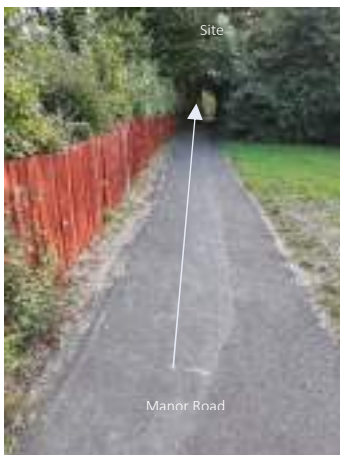
Figure 2.5: Pedestrian entrance to the site via Manor Road

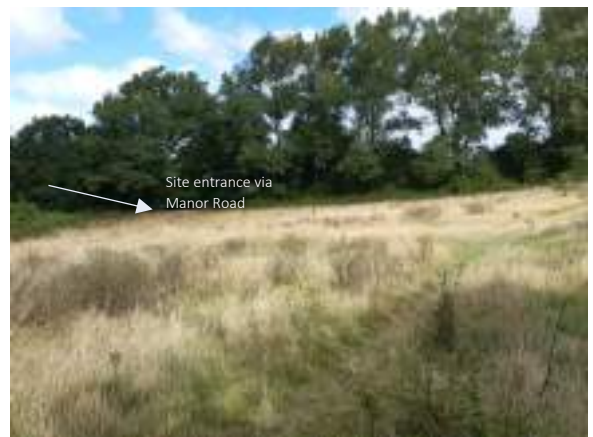
Figure 2.6: Looking to North boundary of site

| Item | Brief Description |
|---|---|
| Site boundaries and surrounding land | The site is bound to the east by mature trees in line with a footpath and a drainage channel approximately 1.0m wide, with a field with crops further east. To the north the site is bound by a footpath surrounded by mature trees and a drainage ditch approximately 1.0m wide with an open grassed field beyond. To the west, there is a pathway leading to Manor Road, dense vegetation and mature coniferous trees, and rear gardens of houses to the south west. Evidence of fly-tipping was noted across the west of the site (litter, timber pallets, old tyres). To the south, the site bounds with rear gardens and a tarmac pathway leading to Southleigh Grove roundabout. |

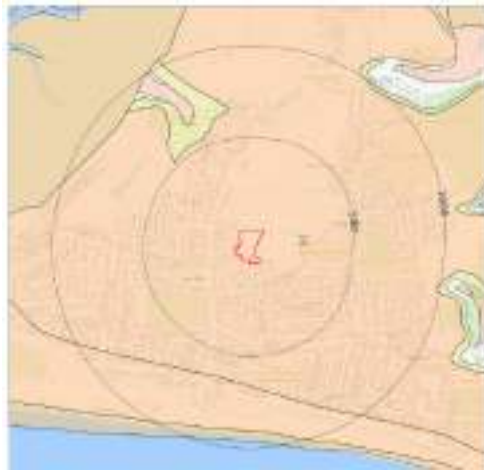
Figure 2.7: Superficial deposits.  
(Reproduced with permission from Groundsure)

Extracts from the geological maps are shown in Figure 2.7 and Figure 2.8.

| Ref. for Figures | Location | Stratigraphic Name | Description |
|---|---|---|---|
| Superficial Deposits (Figure 2.7) | | | |

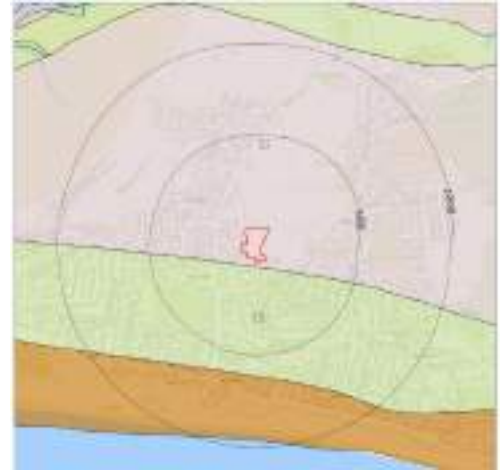
Figure 2.8: Solid geology.  
(Reproduced with permission from Groundsure)

| Ref. for Figures | Location | Stratigraphic Name | Description |
|---|---|---|---|
| Solid Geology (Figure 2.8) | | | |
| 1 | On site. | London Clay Formation | Clay, silt and sand |

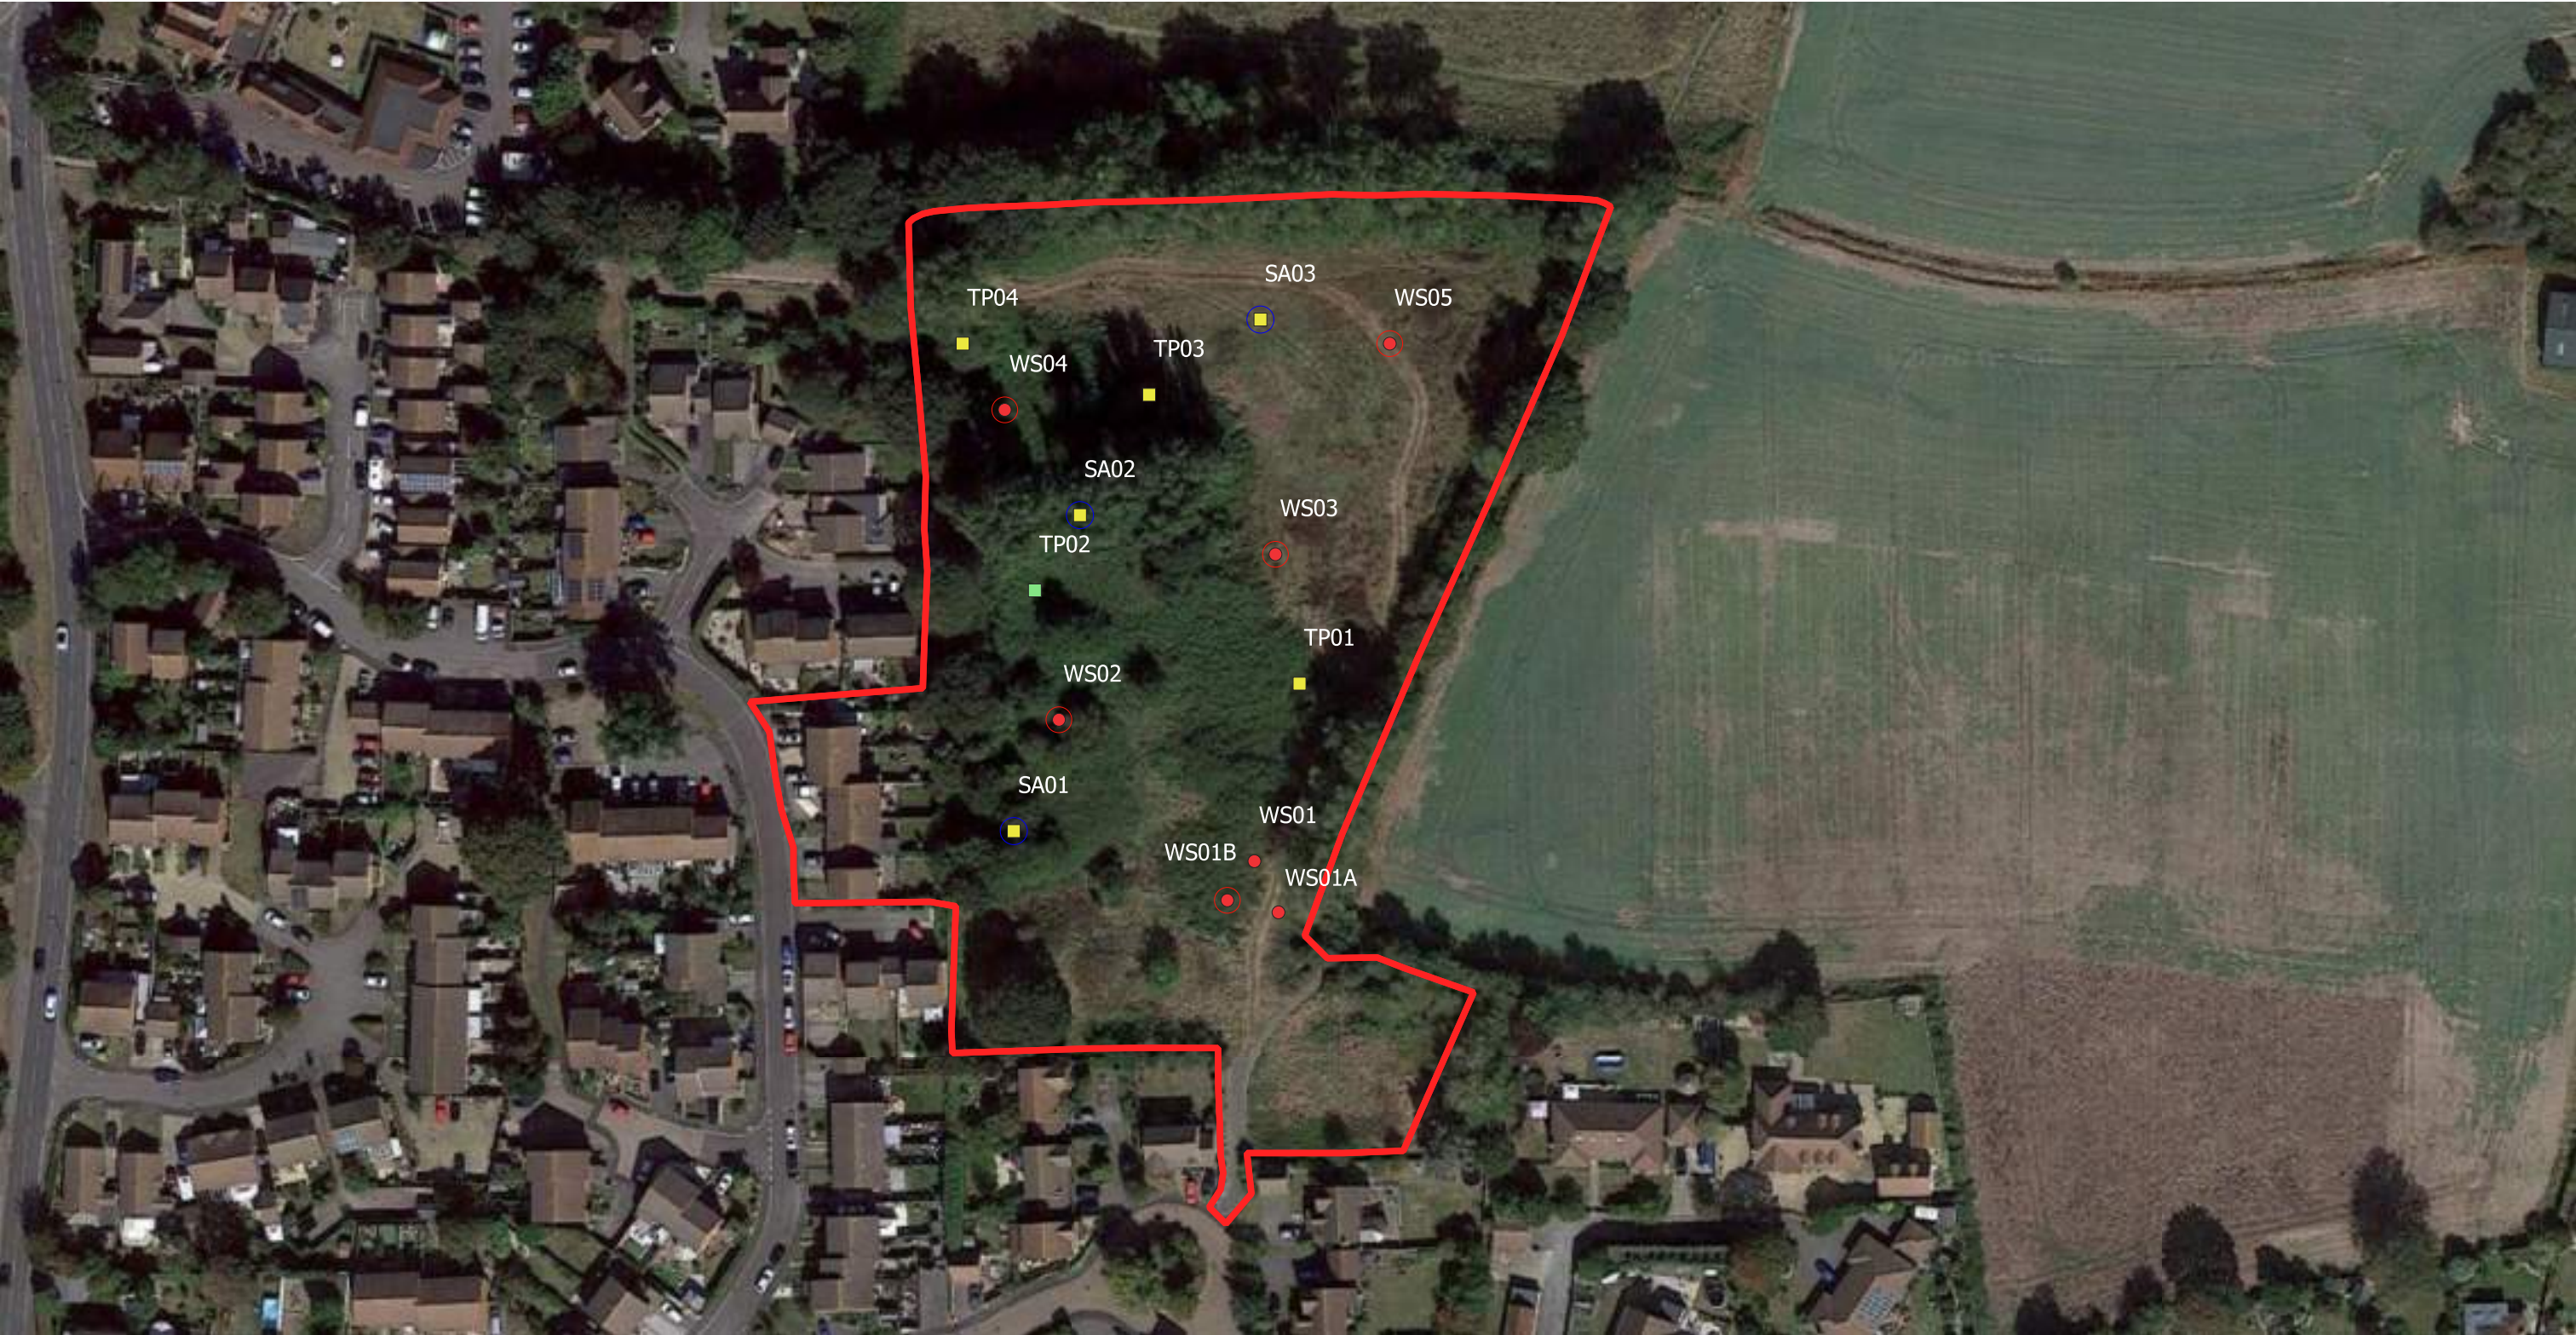
| KEY PLAN | | <div>NOTES</div> <div>Site Plan for indicative purposes only.</div> <div><div>- Contains OS data © Crown copyright and database right 2020</div><div>- Where you use Code-Point Open data, you must also use the following attribution statements:</div><div>- Contains Royal Mail data © Royal Mail copyright and Database right 2020</div><div>- Contains National Statistics data © Crown copyright and database right 2020</div></div> | | REVISIONS | | <div><div><div>Hydrock</div><div><div></div><div></div></div></div><div>Hydrock<br/>White Building<br/>1-4 Cumberland Place<br/>Southampton<br/>SO15 2NP<br/>Tel: +44 (0)2382 140 907</div></div> | | TITLE<br>Exploratory Hole Location Plan | | | |

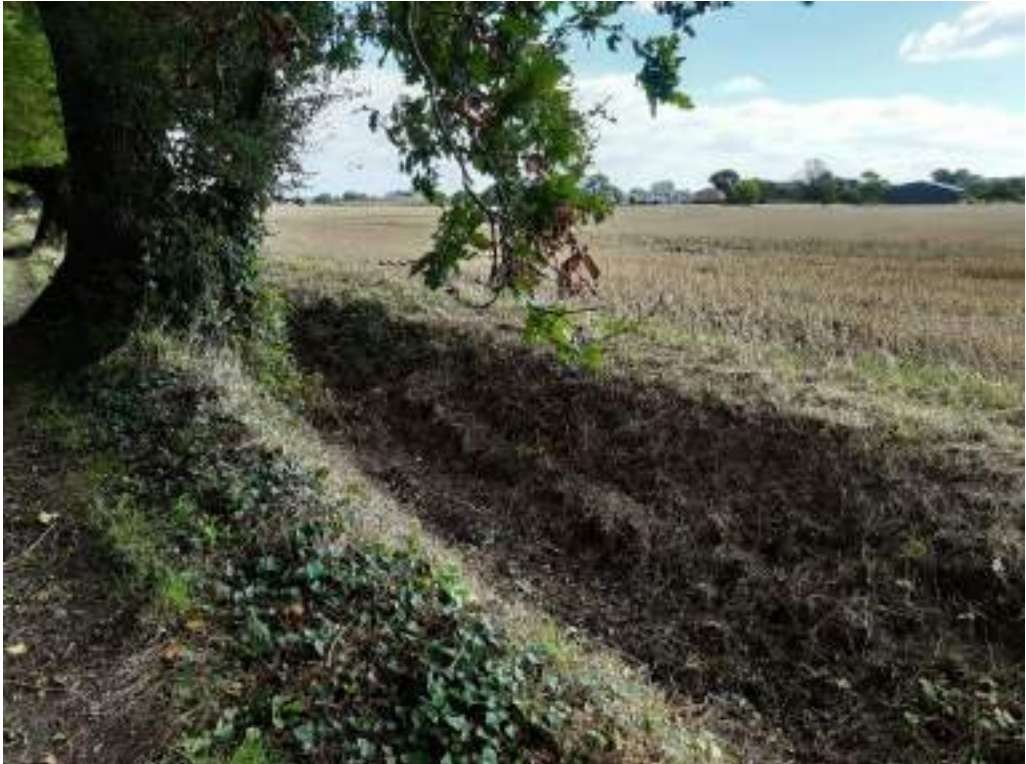
| <b>DS Photograph 7</b> | |

| <b>Description:</b><br><br>Evidence of drainage between footpath and Agricultural Field along the East side of the site | |

During the walkover, a drainage ditch was observed along the north and east boundary of the site.

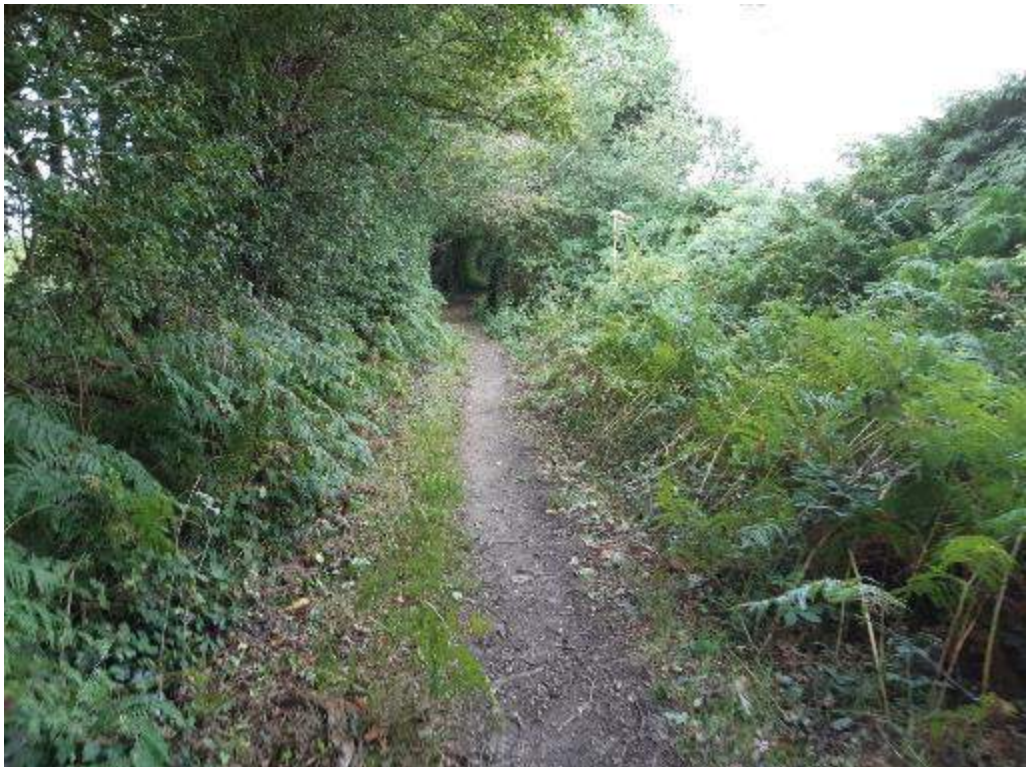
| <b>DS Photograph 10</b> | |

| <b>Description:</b><br><br>Public footpath surrounded by mature trees (to the left) and drainage and vegetation (to the right) along the north boundary of the site. | |

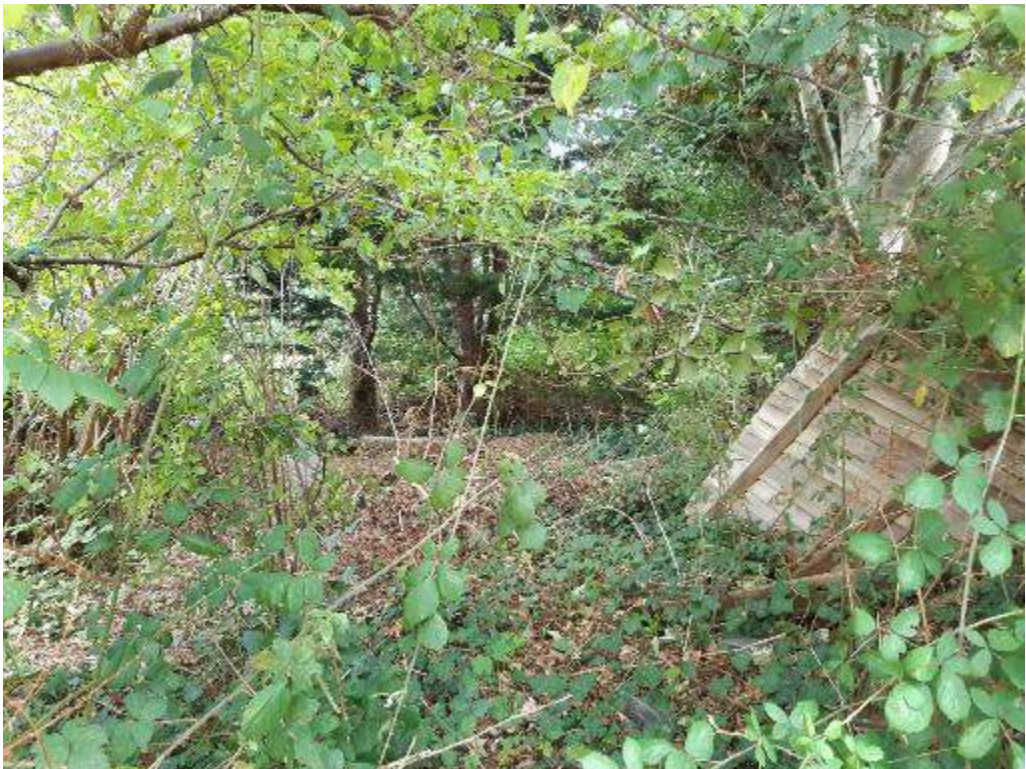
| <b>DS Photograph 19</b> | |

| <b>Description:</b><br><br>Evidence of rubbish at the west boundary of the site | |

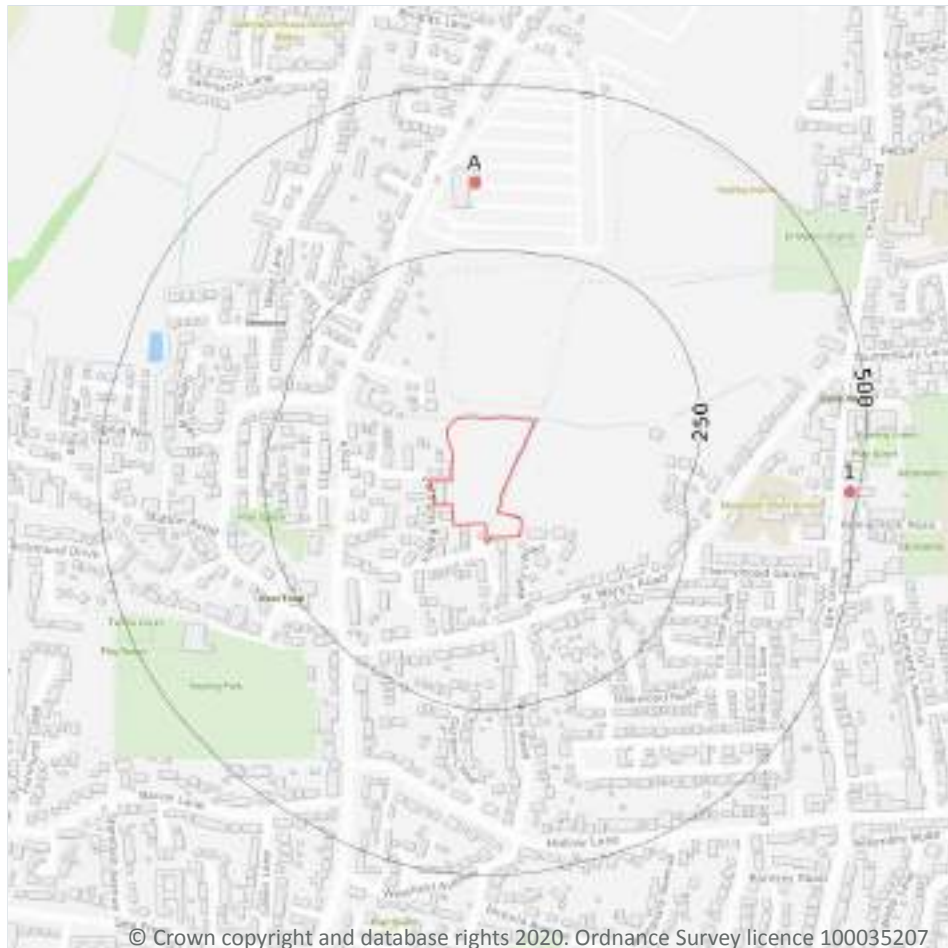
## 3 Waste and landfill

- Site Outline
- Search buffers in metres (m)
- Waste exemptions

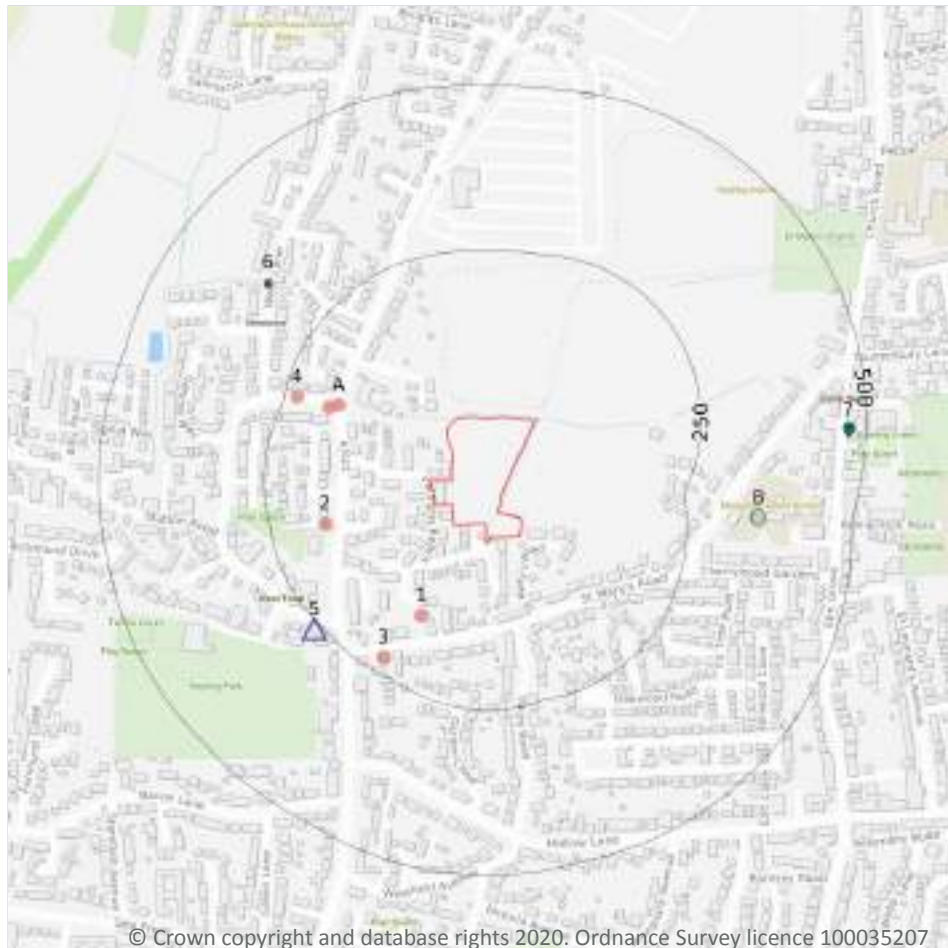
## 4 Current industrial land use

- Site Outline
- Search buffers in metres (m)
- Recent industrial land uses
- △ Current or recent petrol stations
- ◆ Licensed pollutant release (Part A(2)/B)
- ◆ Licensed Discharges to controlled waters
- Pollution Incidents (EA/NRW)

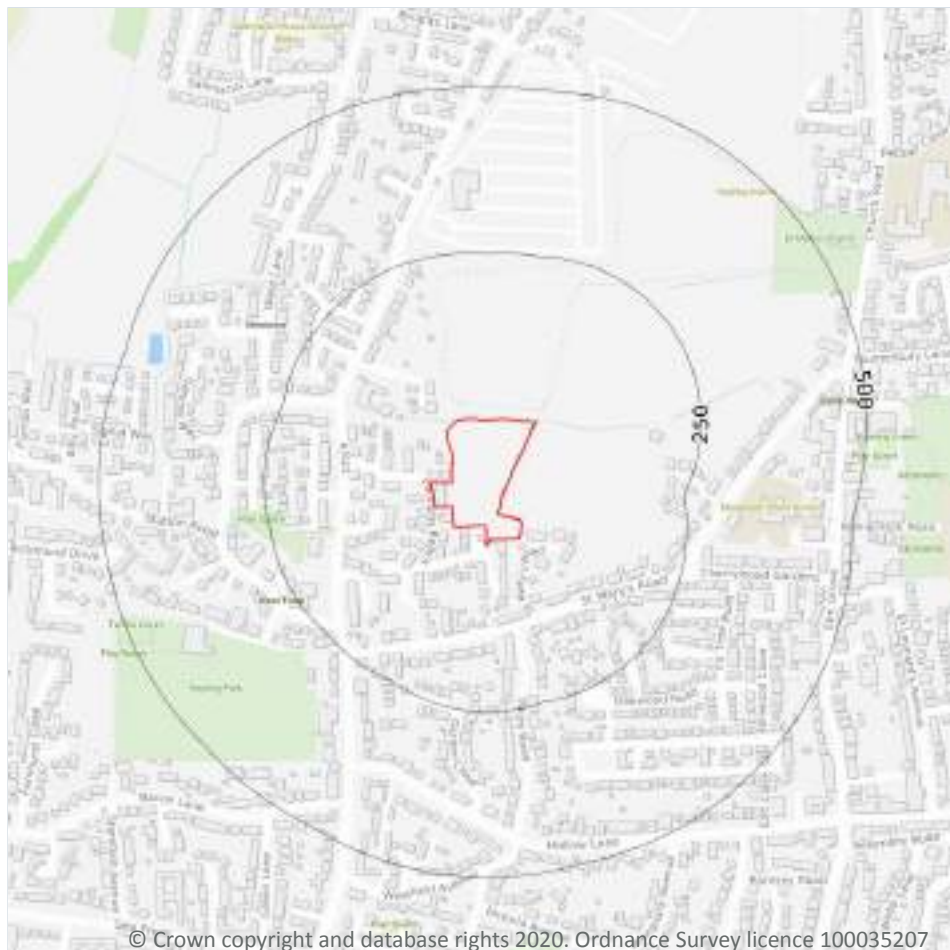
## Abstractions and Source Protection Zones

- Site Outline
- Search buffers in metres (m)
- Source Protection Zone 1  
Inner catchment
- Source Protection Zone 2  
Outer catchment
- Source Protection Zone 3  
Total catchment
- Source Protection Zone 4  
Zone of Special Interest
- Source Protection Zone 1c  
Inner catchment - confined aquifer
- Source Protection Zone 2c  
Outer catchment - confined aquifer
- Source Protection Zone 3c  
Total catchment - confined aquifer
- Drinking water abstraction licences  
Polygon features
- Drinking water abstraction licences  
Linear features
- Groundwater abstraction licence (point)
- Groundwater abstraction licence (area)
- Groundwater abstraction licence (linear)
- Surface Water Abstractions (point)
- Surface Water Abstractions (area)
- Surface Water Abstractions (linear)

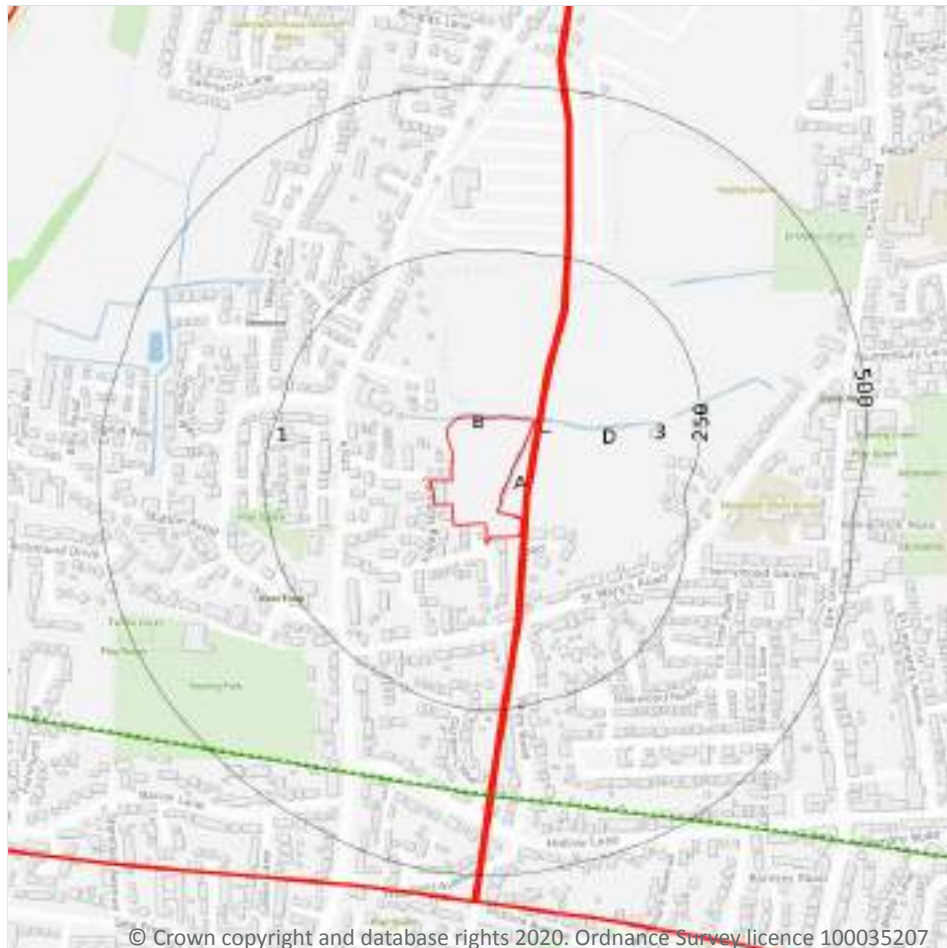
## 6 Hydrology

- Site Outline
- Search buffers in metres (m)
- Water Network (OS MasterMap)
- Surface water features (wider than 5m)
- Surface water features (narrower than 5m)
- ... WFD River, canal and surface water transfer water bodies
- WFD Lake water bodies
- WFD Transitional and coastal water bodies
- WFD Surface water body catchments boundaries
- WFD Groundwater body boundaries

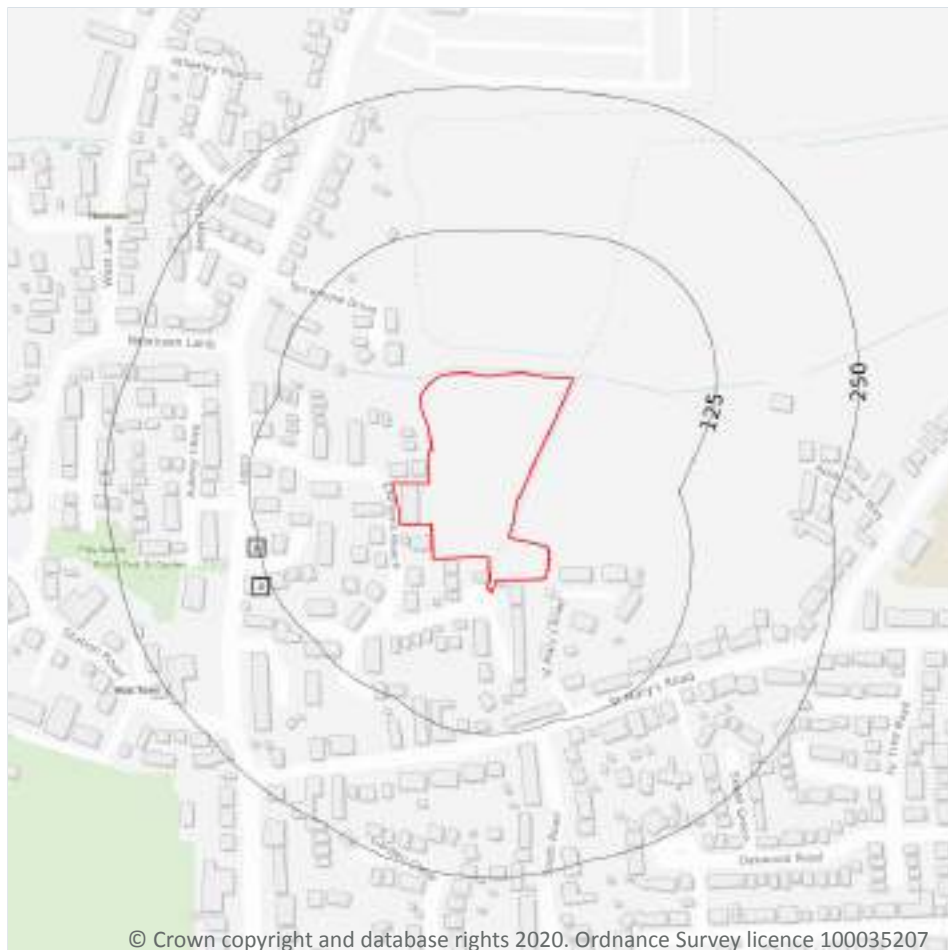
## 7 River and coastal flooding

- Site Outline
- Search buffers in metres (m)
- Environment Agency river and coastal flooding:
  - High
  - Medium
  - Low
  - Very Low
- Historical Flood Events
- Areas Used for Flood Storage
- Areas Benefiting from Flood Defences
- Flood Defences

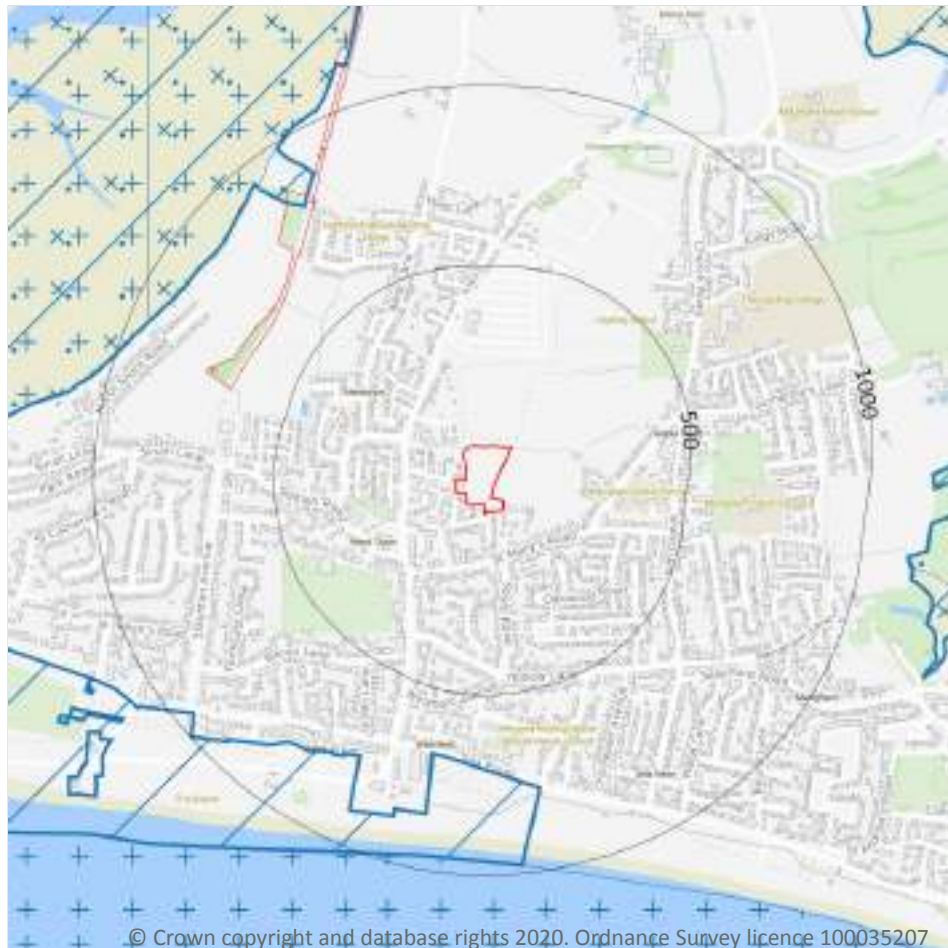
## 10 Environmental designations

- Site Outline
- Search buffers in metres (m)
- / Sites of Special Scientific Interest (SSSI)
- X Conserved wetland sites (Ramsar sites)
- + Special Areas of Conservation (SAC)
- Special Protection Areas (SPA)
- + Local Nature Reserves (LNR)
