# Public Safety Risk Assessment – Tree Survey Schedule

| Site Name: Middle Parkway, Havant | Site Ref: | AIMS ID: | NGR: SU 71765 08684 |

Middle Parkway, Havant, PO9 5EN

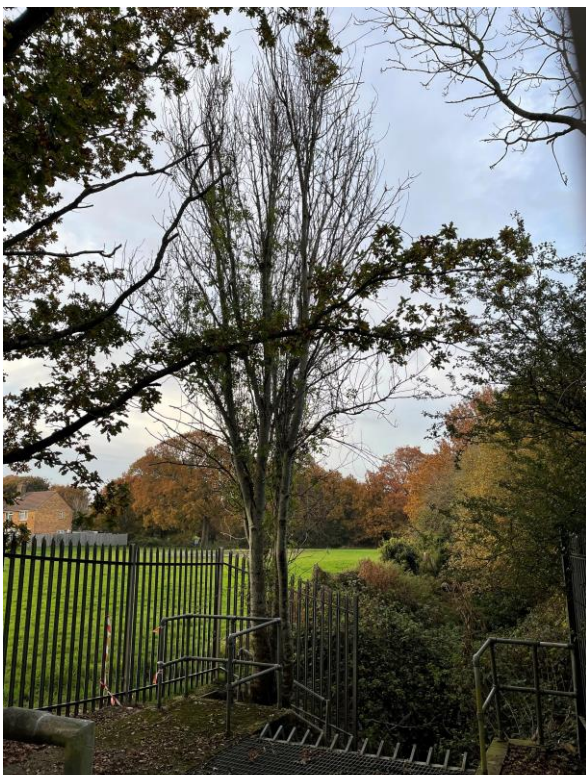
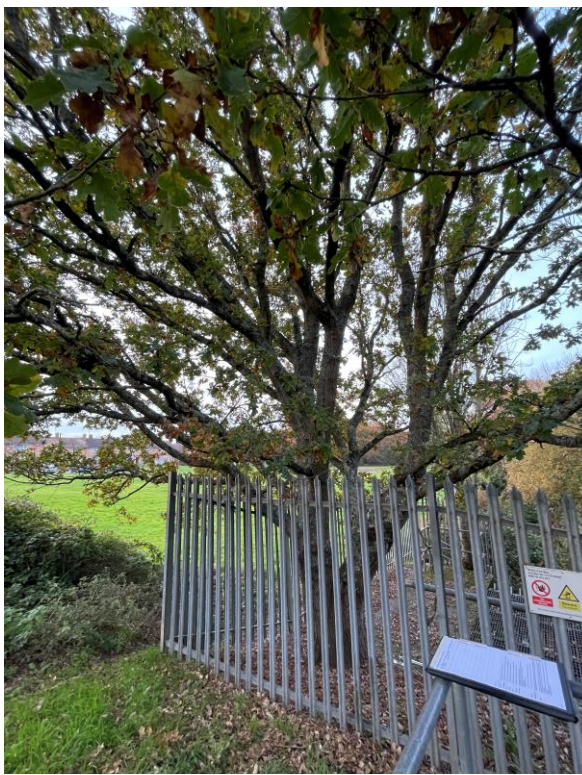
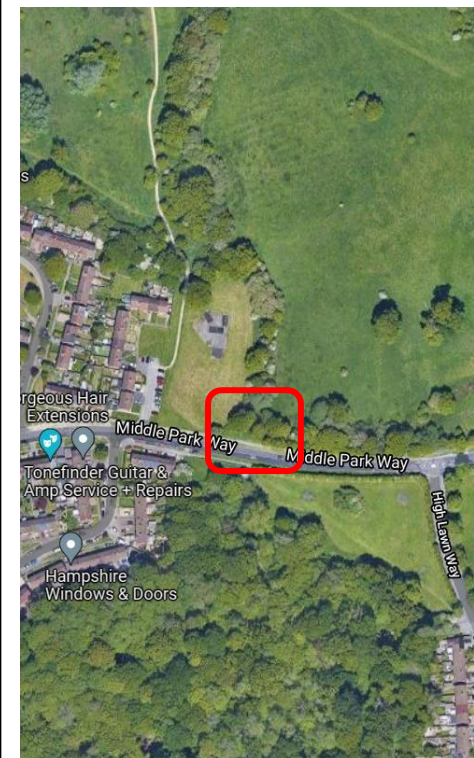
## Site photos and maps

A small site located amongst parkland and residential housing. The site is contained within palisade fencing and consists of only two trees adjacent to a small watercourse. Access within the compound was not possible at the time of inspection, however sufficient detail was observed to make accurate recommendations from outside of the compound.

| Tree Number | Description of location (NGR if available) | Species | Top Ht. (m) | Stem Ø (cm) | Age Category | Physical Condition | Comments | Recommended Action | Priority |
|---|---|---|---|---|---|---|---|---|---|
| T1 | SU 71765 08684 | Oak | 13 | 895 | M | Good | Well balanced crown with some signs of deadwood in upper crown. Low lateral limbs over palisade fence. | Crown raise lower lateral limbs to provide 1.5-2m of clearance from fence. Remove all significant deadwood which poses a risk of damage or injury. | C |
| T2 | SU 71765 08684 | Ash | 10 | 3x stems @ average 230 | Y-MA | Poor | Signs of major dieback throughout tree. Evidence of stress related growth in crown. | Remove to ground level and chemically treat stump to prevent regrowth. | C |
