**TREE SURVEY,  
ARBORICULTURAL IMPACT ASSESSMENT,  
TREE PROTECTION PLAN &  
ARBORICULTURAL METHOD STATEMENT  
Rev:0,**

**Planning Condition no. 18 attached to planning  
permission reference APP/20/01127,**

**Mill Rythe Holiday Village, 16 Havant Road,  
Hayling Island, PO11 0PB,**

**Job no. MJC-21-0203**

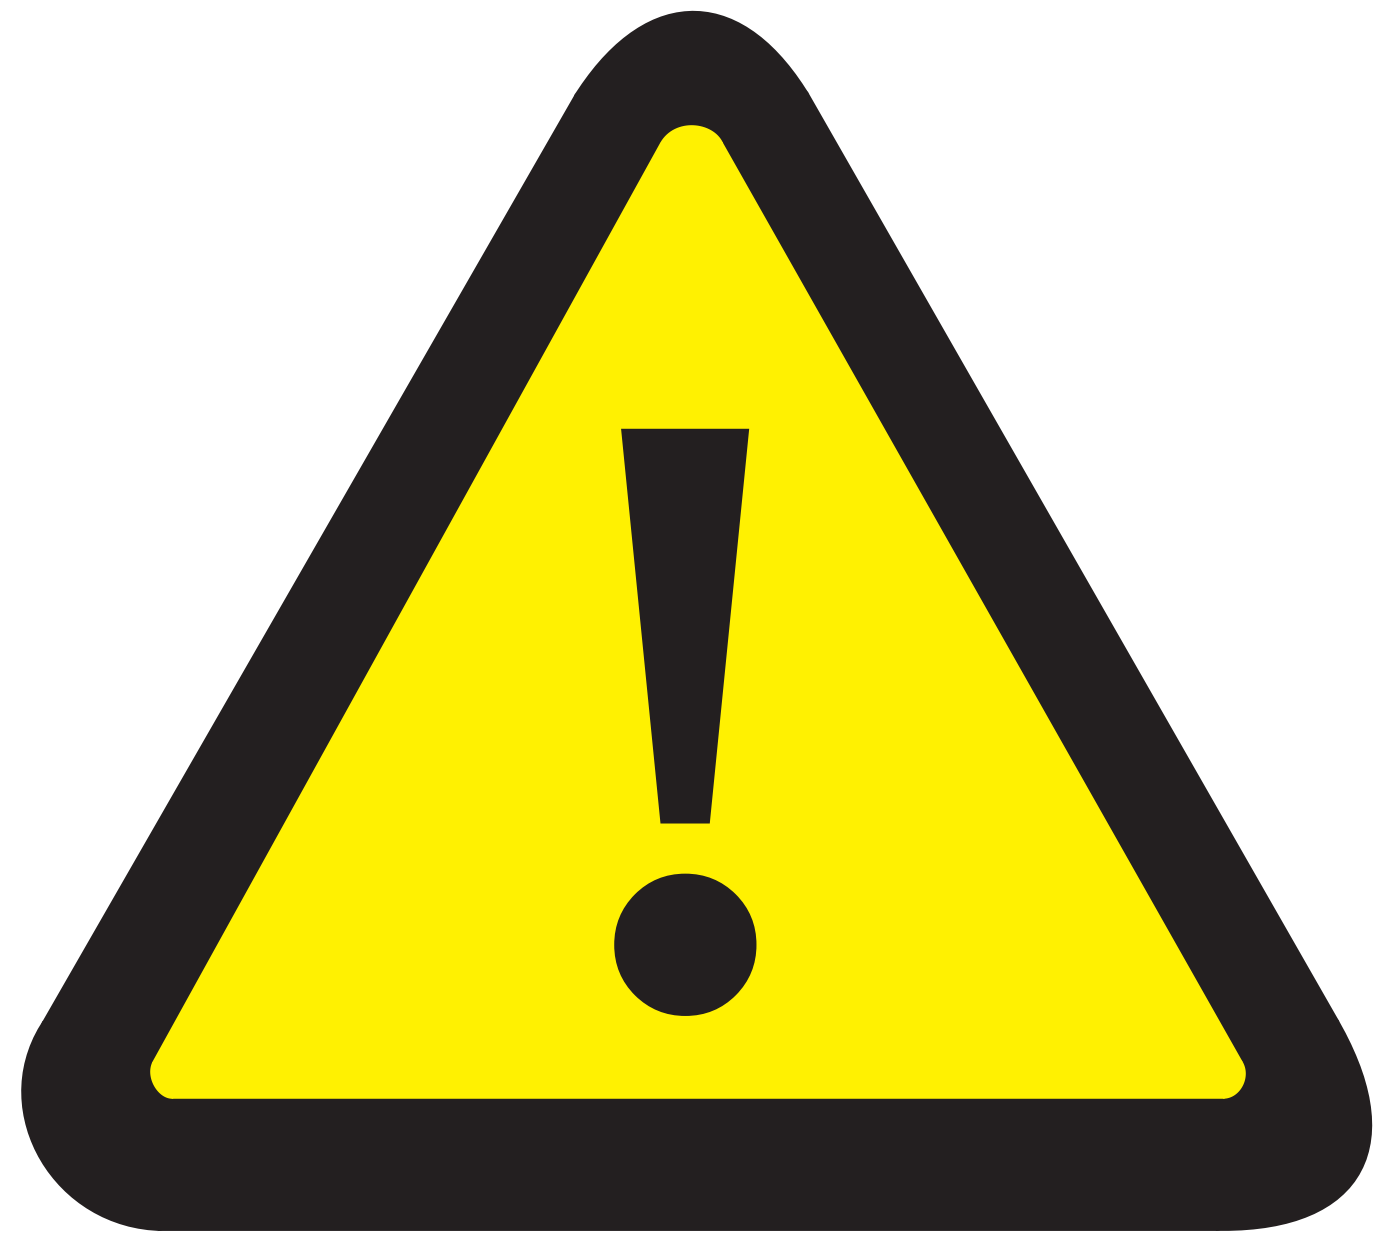
## **9.0 Tree Protection Barrier Sign**

**PROTECTIVE FENCING. THIS  
FENCING MUST BE  
MAINTAINED IN ACCORDANCE  
WITH THE APPROVED PLANS  
AND DRAWINGS FOR THIS  
DEVELOPMENT.**

**TREE PROTECTION AREA  
KEEP OUT !**

**(TOWN & COUNTRY PLANNING ACT 1990)  
TREES ENCLOSED BY THIS FENCE ARE PROTECTED BY  
PLANNING CONDITIONS AND/OR ARE THE SUBJECTS OF A  
TREE PRESERVATION ORDER.  
CONTRAVENTION OF A TREE PRESERVATION ORDER MAY  
LEAD TO CRIMINAL PROSECUTION**
