# **Validation Report**

(Area A – B – Commercial Offices)

58-64 STATION ROAD  
HAYLING ISLAND, HAMPSHIRE  
PO11 0EL

Report Ref: 517 / R06

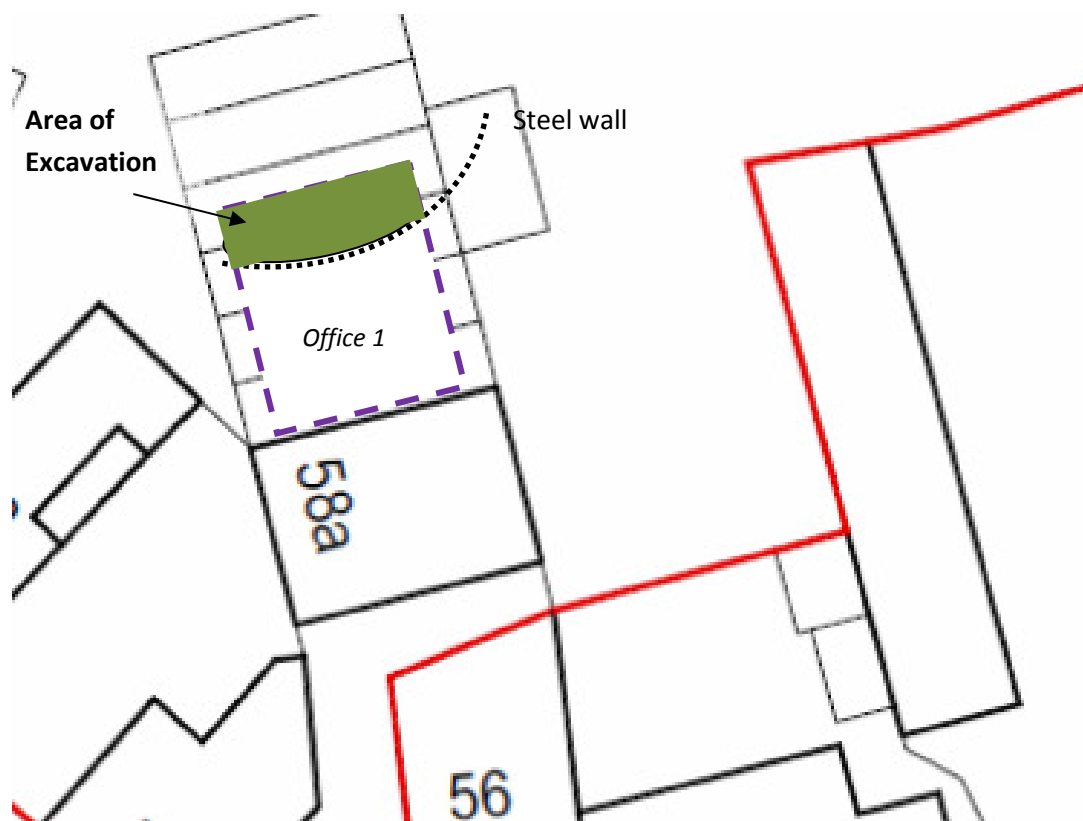
**Figure 4 : Area of excavation**

Following discussion with the developer it was decided to further investigate and remove all material within the proposed office footprint that lay between the concrete surface and the metal rim of the former tank feature. Figure 4 shows the area of soils removed. **Annex C** shows photographs of the works taking place. There had been concerns that some gas works type waste may exist at the low corner where the metal rim and concrete met, in actuality no gas works type wastes were encountered. The annulus had been backfilled with a brick rubble with many old iron pipes, bicycle frames, rare timbers and near the surface some twigs and branches assumed to have been from maintenance of the nearby ditches. All the material, was removed to 1.5m<sup>3</sup> rubble bags that were stored on a bunded area for off site disposal. The works were witnessed by David Grant from Dig-Geotech Ltd. Following the clearance the void are was backfilled with a crushed concrete.

The area has been left at ground level whilst other site works continued. The developer now wishes to proceed with the office building. We see no reason to not proceed. The building shall still have a gases proof membrane as originally proposed.

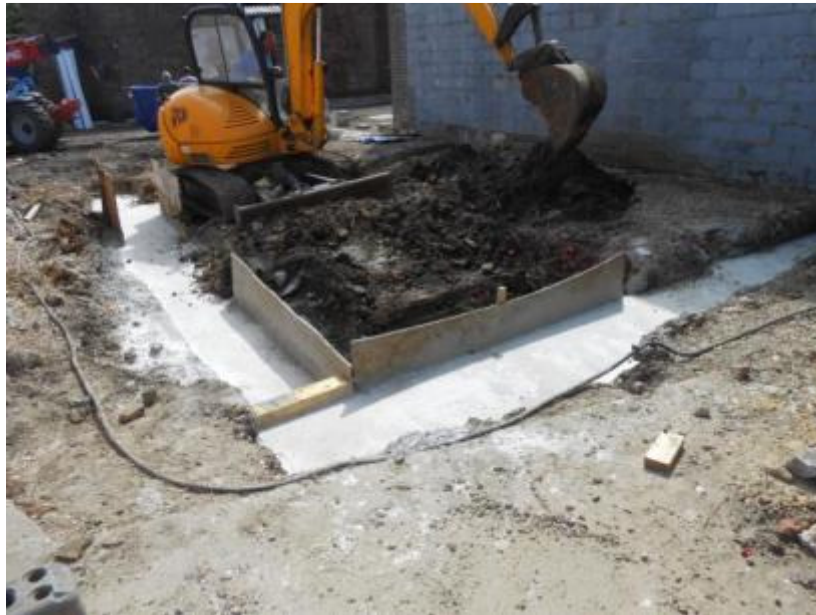
Above : pre removal works. Concrete is top of ormer trial trench / foundations

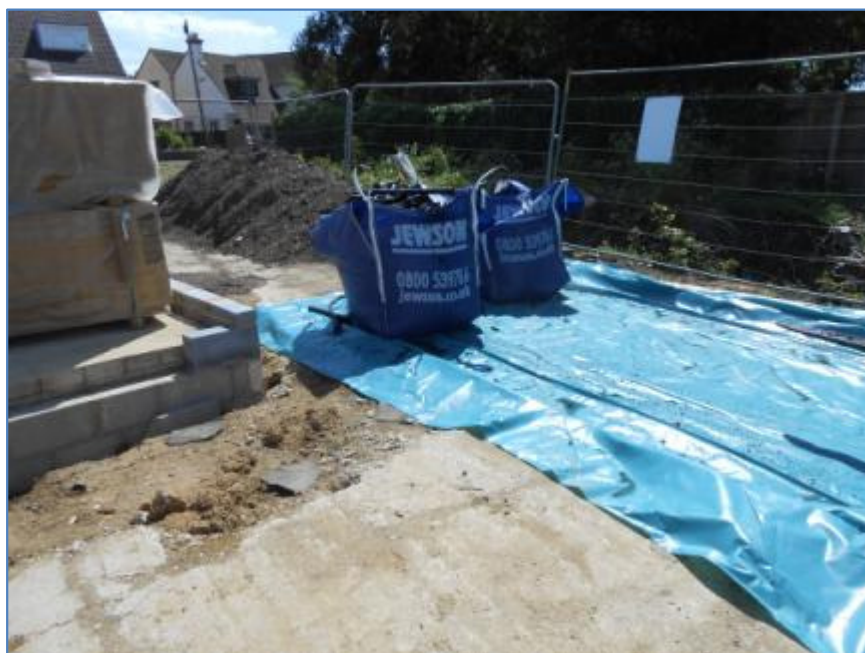
Below : bunded & lined area for storage of removed soils

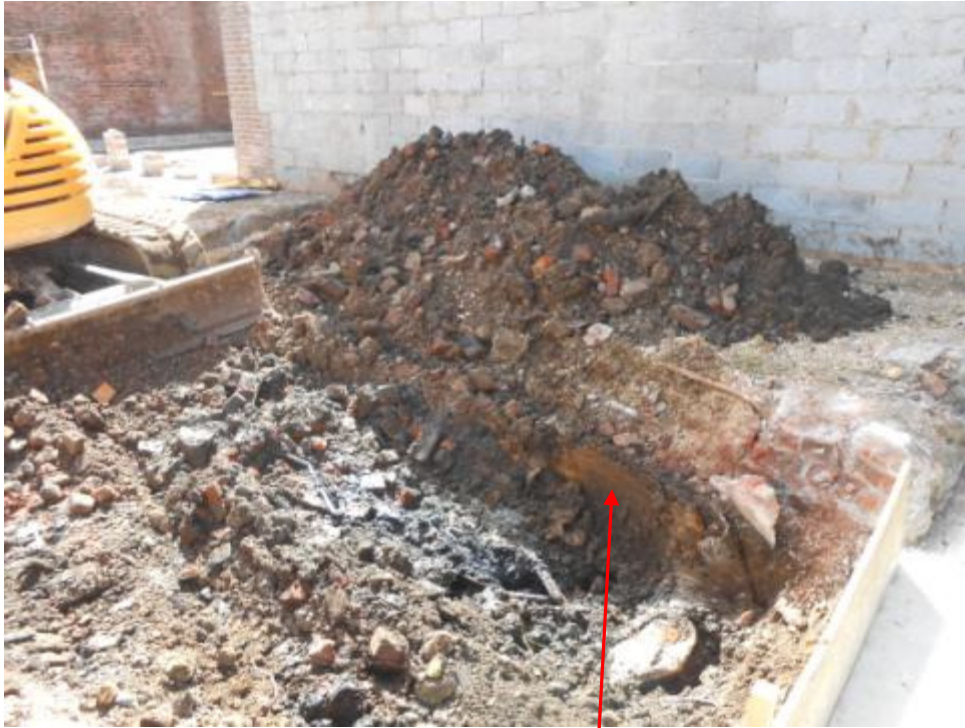
Steel rim

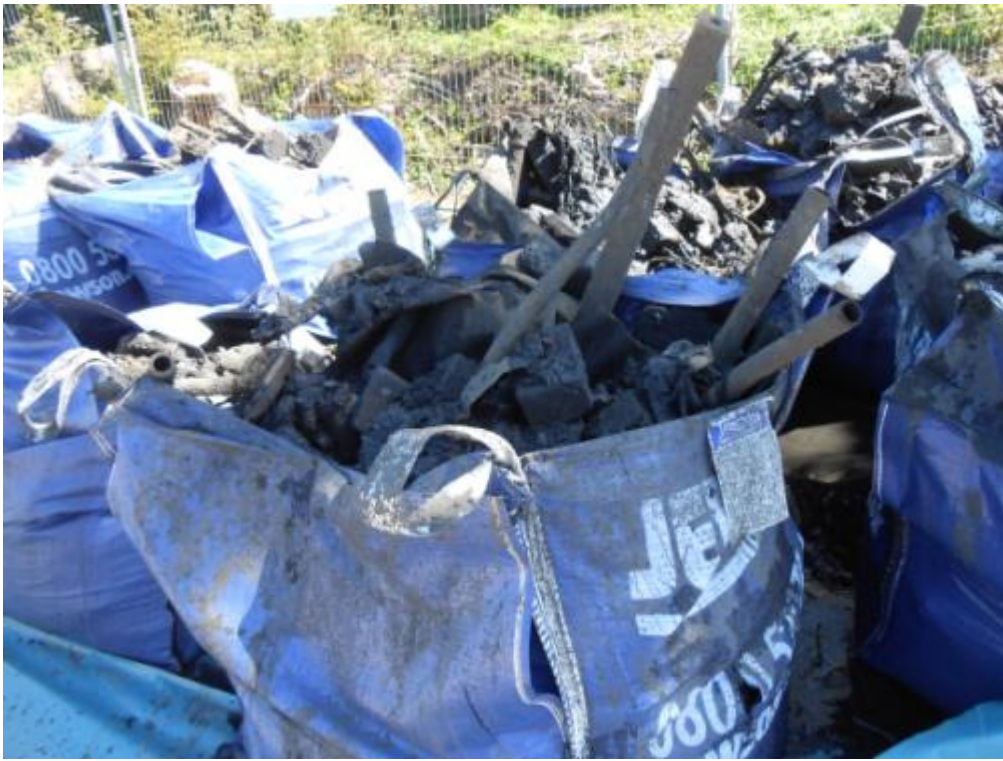
Typical waste material : pipes& brick rubble

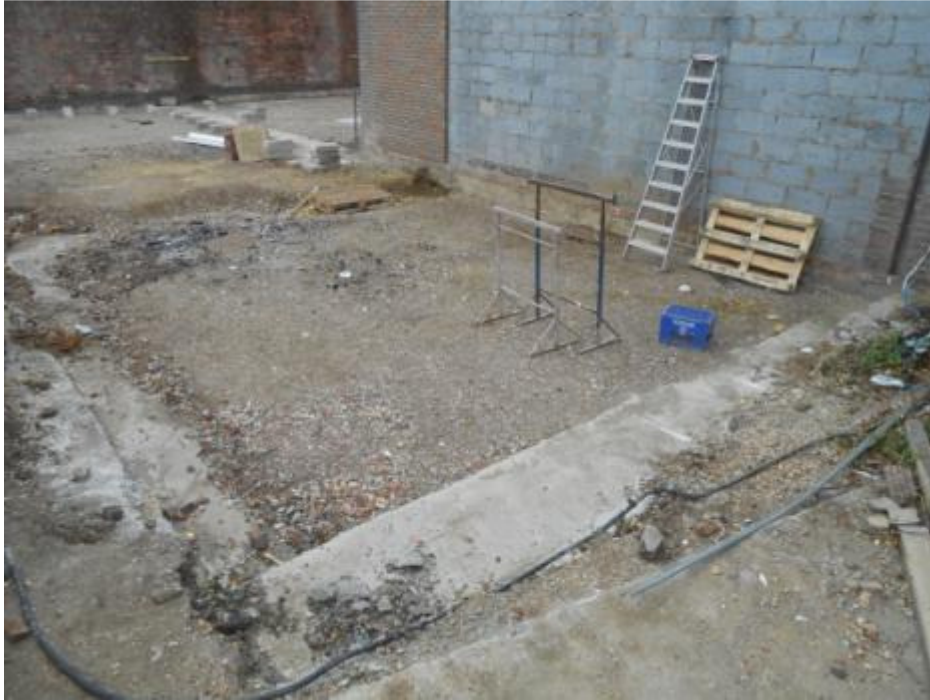
Backfilled with crushed concrete

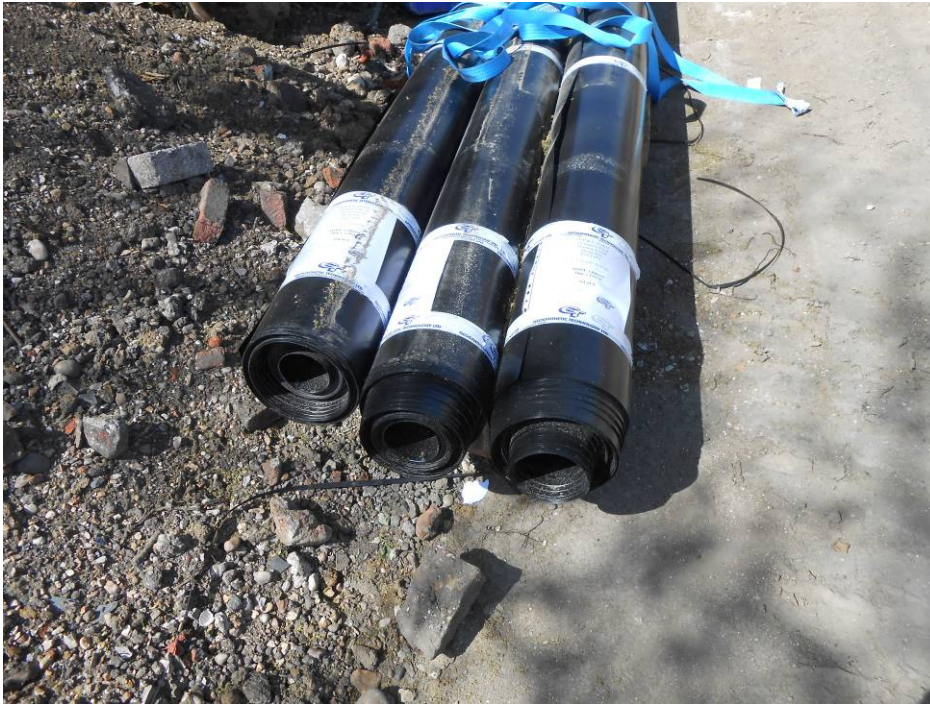
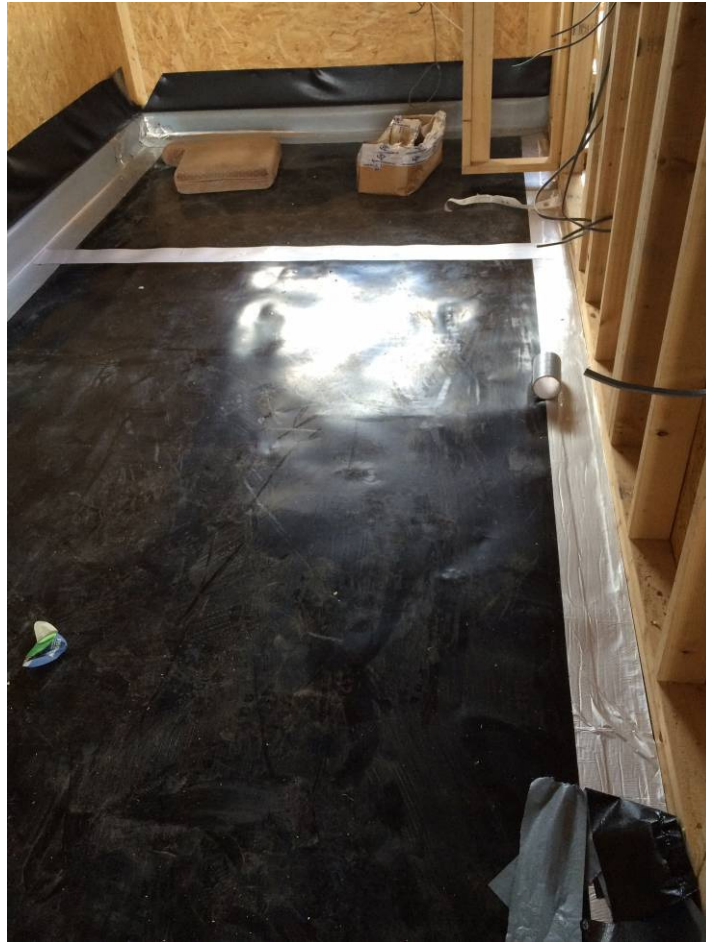
## Appendix B - Gases membrane installation

The barrier was installed as required. Photographs of the works taking place are enclosed as **Appendix B**.

A Visqueen (or similar) membrane was to be placed above the ventilated floor slabs. The appropriate grade of Visqueen was to be a minimum of a Visqueen Gas Barrier membrane if placed above a concrete floor with suitable protection. Installation was to be to manufactures' guidance.
