# Trevor Heaps

### Short report for 45 Hulbert Road Waterlooville, PO7 7NX

Date: 19<sup>th</sup> February 2021

Ref: TH 2727

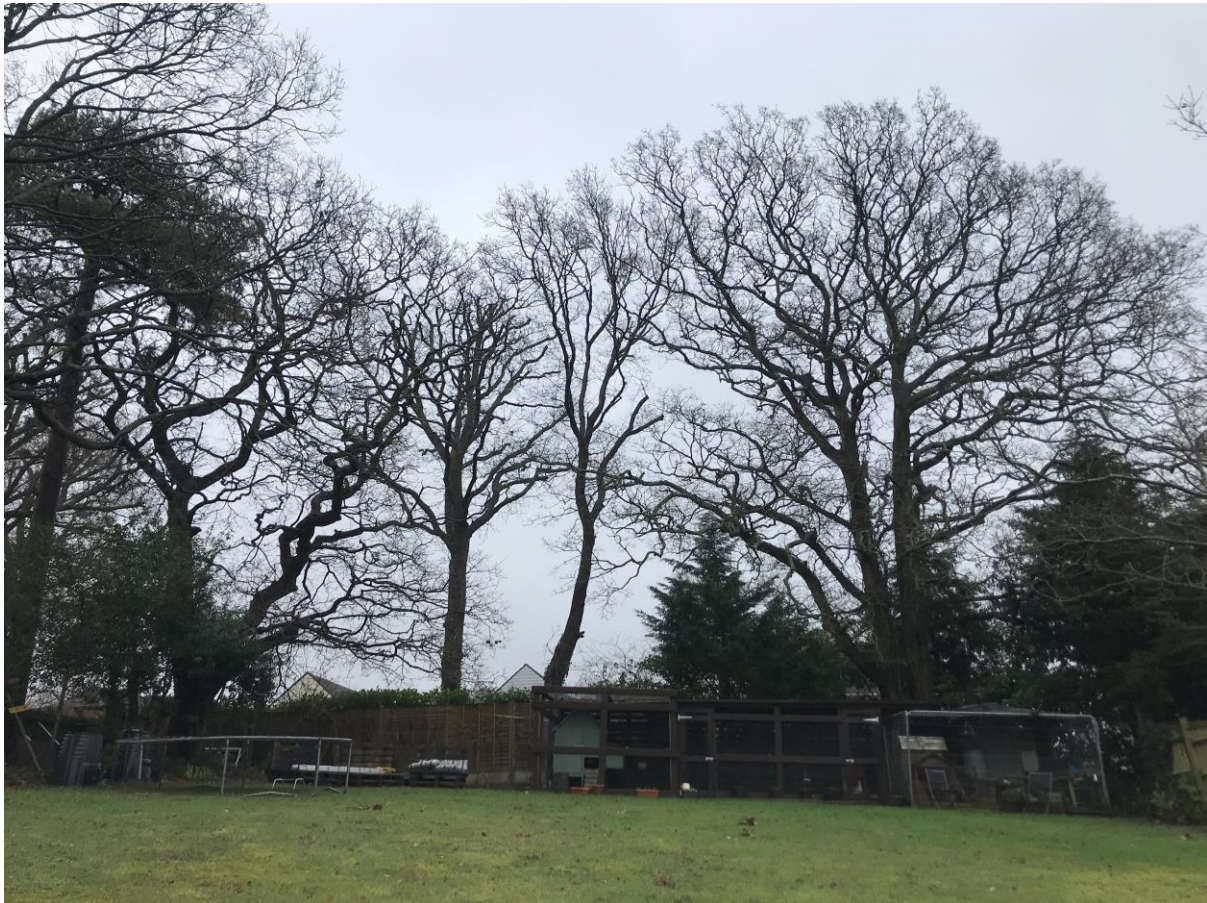
**Photo 1**

2.1 At the top of the rear garden (eastern end), a chicken coup has been constructed close to a mature, third-party Oak. The coup has been constructed using light building materials and is supported by wooden posts sunk into the ground. Apart from the digging of the post holes, there does not appear to have been any excavations or changes in levels around the tree. The paving slabs that run along the rear of the coup are simply resting on the ground.

2.2 The building will have a slight 'umbrella' effect on the rooting area of the tree (due to intercepted rainwater that would otherwise have reached the ground); however, the rainwater guttering pipe runs off the back of the coup (between it and the Oak) and so, due to the sloping land, some rainwater will percolate beneath it – to within the area now covered.

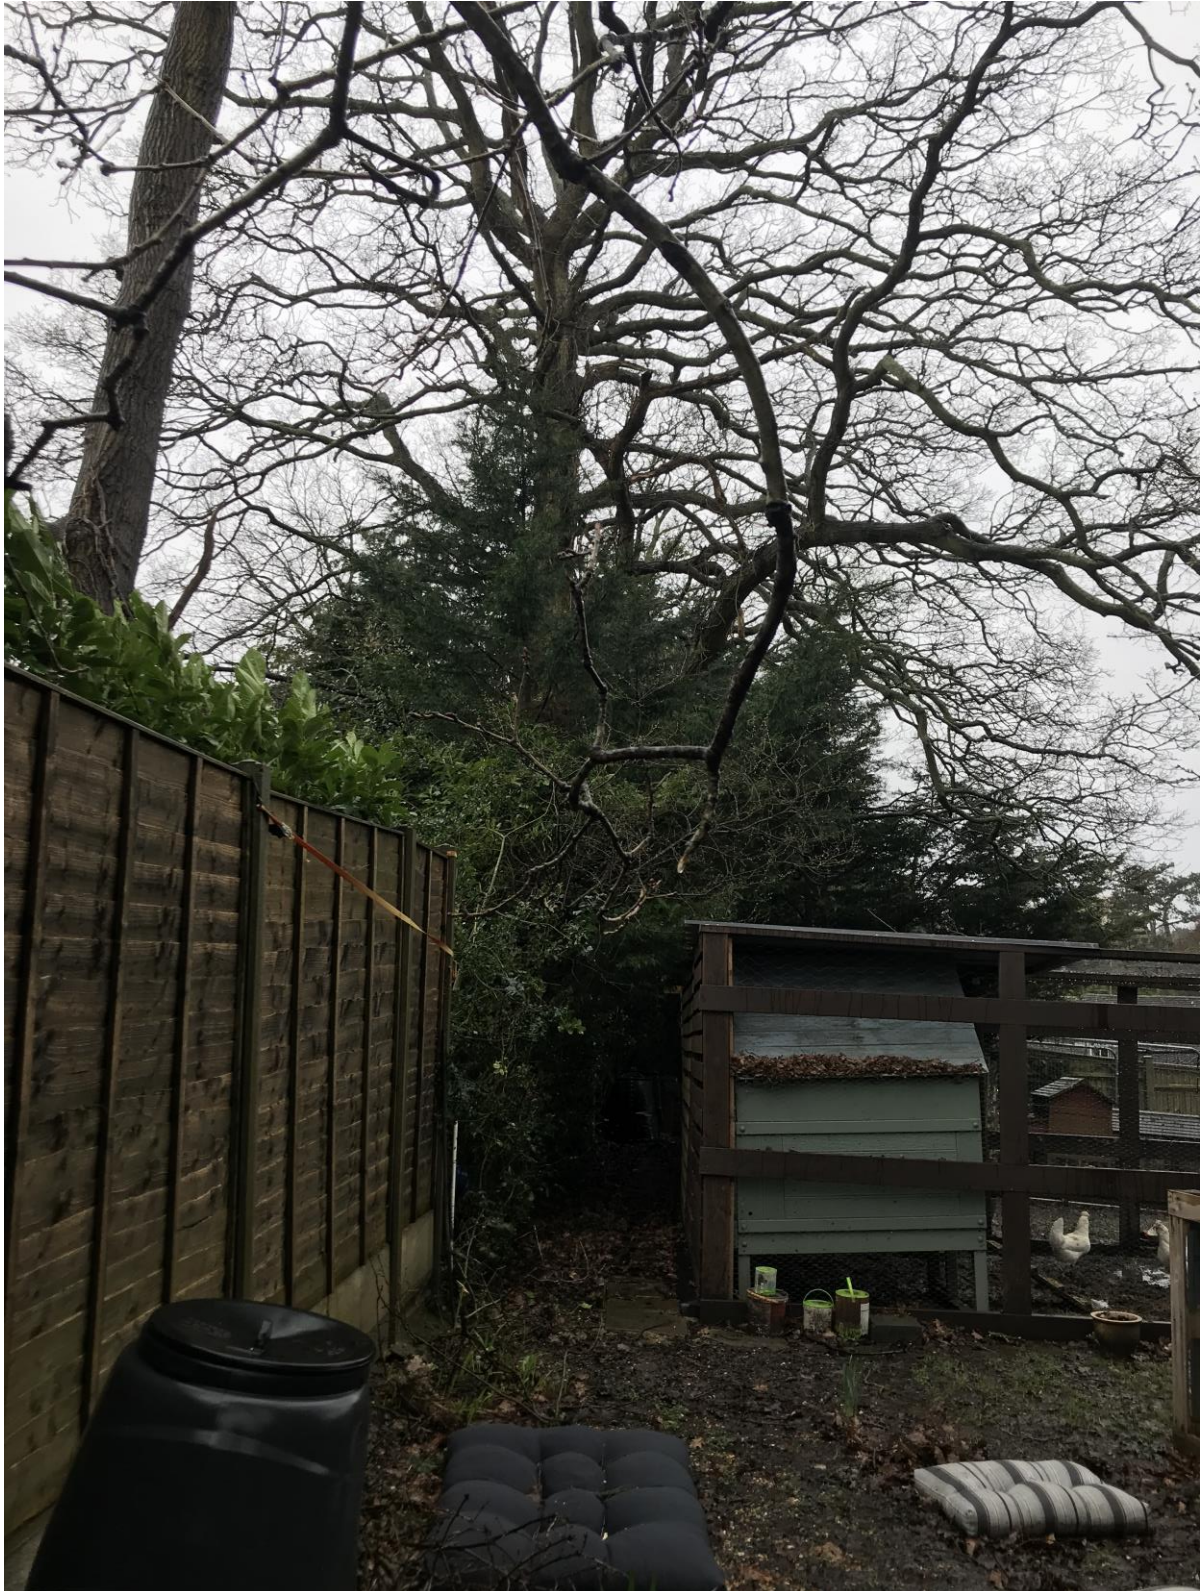
**Photo 2.** There have been no changes in ground levels.

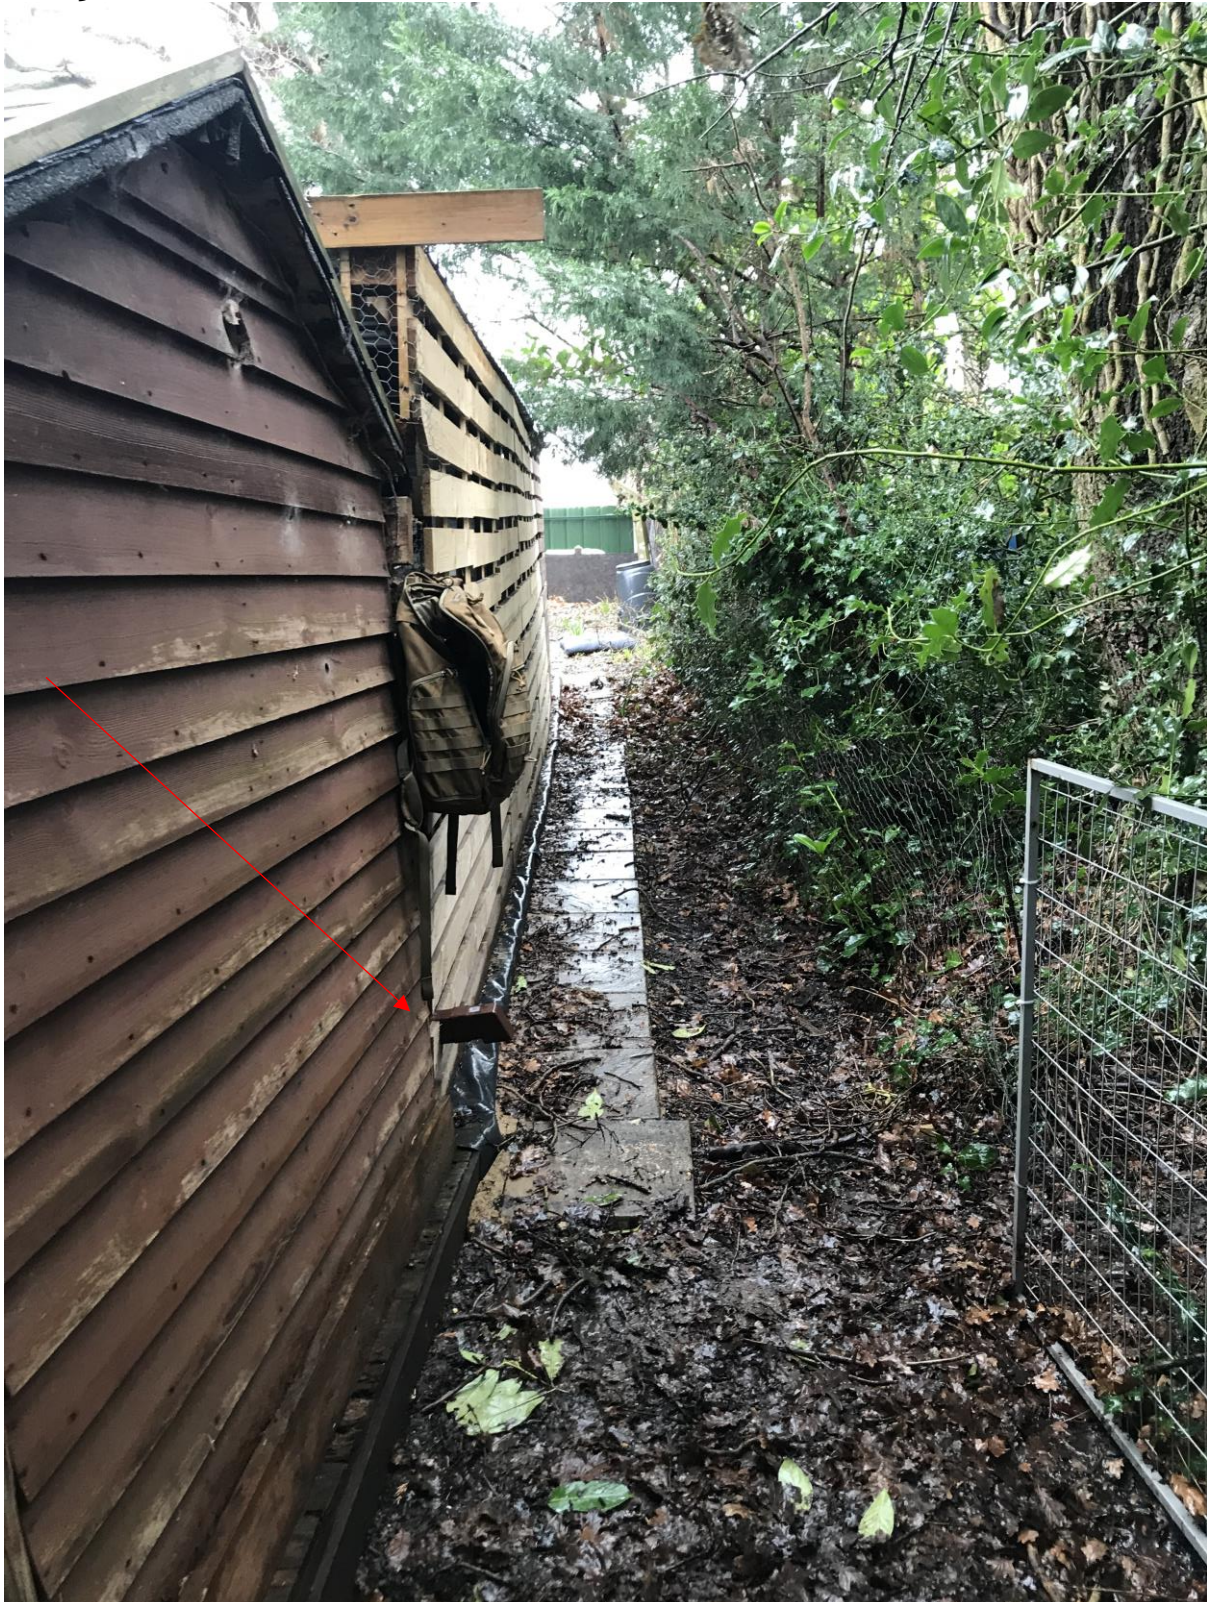
**Photo 3.** Rainwater outlet marked with an arrow

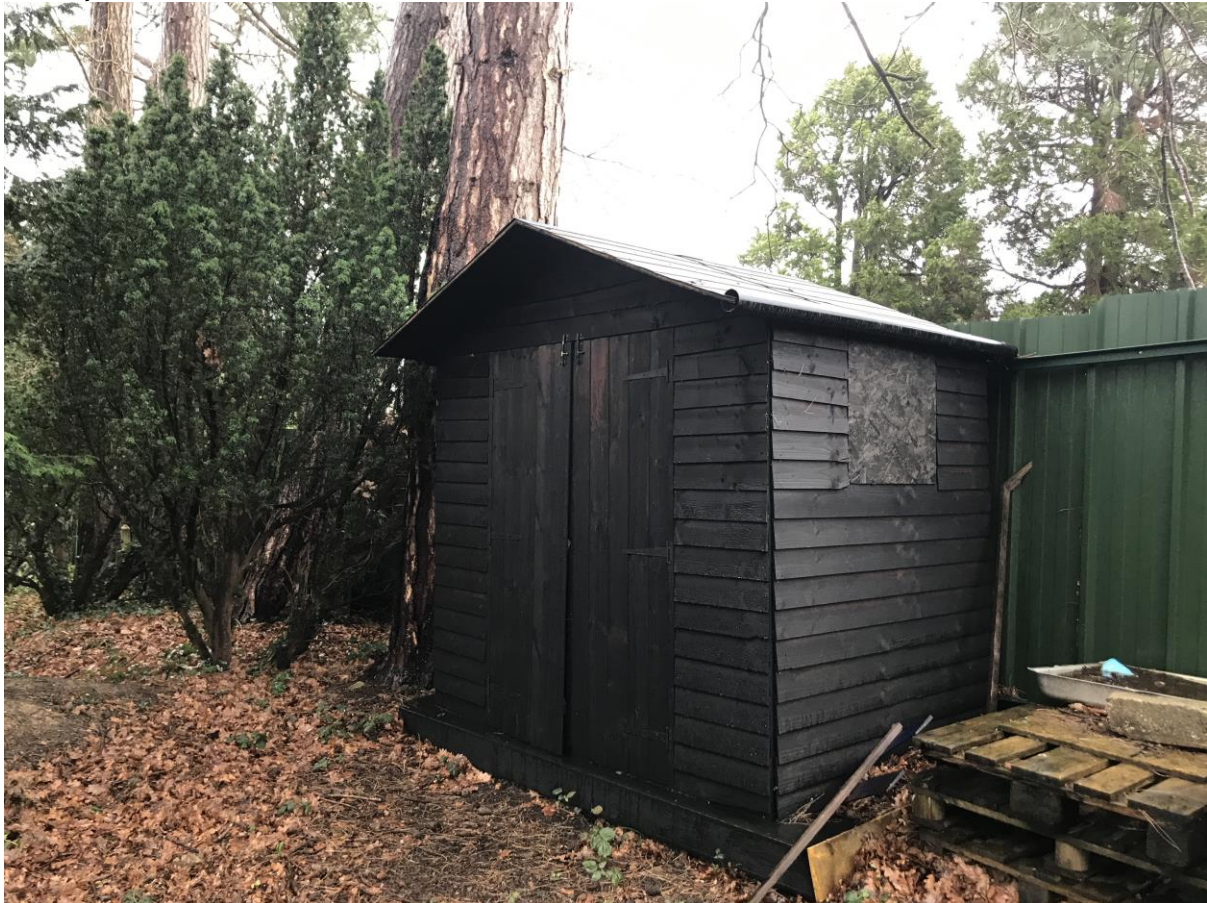
Photo 4

3.1 Along the northern boundary of the rear garden, a small shed has been constructed close to a mature Corsican Pine. The shed sits on a wooden crate and so there has not been any excavations or changes in levels around the tree. The shed is far too small to have any effect on rainwater reaching the roots.

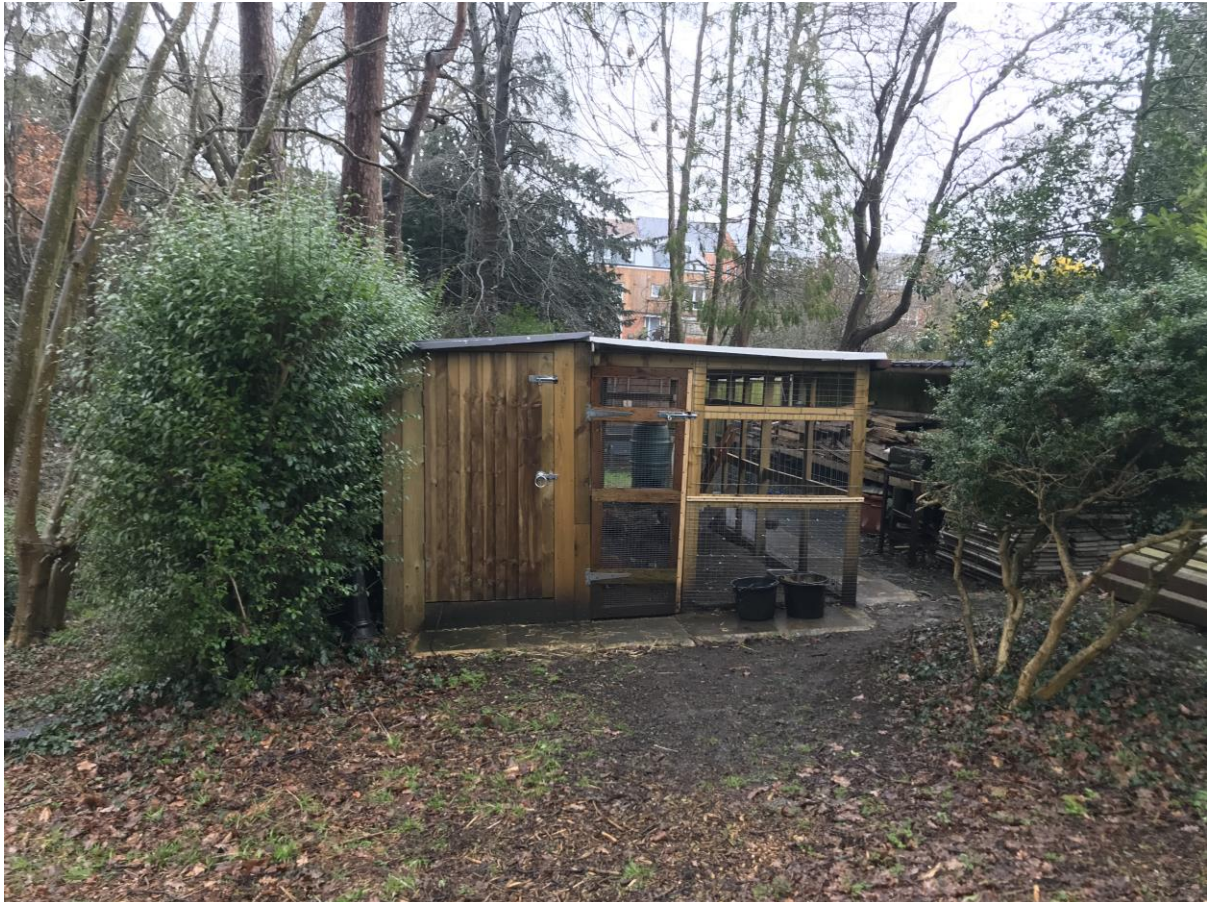
**Photo 5**

4.1 Close to the north-eastern section of the garden, a 2<sup>nd</sup> chicken coup has been constructed close to line of maturing Pines and Ashes. Again, it has been constructed using light building materials and is supported by wooden posts sunk into the ground. Again, apart from the digging of the post holes, there does not appear to have been any excavations or changes in levels around the tree. The trees are growing next to a small stream, and so there are no concerns about the lack of rainwater reaching the roots. The paving slabs that run along the front and side of the coup rest on the ground.

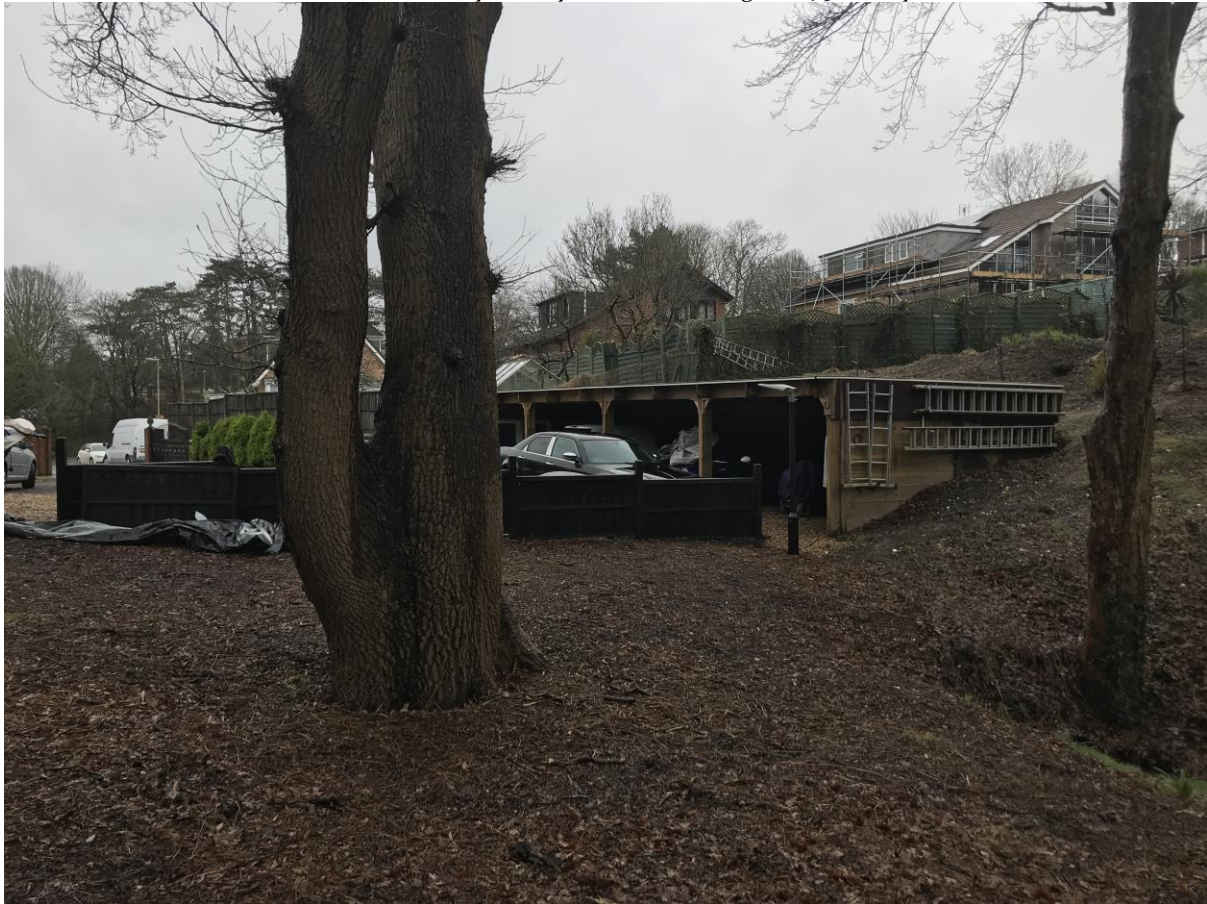
5.1 A new car port has been constructed by excavating into a raised area of soil. There may have been some very minor root damage at the periphery of the nearby Sycamore's rooting area, but it is 4.5m away and so any damage will have been negligible. The nearby Oak is over 10m away and so it is unlikely to have been affected at all. In any case, it is possible to off-set any minor root incursions, for both trees, within soft areas contiguous with their rooting areas.

**Photo 6.** The Oak on the left is over 10m away. The Sycamore on the right is 4.5m away
