# Geo-Environmental Assessment

**Former Brockhampton West Landfill, North of Harts Farm Way, Havant**

**Presented to Clowes Developments (UK) Ltd**

Delta-Simons Project No. 19-2099.04

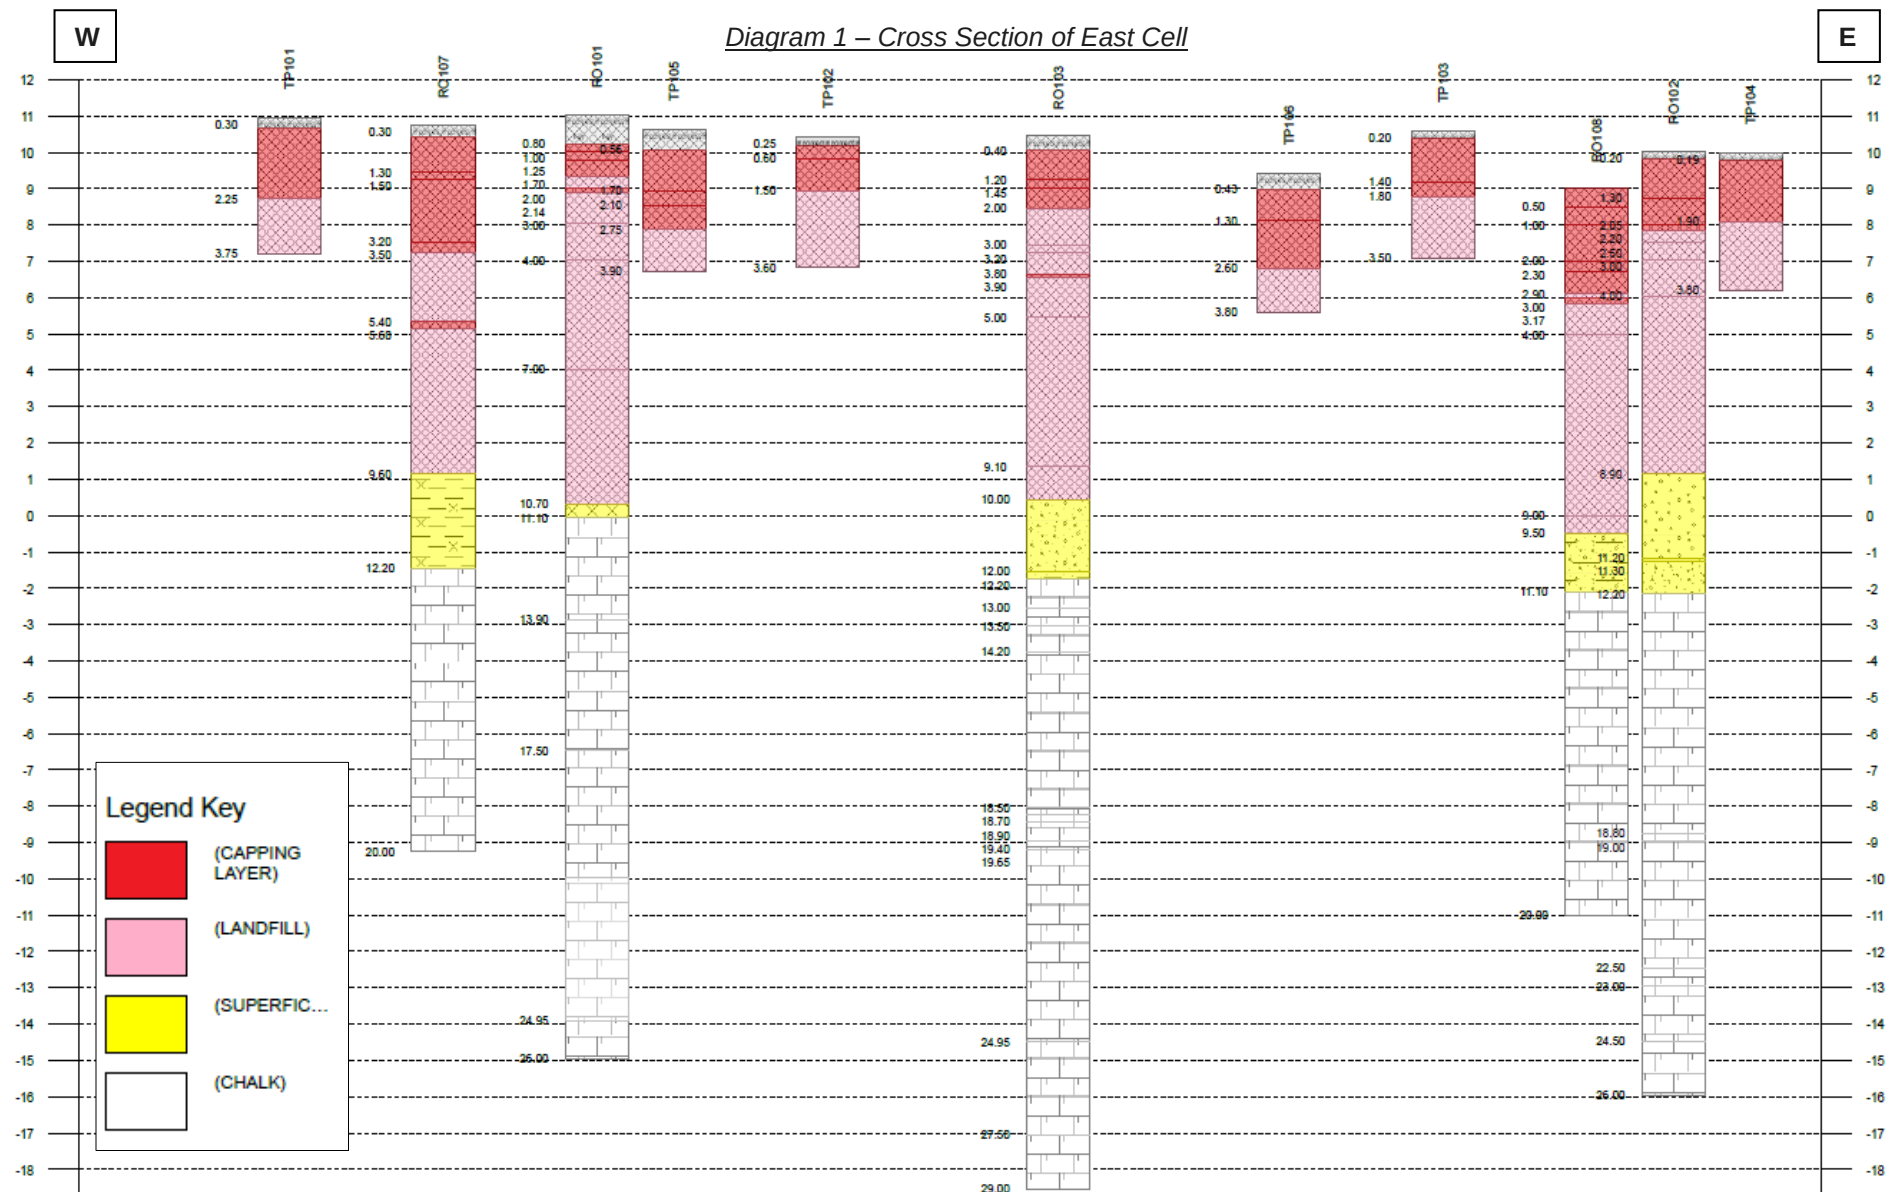
The cross section below (Diagram 1), for the east cell, demonstrates the varying thickness of the cover material and superficial deposits. The cross section also highlights the potential original re-engineered cover system materials situated within the waste. This may be associated with the brief termination of landfill waste disposal and provision of a 'cover system' followed by further waste disposal.

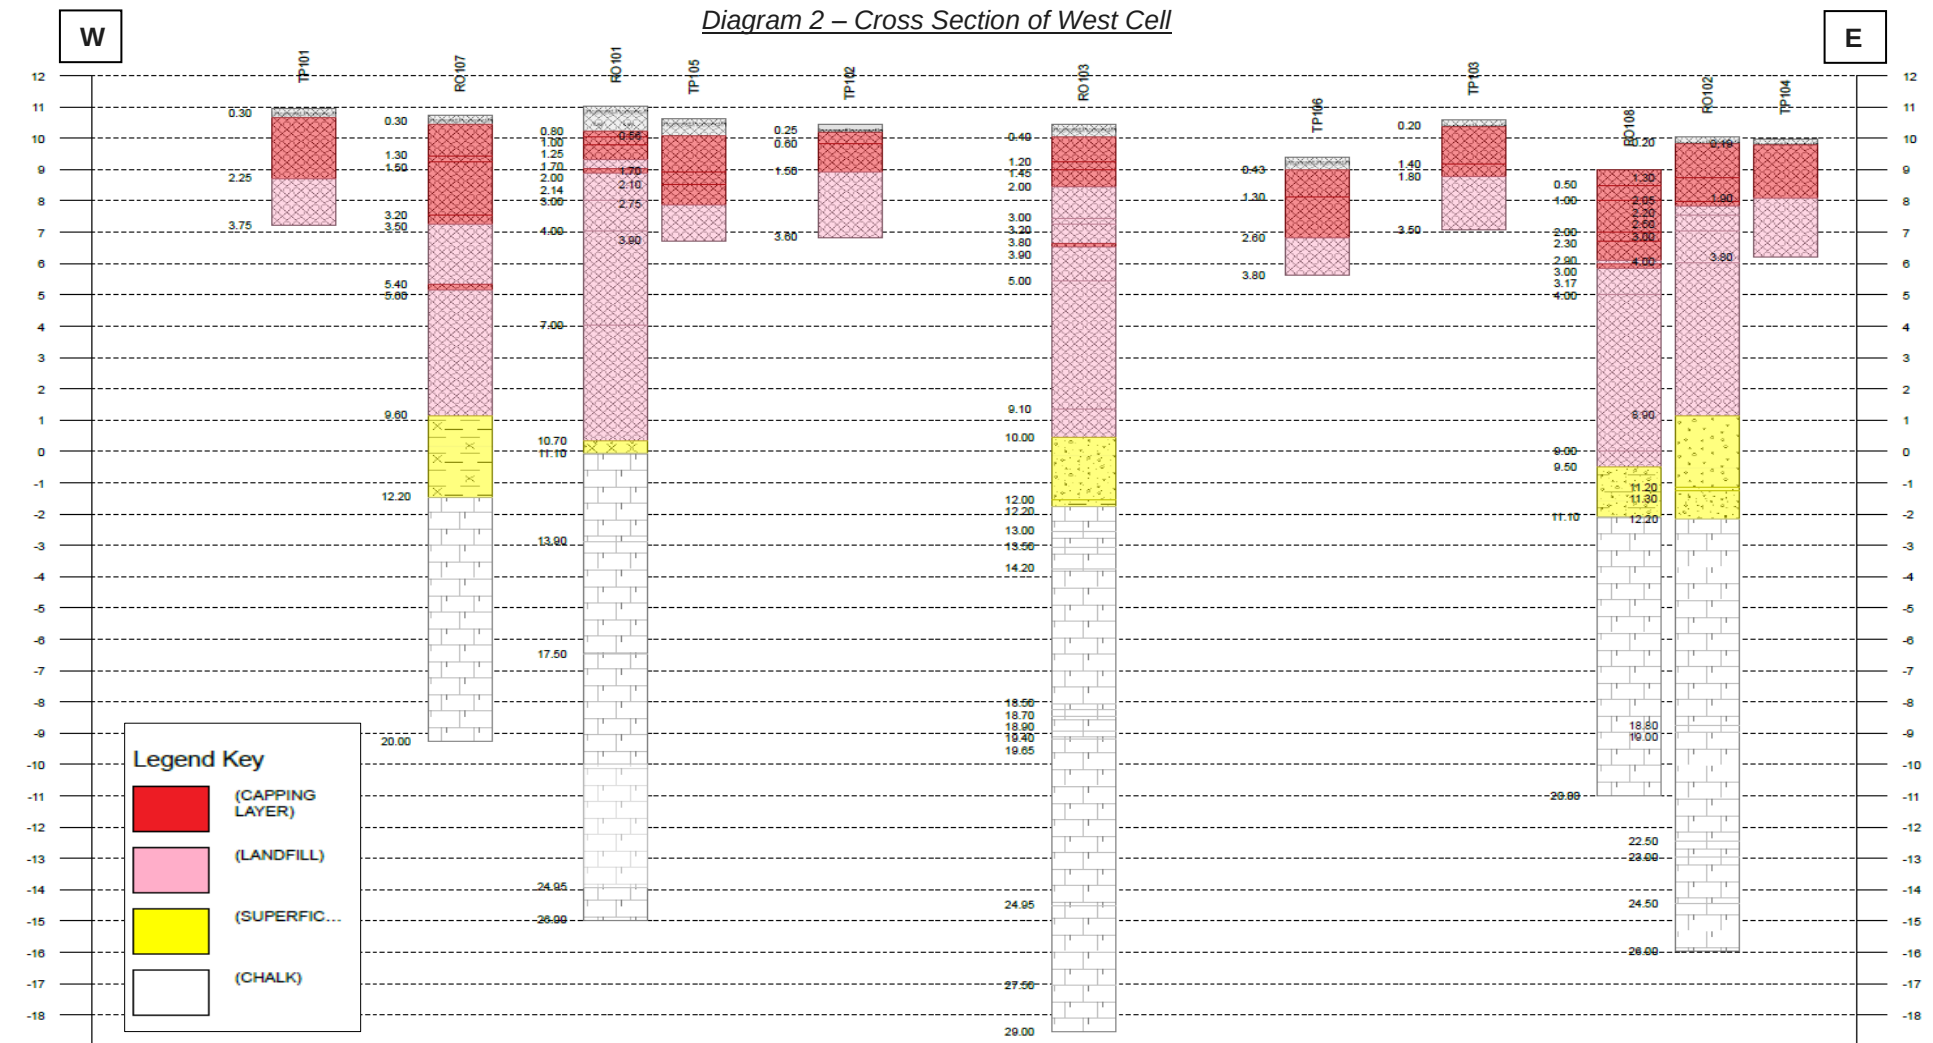
Similar to the east cell, the west cell also has varying thicknesses of re-engineered cover system material, landfill waste and superficial deposits (see Diagram 2 below).

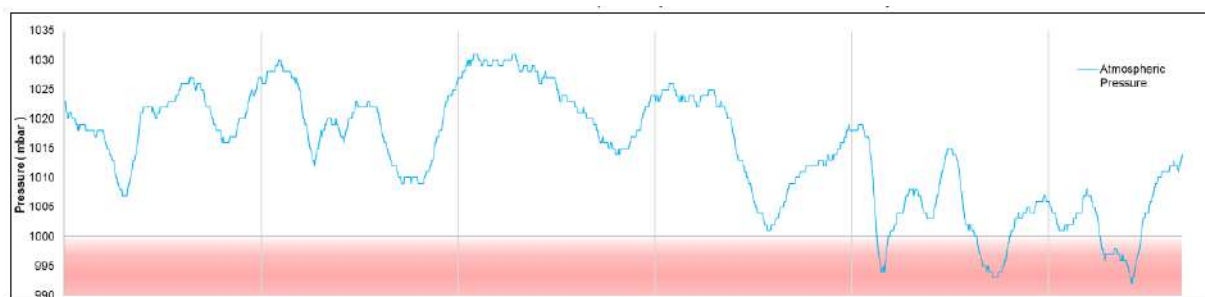
Figure 3 Atmospheric pressure trend during the continuous monitoring period, with shaded area below 1000mb.

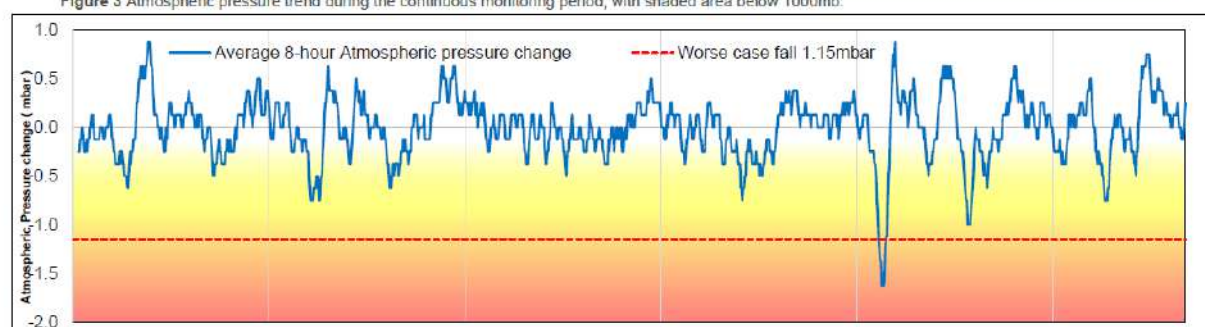
Figure 4 8-hour average atmospheric pressure trend during the continuous monitoring period.

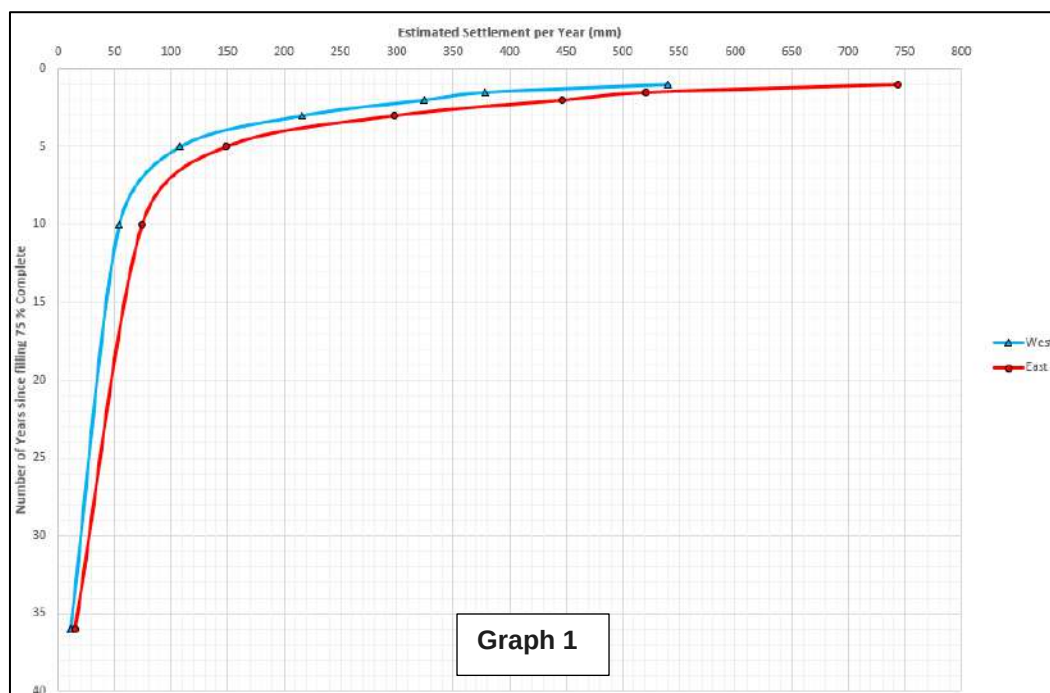
Graph 1 below is based on the calculations above and is a plot of estimated settlement per year versus years since filling 75 % complete. It is useful for demonstrating how the rate of settlement reduces overtime.

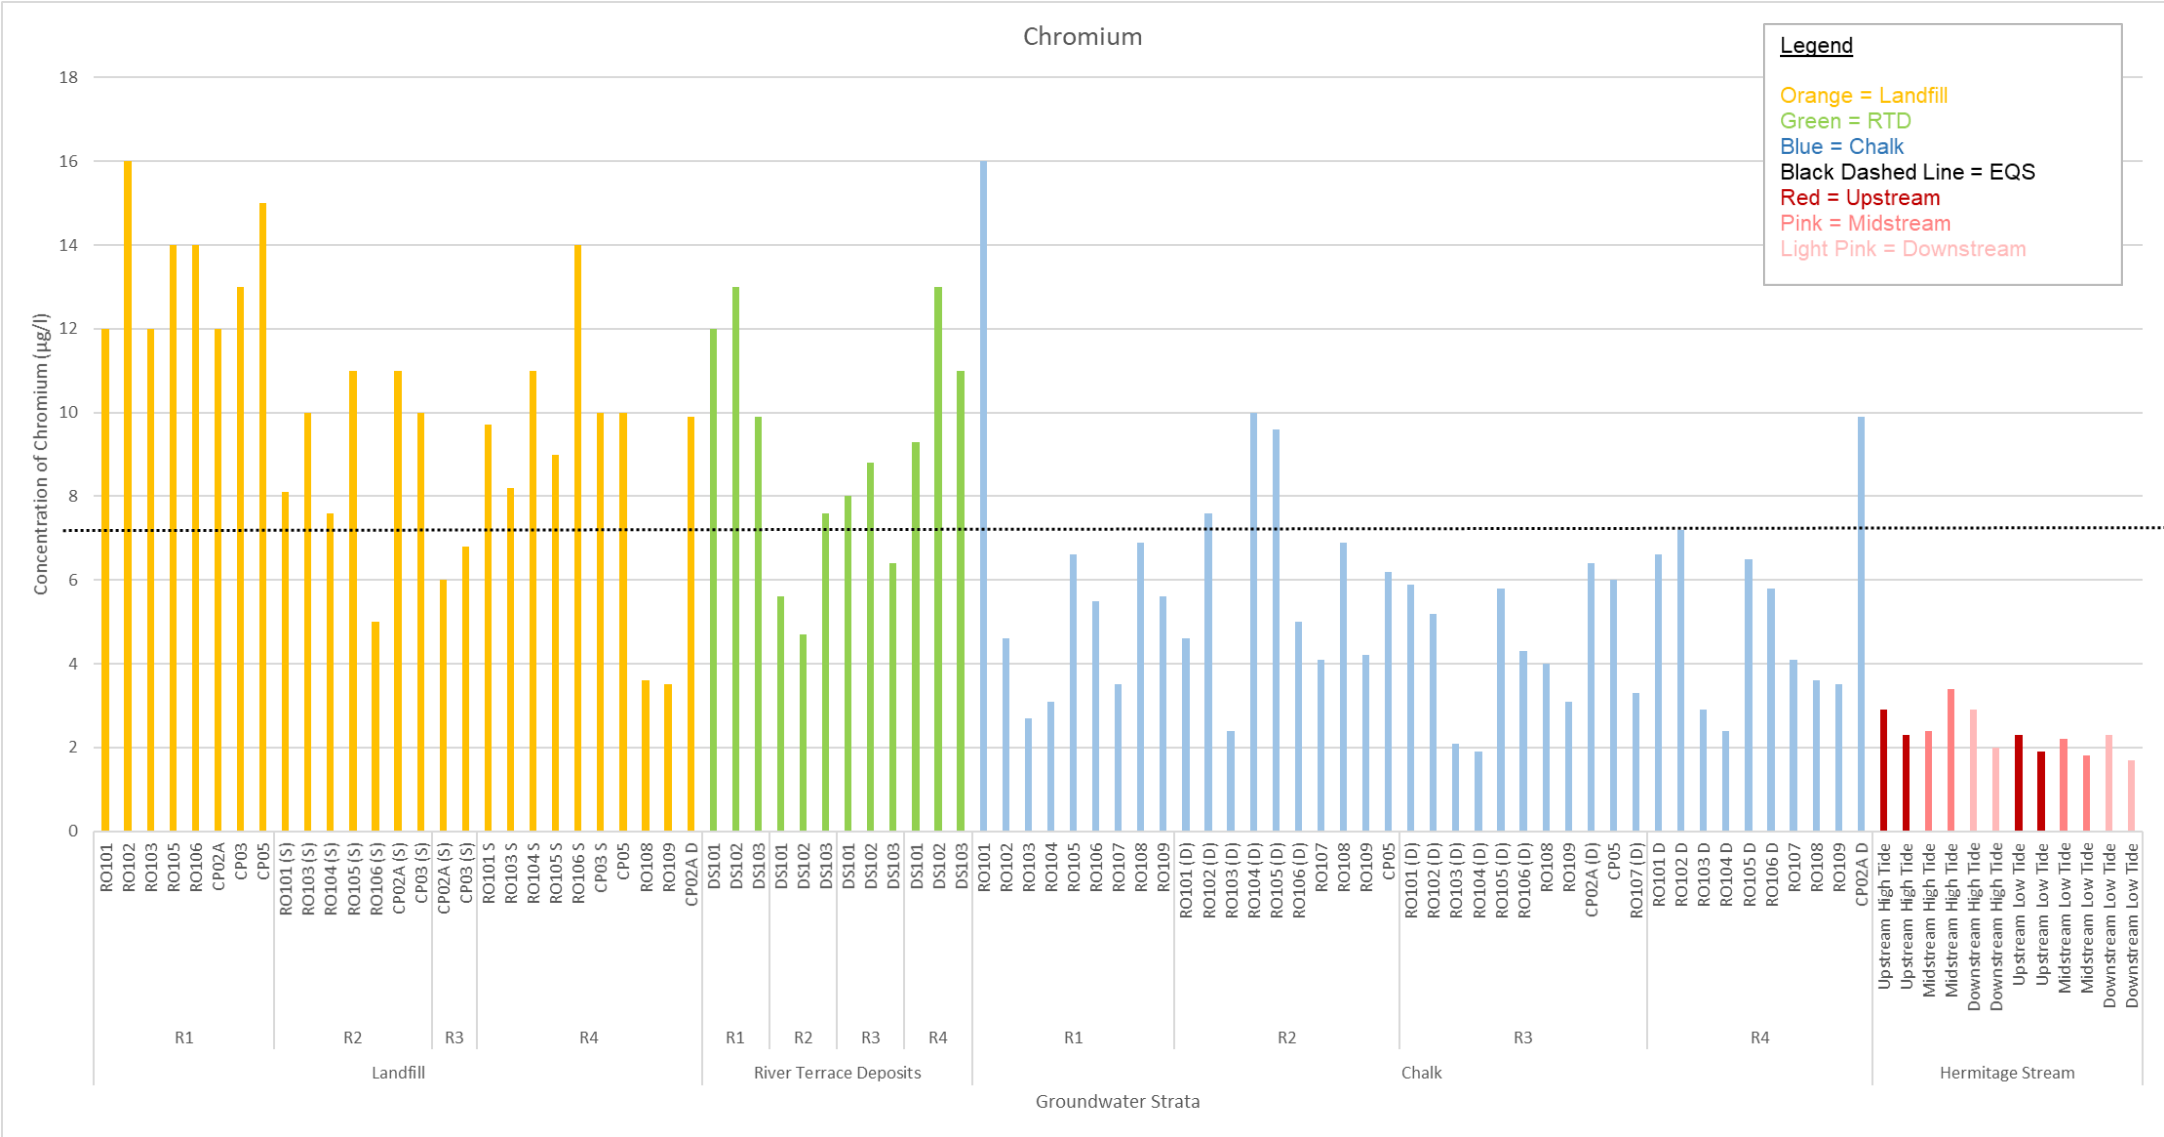
Diagram 5 – Chromium Concentrations in Groundwater and Hermitage Stream

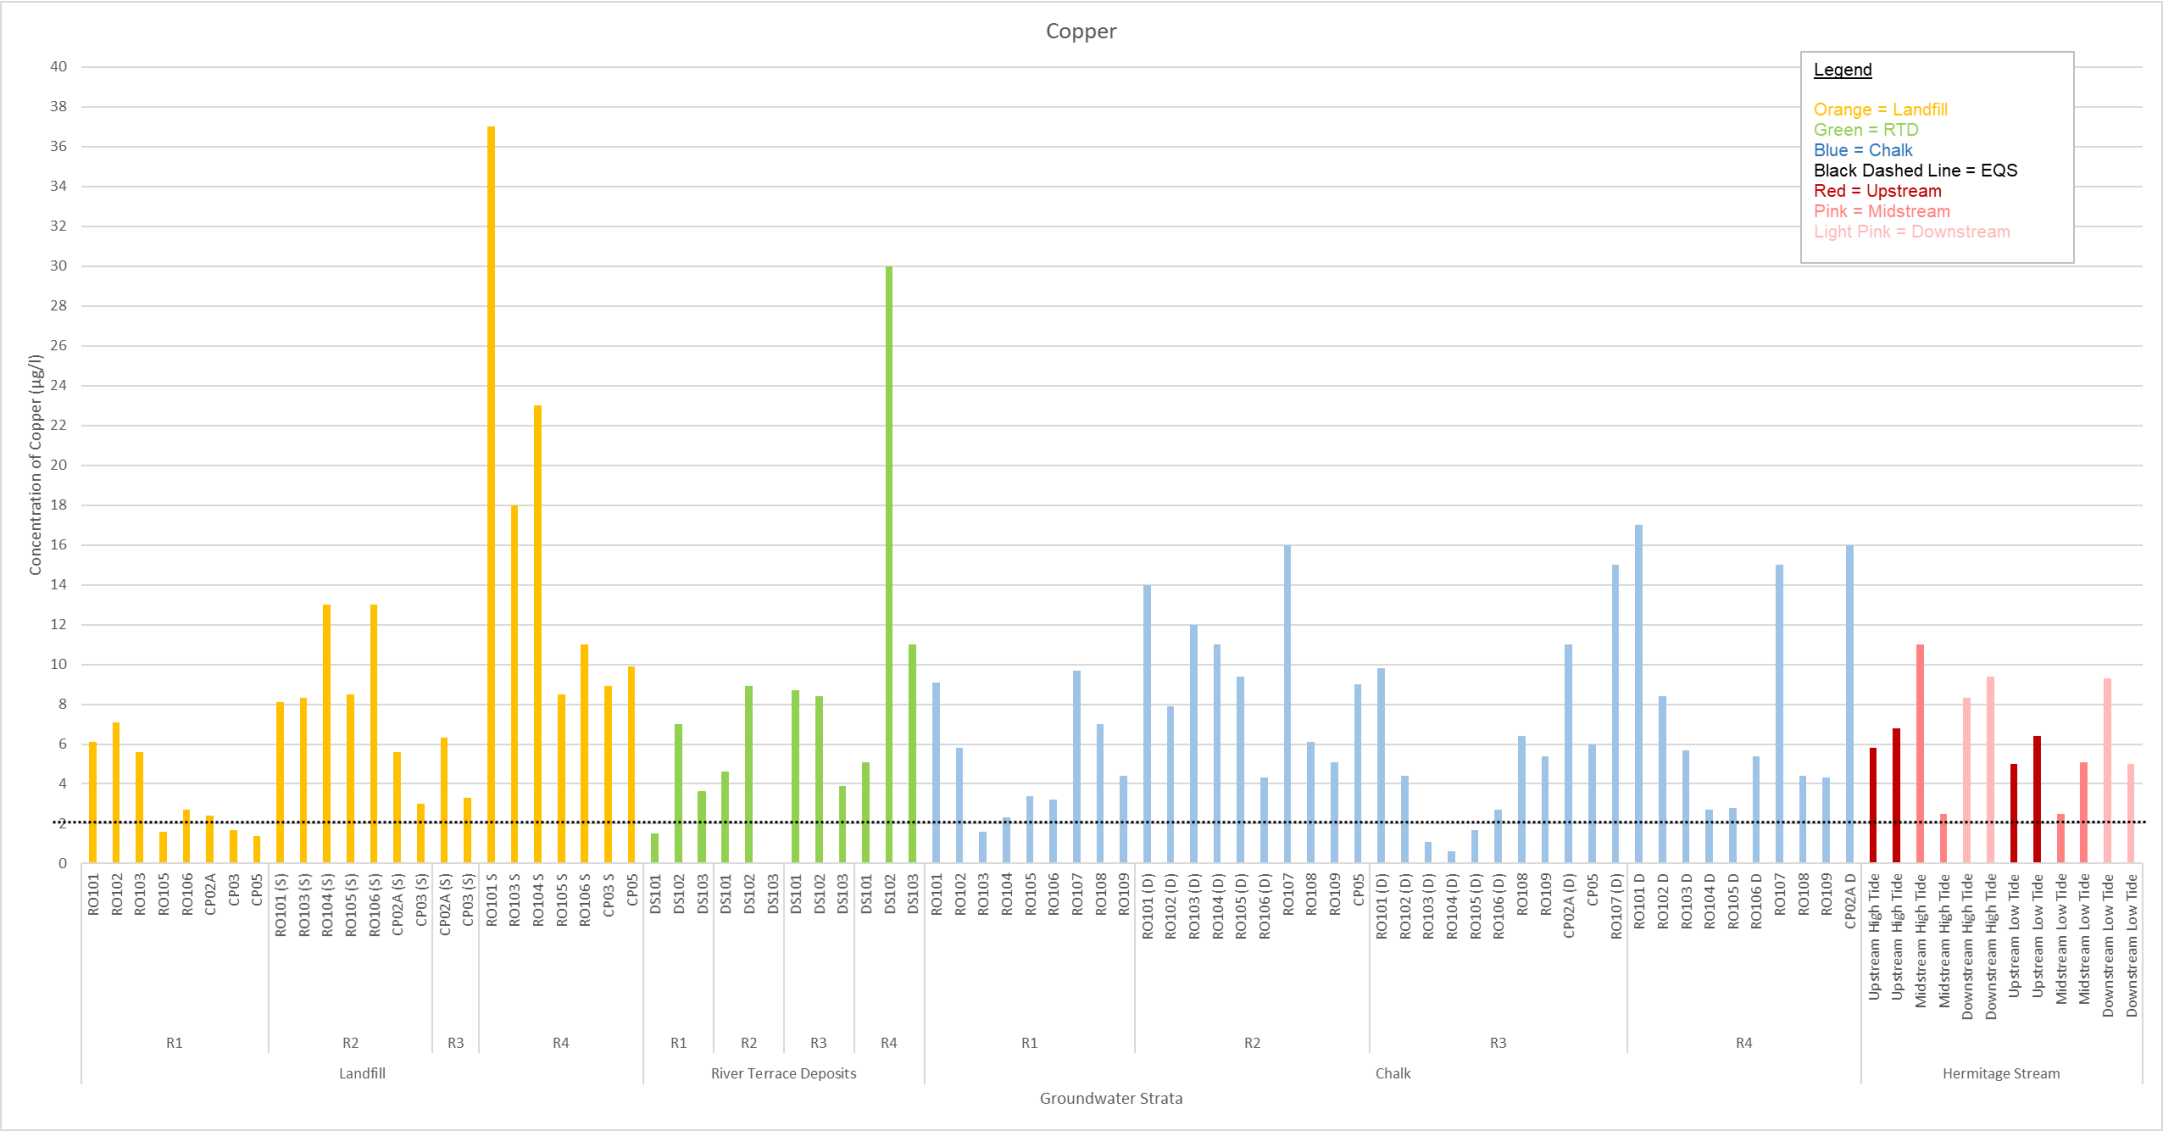
Diagram 6 – Copper Concentrations in Groundwater and Hermitage Stream

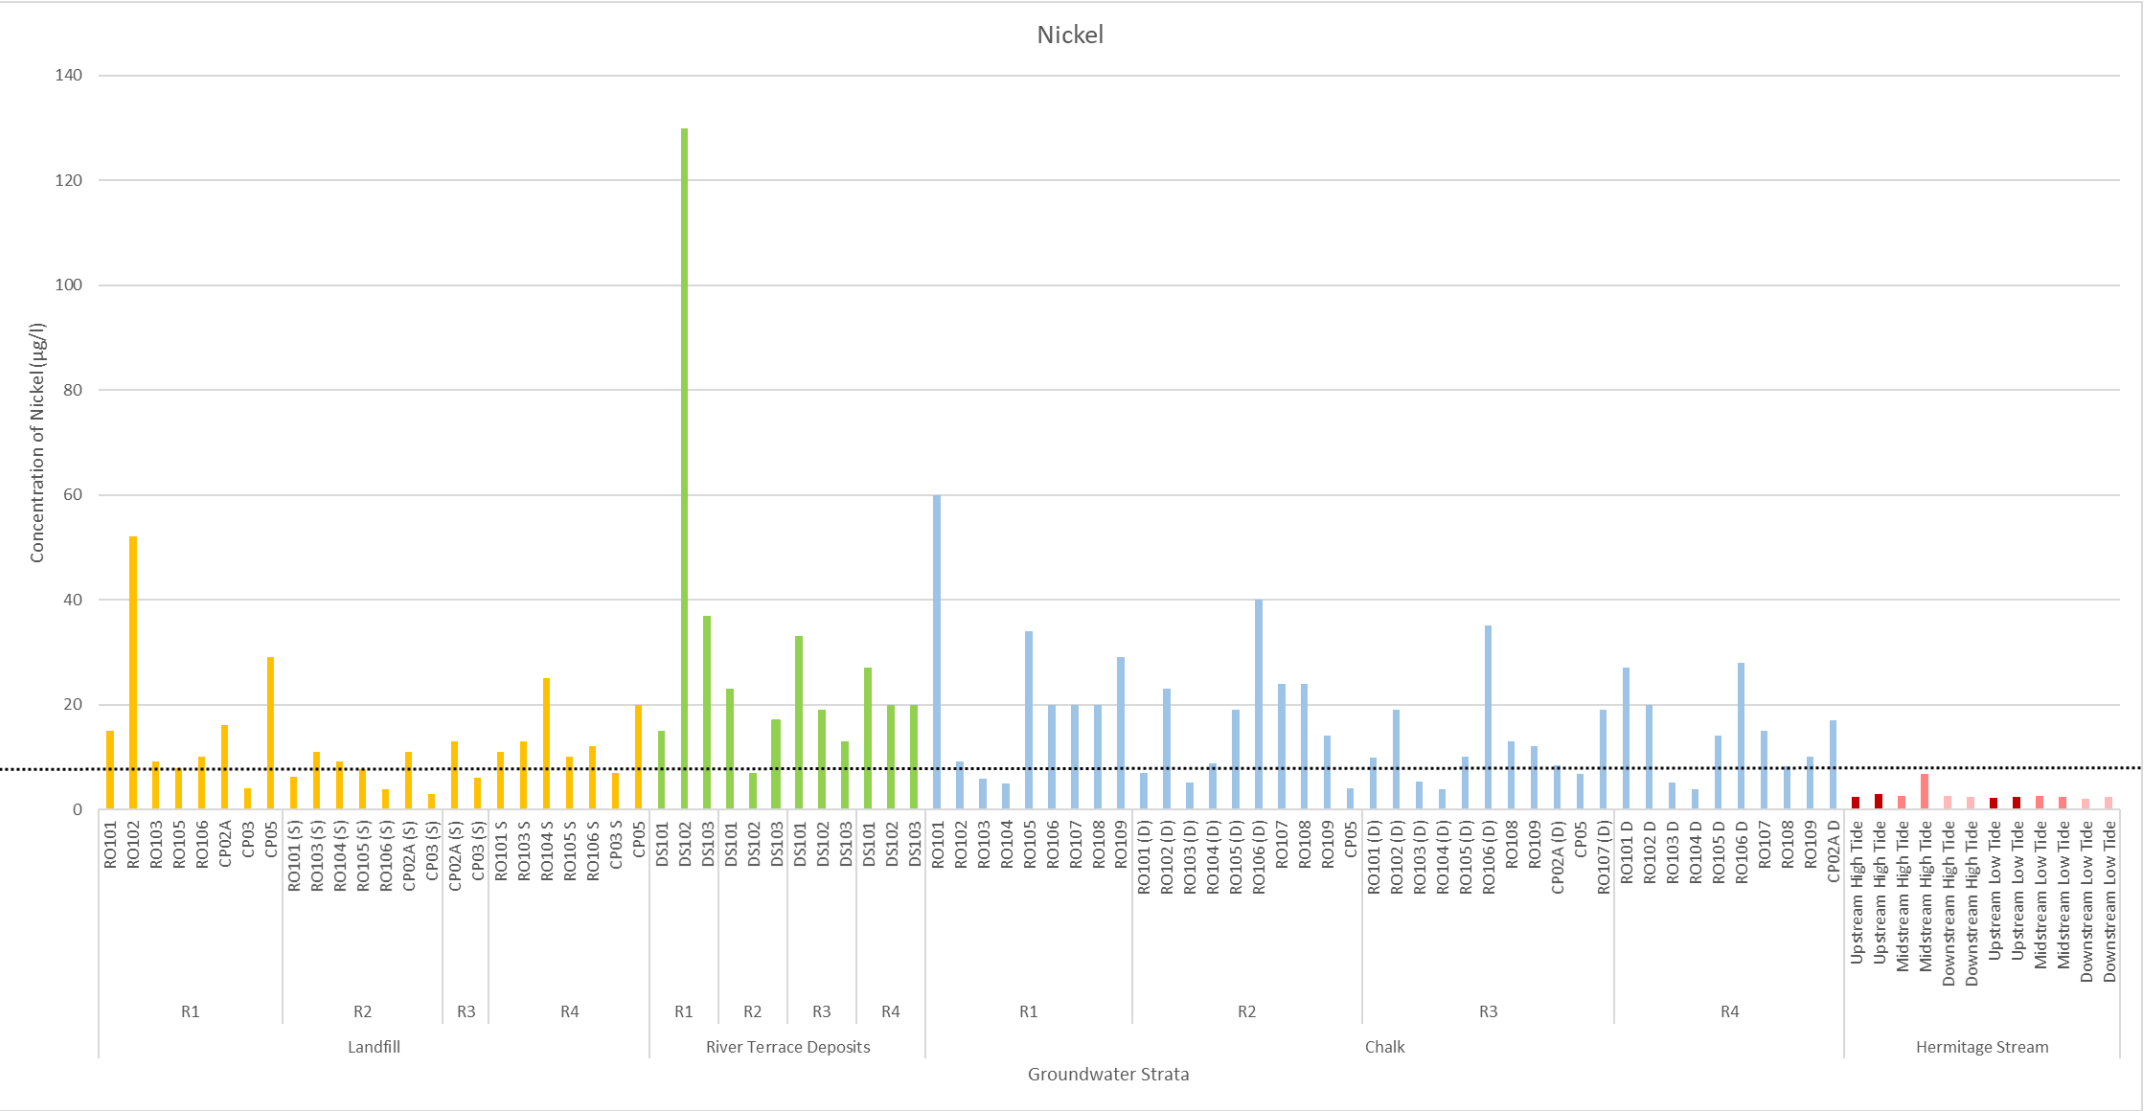
Diagram 7 – Nickel Concentrations in Groundwater and Hermitage Stream

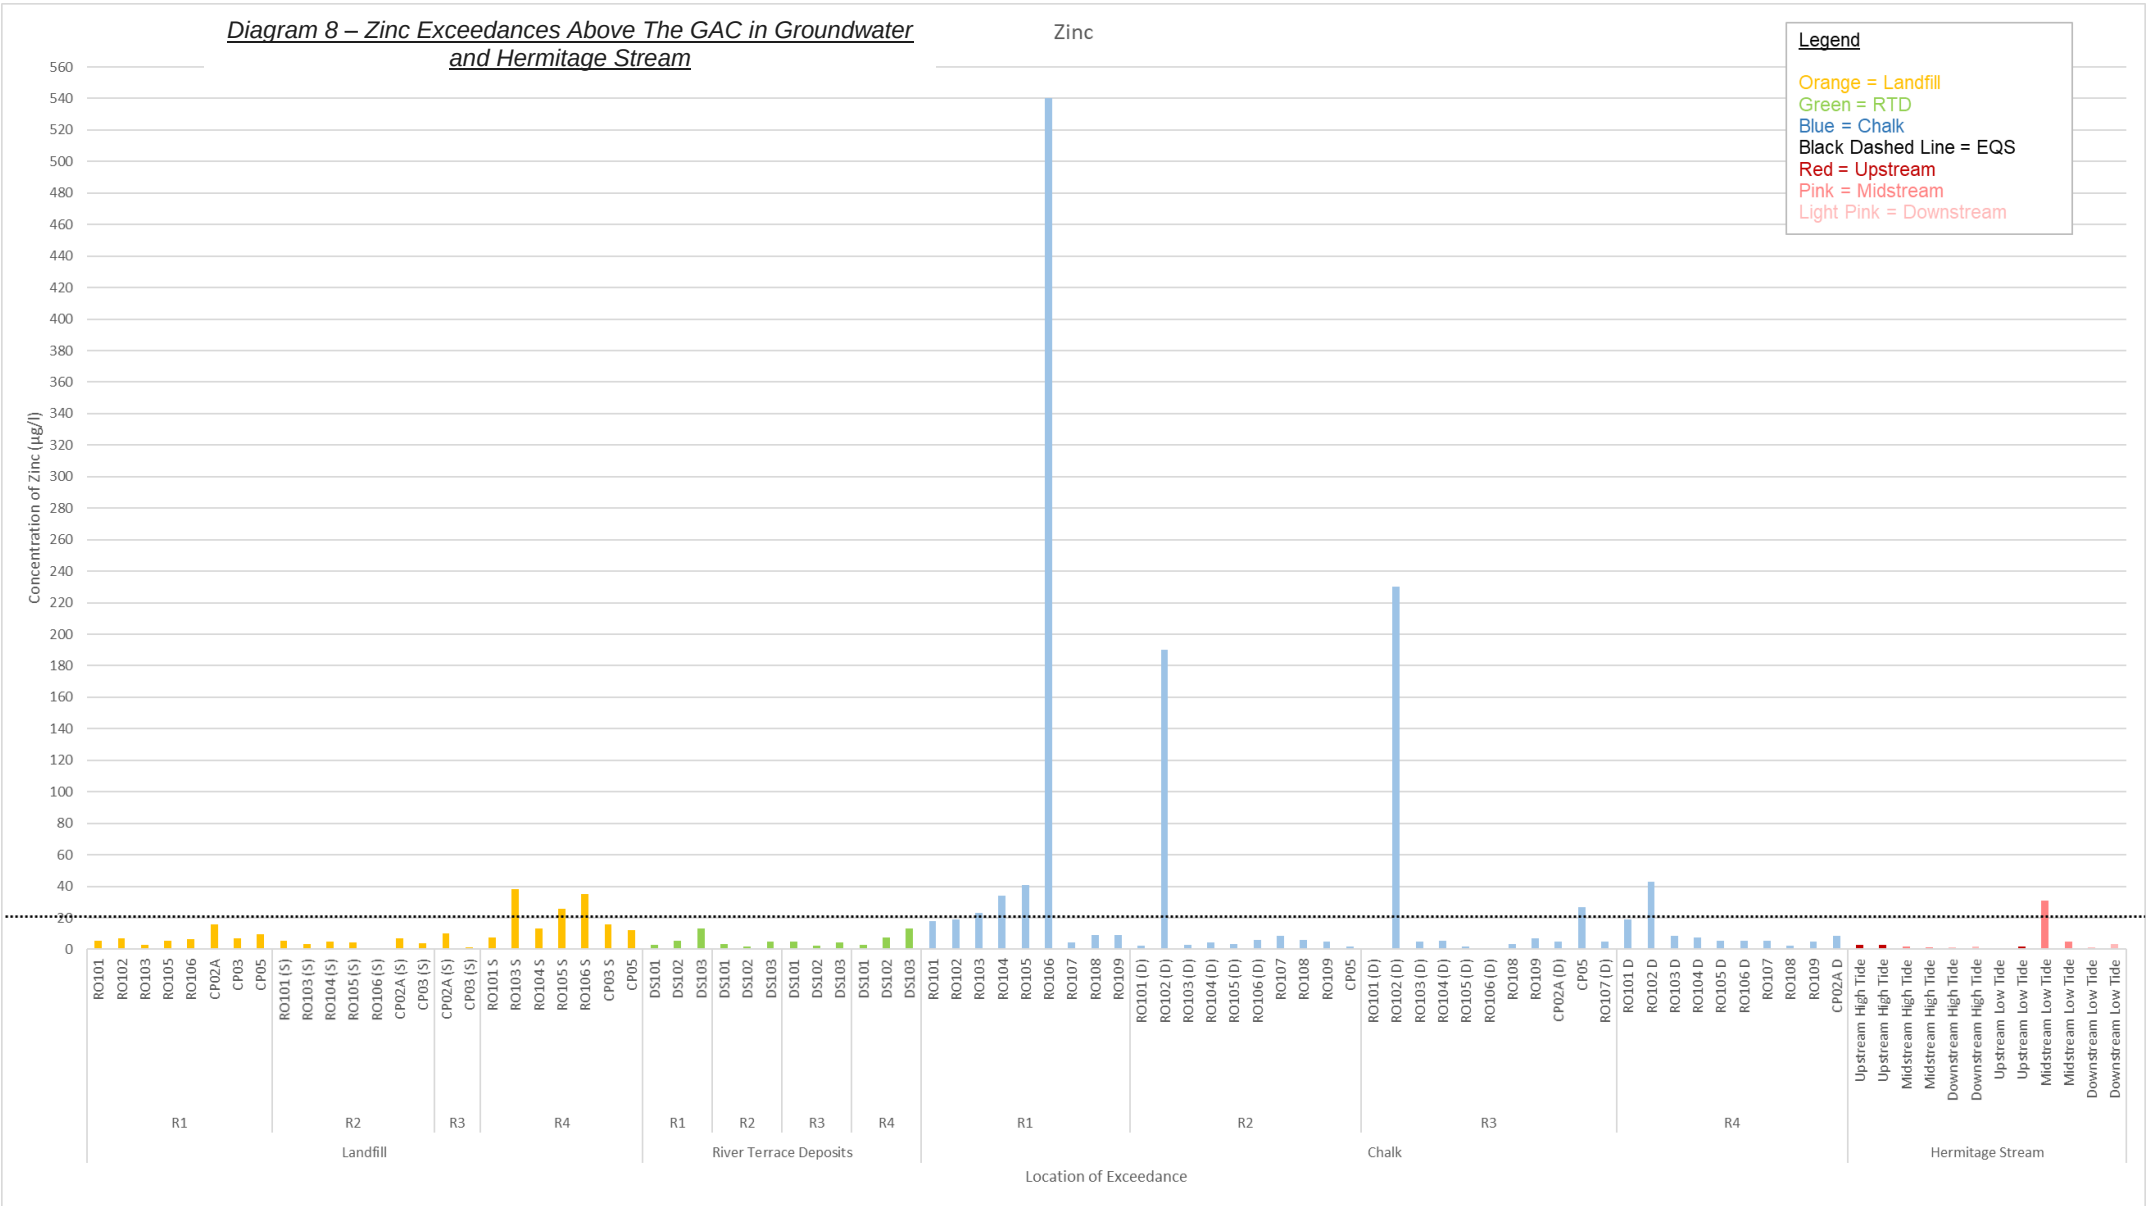
Diagram 8 – Zinc Exceedances Above The GAC in Groundwater  
and Hermitage Stream

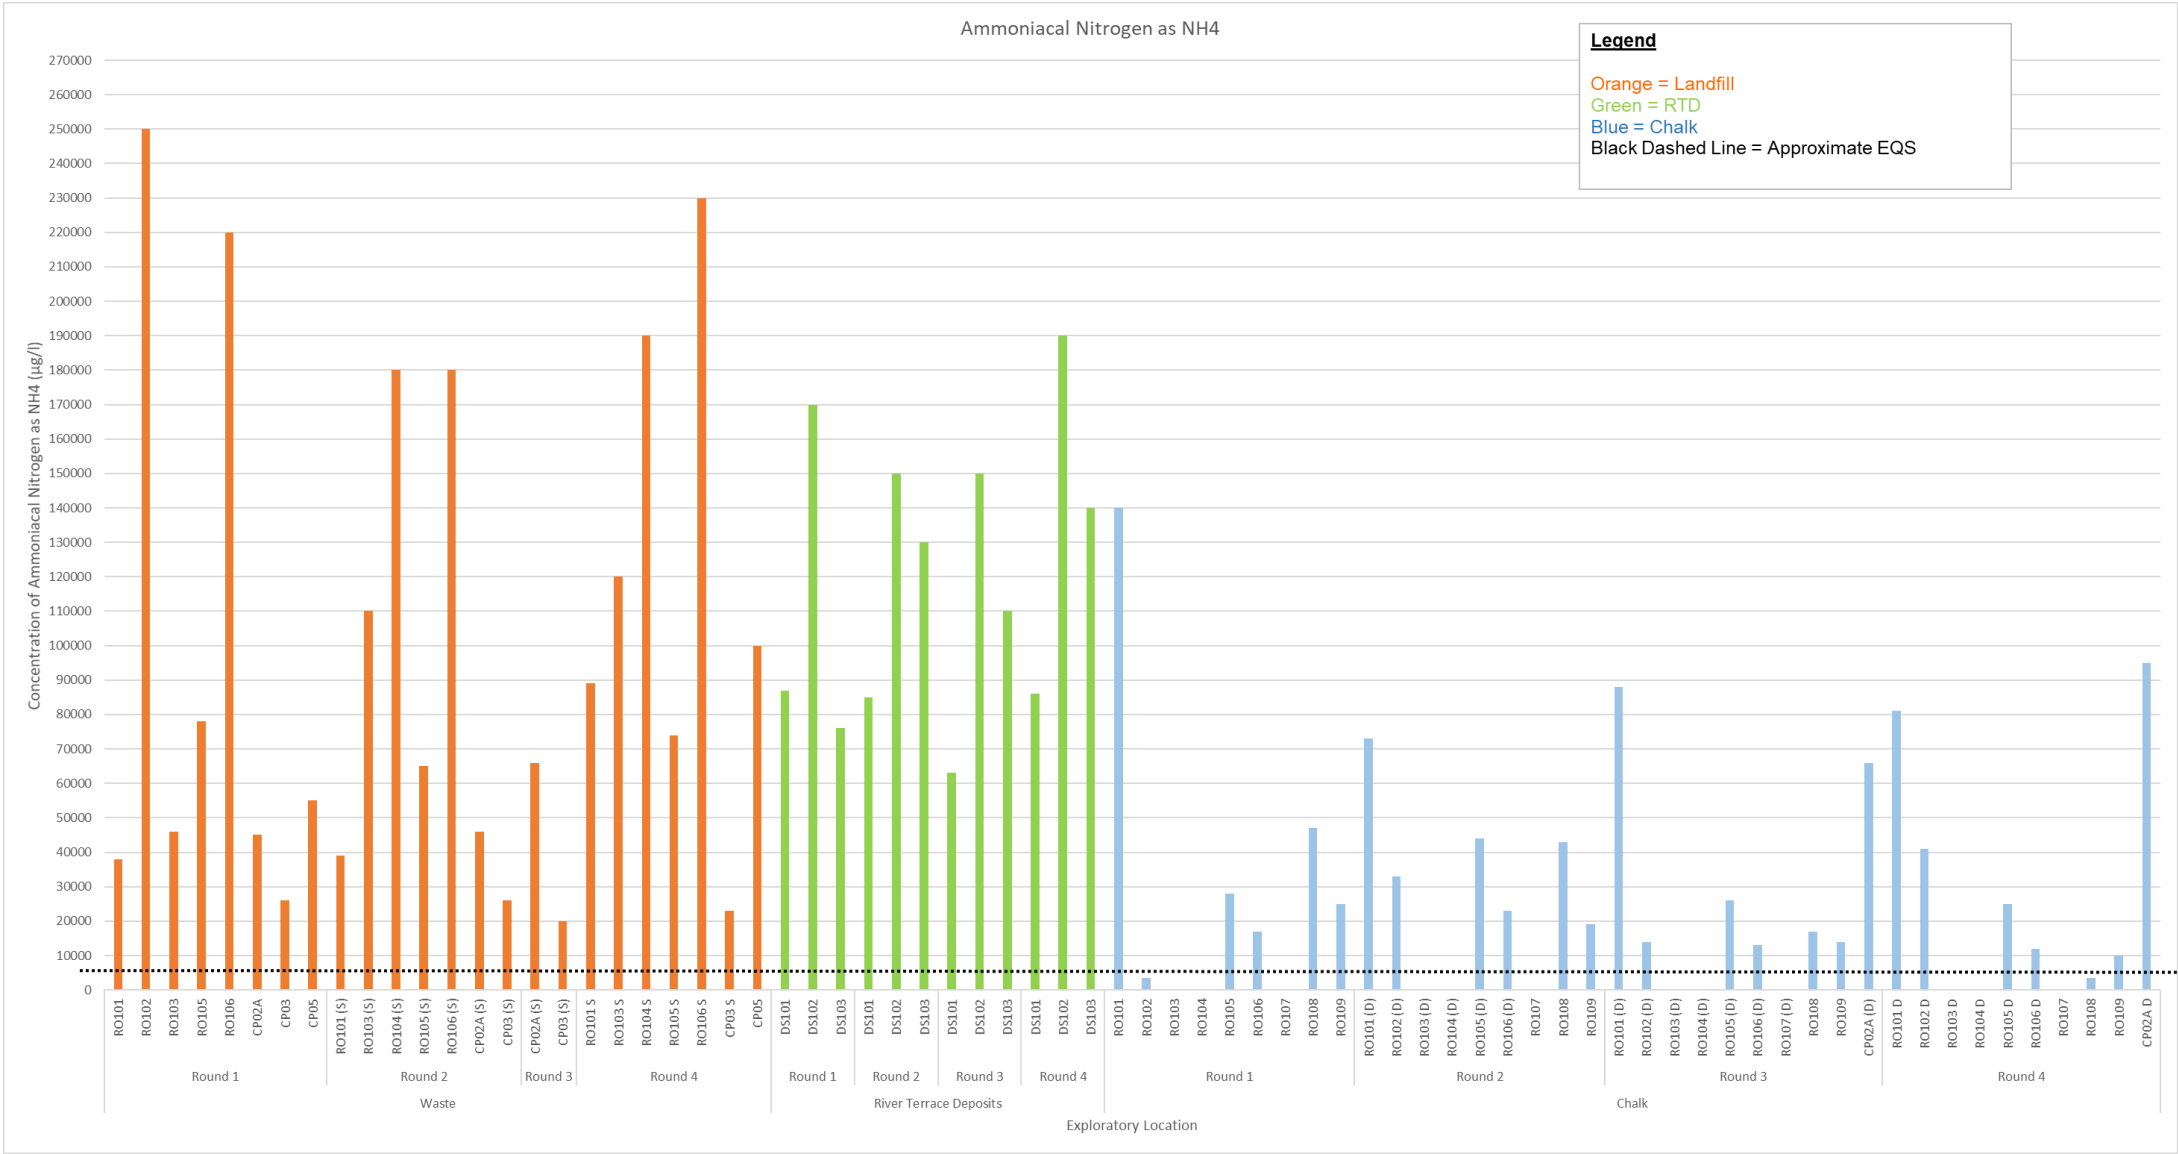
*Diagram 9 – Ammoniacal Nitrogen as NH4 Concentrations in Groundwater*

The concentrations of ammoniacal nitrogen as  $\text{NH}_4$  significantly decrease as the groundwater migrates downward from the landfill waste into the RTD and then into Chalk. The maximum concentration recorded within the Chalk is almost four times lower than the maximum concentration recorded within the landfill waste.

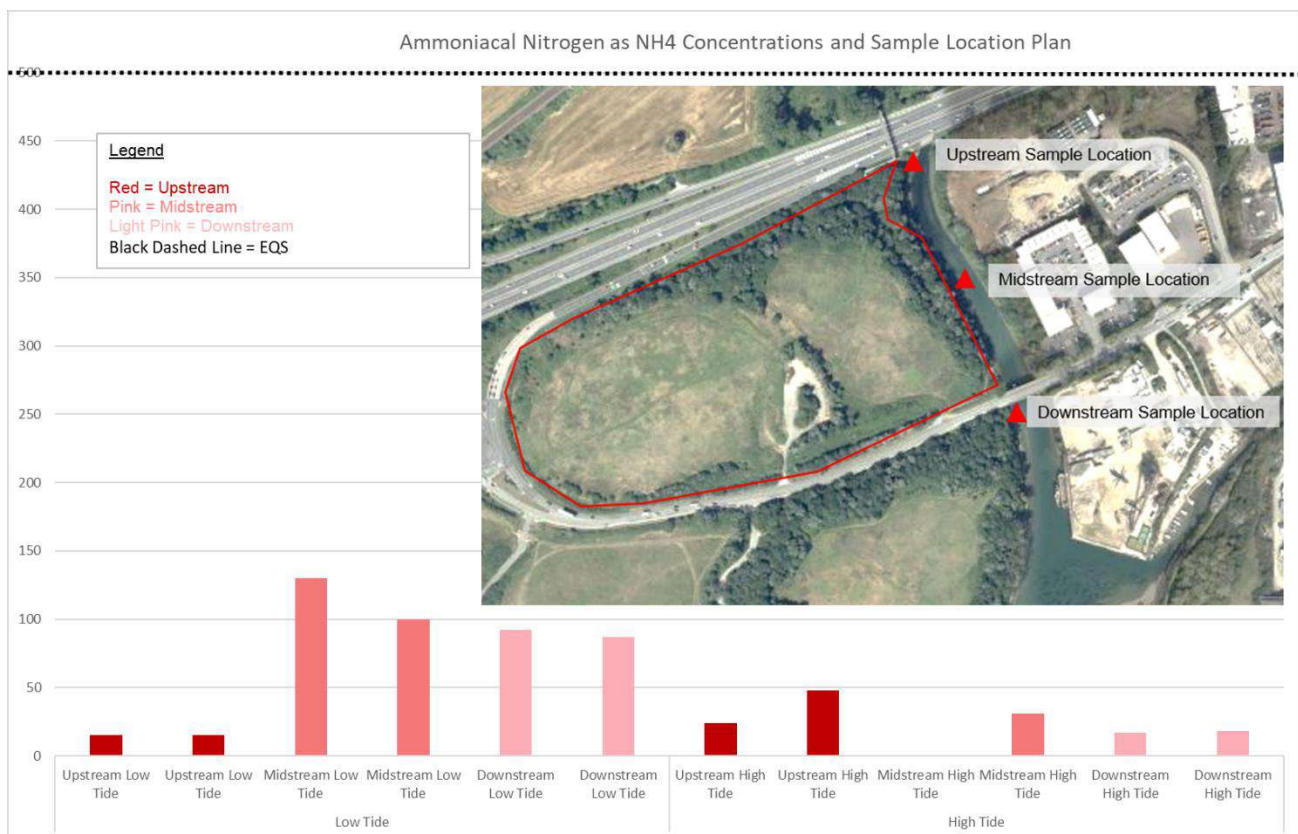
*Diagram 10 – Ammoniacal Nitrogen as  $\text{NH}_4$  Concentrations in Hermitage Stream*

Based on the chemical data, it is considered that attenuation and/or dilution is acting at a sufficient level for both  $\text{NH}_4$  (drinking water risk driver) and  $\text{NH}_3$  (aquatic life risk driver) is only marginally above the conservative GAC on Site. The risks to controlled waters posed by ammoniacal nitrogen is therefore considered to be low.

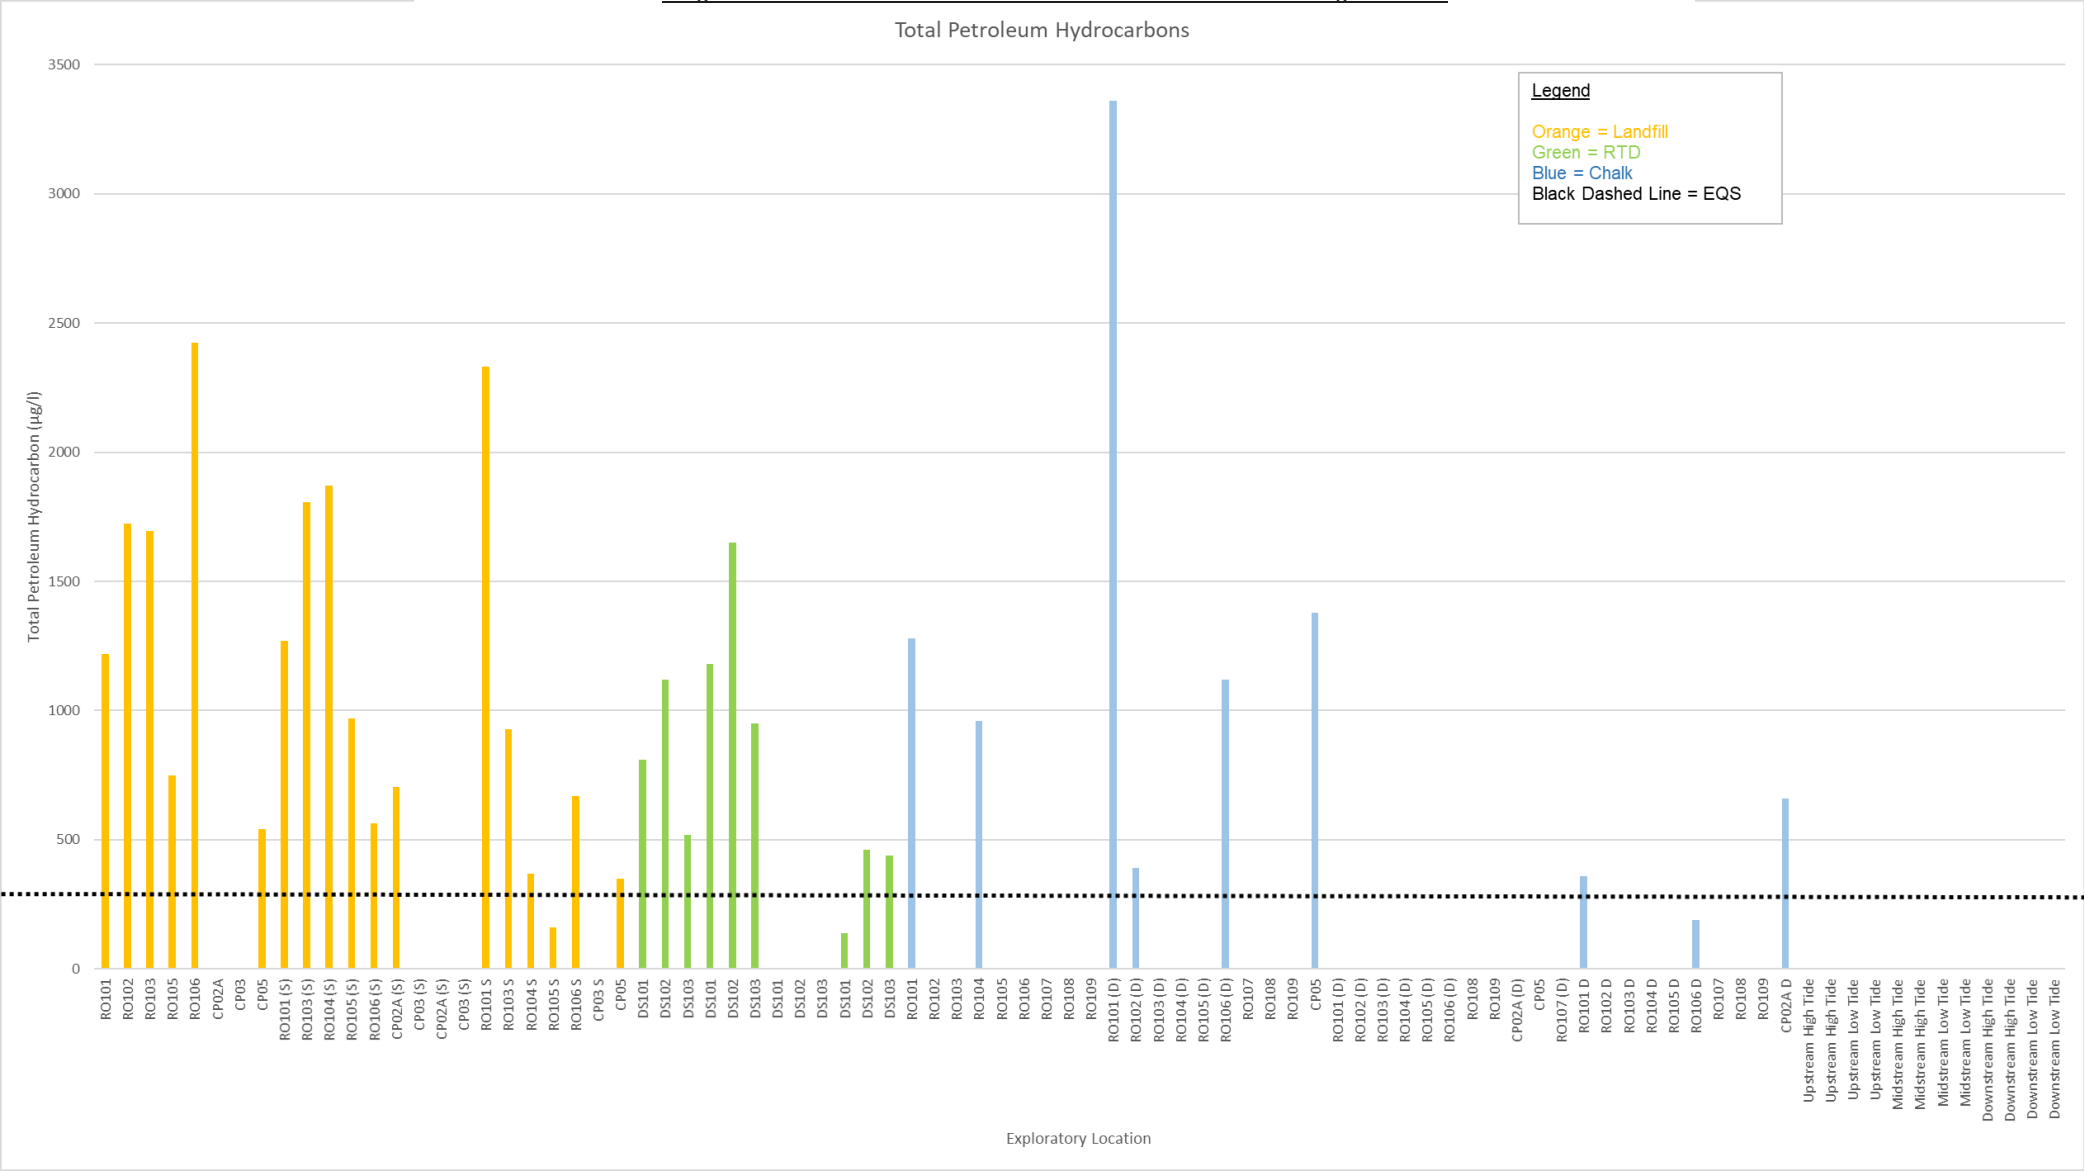
Diagram 11 – TPH Concentrations in Groundwater and Hermitage Stream

Whilst the concentrations within the Chalk are elevated that are based on a conservative aliphatic hydrocarbon surrogate GAC of 300 µg/l which are exceeded by up to an order of magnitude in RO101 (Chalk) but generally concentrations are below 2,000 µg/l. There was no visual/olfactory evidence of NAPL recorded during the groundwater monitoring supporting the considered minor hydrocarbon impact on the chalk aquifer. Given that not all Chalk boreholes encountered elevated petroleum hydrocarbons it is considered that the impact on the aquifer is localised. Furthermore, no surface water samples collected from the Hermitage Stream recorded TPH concentrations above the limit of detection.
