# Geo-Environmental Assessment

**Former Brockhampton West Landfill, North of Harts Farm Way, Havant**

**Presented to Clowes Developments (UK) Ltd**

Delta-Simons Project No. 19-2099.04

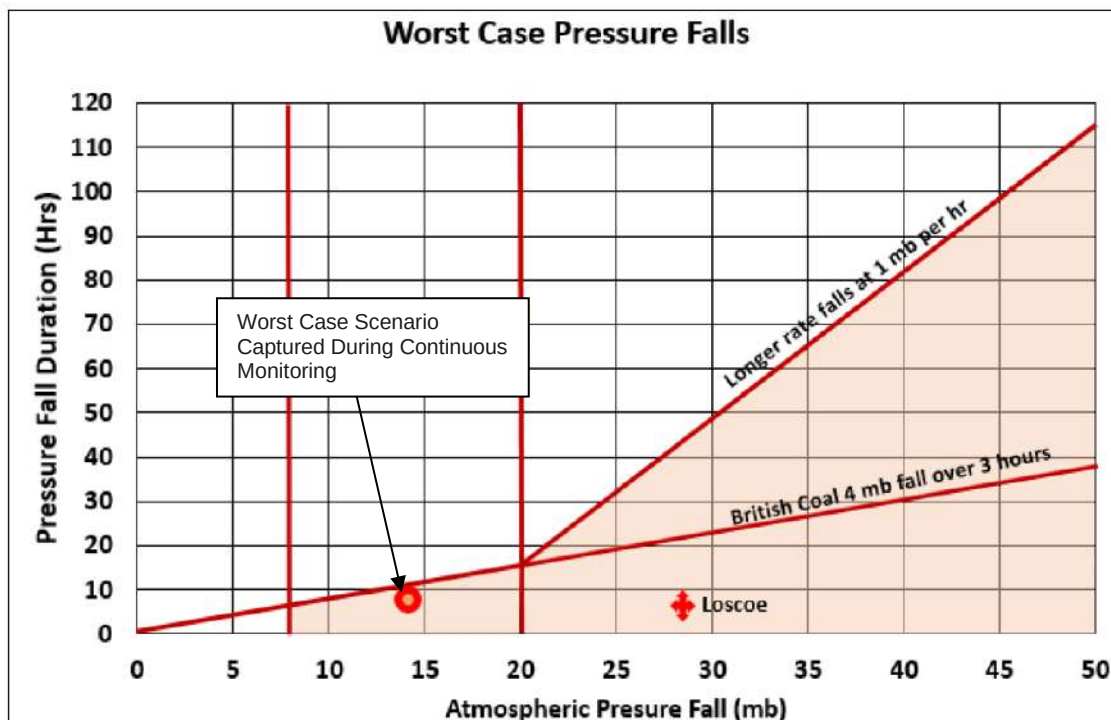
Notwithstanding this lack of correlation, it is still considered that there was sufficient low pressures systems and pressure falls to demonstrate a comparable worst-case ground gas risk scenario. This is illustrated in the graph below (refer to Delta-Simons Factual Geo-Environmental Investigation Report) which identified the Site specific pressure fall (red circle) compared to other pressure falls that have caused ground gas incidents to occur (red shaded area) for example Loscoe, Derbyshire.

Based on the time series graphs produced by Ground Gas Solutions (refer to Delta-Simons Factual Geo-Environmental Investigation Report) it is evident that there appears to be no significant correlation between atmospheric pressure and gas concentrations at the Site. This included low atmospheric pressure systems and also significant atmospheric pressure falls that did not correlate to a significant increase in ground gas concentrations or flow. There also appeared to be no clear correlation between atmospheric pressure conditions and borehole differential pressures; recorded differential pressures appeared to be at, or close to, zero, indicating that where borehole flow rates have been recorded, these are likely to be as a result of changes in ground water levels &/or minor barometric pumping effects, rather than evidence of significant gas generation.

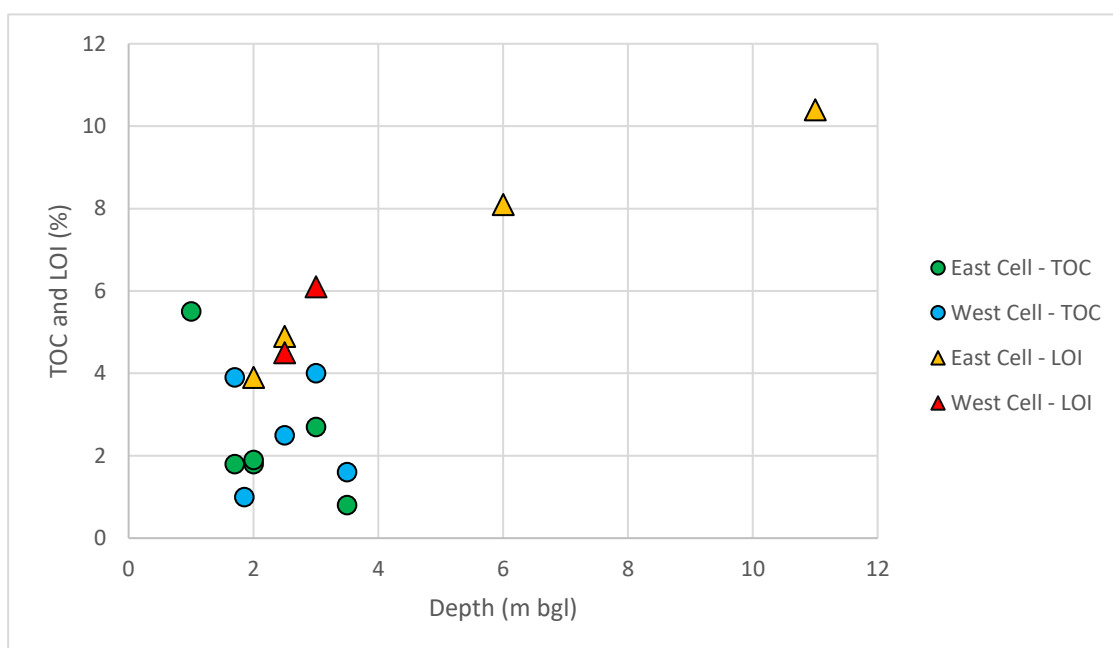
The percentage of putrescible material within the landfill waste in the east cell ranged between 2.1 to 19.6 % and 0 to 10.5% in the west. These results suggest that, generally across the Site, the biodegradable content within the waste is not significant but, that there is some differentiation between the east cell and the west cell. The percentage of Loss on Ignition (LOI) and TOC has been plotted against depth on the graph below.

Generally, the graph indicates that the TOC and LOI percentages are not significant (< 12% but generally below 6% in shallow waste materials) and there is again, a small variation between the east cell and the west cell. The TOC and LOI percentages were broadly greater in the east cell but, the data highlights the landfill waste is variable both with depth and laterally.

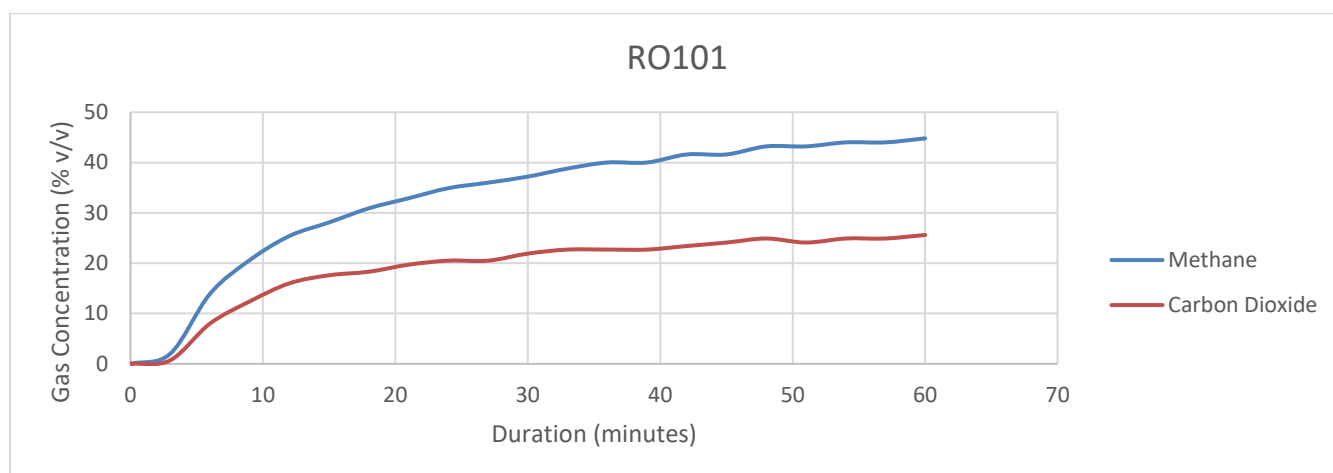
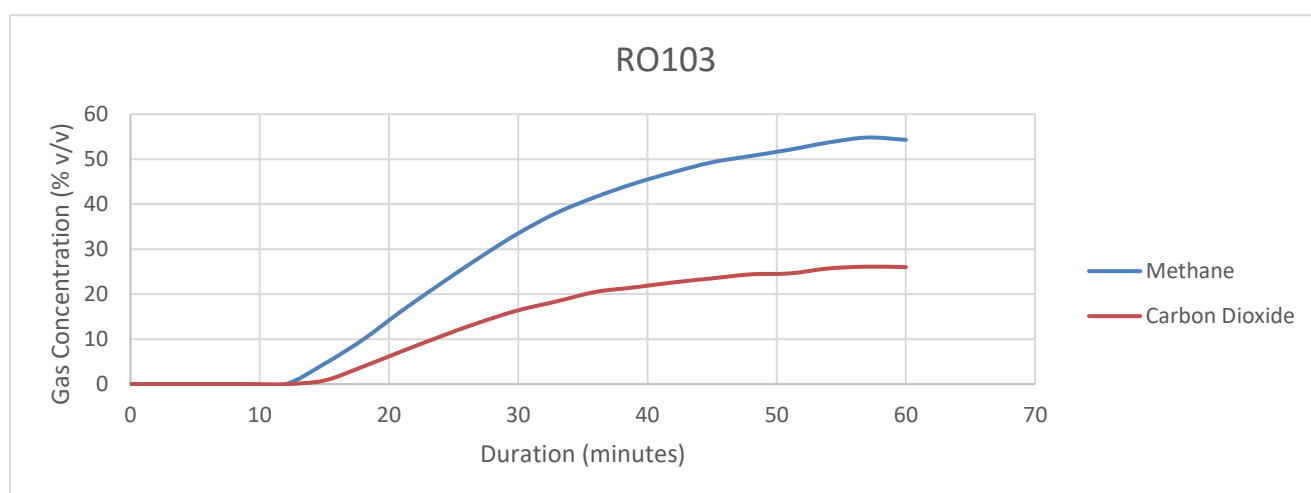
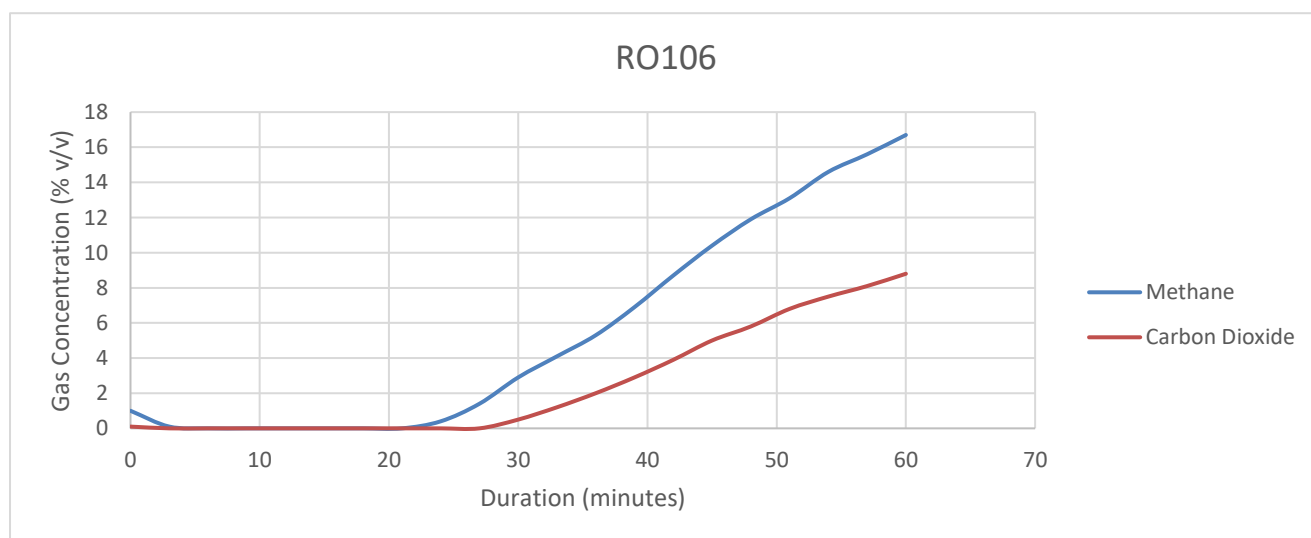
Whilst the above graphs present delayed recovery and no significant recovery (RO104), the calculated methane fluxes range between 5.590 (RO106) and 9.347 (RO103). These values indicate a potentially significant gas storage potential, and thus subsequent generation potential at these locations across the Site.

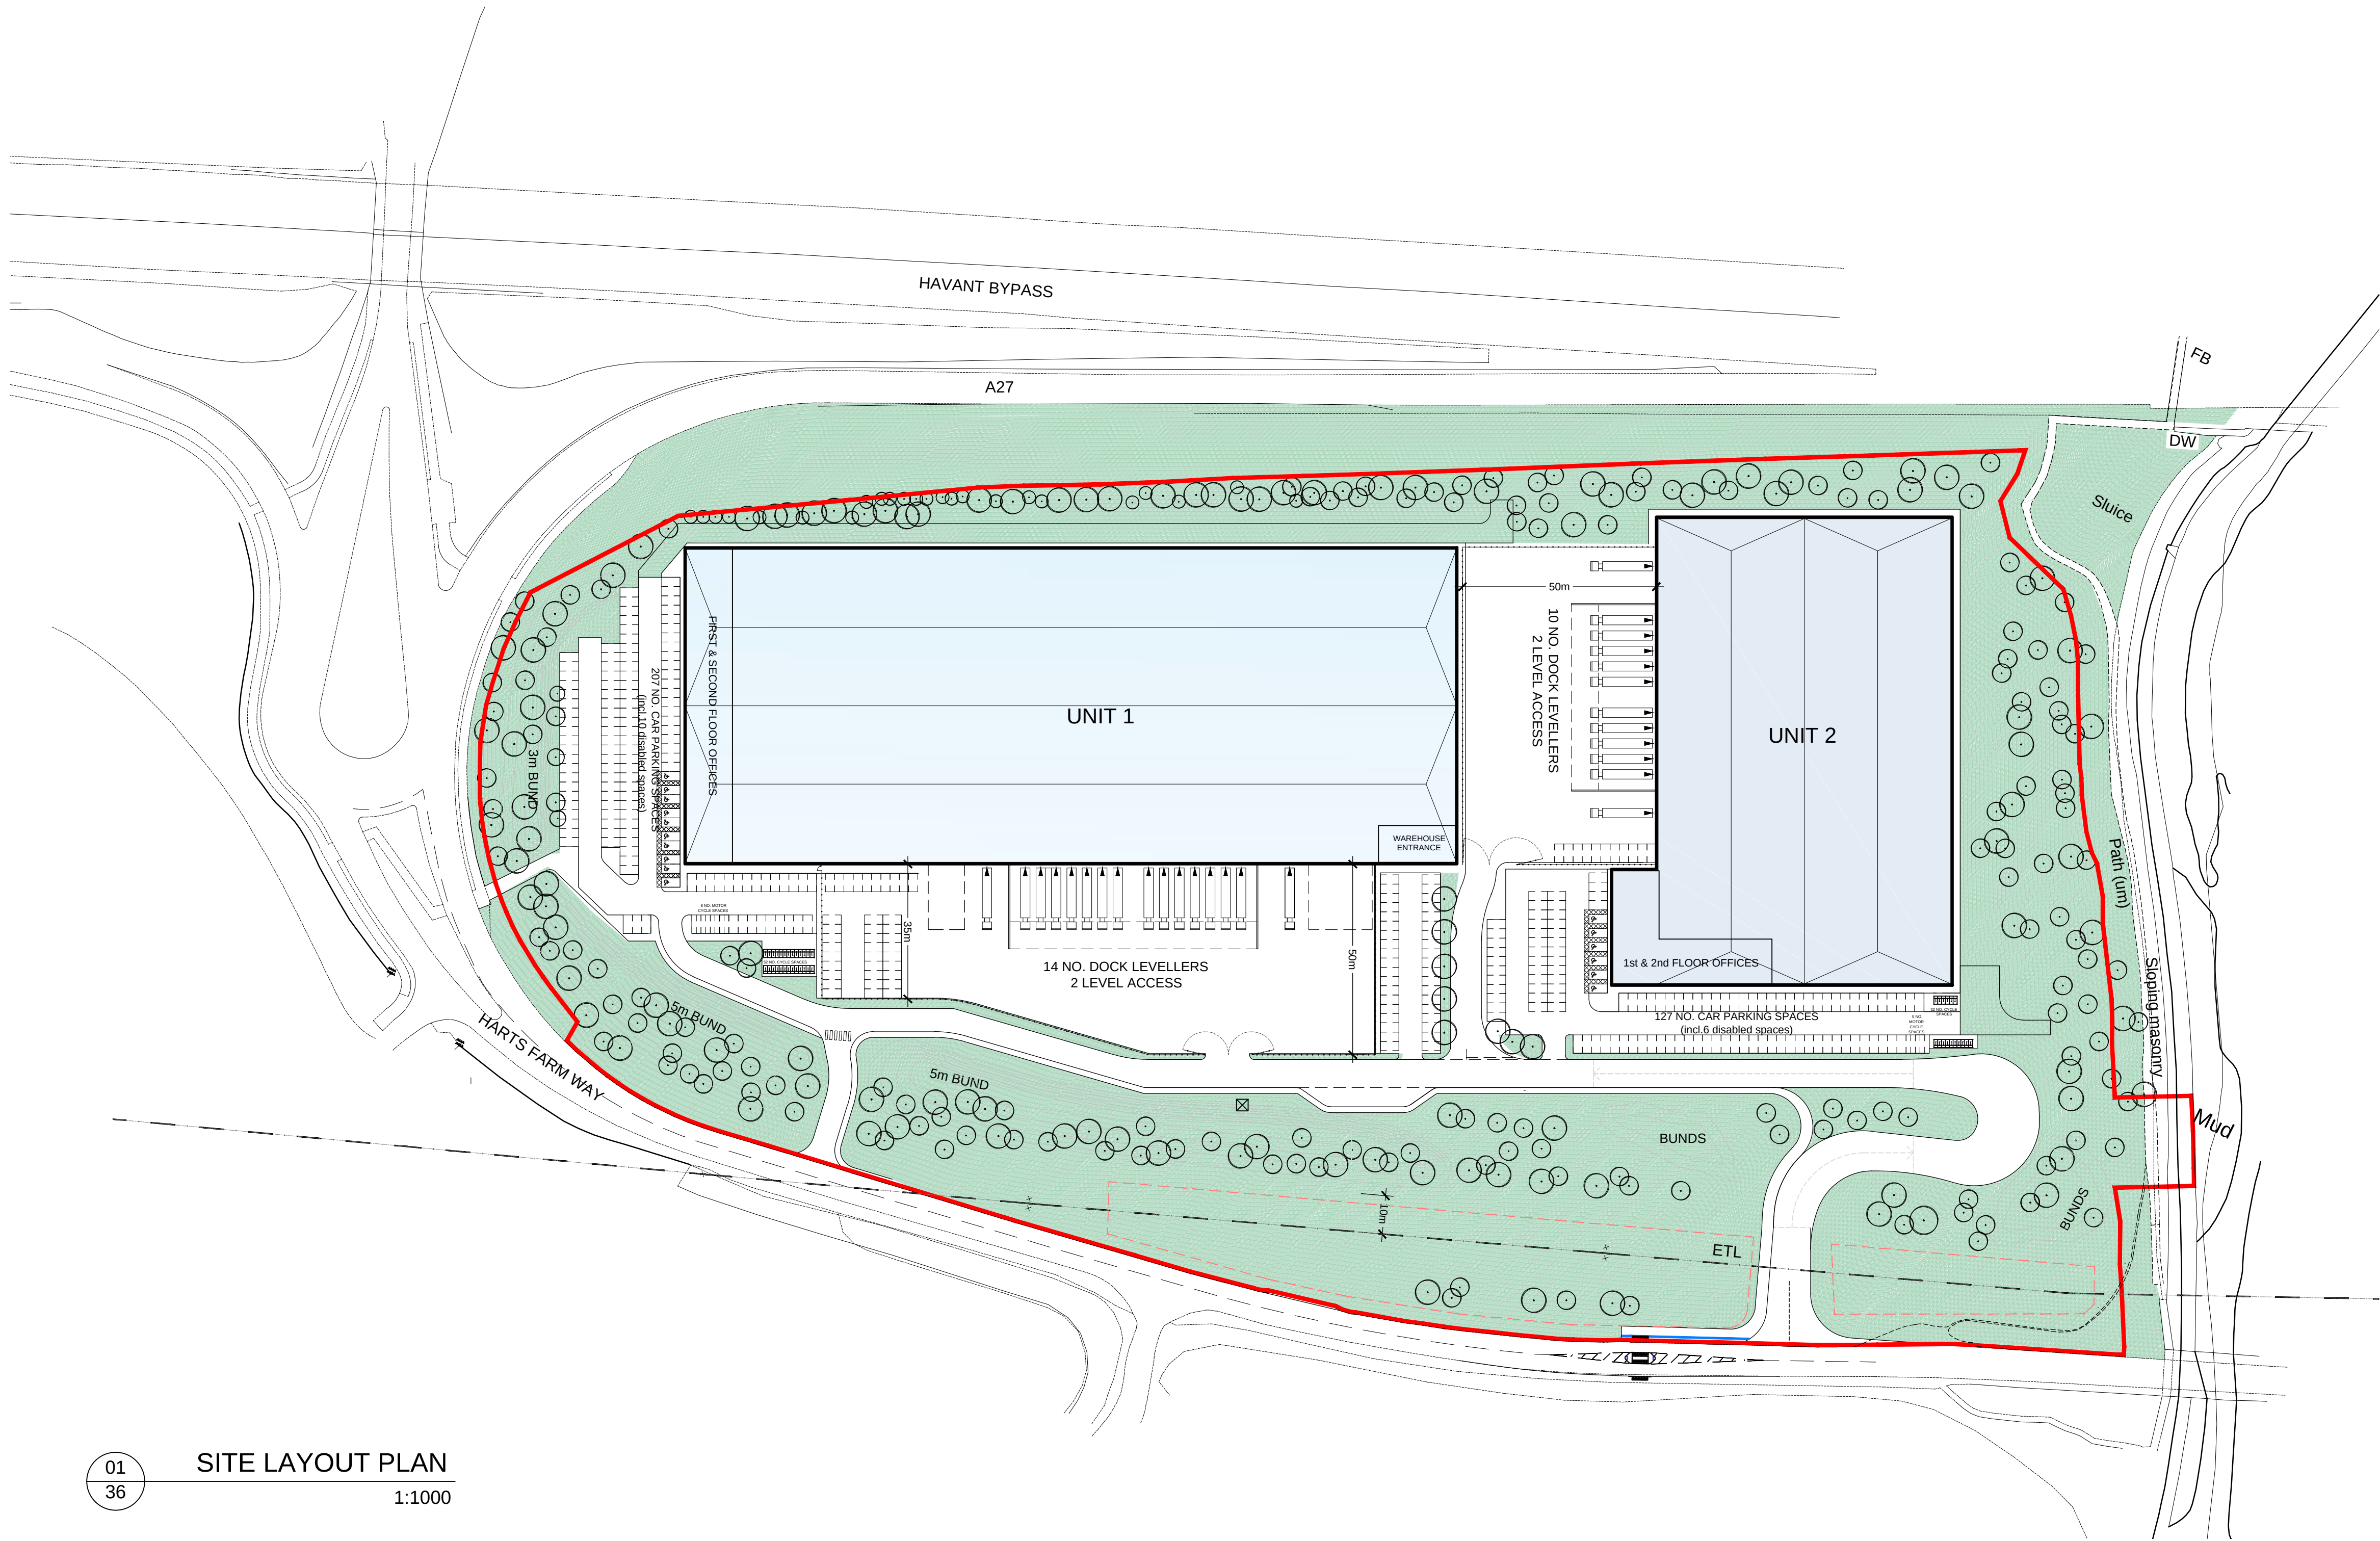
# Drawing 1 – Site Layout Plan, Harts Farm Way, Havant by Michael Sparks Associates (Ref: 31383/FE/37)

SITE LAYOUT PLAN  
1:1000

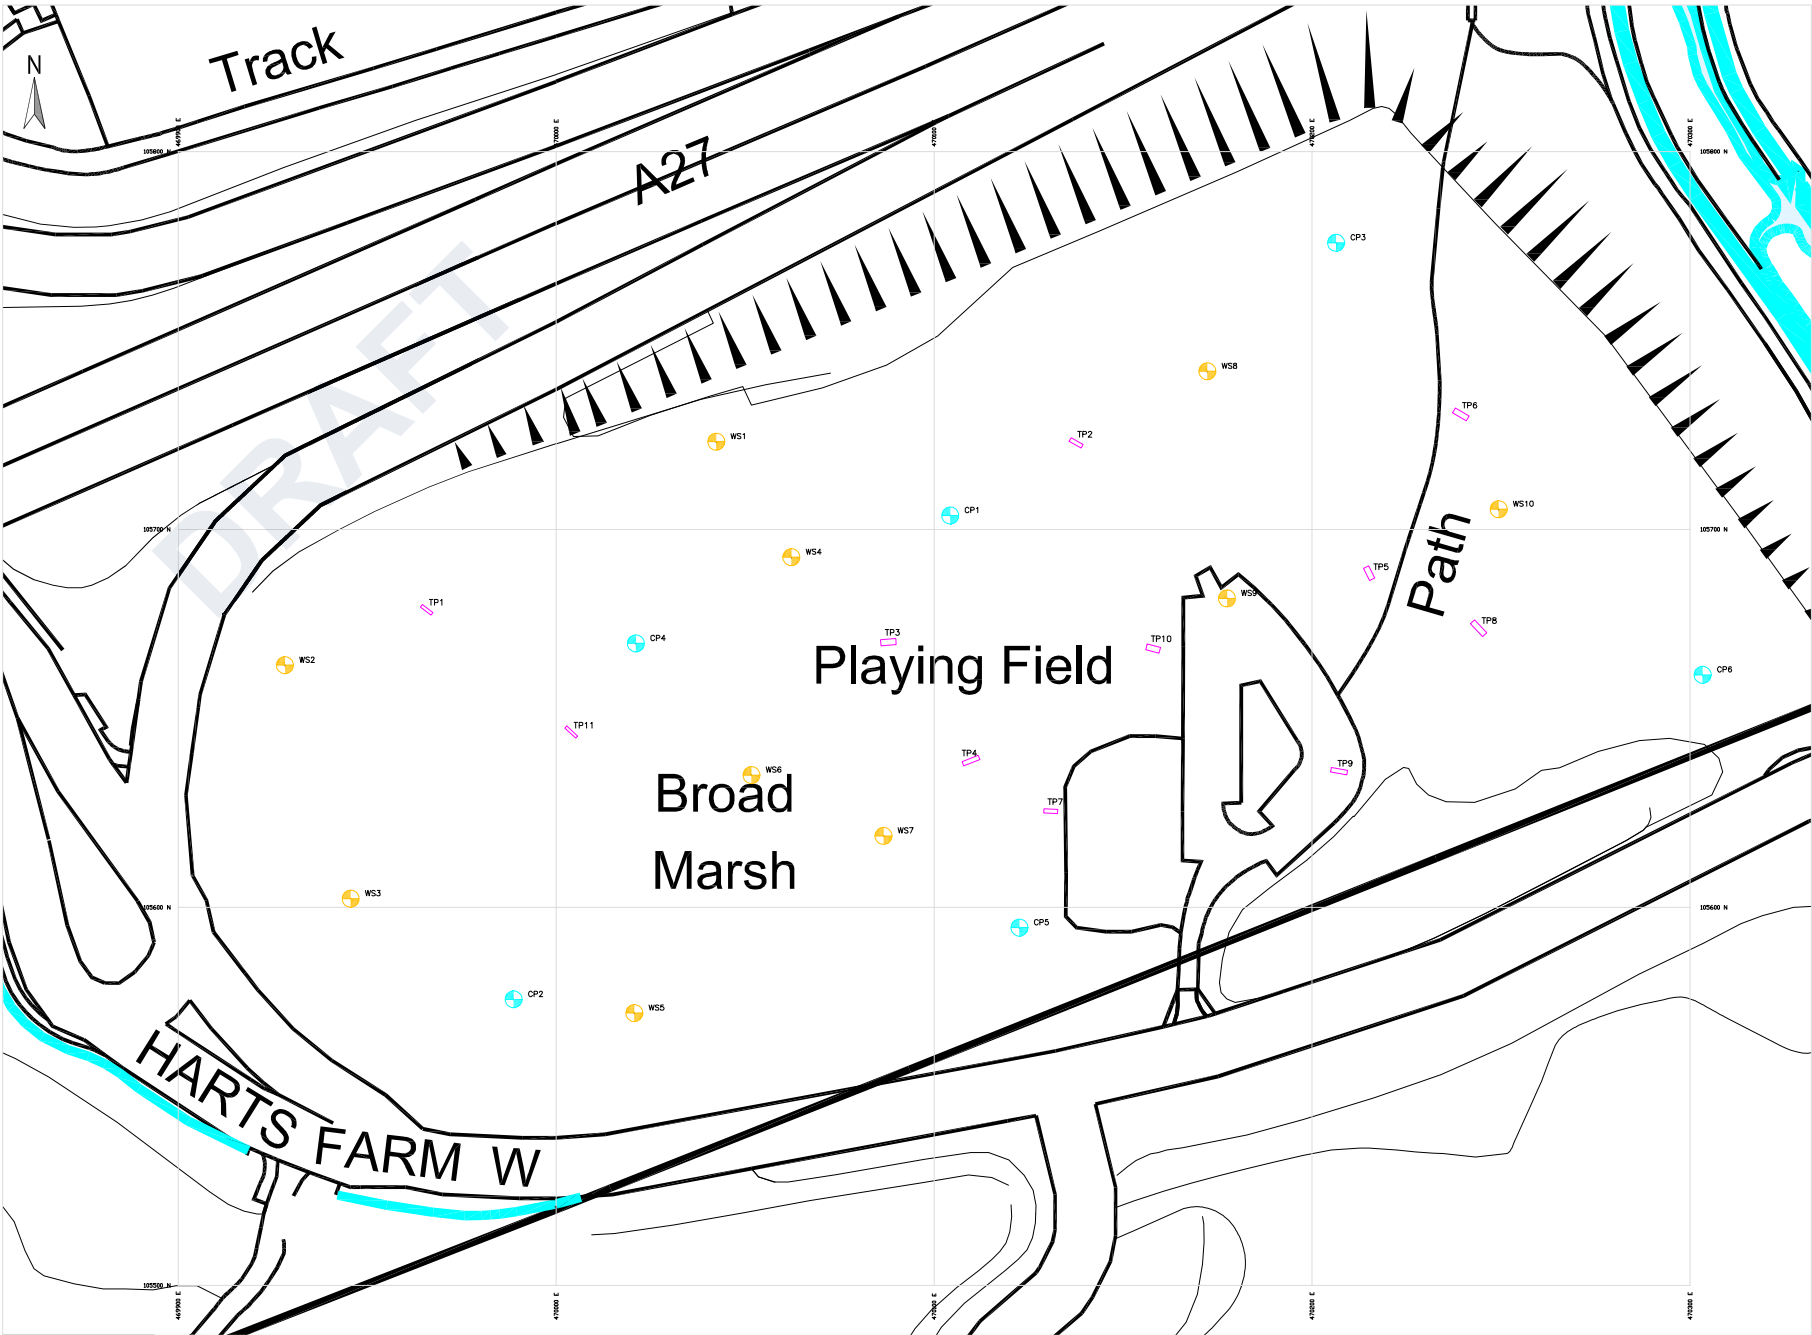
## Drawing 2 – WYG Exploratory Hole Location Plan

- KEY:
- BOREHOLE
  - WINDOW SAMPLE
  - WINDOW SAMPLE

The sections below summarise the ground and groundwater conditions encountered during the site investigation. This section will also include data from the Draft Phase II Environmental Audit prepared by WYG (August 2017). The WYG exploratory hole location plan is included as Drawing 2 and the exploratory hole logs are included as Appendix B within the *Factual Geo-Environmental Investigation Report* by Delta-Simons.

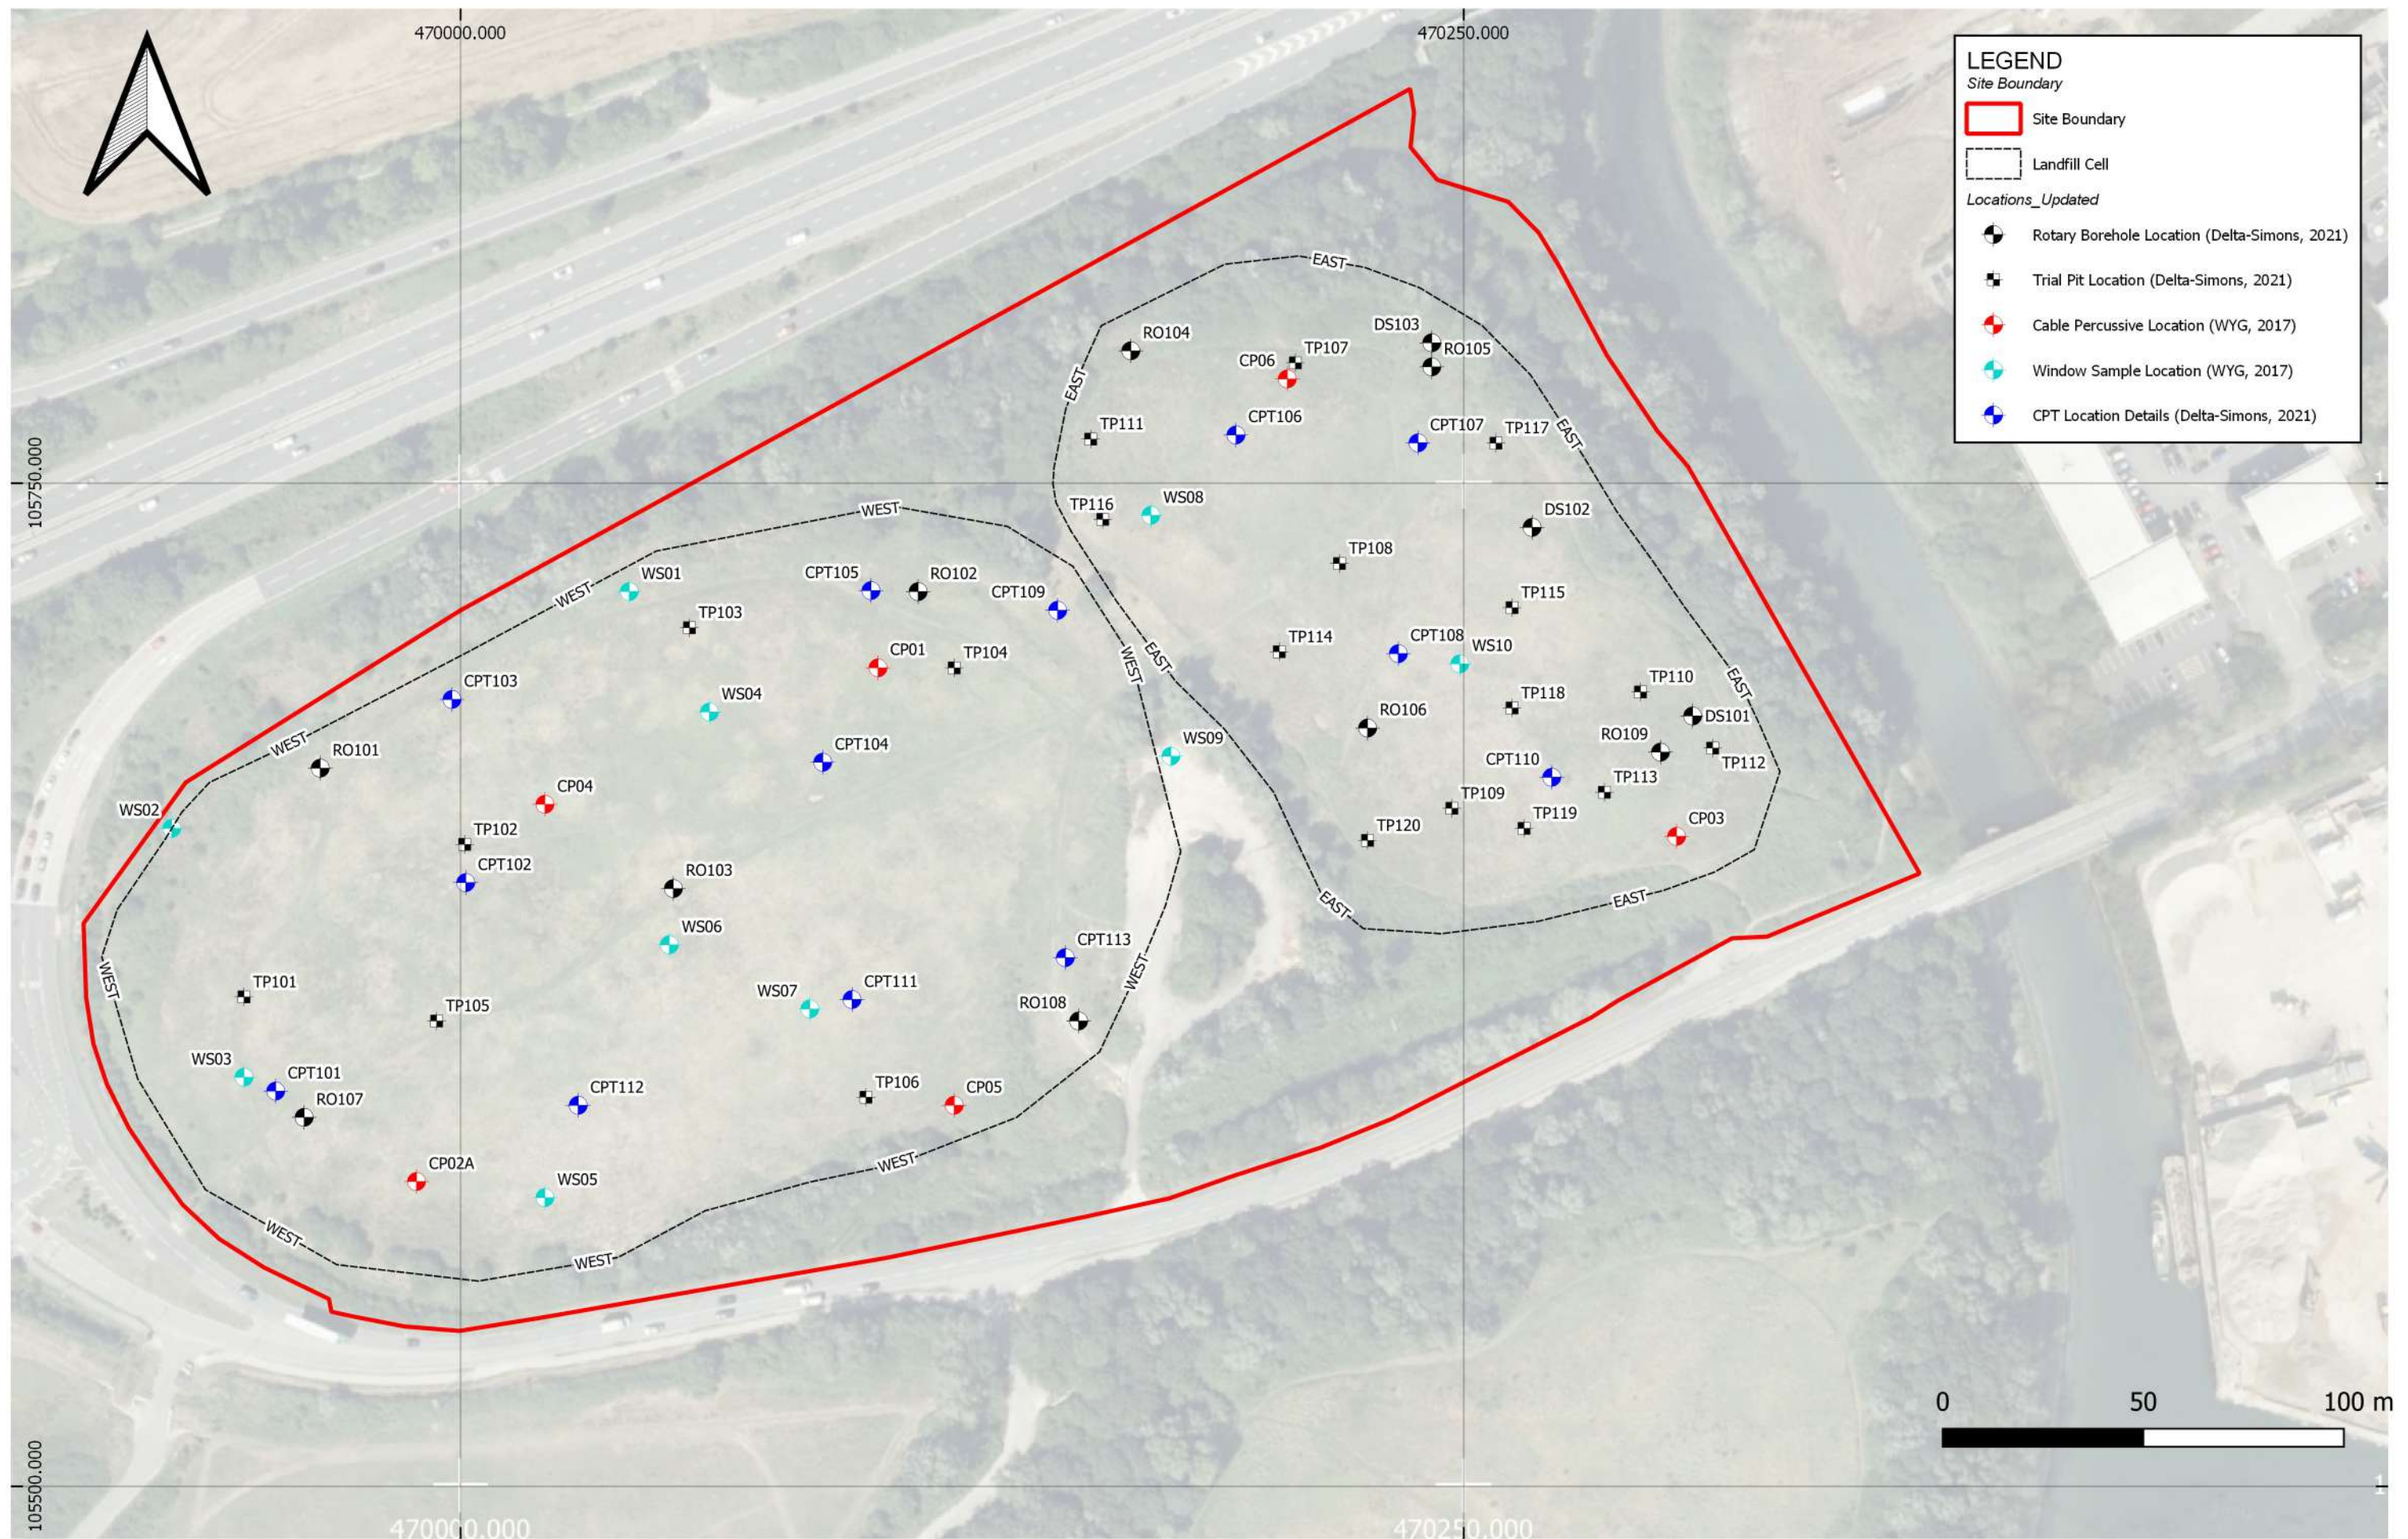
## Figure 1 – Exploratory Hole Location Plan

Aerial Photography (c) Bing Maps 2021. Data from WYG, 2017 and Delta-Simons 2021.

The ground conditions were variable across the Site, both in composition and proven thickness of the various strata. With regard to the landfill, based on the topography of the Site and the general composition of the waste, the Site can be generally split into two landfill 'cells' (refer to Figure 1). These cells are indicative and are assumed to extend to the boundaries of the Site specifically the exiting road network and the stream to the east. The wider landfill (including other likely cells for disposal) is known to extend to the south and west.

The locations of the monitoring wells are highlighted on Figure 1 and indicate representative coverage across the whole study area which is within the boundary of the former landfill.

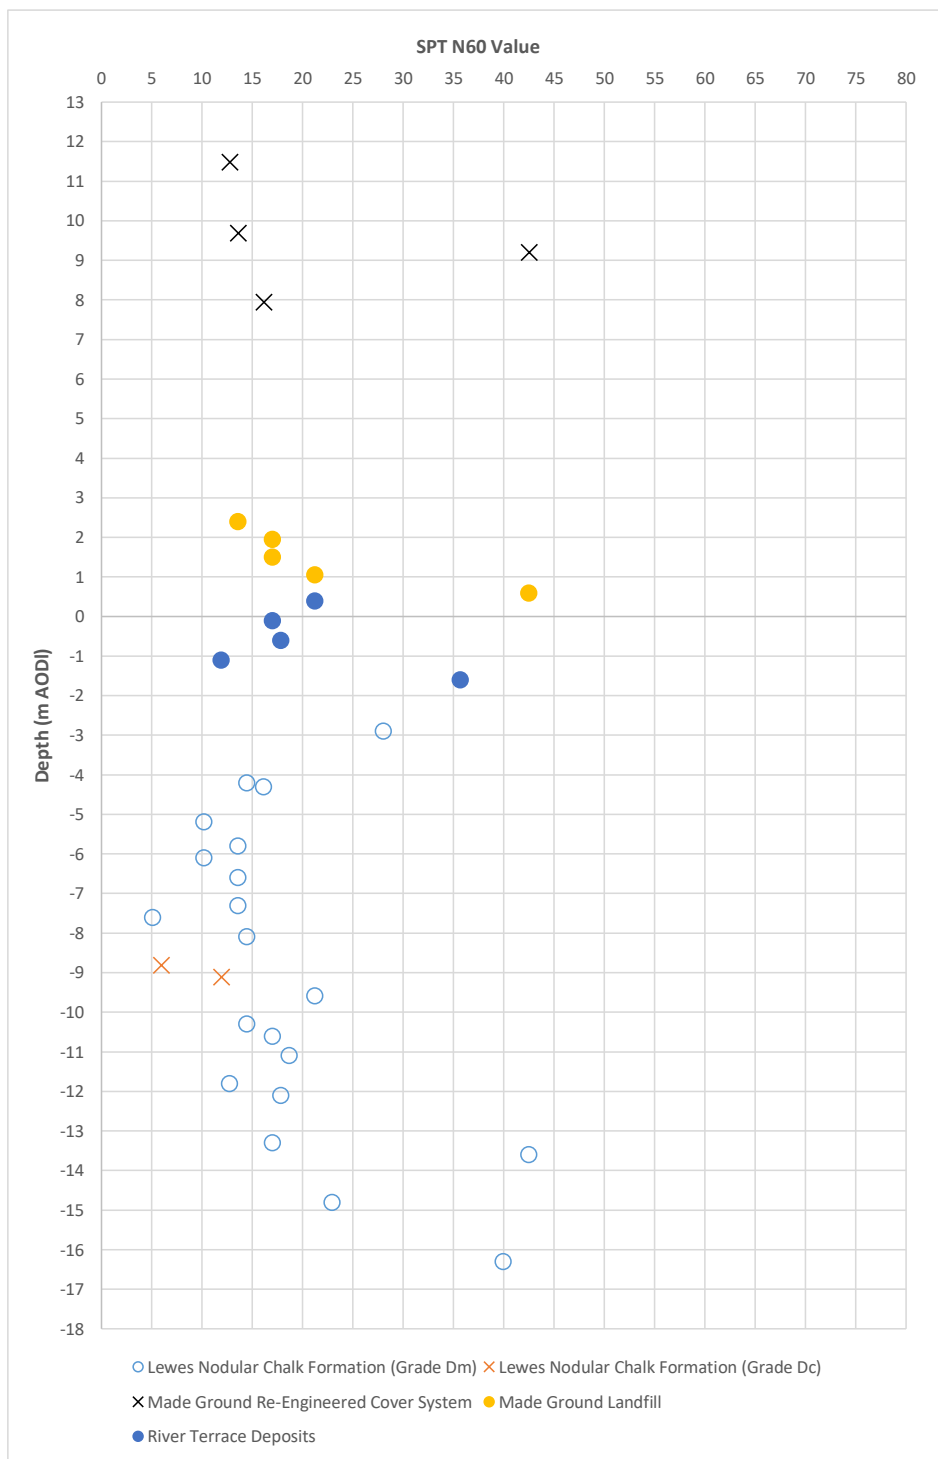
## Figure 4b – SPT vs Depth Plot (m AOD) – East Cell

Corrected SPT N<sub>60</sub> Values vs Depth Plot  
 (m AOD)  
 Eastern Landfill Cell, Brockhampton

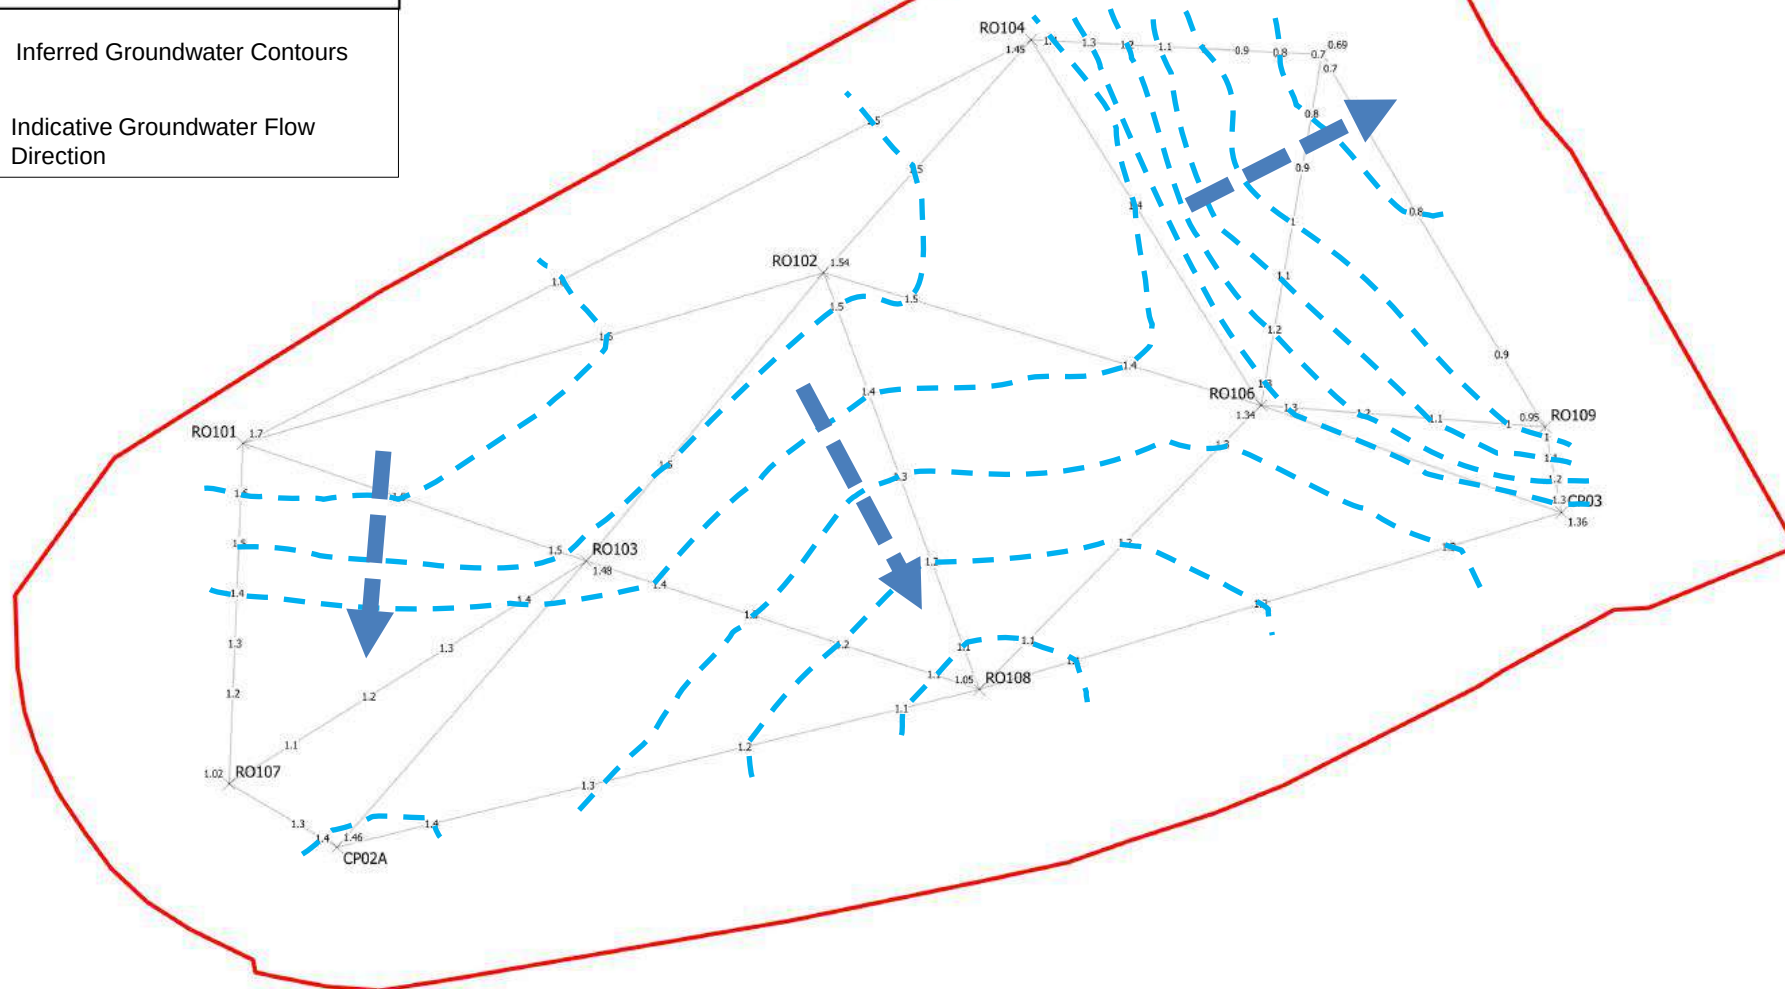
Inferred Groundwater Contours

Indicative Groundwater Flow Direction

Groundwater Contour Plan (Round 4 Groundwater Monitoring)  
Brockhampton West, Havant

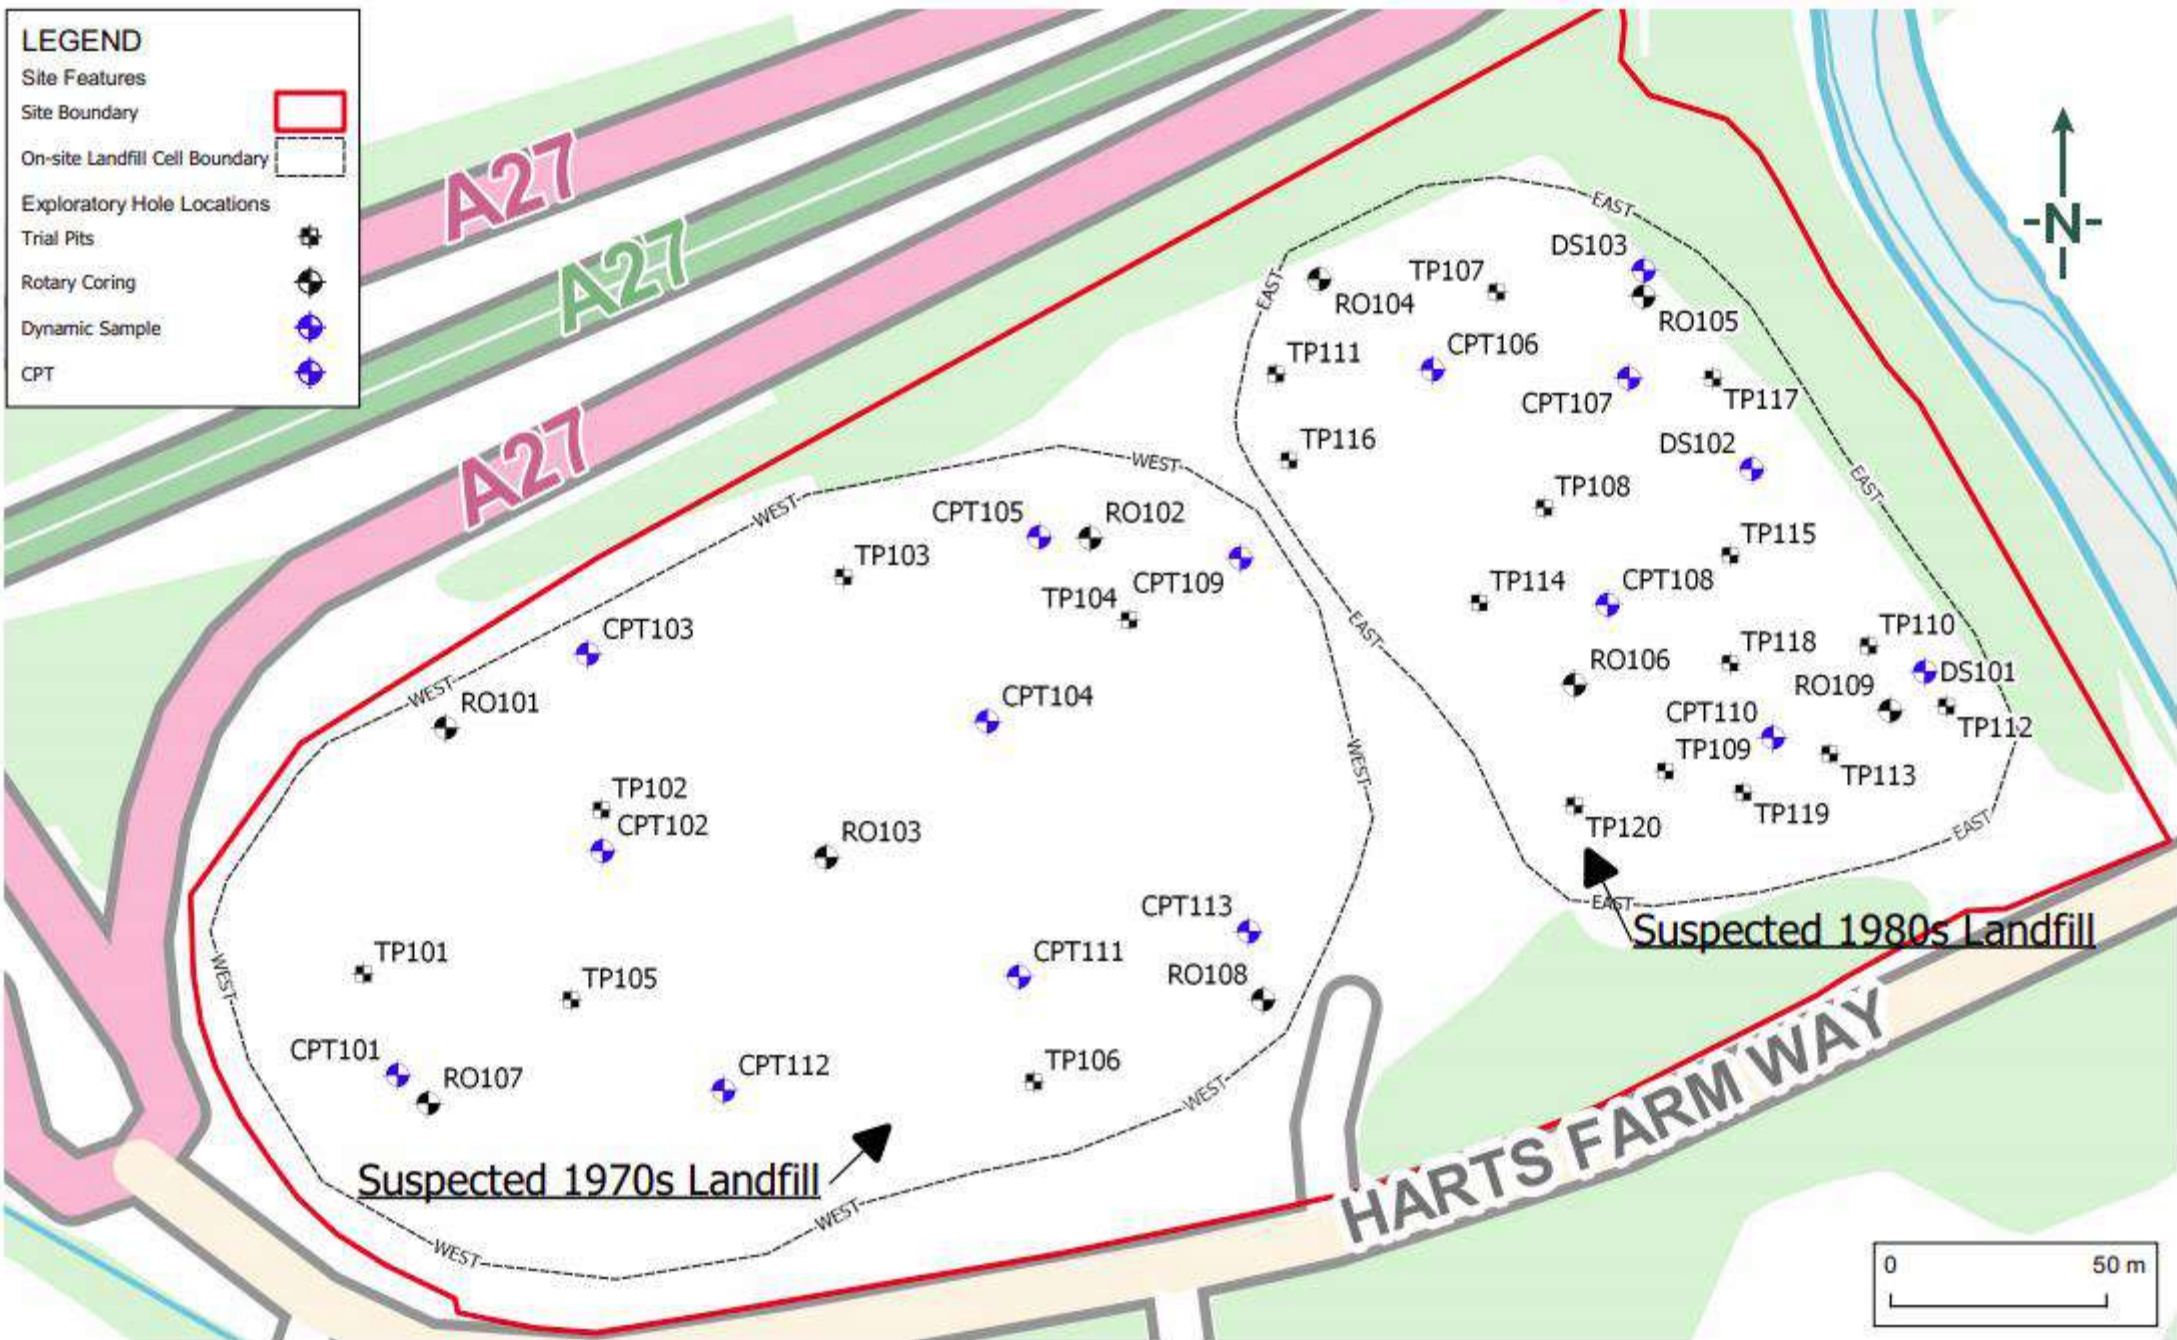
## Appendix C – CPT Data Interpretation

**Typical Young's modulus (E') for cohesive and granular material (MPa)** (based on Obrzud & Truty 2012 compiled from Kezdi 1974 and Prat et al. 1995)

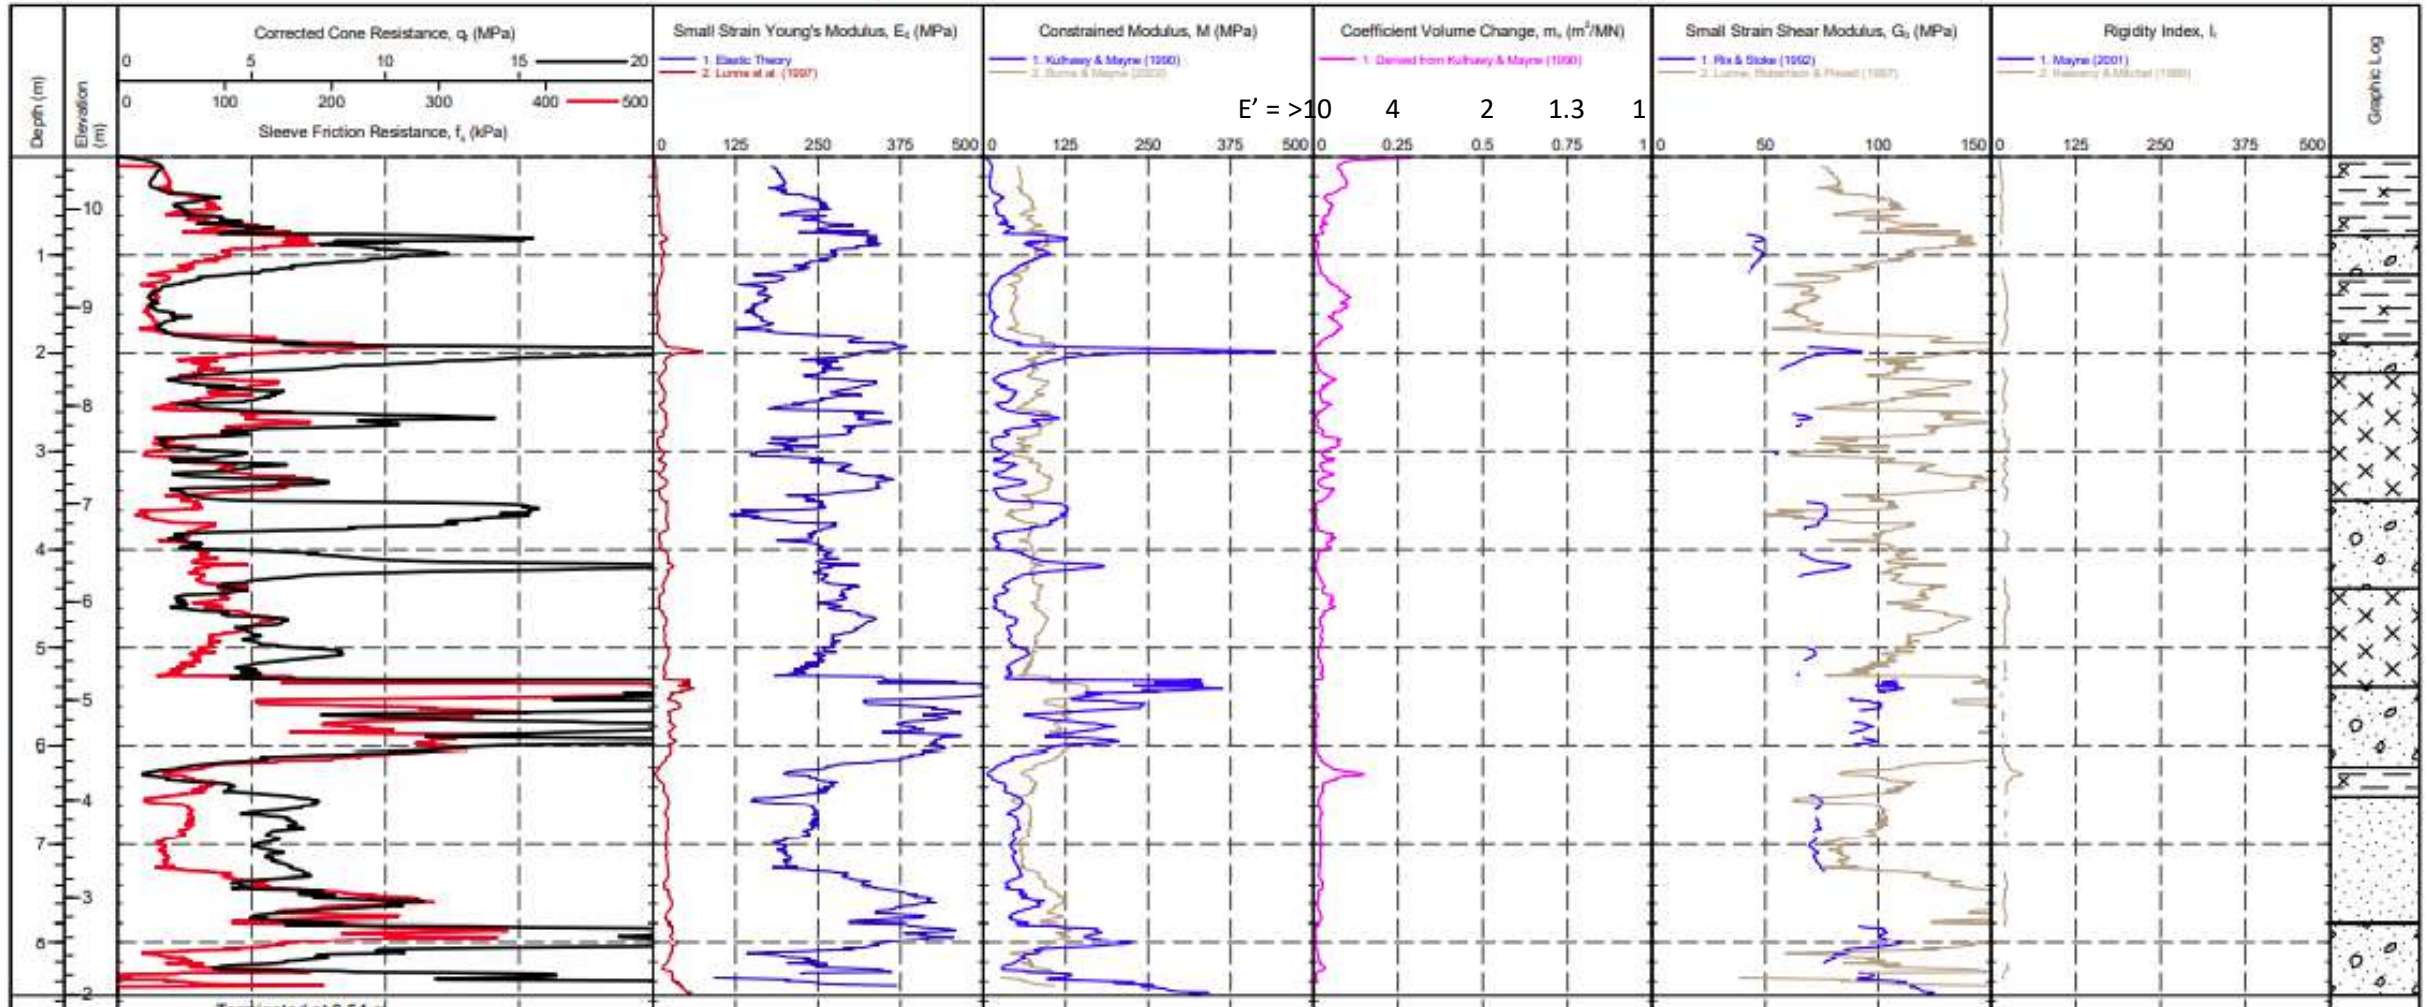
Remark:  
Test refused on total pressure.

SHEET : 1 OF 1  
STATUS : Final  
TEST DATE : 30/03/2021  
PLOT DATE : 25/05/2021  
METHOD : ISO 22476-1:2012
