# Geo-Environmental Assessment

**Former Brockhampton West Landfill, North of Harts Farm Way, Havant**

**Presented to Clowes Developments (UK) Ltd**

Delta-Simons Project No. 19-2099.04

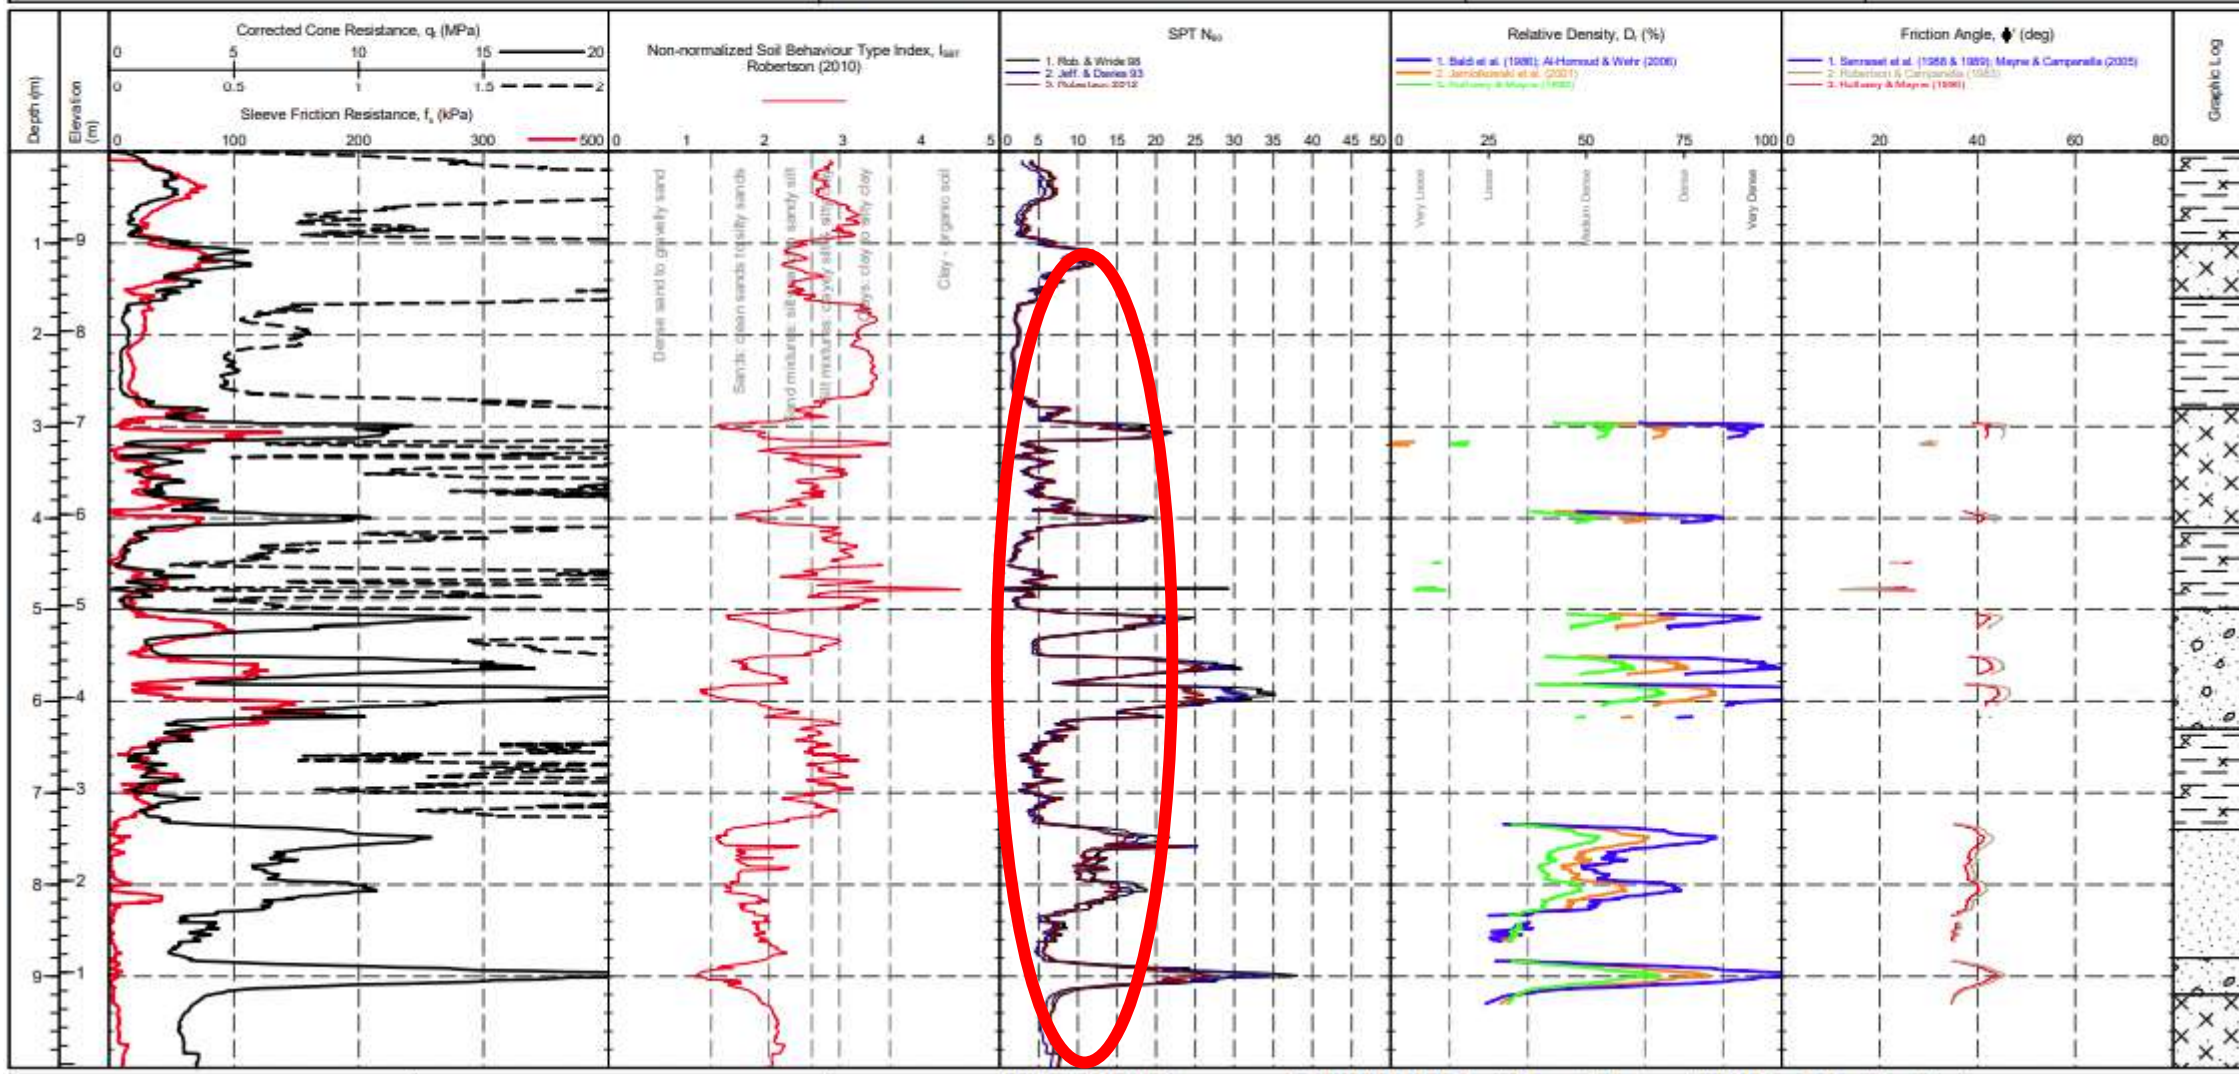
CLIENT : Delta Simons  
PROJECT : Brockhampton  
LOCATION : Brockhampton  
PROJECT No. : 1210220

EASTING : 470097.5 m  
NORTHING : 105621.3 m  
ELEVATION : 9.96 m OD  
CHECKED BY : LD  
TERMINATION REASON : Refusal

Remark:  
Test refused on total pressure.

SHEET : 1 OF 3  
STATUS : Final  
TEST DATE : 29/03/2021  
PLOT DATE : 25/05/2021  
METHOD : ISO 22476-1:2012

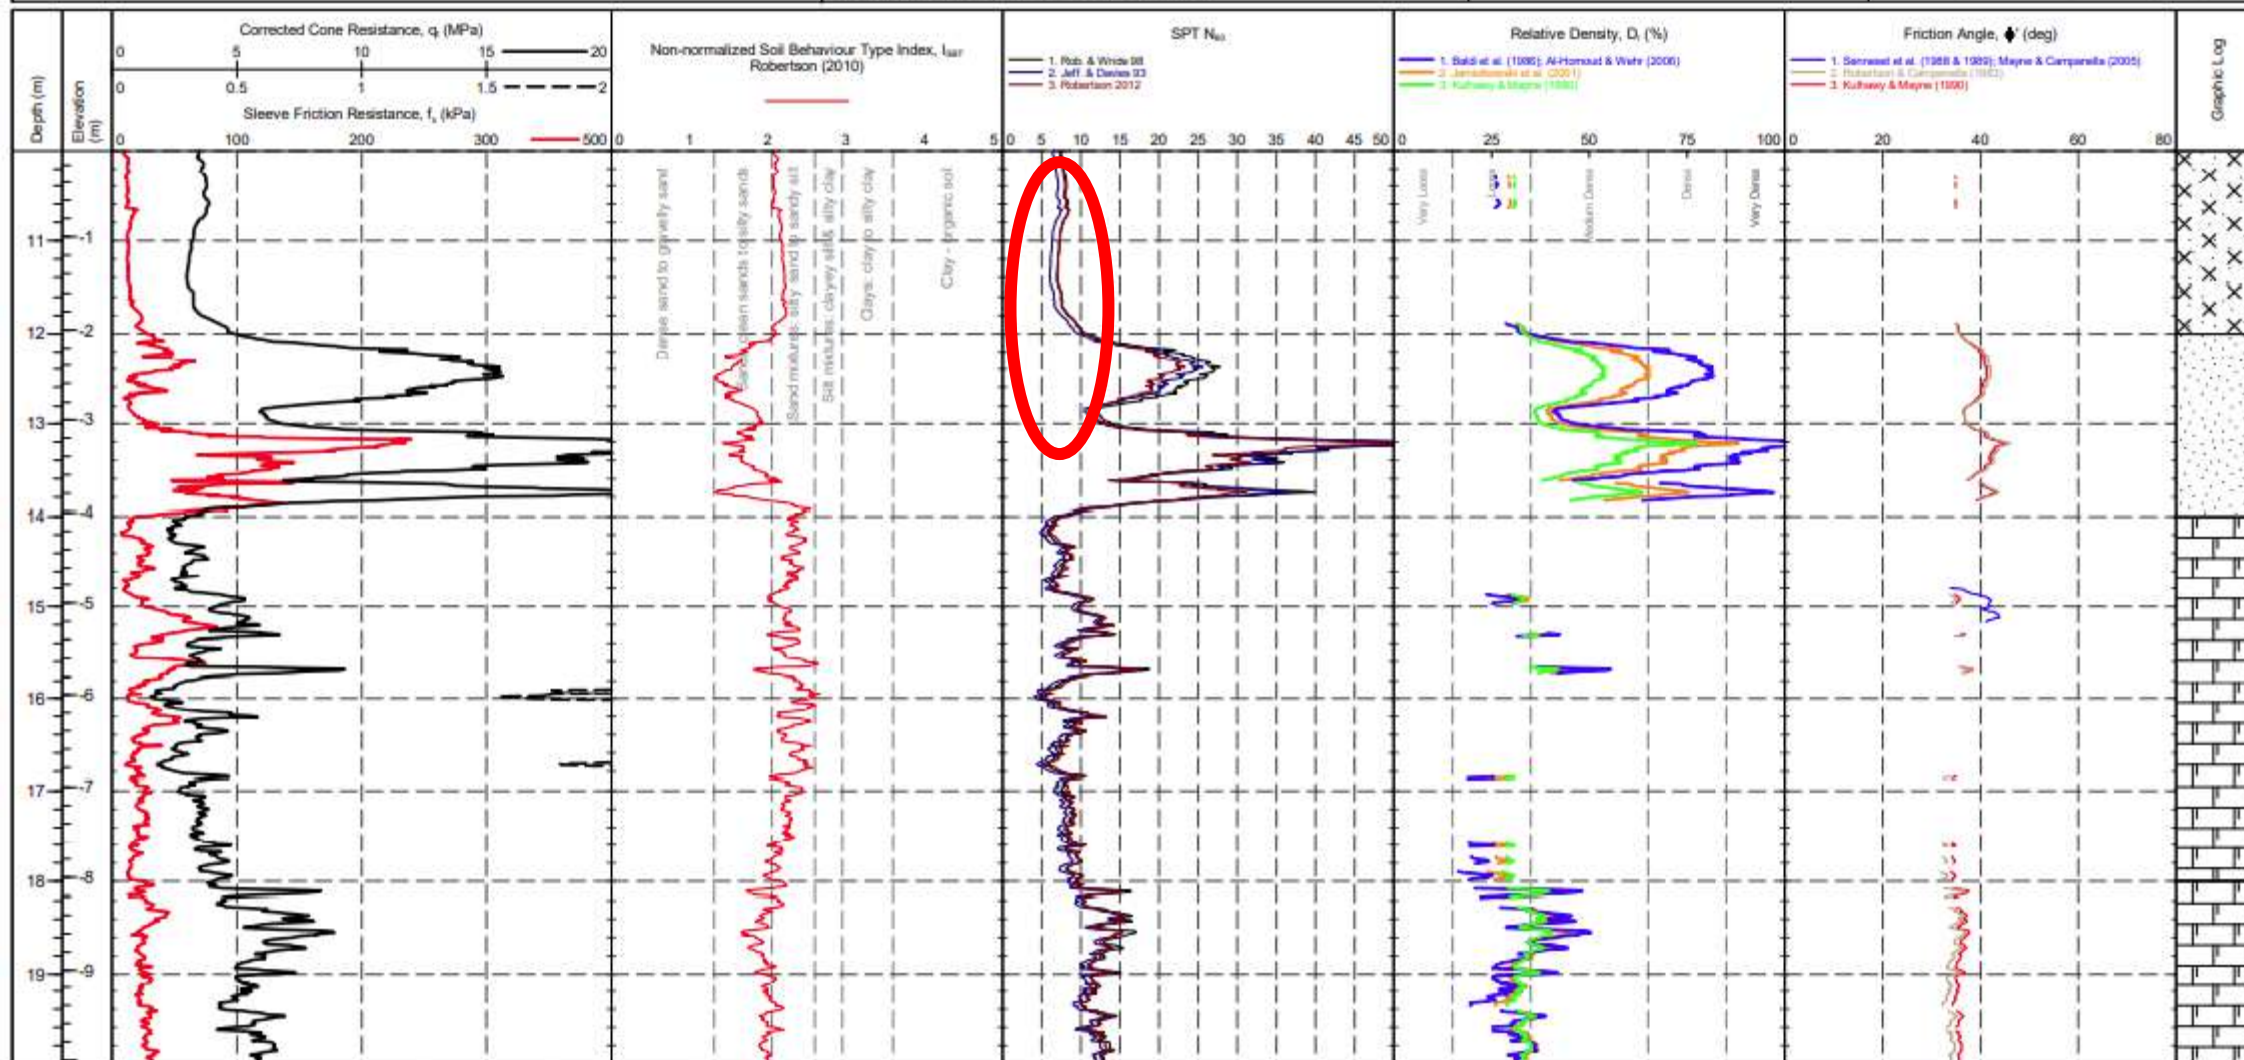
CLIENT : Delta Simons  
PROJECT : Brockhampton  
LOCATION : Brockhampton  
PROJECT No. : 1210220

EASTING : 470097.5 m  
NORTHING : 105621.3 m  
ELEVATION : 9.96 m OD  
CHECKED BY : LD  
TERMINATION REASON : Refusal

Remark:  
Test refused on total pressure.

SHEET : 2 OF 3  
STATUS : Final  
TEST DATE : 29/03/2021  
PLOT DATE : 25/05/2021  
METHOD : ISO 22476-1:2012

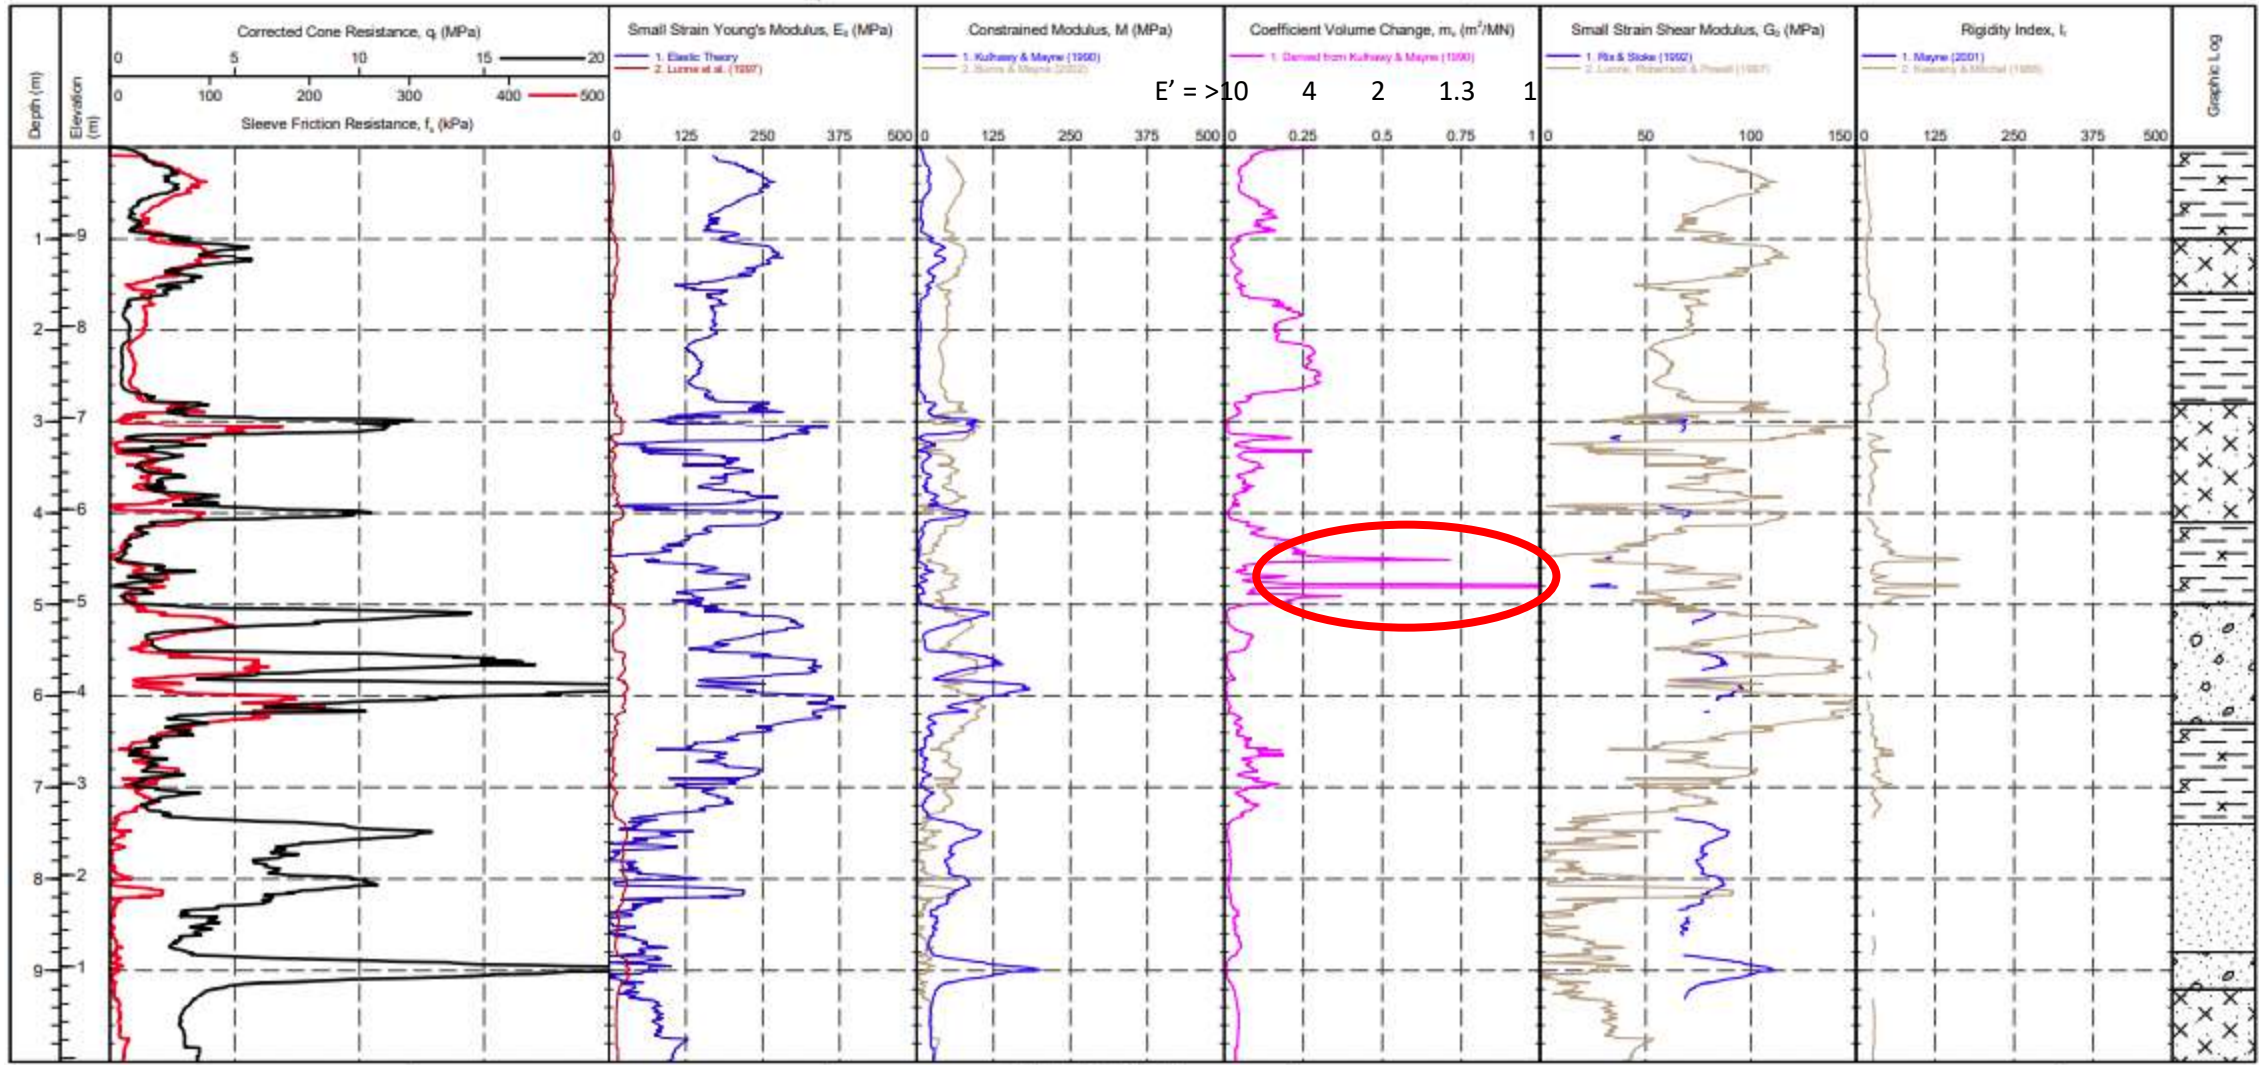
CLIENT : Delta Simons  
PROJECT : Brockhampton  
LOCATION : Brockhampton  
PROJECT No. : 1210220

EASTING : 470097.5 m  
NORTHING : 105621.3 m  
ELEVATION : 9.96 m OD  
CHECKED BY : LD  
TERMINATION REASON : Refusal

Remark:  
Test refused on total pressure.

SHEET : 1 OF 3  
STATUS : Final  
TEST DATE : 29/03/2021  
PLOT DATE : 25/05/2021  
METHOD : ISO 22476-1:2012

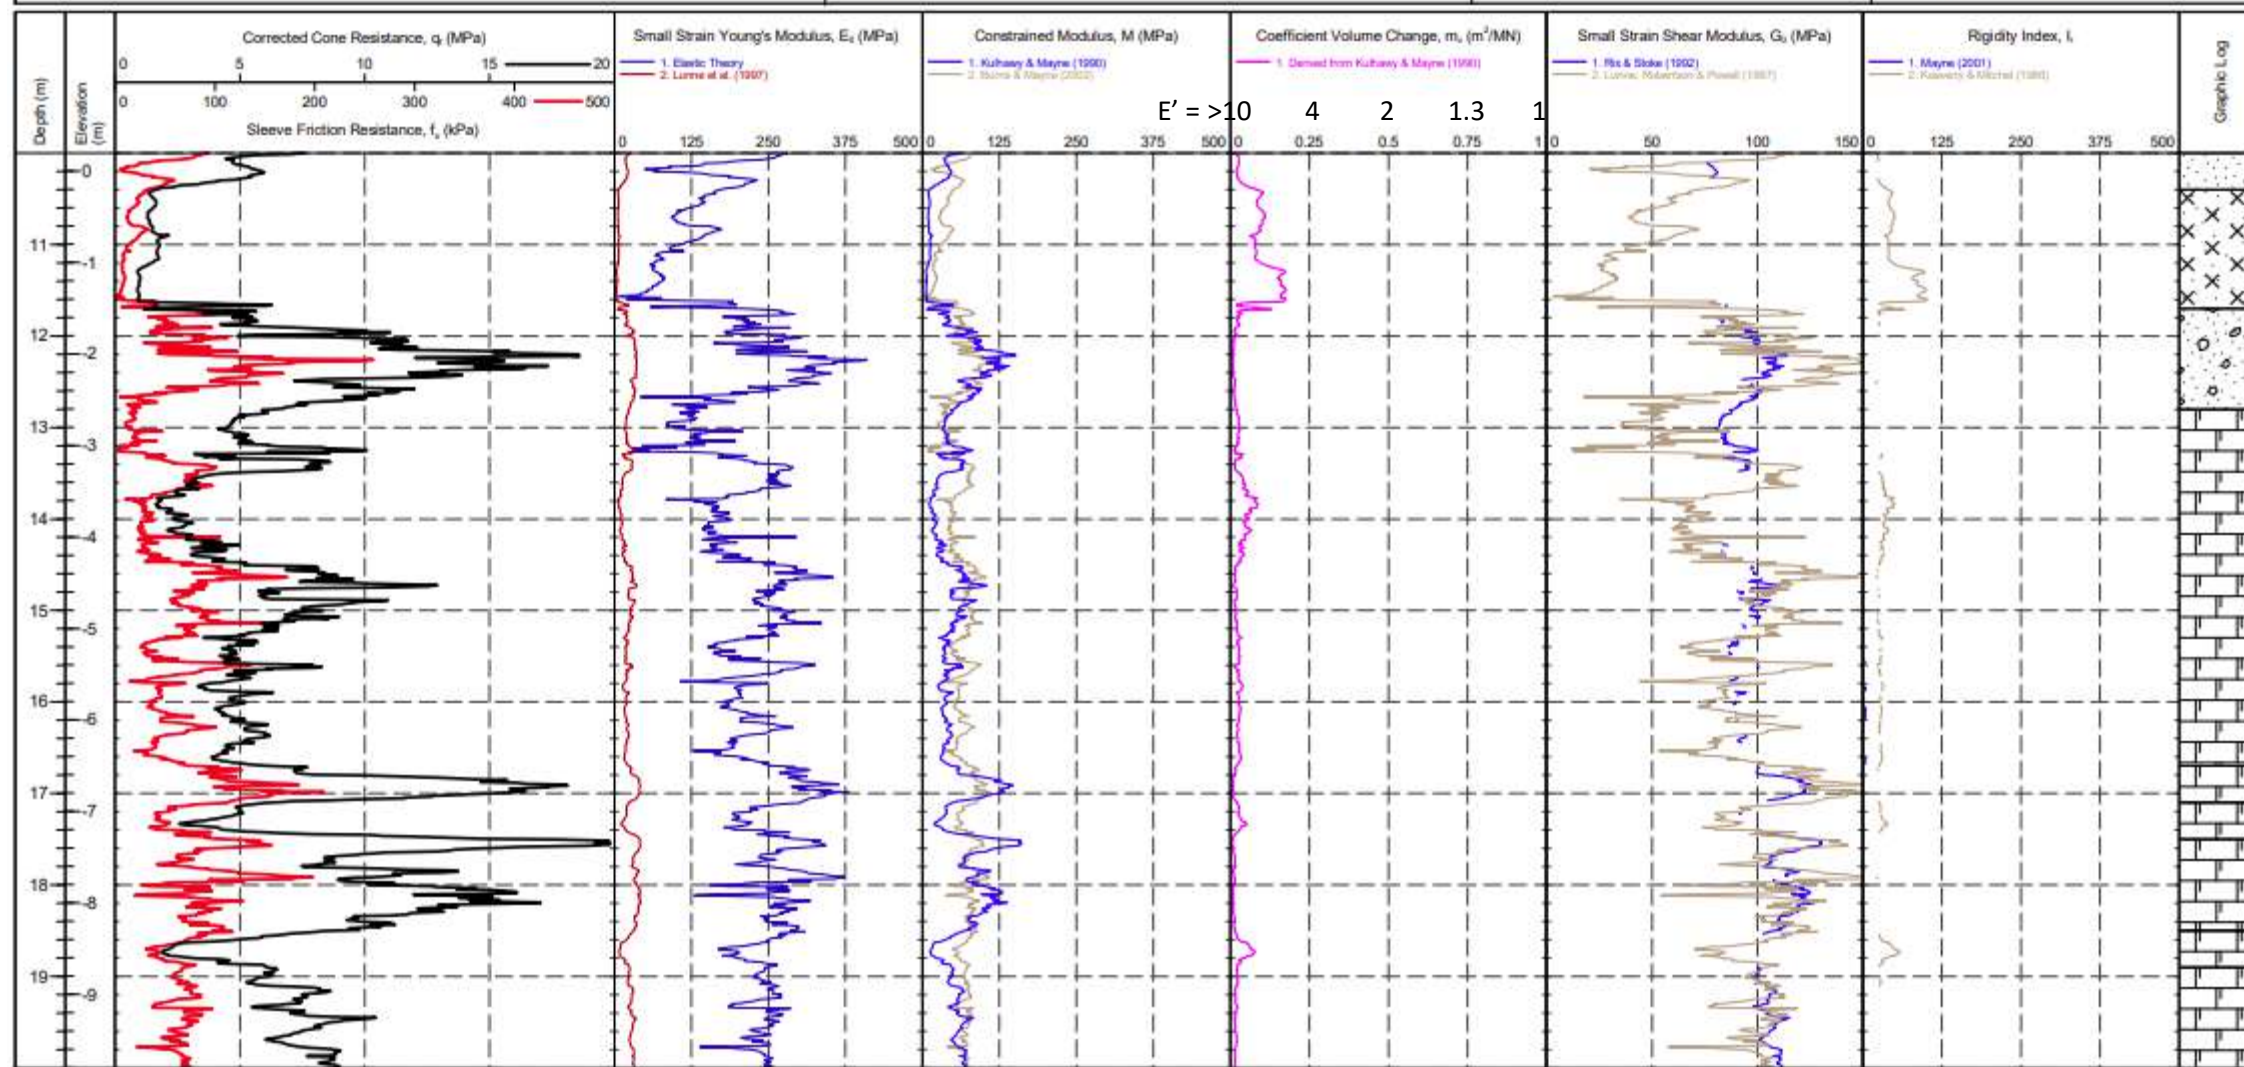
CLIENT : Delta Simons  
PROJECT : Brockhampton  
LOCATION : Brockhampton  
PROJECT No. : 1210220

EASTING : 470029.3 m  
NORTHING : 105595.0 m  
ELEVATION : 10.20 m OD  
CHECKED BY : LD  
TERMINATION REASON : Refusal

Remark:  
Test refused on total pressure.

SHEET : 2 OF 4  
STATUS : Final  
TEST DATE : 29/03/2021  
PLOT DATE : 25/05/2021  
METHOD : ISO 22476-1:2012

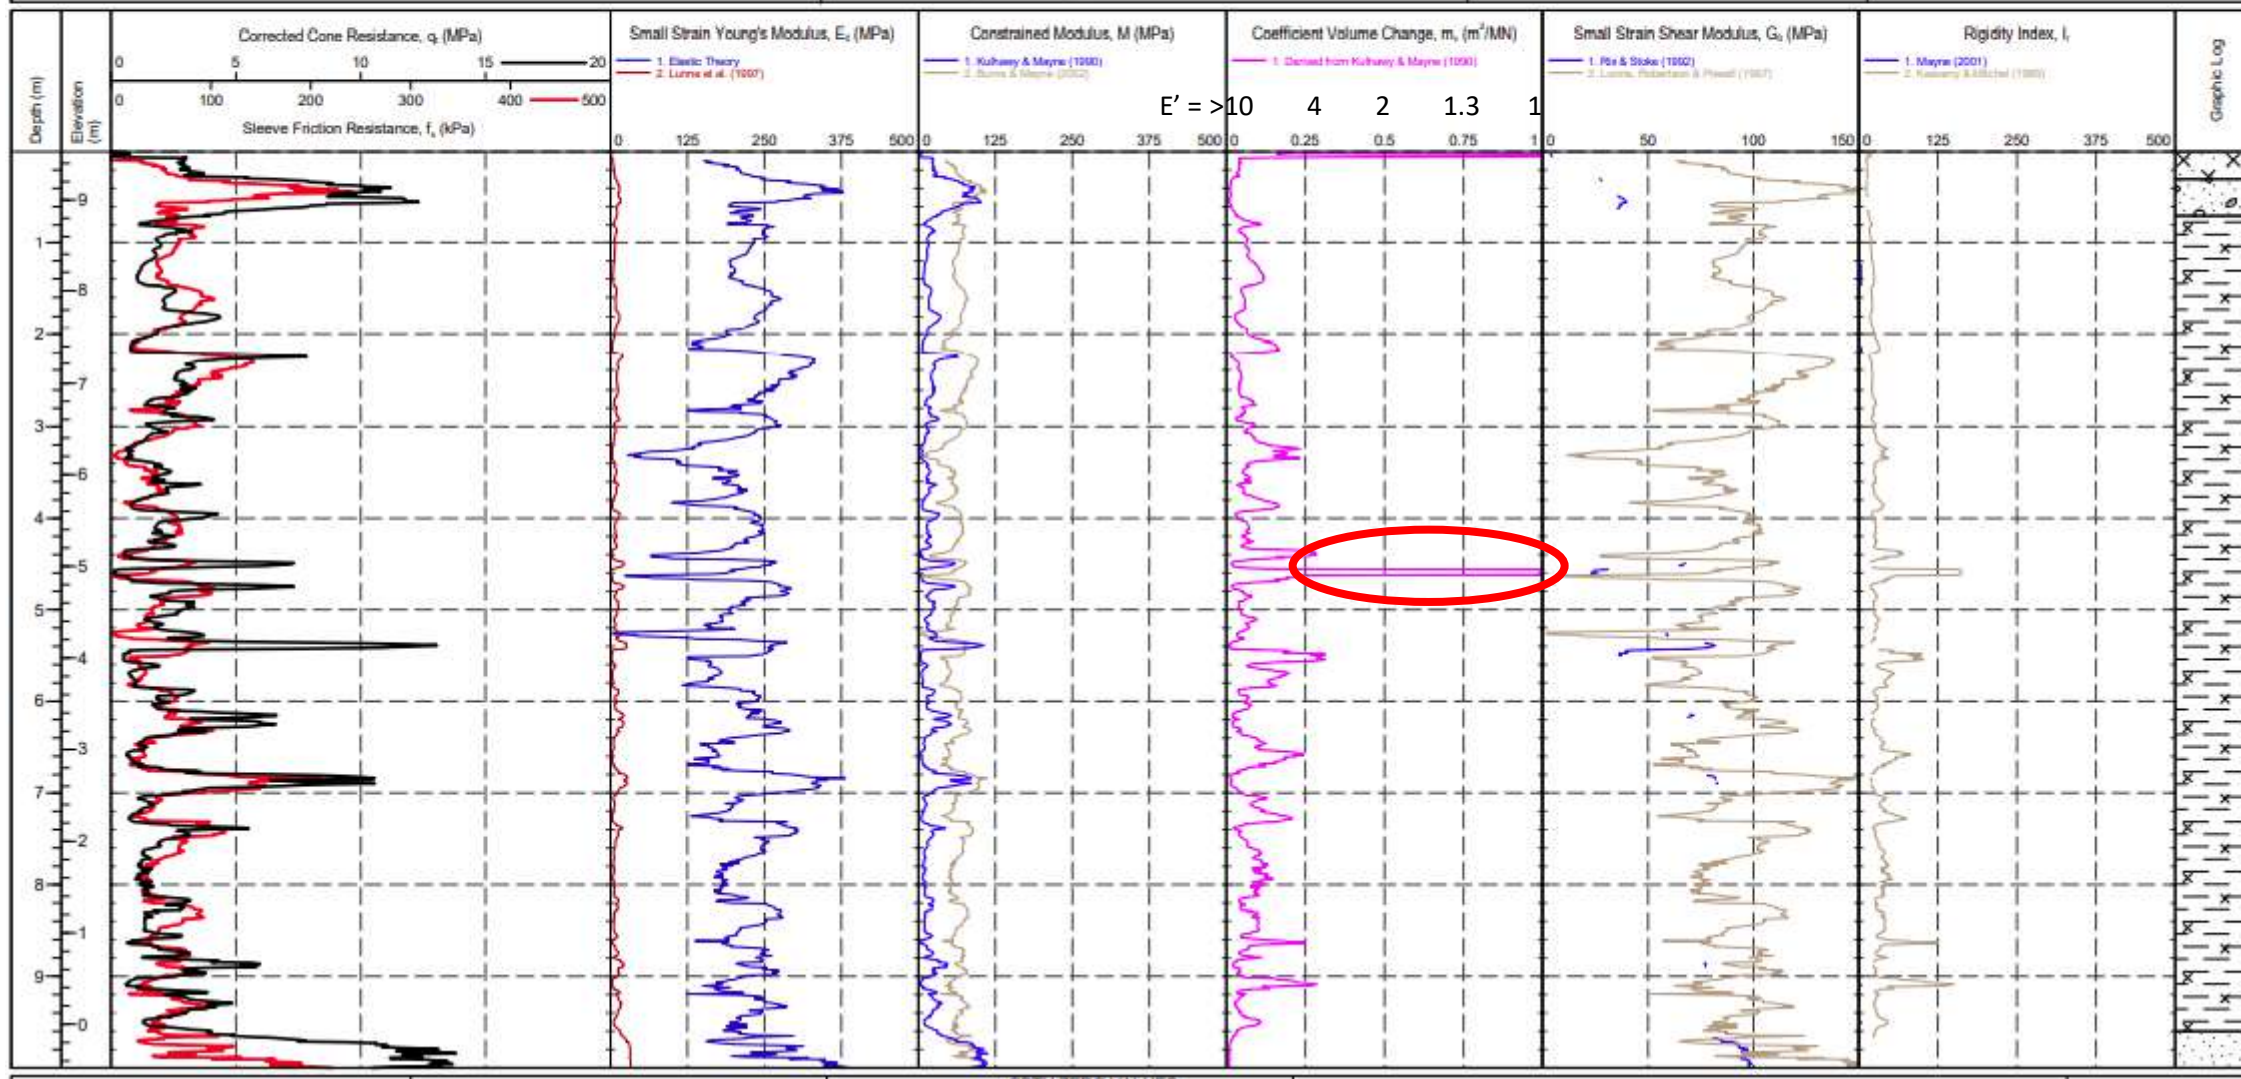
CLIENT : Delta Simons  
PROJECT: Brockhampton  
LOCATION : Brockhampton  
PROJECT No. : 1210220

EASTING : 470150.7 m  
NORTHING : 105631.8 m  
ELEVATION : 9.53 m OD  
CHECKED BY : LD  
TERMINATION REASON : Refusal

Remark:  
Test refused on total pressure.

SHEET : 1 OF 4  
STATUS : Final  
TEST DATE : 29/03/2021  
PLOT DATE : 25/05/2021  
METHOD : ISO 22476-1:2012
