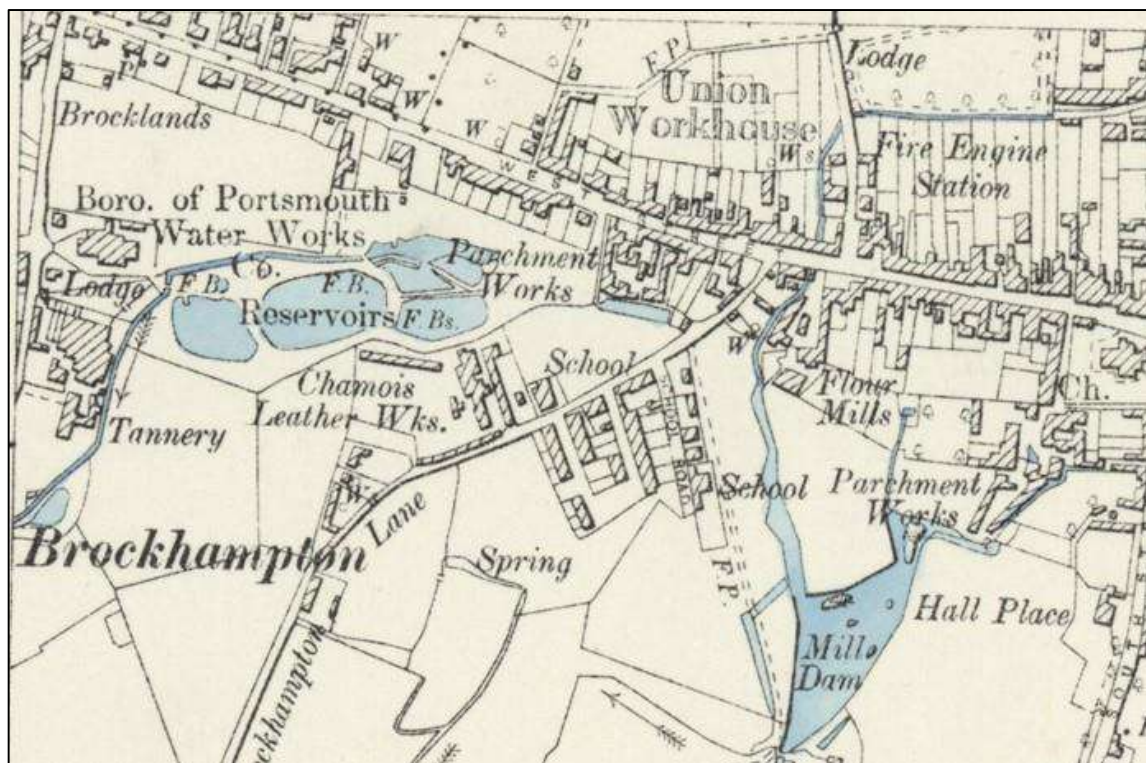
Figure 4: Portsmouth Water Head Office Site – 1895 (National Library of Scotland)

Off-site, the Havant area has become progressively built-up, alongside the springs. Havant was well known for leather production between the 1700s – early 1900s, with leather production recorded in 1895 historical maps along Brockhampton Lane, and tannery buildings close-by (see Figure 4). Parchment production was also a large industry for the area, continuing up until the 1930s, which required a reliable, clean water source, so factories were located close to the springs, as well as several breweries in the 1800s. These industries presented a risk to the source of water they were dependent upon, with waste products posing a contamination risk to the springs. The large spring collection basins on-site can clearly be seen on the historical maps.
