# Remediation Strategy Report Langstone Technology Park, Havant

## Prepared for AG Langstone B.V.

**November 2020**

**10/1425/005 Rev. 00**

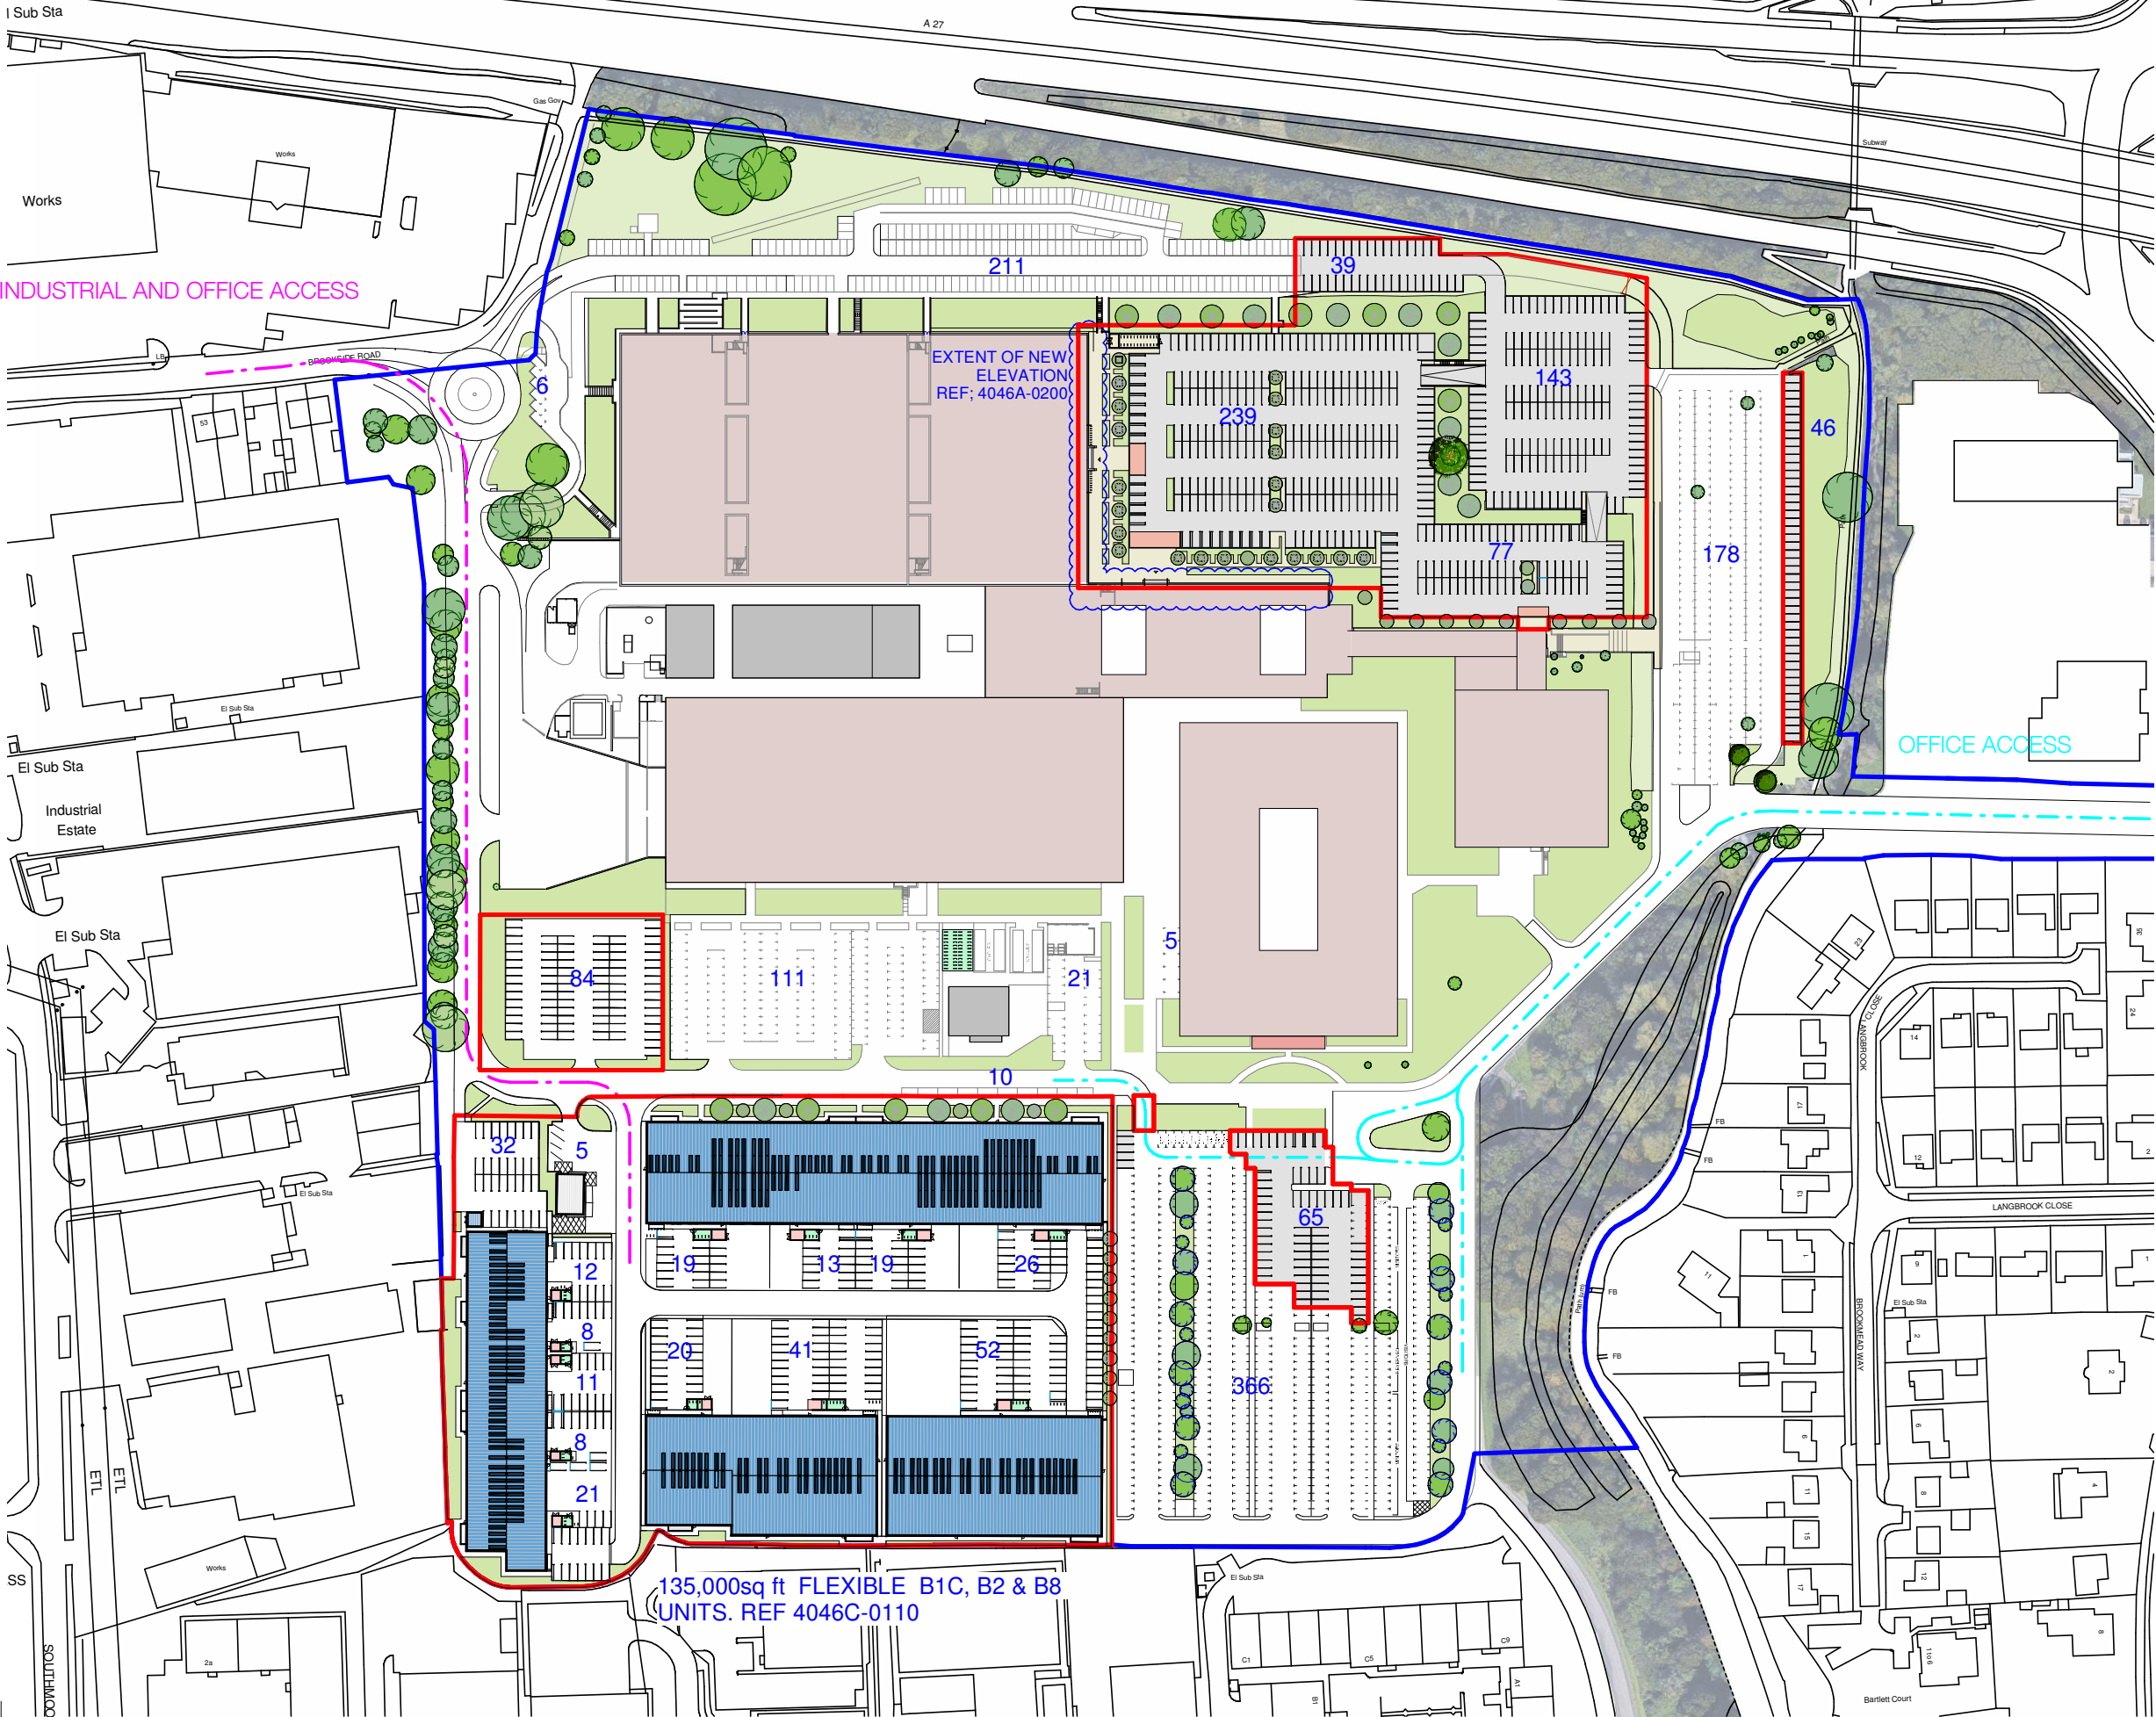
Proposed Layout Plan Opt 02

It is proposed to partially demolish and reconfigure part of B1000 in the northern section of the site and to construct twelve light industrial / commercial units with associated parking in the southern section of the site..

Proposed site layouts and floor plans are shown in Appendix I.

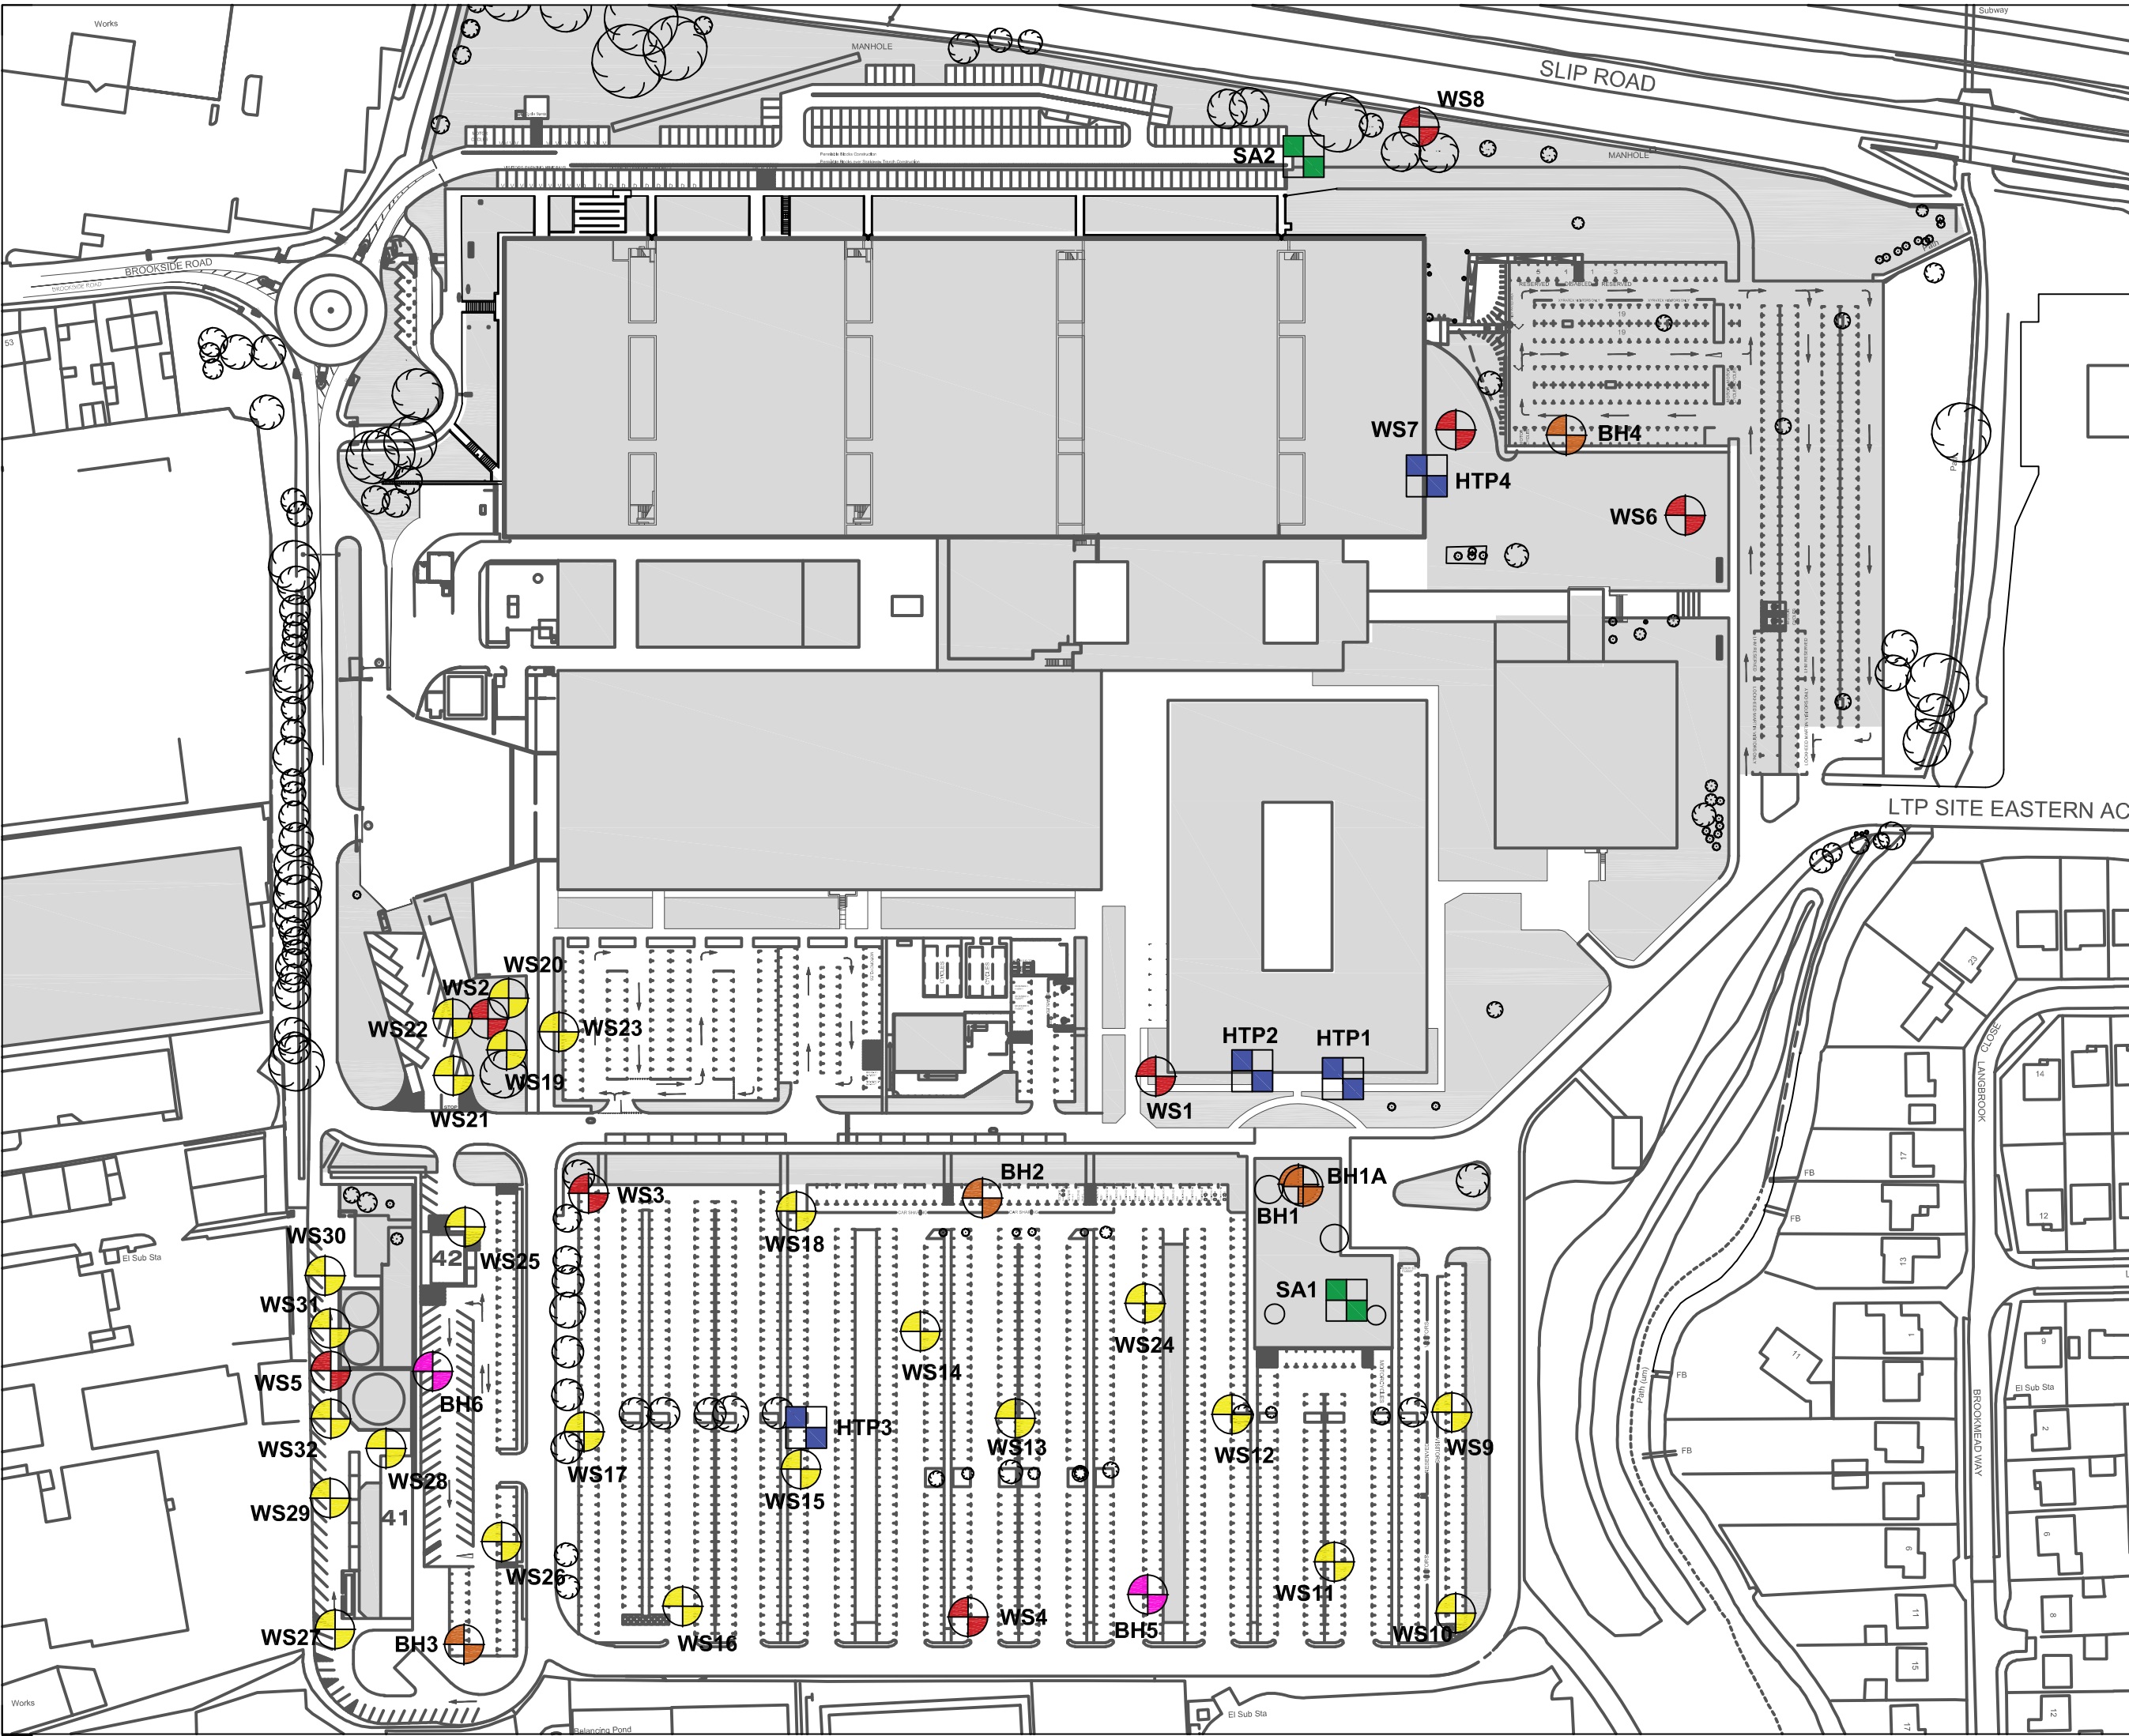
Exploratory Hole  
Location Plan

- Six cable percussion boreholes (BH01 to BH06) to depths ranging from approximately 20.00m to 30.00m below ground level (bgl);
- 32 window samples boreholes (WS01 to WS32) to depths ranging from approximately 4.45m to 5.45m bgl;
- Installation of groundwater and ground gas monitoring wells in selected boreholes;
- Two machine excavated trial pits (SA01 and SA02) to depths of up to approximately 2.00m bgl; and
- Nine hand dug foundation inspection pits (HPT1 to HPT4 and TP01 to TP05) to depths of up to 1.40m bgl.
