## Ecological Appraisal

**Morelands Primary School,  
Crookhorn Lane, Purbrook  
Waterlooville, PO7 5QL**

*Reclad of the main block*

13 May 2016

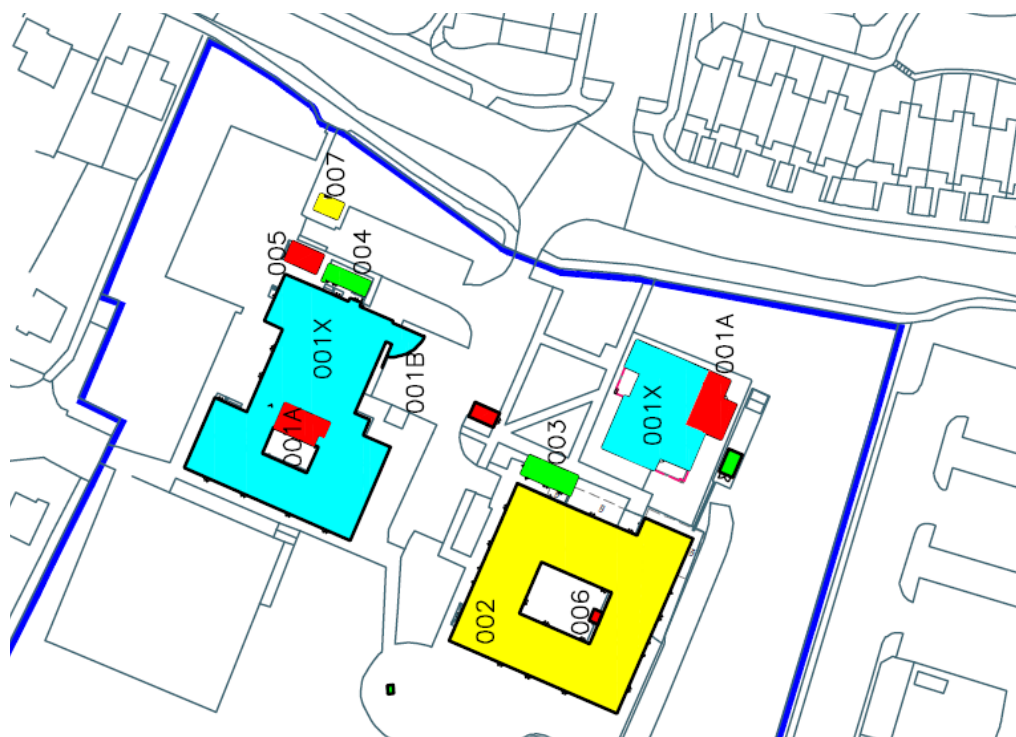
Figure 1: Proposals are to undertake works to building 001 and associated outbuildings

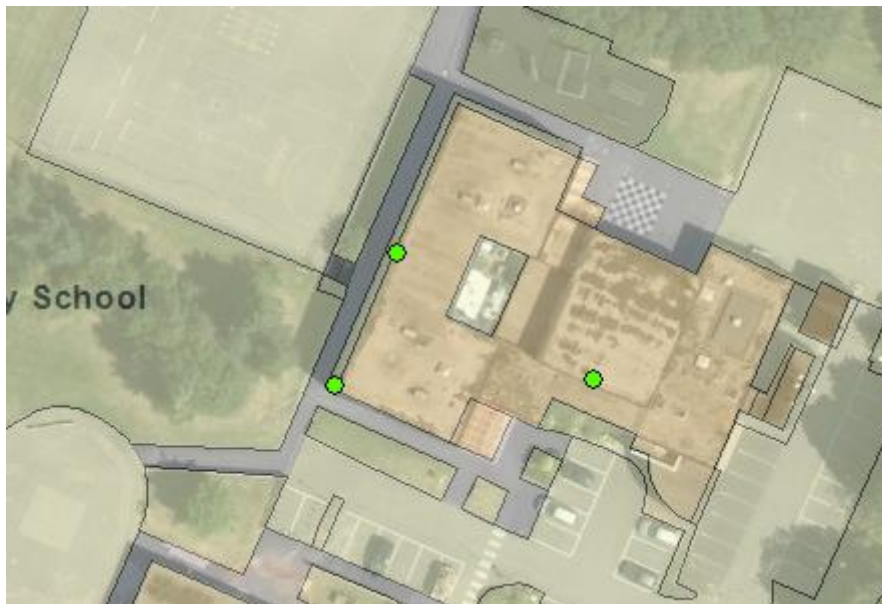
- A gap in the wooden cladding above the first floor windows toward the centre of the western aspect of building;
- Damaged wooden cladding to the south of the protruding structure above the single storey part of the building, visible from the south; and
- A hole in cladding on the south western corner of the structure. A blue tit was observed to be nesting within this feature.

The location of these features is shown on the plan (Figure 2) alongside photographs of the structure.

**Figure 2: Approximate Location of features identified on school building**

The building currently supports nesting birds. All species of bird and their eggs are legally protected and it is therefore necessary to ensure that the nest is vacant before works commence. HCCET can monitor the nest and it may be blocked up when confirmed to be inactive.

National and local policy requires planning decisions to work to ensure there is no net loss of biodiversity, and net gains should be sought where possible. Therefore, it is recommended that once the recladding work is complete, a minimum of two new nest boxes, of a type designed for tits and / or general urban bird species, are installed on suitable building locations at high level. We would be happy to provide detailed information on suitable boxes if you require.

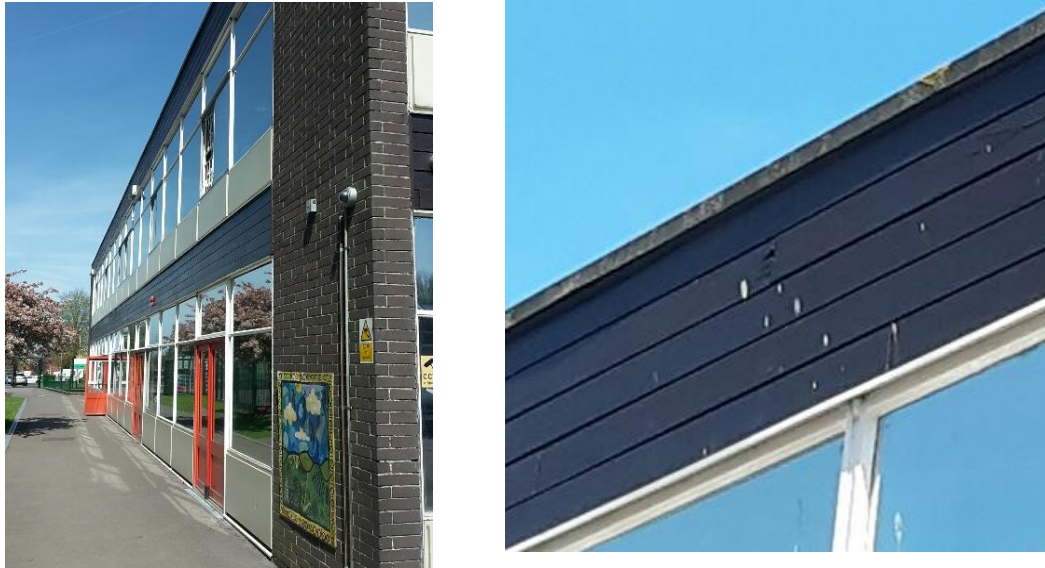
The building comprises a typical SCOLA type building. It contains a mixture of single and two storey elements. The structure is construction containing both brick and wooden clad elements.

**Figure 3: Photographs of the building. Above right shows gap in cladding identified on the west of the building**

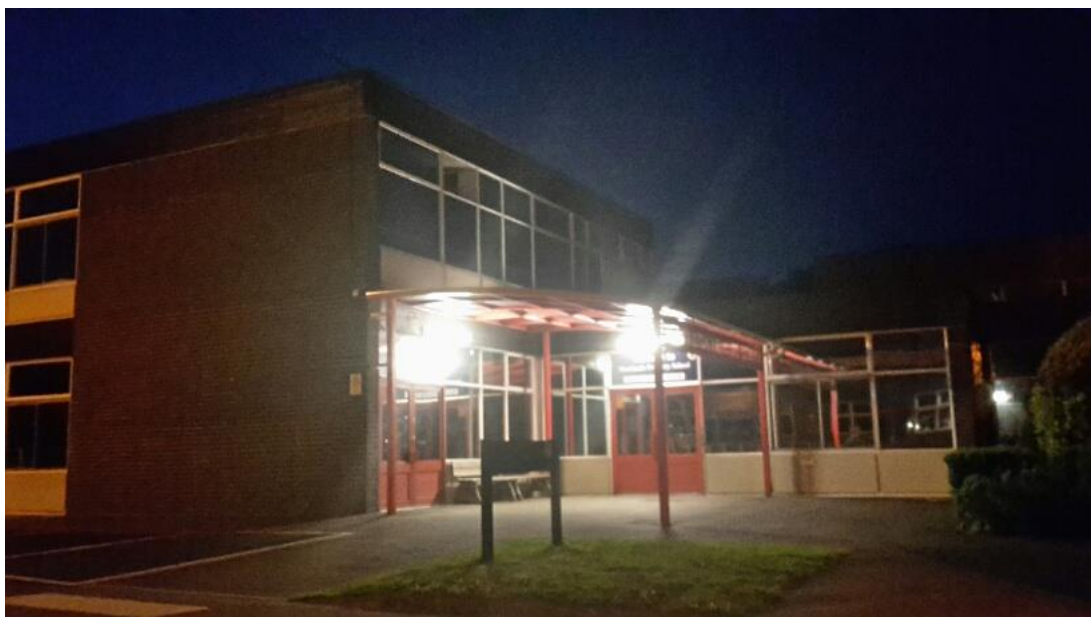
As shown on Figure 4 below, extensive external lighting surrounds the building, reducing the likelihood that bats would use the building for roosting, and it is therefore concluded that roosting bats are likely absent from the structure.

**Figure 4: Extensive external lighting surrounds the building**
