In this case, the facts are that able-bodied patients are able to take a direct path from the surgery entrance across the car park, up the step and into the pharmacy. Disabled people who cannot accommodate the step, ie those in wheelchairs or mobility scooters or who have long term mobility problems preventing them from climbing steps without appropriate guard-rails are obliged to take a much different route.

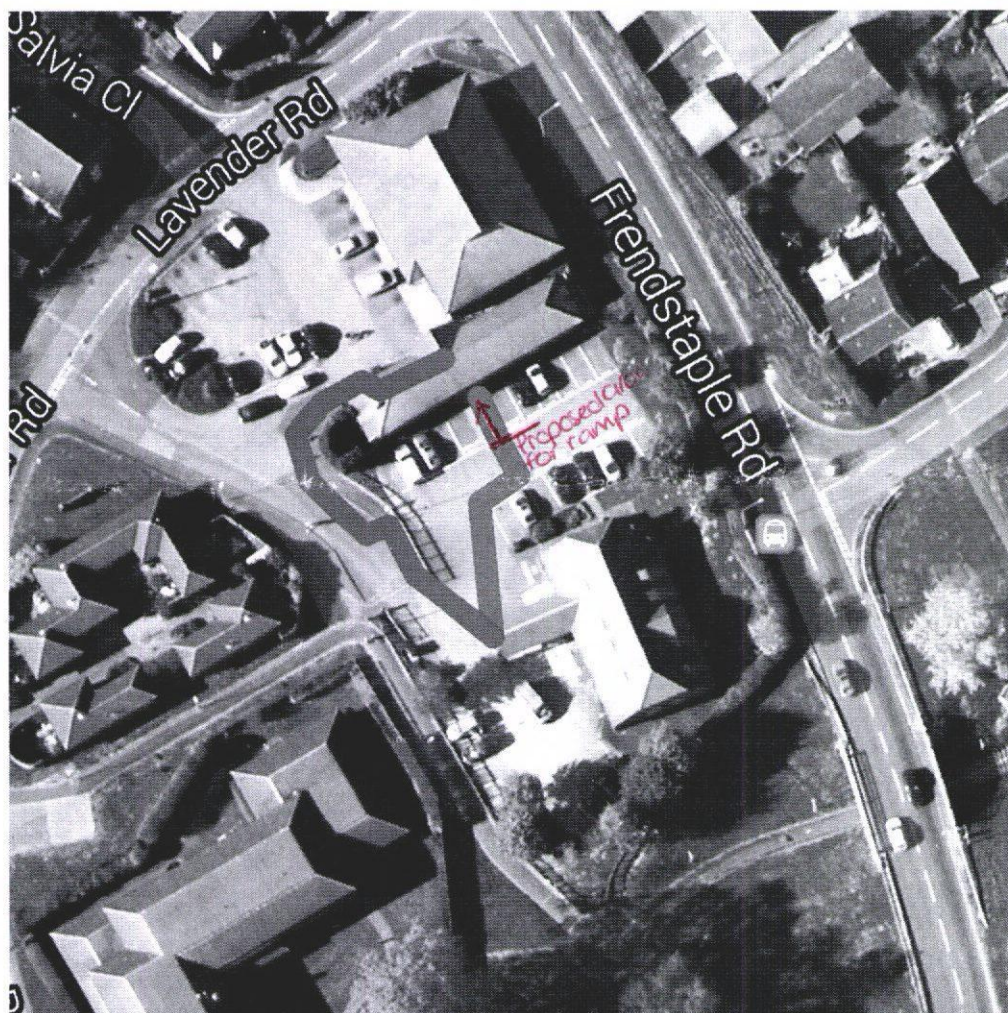
Making use of Google Maps latest incarnation, I've produced this approximate illustration of the difference in routes.

I believe it would be quite clear that the green route represents that which can be taken by able bodied patients, whereas the red route is the shortest option available to those using wheelchairs, scooters, etc. Note the need to leave the pavement and use the road, this is because the pavement does not match with the paving in the complex, and there is no dropped kerb facility to leave the pavement at any other point further along its length. This problem is illustrated clearly in the following photograph:

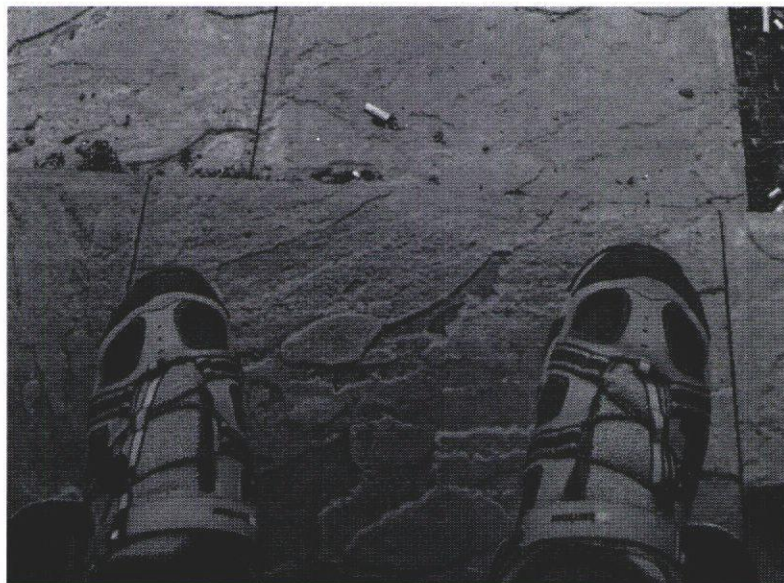
This first photograph shows the step as seen from the perspective of a wheelchair user, from within the shopping complex heading through the gate towards the surgery.

Indeed there is little or no contrast which in itself is a health and safety risk which ought to be considered by those responsible for the entrance as those with limited vision may not appreciate the step is actually there.

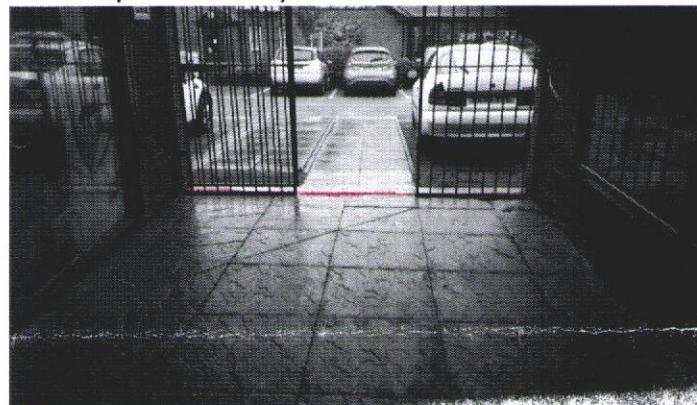
This second photograph shows a wider view of the gateway and internal route to the surgery. The windows to the left are part of the pharmacy, and to the right are part of the Chinese Take-Away.

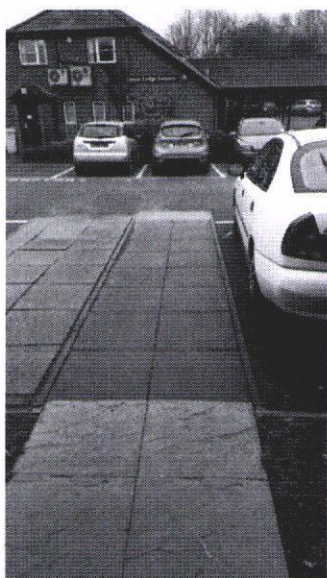
Looking out, we see a long pier which marks a pedestrian route, distinct from the car park itself, reaching part-way to the surgery building, and finally the step itself. Interestingly, when I measured the height of the step, it was only 17cm approximately, which equates to 6.7" high, which for the sake of later discussion we shall round up to 7 inches.

Therefore there are two key figures here to carry forward to any ramp discussion later on, the first being the height of the step, at 170mm, and the second being the size of the slab, at 600mm square. From this we can extrapolate the potential types of ramps possible.

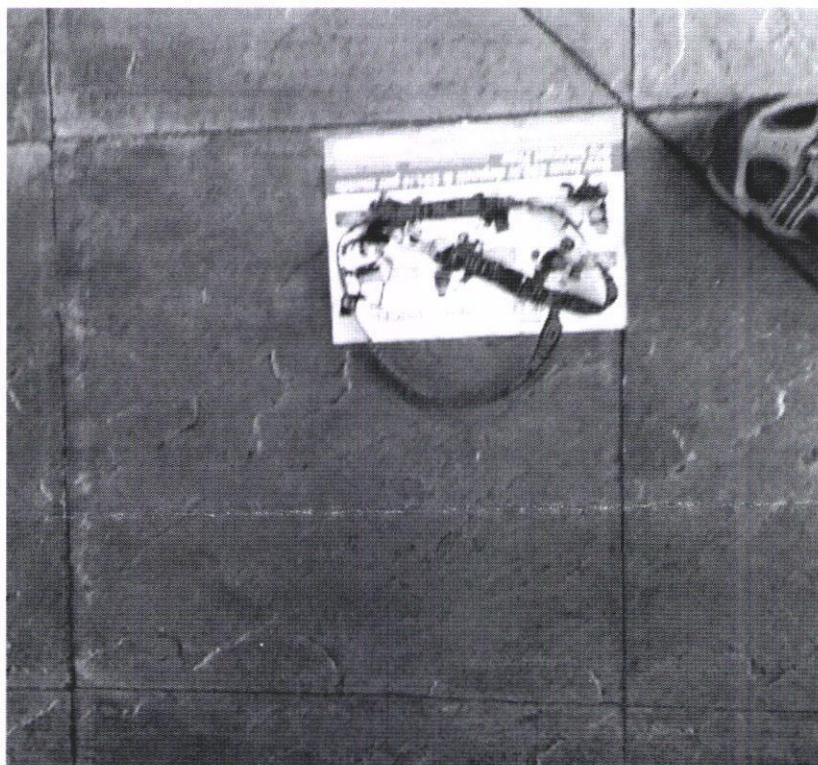
However, for purposes of measurement and approximation, I have used an A4 leaflet which was folded in line with the step (and later measured) and also used to measure the approximate size of the square slabs used throughout the complex and also the 'pier' which extends into the car park of the surgery.

To estimate the size of the slab, I have unfolded the A4 sized leaflet, which is 210mm x 297mm the length being 11.7", the width being around 8.25".
