## Ecological Appraisal

## Riders Infant and Junior Schools

*Expansion from 2FE to 3FE*

June 2014

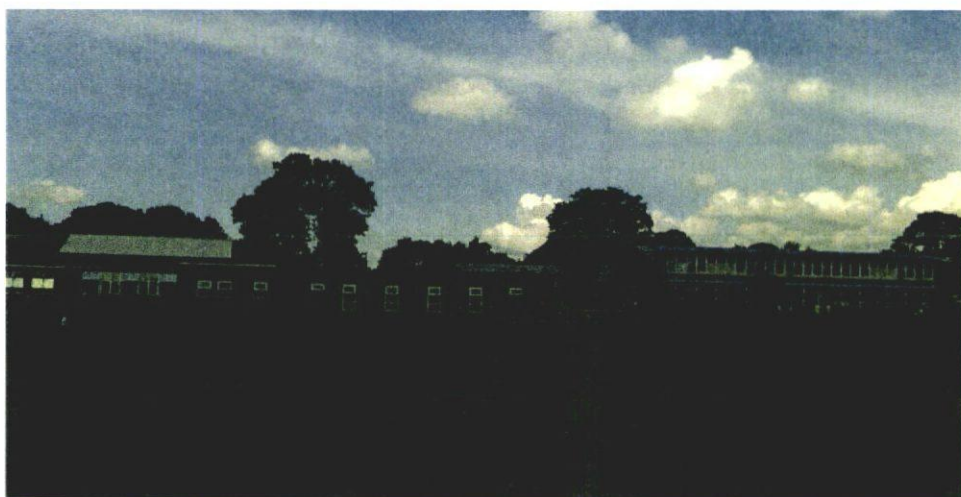
Figure 1. South-facing side of Riders Infant (left) and Junior (right) Schools

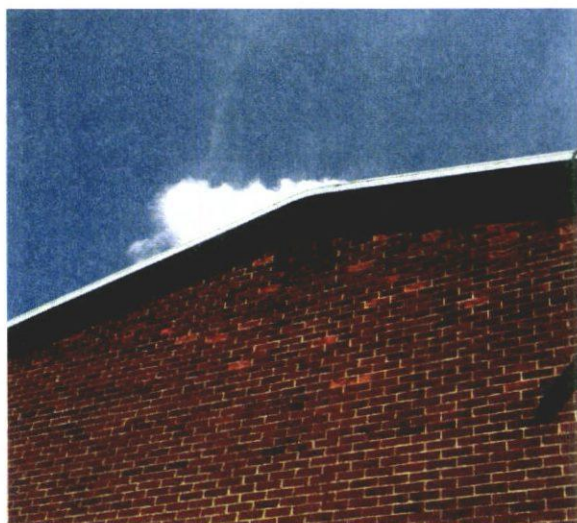
Most of the buildings on site were flat roofed and of low suitability for bats, however, four of the main buildings had shallow pitched roofs with small apex roof voids over floating ceilings. These were restricted from access during the survey, due to asbestos issues and fibreglass insulation laid directly over the floating ceilings. The only pitched roof in the Infant School area was of the main hall which will not be in direct contact with the building work. Two of the buildings with pitched roofs in the Junior School will be adjacent to new buildings; these had air grills (Figure 2) at gable ends and have potential to be occupied by bats. The boiler room of the Junior School was inspected internally due to slatted door access holes, the cellar boiler room of the Infant school was also internally inspected but here, there were no access holes located, both boiler rooms were very clean with no signs of bat use. A small 'Wendy house' with a missing window pane at the west end of site was also internally inspected but no signs of bat use were found.

**Figure 2. Apex air grille in the west-facing gable end of the south Junior School building**

Due to the restricted internal access it is considered that structures within the survey area exhibit **moderate potential** for supporting roosting bats.

The survey results from the Phase 2 bat survey indicated negligible potential for roosting bats due to lack of activity and illumination from artificial lighting. Stripping of roofing materials must however be carried out carefully by hand, should a bat be found during this phase, all works must stop and the Ecology Team contacted immediately.

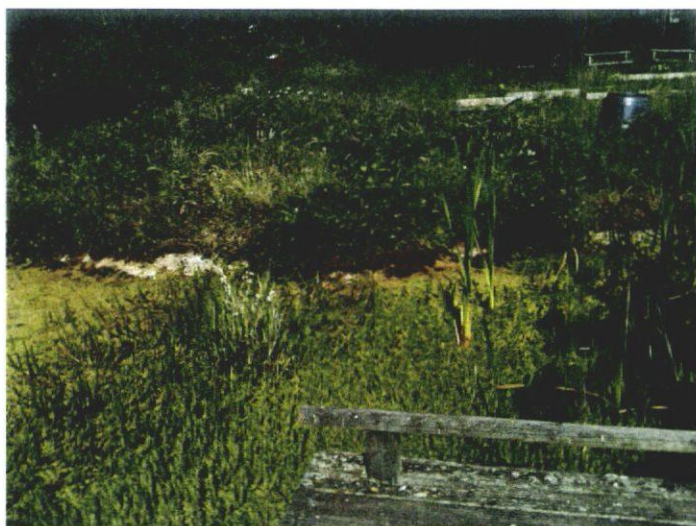
The pond was very shallow at the time of the survey 2x4m and dominated by parrot's feather (*Myriophyllum aquaticum*) a (schedule 9 species under the Wildlife & Countryside Act 1981), it also contained, frogbit (*lemna minor*), yellow flag (*Iris pseudocorus*) and water dropwort (*Oenanthe spp.*). Tall grassland vegetation has grown up in this area with red fescue (*Festuca rubra*), Yorkshire fog, common bent (*Agrostis capillaris*), red clover (*Trifolium pratense*), tormentil (*Potentilla erecta*), ribwort plantain (*Plantago lanceolata*), cut-leaved cranesbill (*Geranium dissectum*), black knapweed (*Centaurea nigra*) surrounded by areas of gravel.

There was one pond (Figure 3) located on the Site. A. Habitat Suitability Assessment was completed for the pond with a resultant Habitat Suitability Index (HSI) of 0.41 which indicates poor suitability for great crested newt. This is due to the lack of suitable waterbodies for breeding great crested newts within 500m and poor connectivity to suitable terrestrial habitats, with significant barriers to movement between sites; it is considered reasonably unlikely that great crested newts are present within the Application Site.

**Figure 3. Pond in the fenced Environmental Area, east side of the Site**

Overall the survey area is considered to offer **low potential** for supporting great crested newts

Although the pond area will not be directly affected for these proposed works, it should be noted that future rescaling of the Environmental area is planned and therefore a further survey of the area should be conducted for those works, it should also be noted that the Schedule 9 plant species under the Wildlife and Countryside Act 1981 (parrot's feather) present in the pond will need to be removed and disposed of responsibly at such time.
