Our ref: J15109/DB/c01a

**RE: LAND NORTH OF STATION ROAD, HAYLING ISLAND**  
**LAND CONAMINATION ASSESSMENT LETTER REPORT FOR THE PROPOSED**  
**RESIDENTIAL REDEVELOPMENT**

**Site** Land North of Station Road, Hayling Island, Hampshire

**Client** BDW Southampton

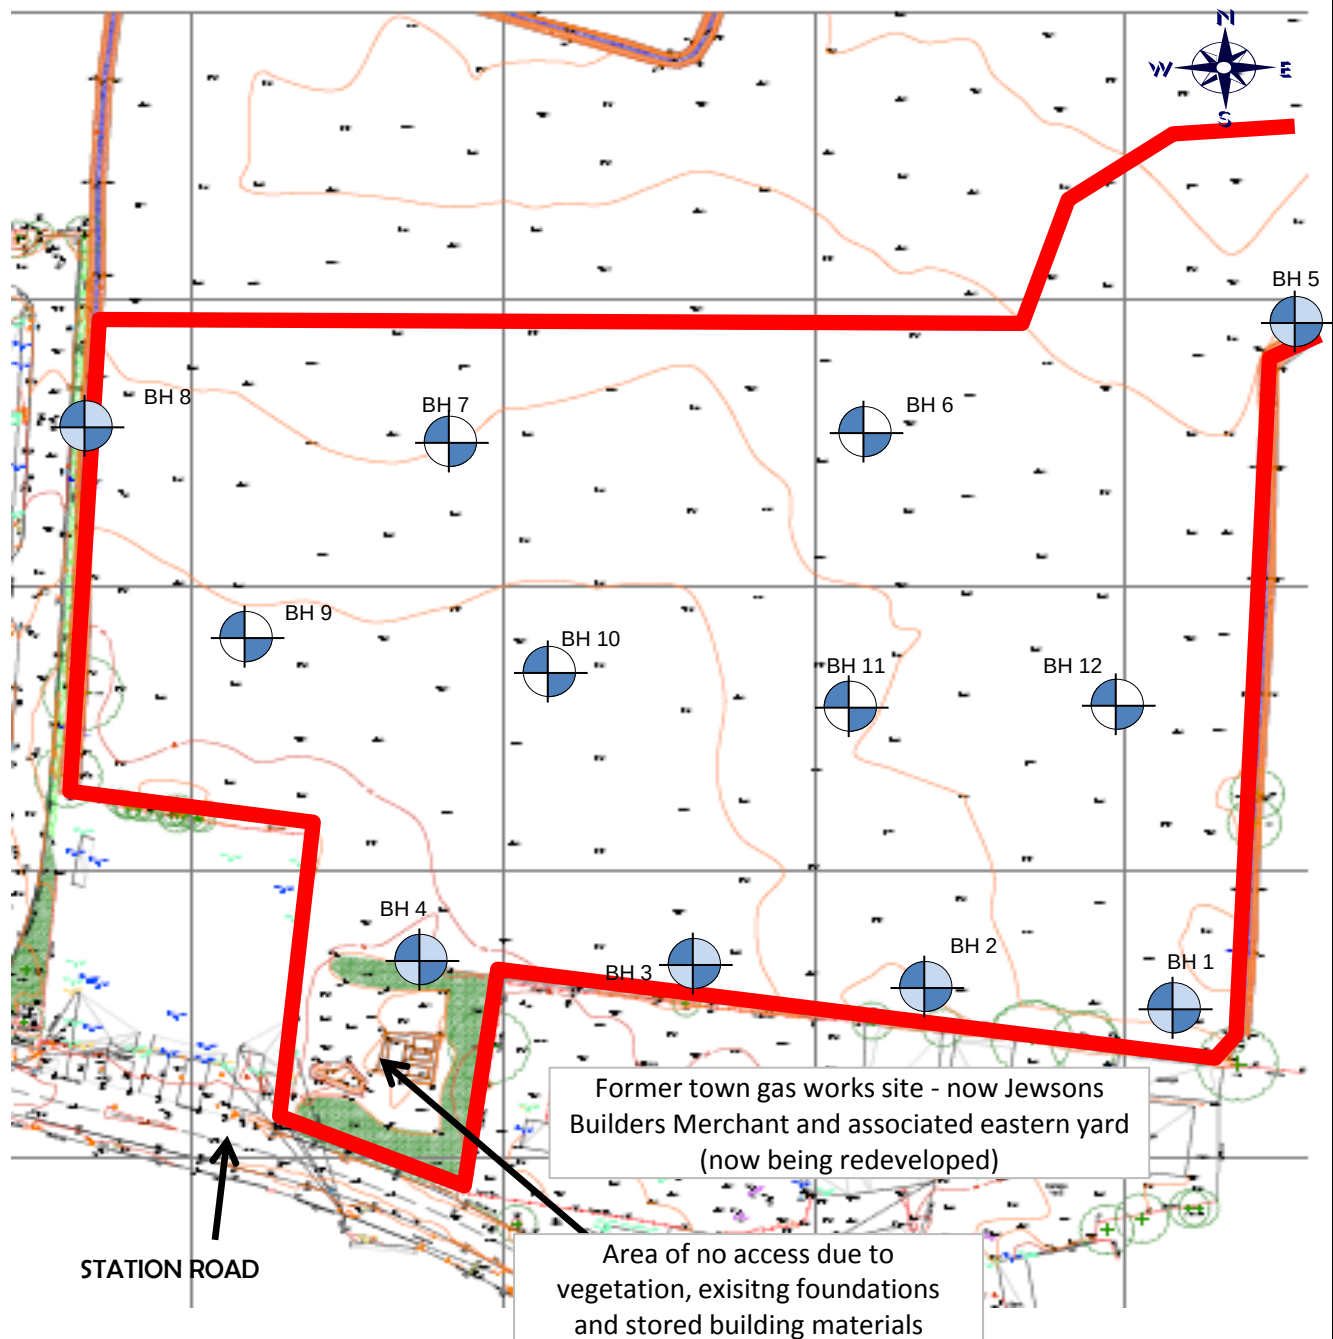
Borehole completed with a monitoring standpipe for soil gas and groundwater

Borehole backfilled with a cementitious grout within clay soils to match existing ground permeabilities

Approximate Scale in metres

The ground investigation has comprised a series of 12 small diameter boreholes drilled across the site to depths of up to 5.00 m below ground level.

The location of the boreholes has been selected to provide an acceptable pre-purchase coverage of the site together with a more detailed focus upon the ground conditions along the southern site boundary, including the installation of four combined soil gas and groundwater monitoring standpipes along this southern site boundary.

Combined soil gas and groundwater monitoring standpipes have been installed in a further two boreholes located remote from the southern site boundary to act as a control and facilitate an assessment of the groundwater flow regime across the site.
