**Extended Phase 1 Habitat Survey**

**Havant Distribution Centre, Stanbridge Road,  
Havant**

**For BCP (Havant) LLP**

**Delta-Simons Project No. 13-0646.02**

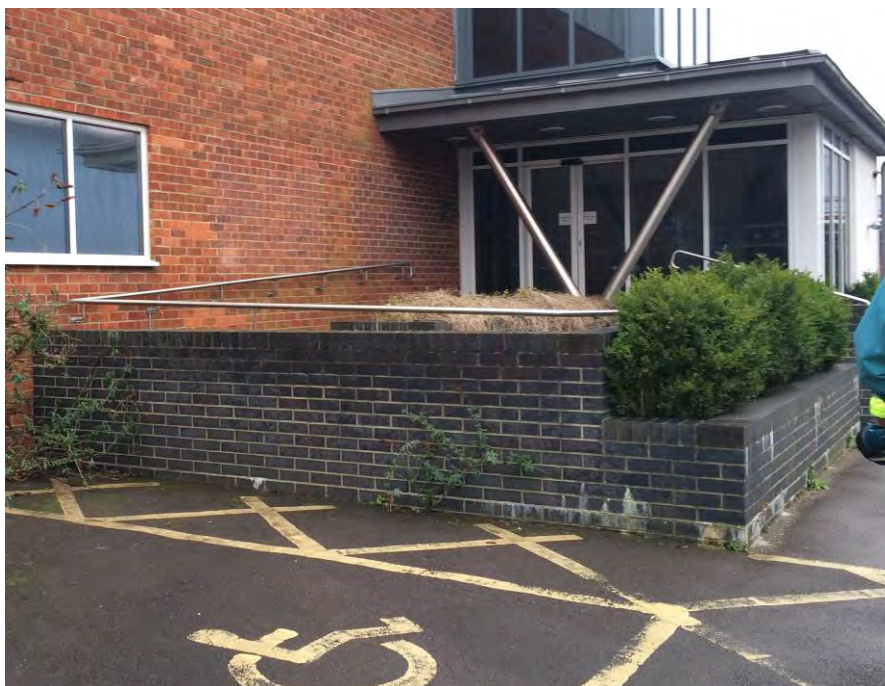
Photograph 1 – Introduced Shrubs

There were small areas of introduced shrub on-Site (Photograph 1). One area was situated within the car park to the north-east and the other was situated at the warehouse entrance to the south-west of the Site. The planting included lavender *Lavandula* sp. and honeysuckle *Lonicera* sp. These areas appeared to have been managed up until the Site was vacated.

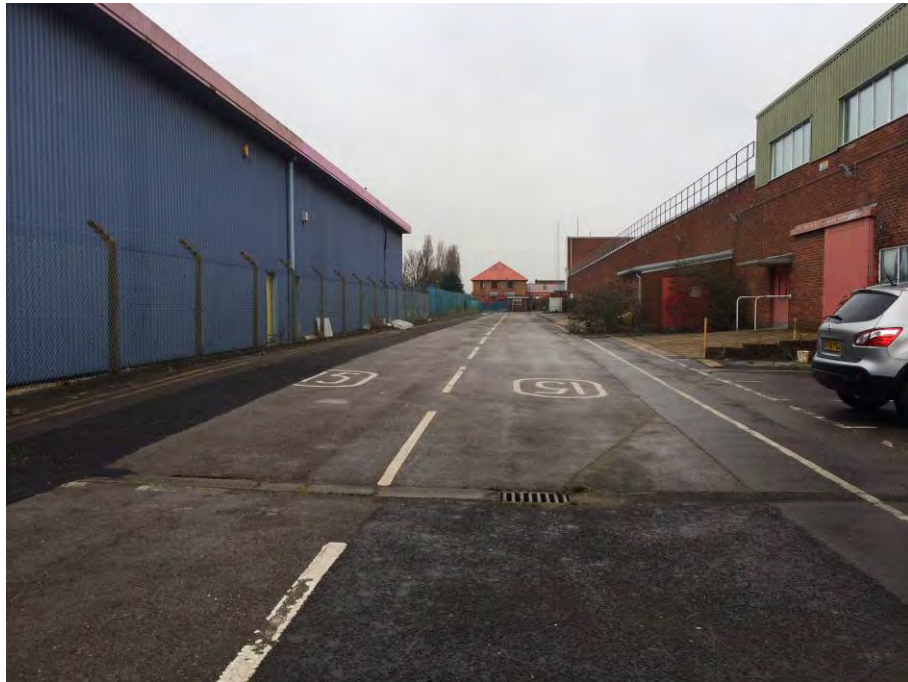
Photograph 3 – Hardstanding

Hardstanding surrounded the buildings on-Site and had previously been used as car parking and vehicular access (Photographs 2 and 3). Most of the hardstanding remained bare, however, the cracks surrounding the buildings and the Site boundary had been colonised by buddleia *Buddleja davidii*. There was increased colonisation down the western aspect of the building where the vegetation from the adjacent railway embankment was encroaching onto Site. This included common nettle *Urtica dioica*, broad-leaved dock *Rumex obtusifolius*, ribwort plantain *Plantago lanceolata*, bramble *Rubus fruticosus* agg scrub and ivy *Hedera helix*.

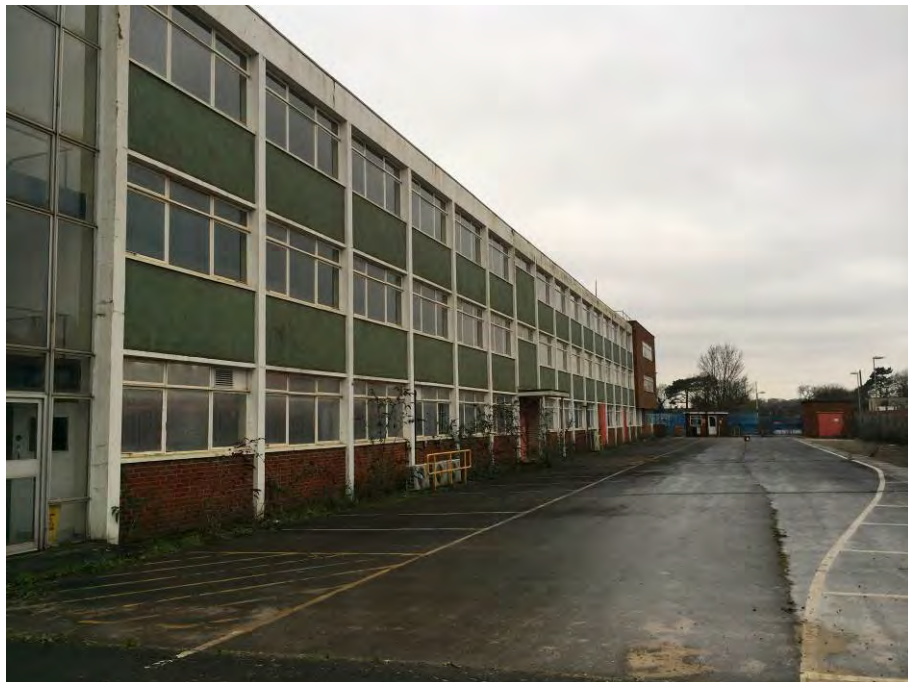
Photograph 4 – North-eastern section of Building 1

The north-eastern section appeared to be the oldest section of the building, however, both the exterior and interior appeared to be in good condition with no internal access for bats recorded. In addition, most of the rooms were light due to the large number of windows, therefore, they were considered unsuitable to support roosting bats. There was also a small chiller room situated on the north-eastern corner of this section, Due to its previous function, this was sealed leaving it inaccessible to bats. The main mid-section of this building was in good condition and lacked any cracks or crevices in the brickwork or roof structures. There was a potential single access point on one of the wooden doors (Photograph 12), however, this was cobwebbed. The majority of this warehouse was internally light due to the clear plastic panels in the

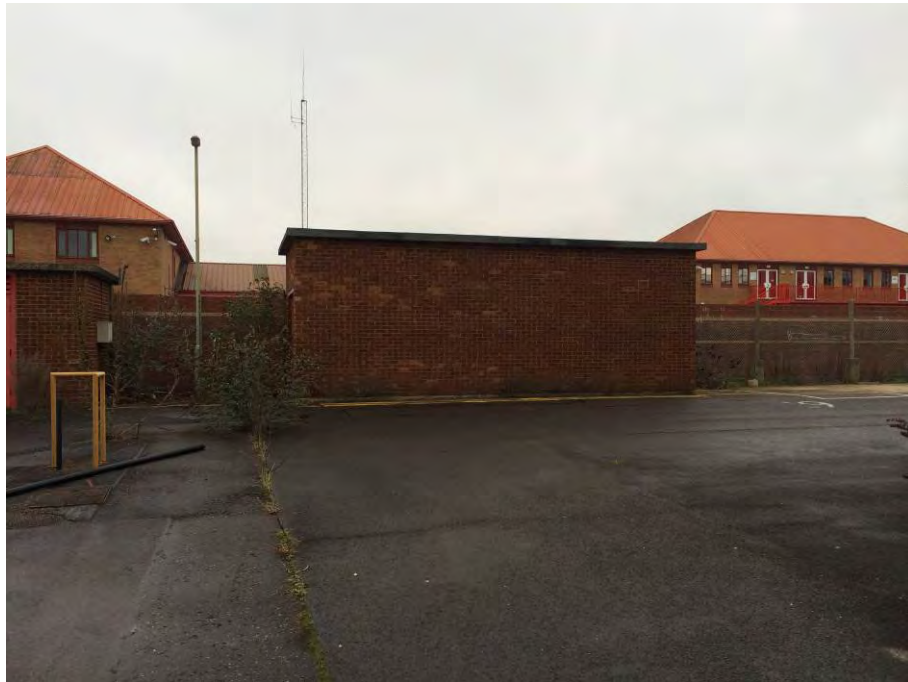
Photograph 9 – Building 2

The roof and brickwork of Building 2 were in good condition. In addition, the wooden door was flush to the surround and provided no access internally. No evidence of bat activity or suitable roosting opportunities was recorded. Building 2 was assessed as having negligible BRP.

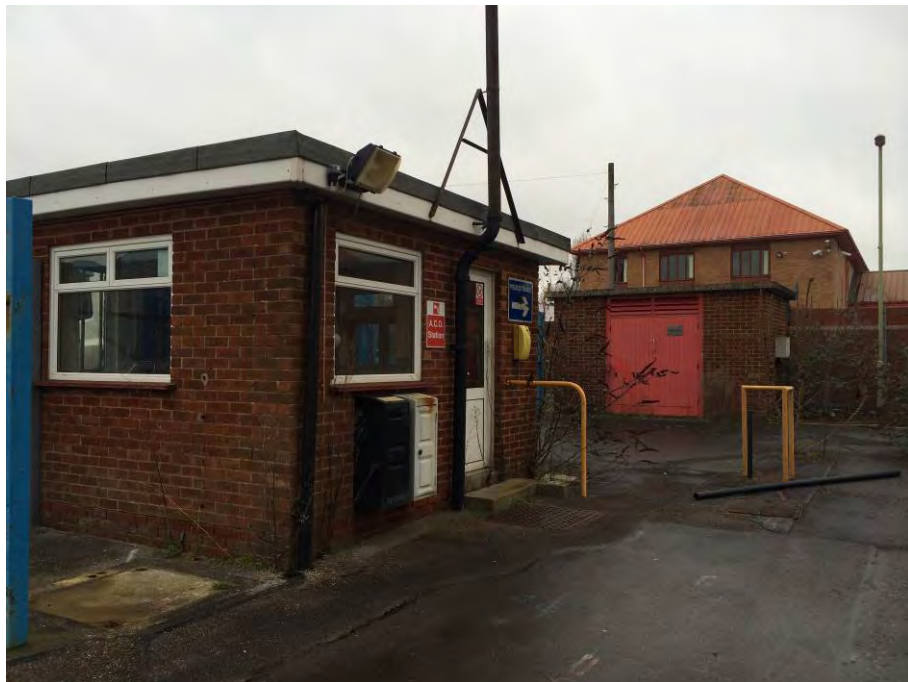
Photograph 10 – Building 3 (right) and Building 4 (left)

The roof and brickwork of Building 3 were in good condition. The wooden door did have vents which could provide access, however, no evidence of bats or bat activity was found, to indicate it had not been used by bats. Furthermore, no features were present that could provide potential roosting opportunities for bats. It was assessed as having negligible BRP.

The roof, brickwork, doors and windows of Building 4 were all in good condition and provided no access to bats. No features were present that could provide potential roosting opportunities for bats and no evidence of bat activity was recorded. It was assessed as having negligible BRP.

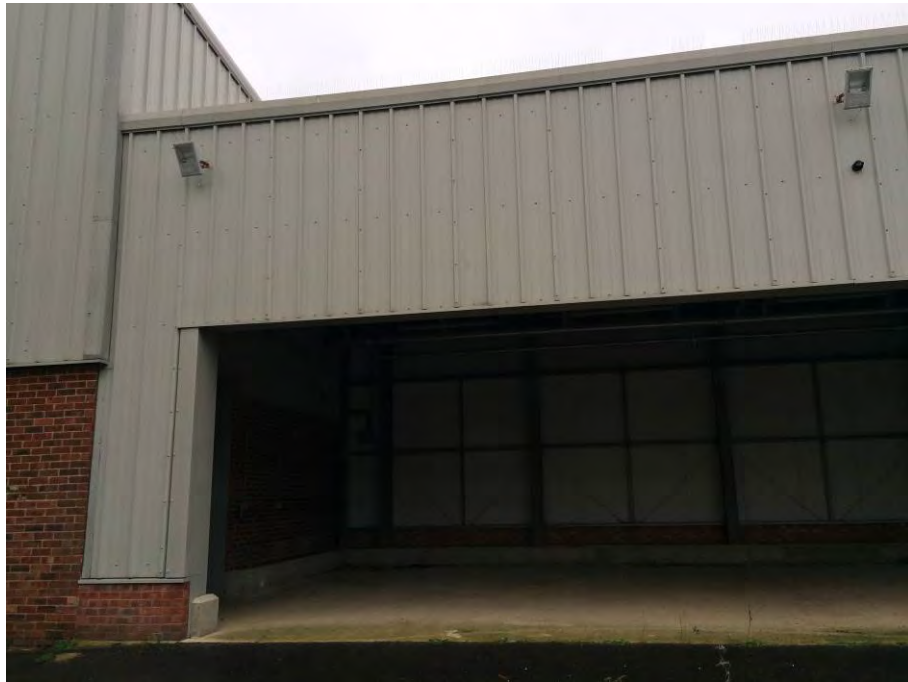
Photograph 11 – Building 5

Building 5 appeared to be in good condition externally. There was no access for bats on the enclosed northern section. The southern section was open on the north-western aspect, however, there was no suitable features for bats to roost and no enclosed spaces. In addition, netting had been placed below the roof to prevent nesting birds, which could deter bats, if present locally. No features were present that could provide potential roosting opportunities for bats and no evidence of bat activity was recorded. Building 5 was assessed as having negligible BRP.

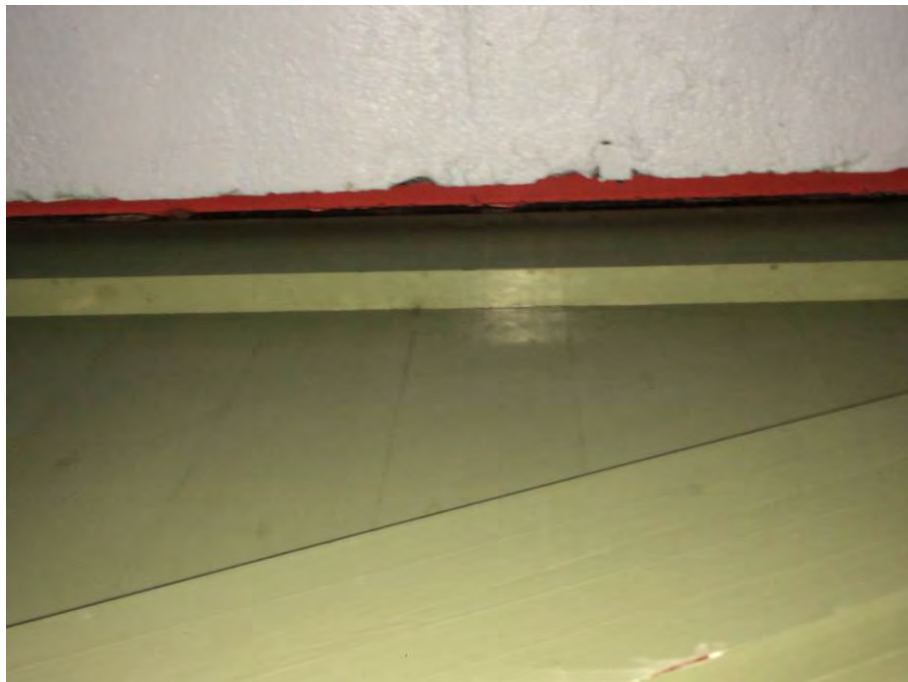
Photograph 12 – Small access point

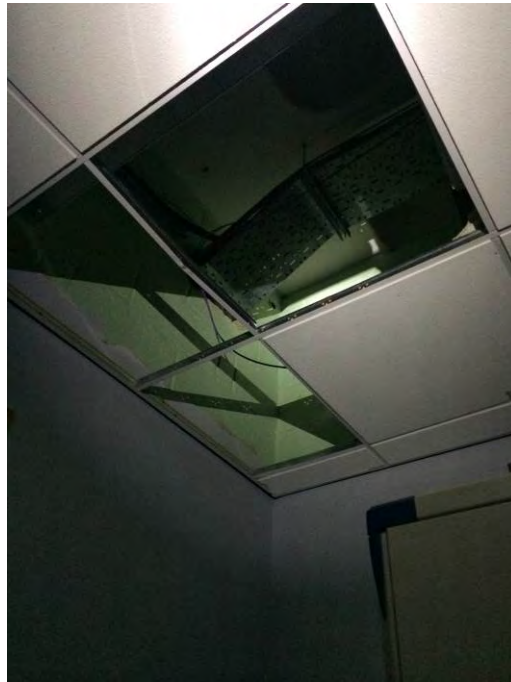
The south-eastern section was in good condition and provided limited access for bats. Within the offices numerous ceiling tiles had been removed (Photograph 13), however, no access points on the exterior were recorded which prevented possible access for bats. In addition, the insulation seen above the suspended ceiling appeared to comprise complete sheets and would also prevent access. Some of the office rooms did have open windows, however, it was light and draughty inside leaving it unsuitable for bats. The lower storey, which featured a continuation of the racking area, had multiple roller doors (Photograph 14), most of these were tight to the walls and floor with the mechanism enclosed. One of the doors on the southern aspect had a gap between the floor and door and at the lower side edge, however, it was cobwebbed, indicating it had not been utilised in recent months. Building 1 was clean inside, both within the offices and warehouse with an even floor surface, therefore, any bat droppings, if present, would have easily identified. No evidence of bat activity or suitable roosting site were recorded. Building 1 was assessed as having negligible BRP.

Photograph 13 – Missing ceiling tiles
