# **Report on Ground Investigation**

(Area A – Proposed Domestic Houses)

**58-64 STATION ROAD  
HAYLING ISLAND, HAMPSHIRE  
PO11 0EL**

**Report Ref: 517 / R03**

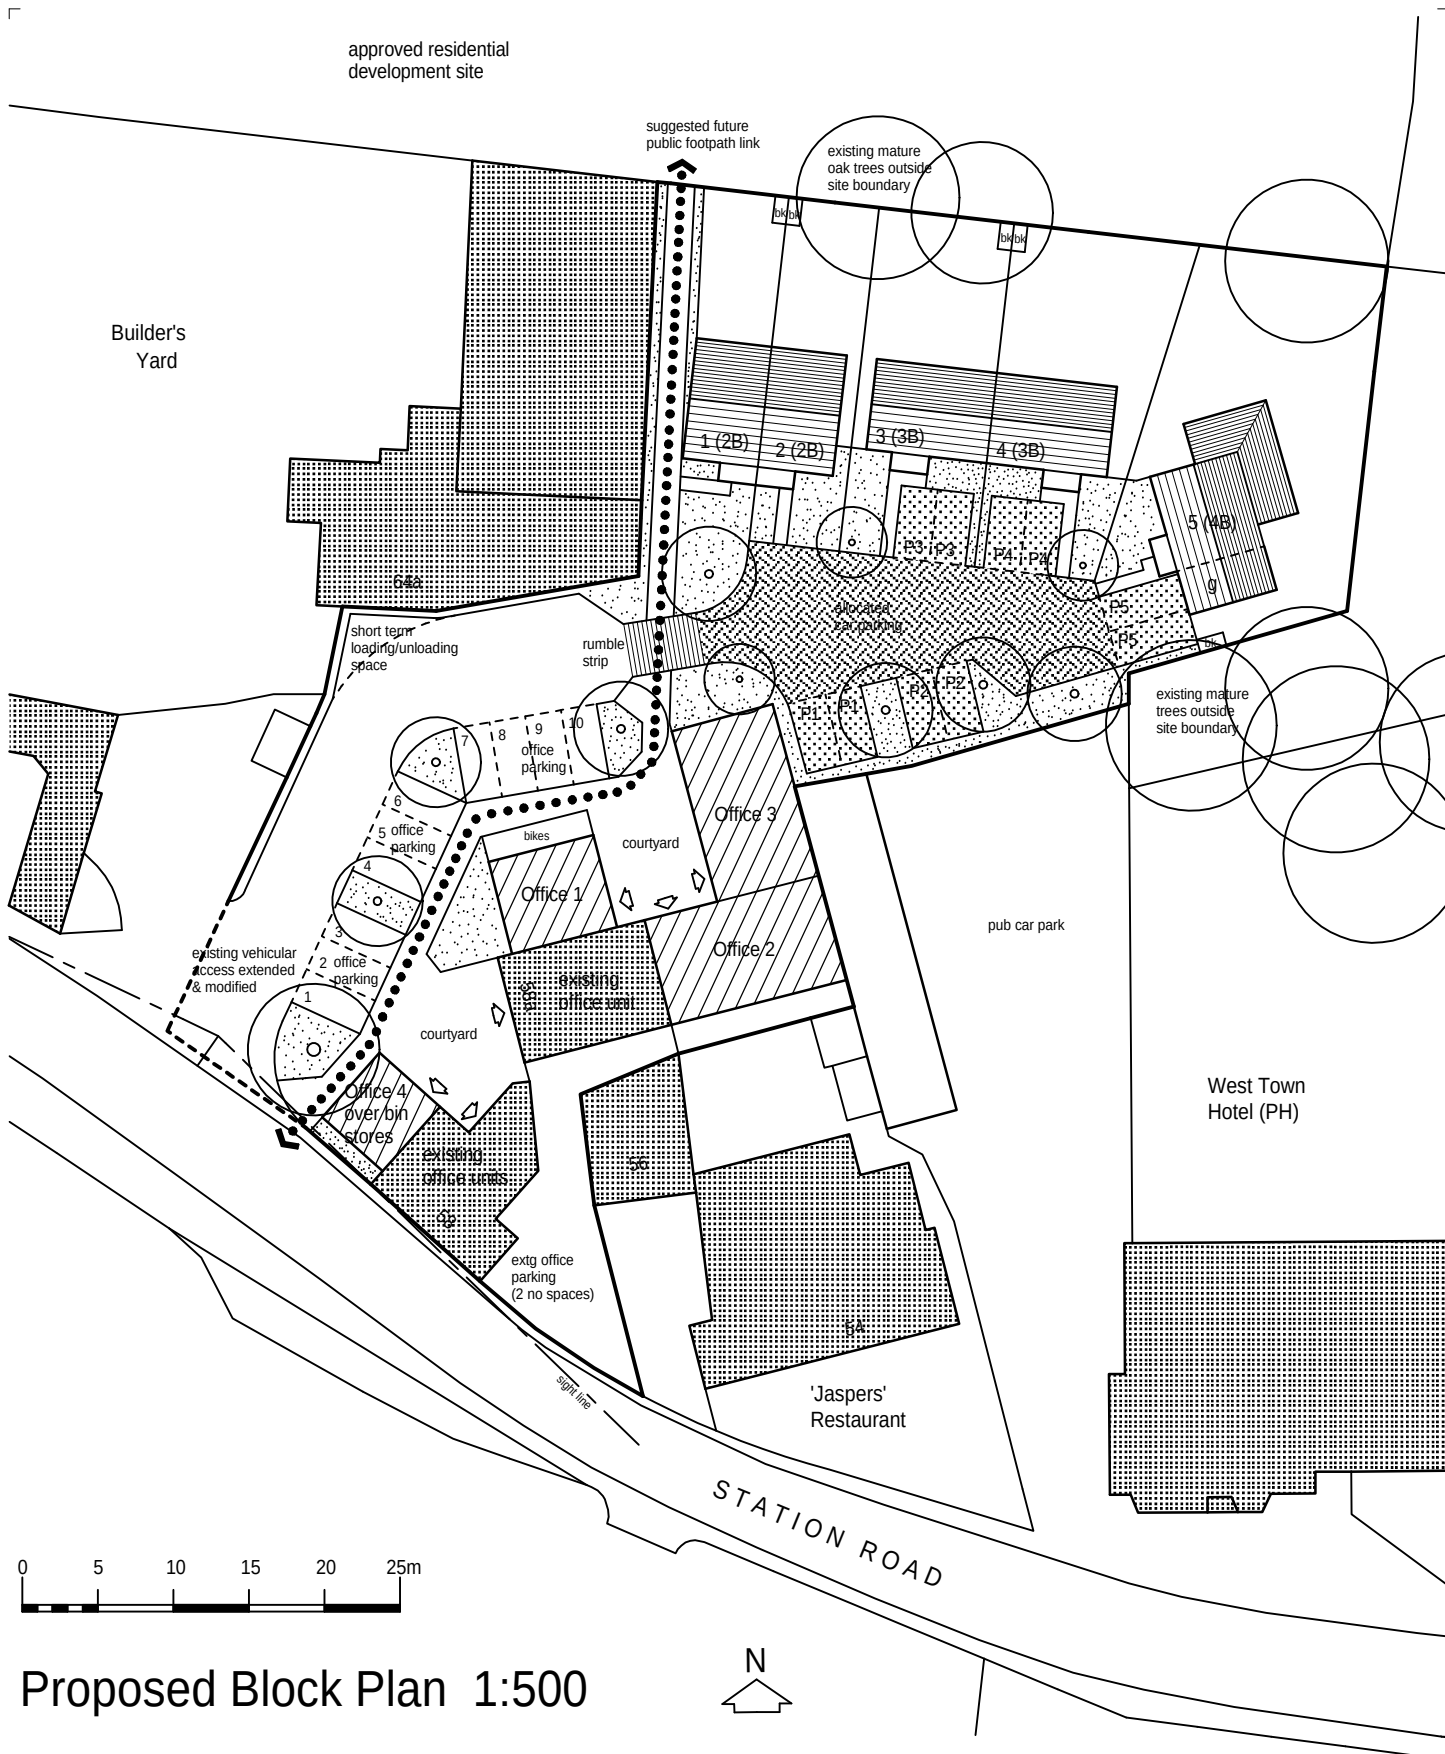
# Proposed Block Plan 1:500

**Appendix A** shows the currently proposed layout. The site is to be redeveloped as five domestic houses with areas of private gardens. The houses are towards the north & east of the site with driveways and allocated parking at the south.

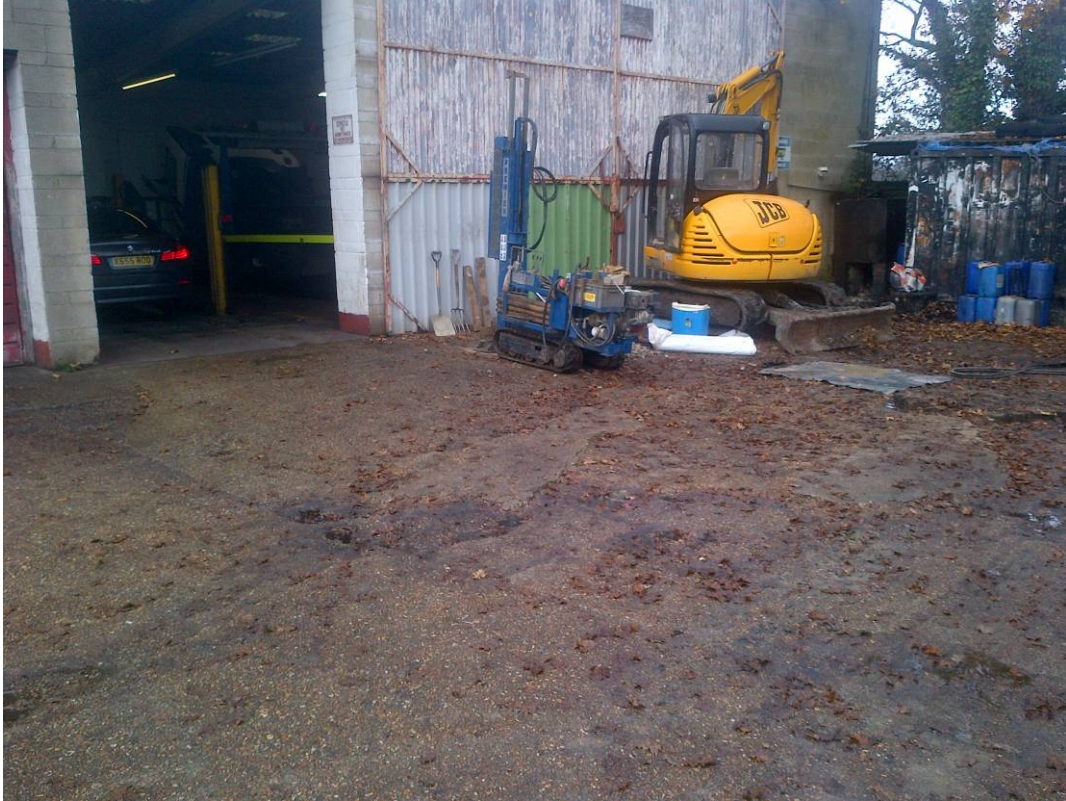
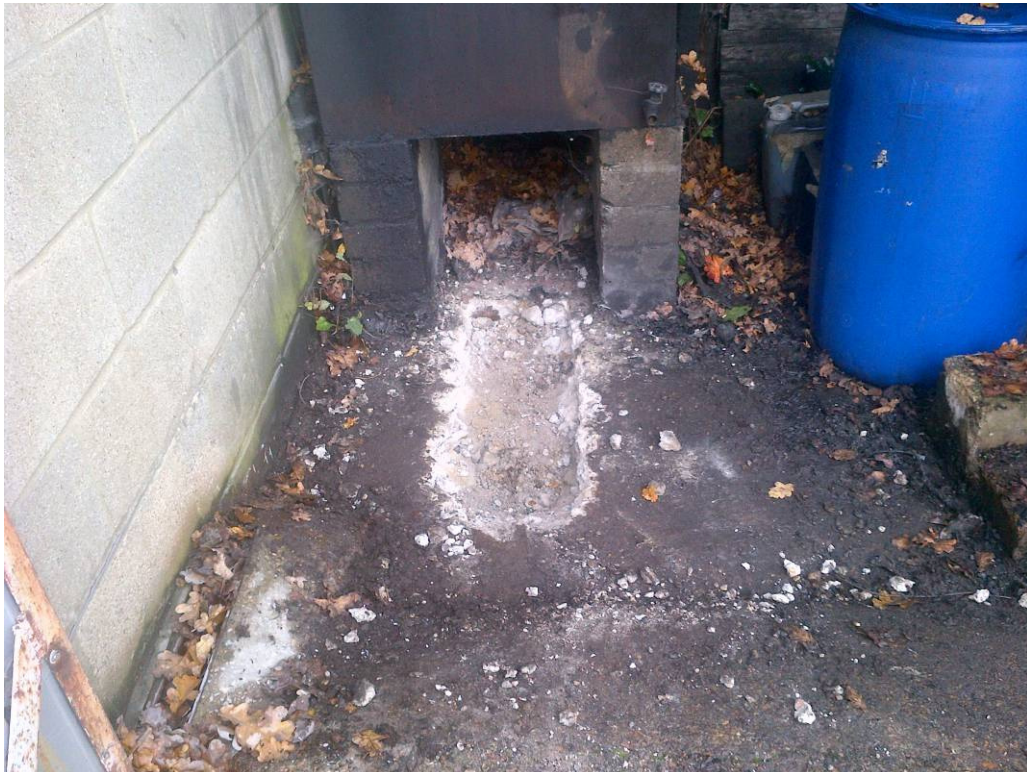
### PHOTOGRAPHS

| Depth (m) | | Strata Description | Sampling |
|---|---|---|---|
| GL – 0.25 | 0.0m | Concrete in good order, slight stain at surface, visually clean immediately below surface | 0.30 D, J |

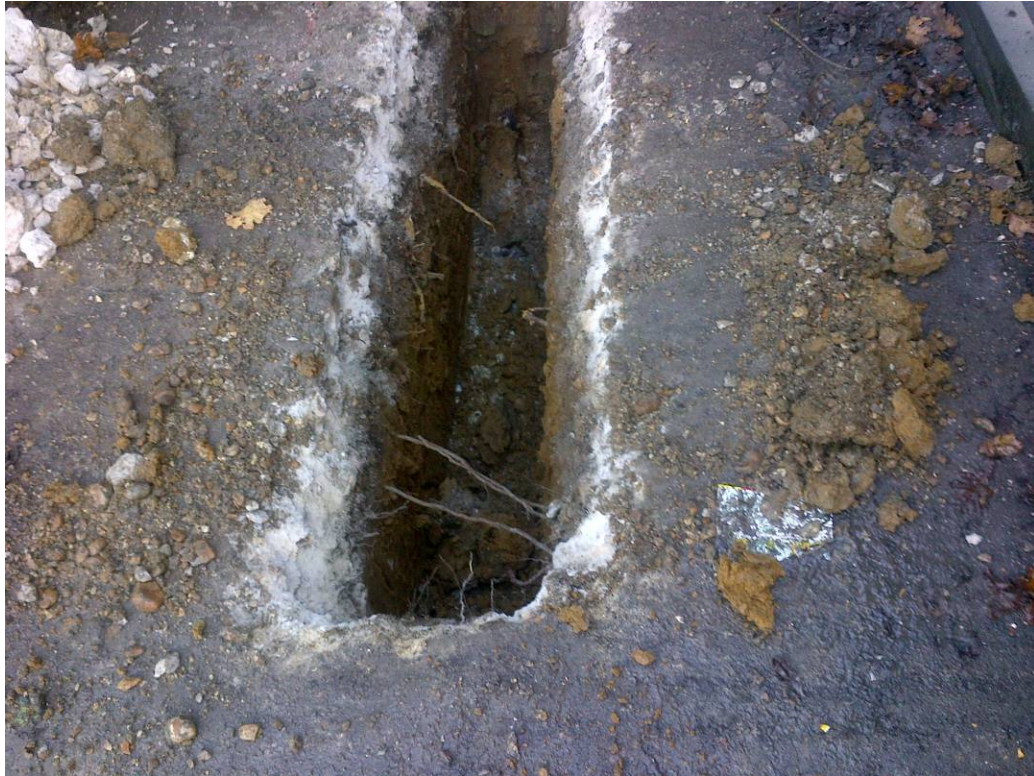
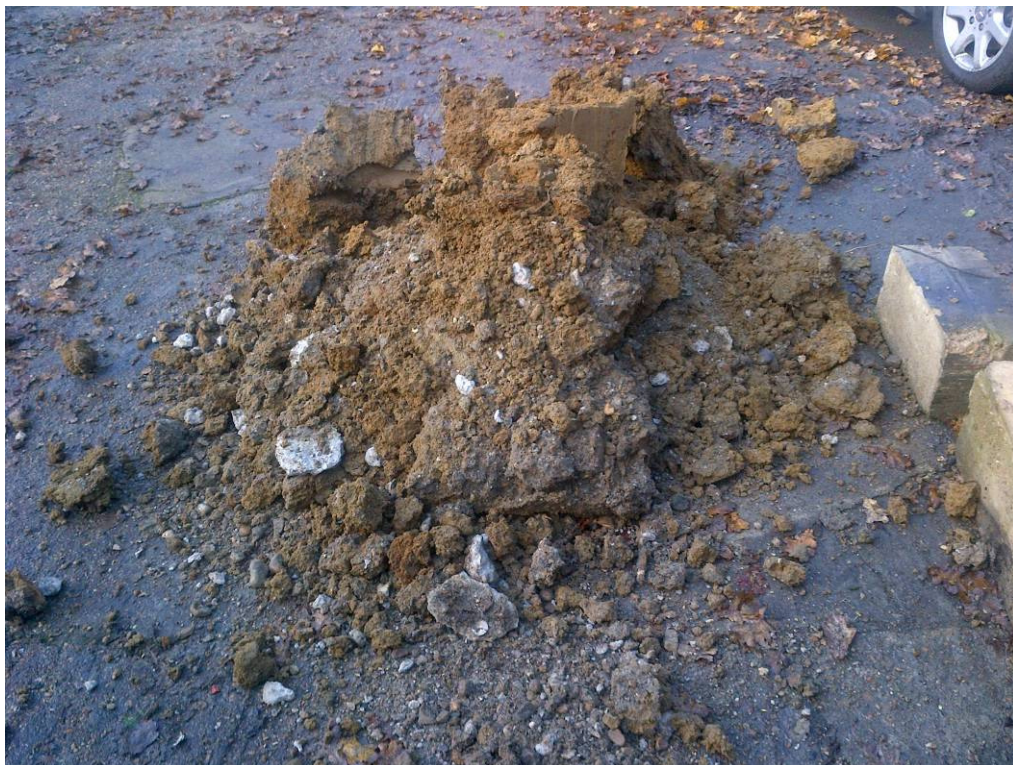
### PHOTOGRAPHS

| Depth (m) | | Strata Description | Sampling |
|---|---|---|---|
| GL – 0.15 | 0.0m | Concrete in good order, slight stain at surface, visually clean immediately below surface | 0.15 J |

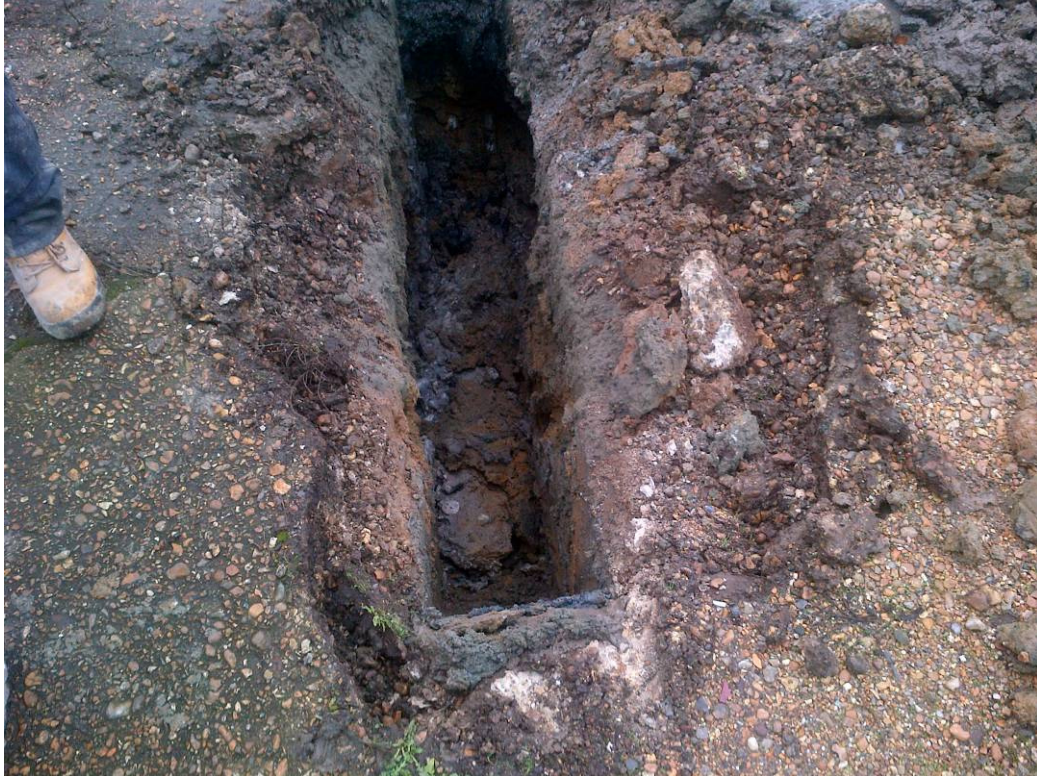
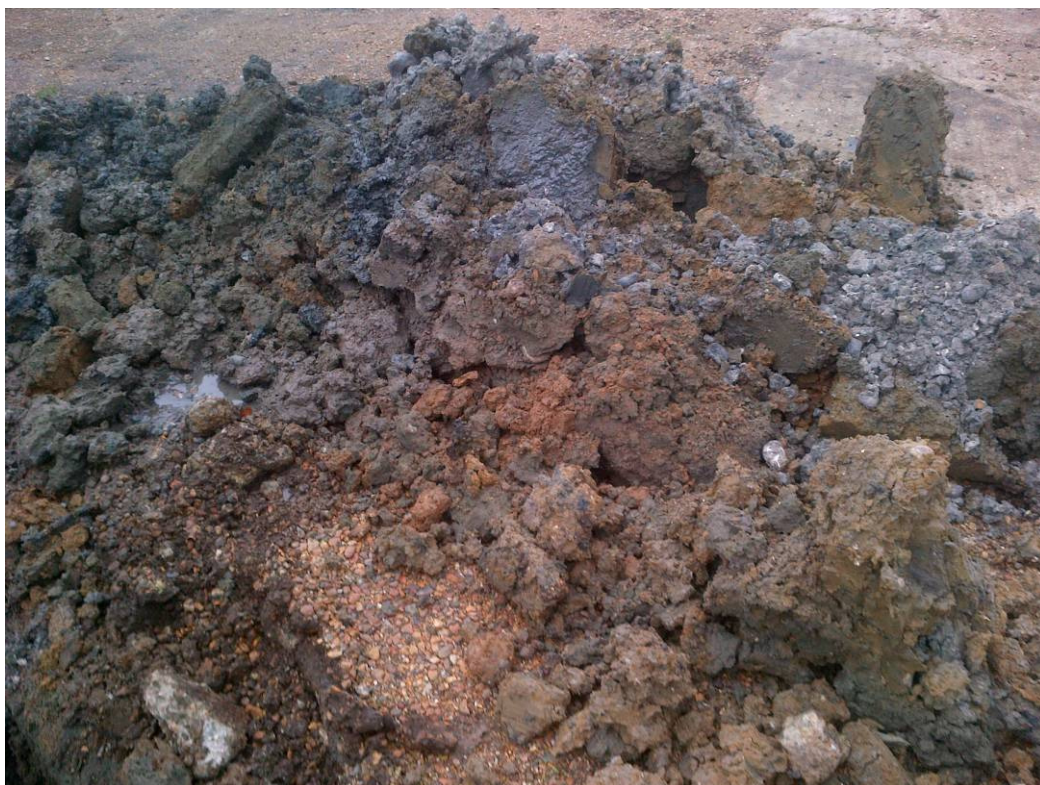
### PHOTOGRAPHS

| Depth (m) | | Strata Description | Sampling |
|---|---|---|---|
| GL – 0.15 | 0.0m | Broken concrete | 0.30 D, J |
