## **Bat Scoping Survey**

**No 29 Record Road,  
Emsworth**

**12<sup>th</sup> August 2015**

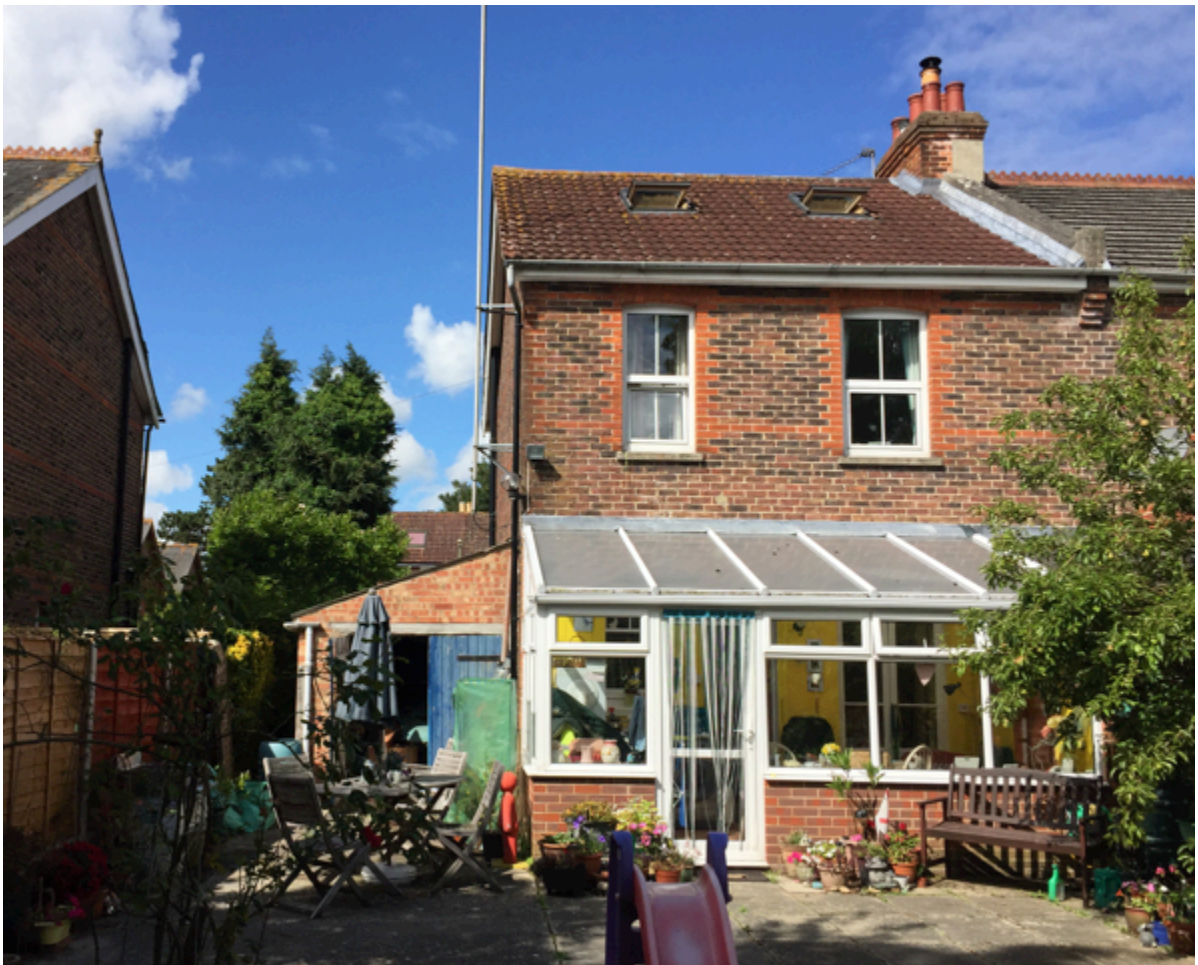
The property is a semi-detached building, that is probably not more than 40 years old. It is a brick building with 'clay effect' concrete interlocking tiles, which are tight-fitting and have no evident gaps that might provide access for bats to the space between the tiles and bitumen lining underneath. The garage that will be demolished is a simple brick structure, with a corrugated chrysotile roof on it.

**Figure 2.** The location of the proposed extension at the side of the property in place of an existing small brick garage.

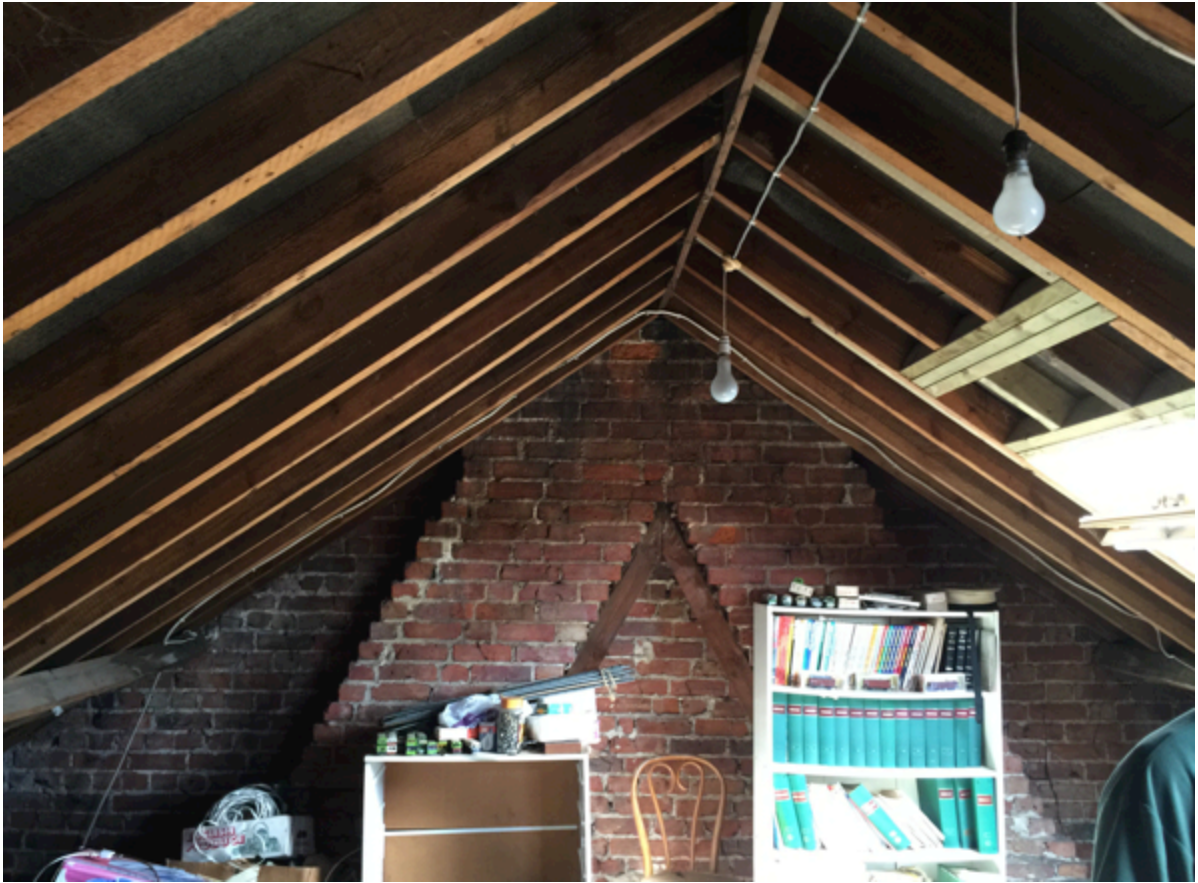
The property has a sealed roof void that is approximately 3 metres high internally from floor to apex and is used for storage. The void is lit via two skylights (see Figure 2) and this illumination makes the void much less suitable for roosting bats. No evidence of past or present use by bats was identified within this void.

**Figure 3.** The well lit roof void of this property.

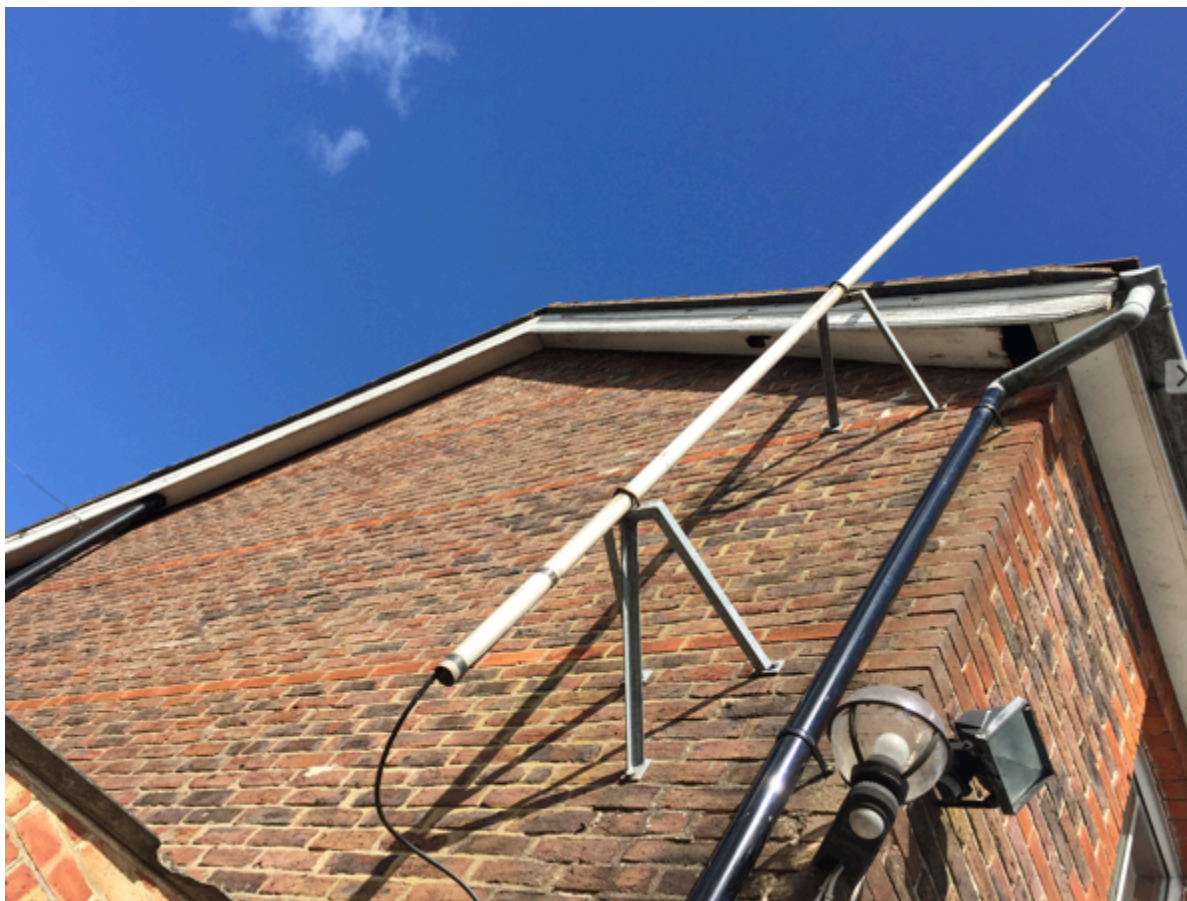
Externally, the only potential feature that might be used by bats was a rotten soffit board at the gable end of the roof (see figure 4 below). This gap offers some potential access for roosting bats, although no bat droppings could be found underneath this gap upon the roof of the garage.

**Figure 4.** The section of rotten soffit boarding at the gable end of the roof, offering some potential for access by roosting bats.

This assessment has identified a single feature that might be used by roosting bats upon the external soffit boards at the gable end of this property. These two gaps under the boards offer some limited potential for bats to roost inside the soffit board – it does not appear that bats could access the roof from this location and the roof void is clearly not being used by bats.

As this soffit board will be removed prior to construction, it is therefore recommended that as a precautionary measure this feature is assessed and removed by hand under the supervision of a licensed bat handler. In the highly unlikely event that a bat or evidence of use by bats is identified, then work will cease and Natural England would be contacted for advice.
