**SUPPLEMENTARY GROUND INVESTIGATION REPORT**  
for the land at  
**HAVANT RETAIL PARK, PORTSDOWN HILL ROAD,**  
**BEDHAMPTON, HAMPSHIRE PO9 3NA**  
on behalf of  
**LINDEN HOMES SOUTHERN LIMITED**

**Havant Retail Park**  
**Linden Homes Southern Limited**

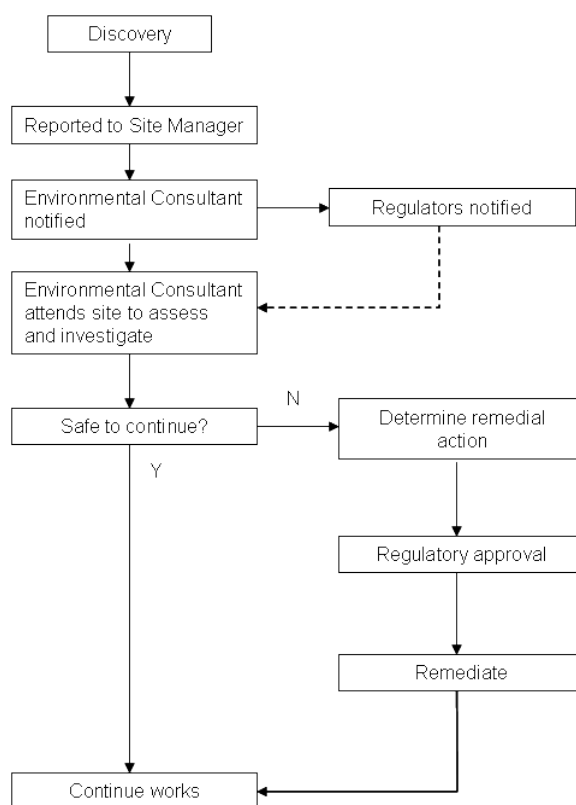
#### Discovery Strategy Process

The process is shown below.

A copy of the discovery strategy should be lodged on site and provisions made to ensure that all workers are made aware of their responsibility to observe, report and act on any potentially suspicious or contaminated materials they may encounter.

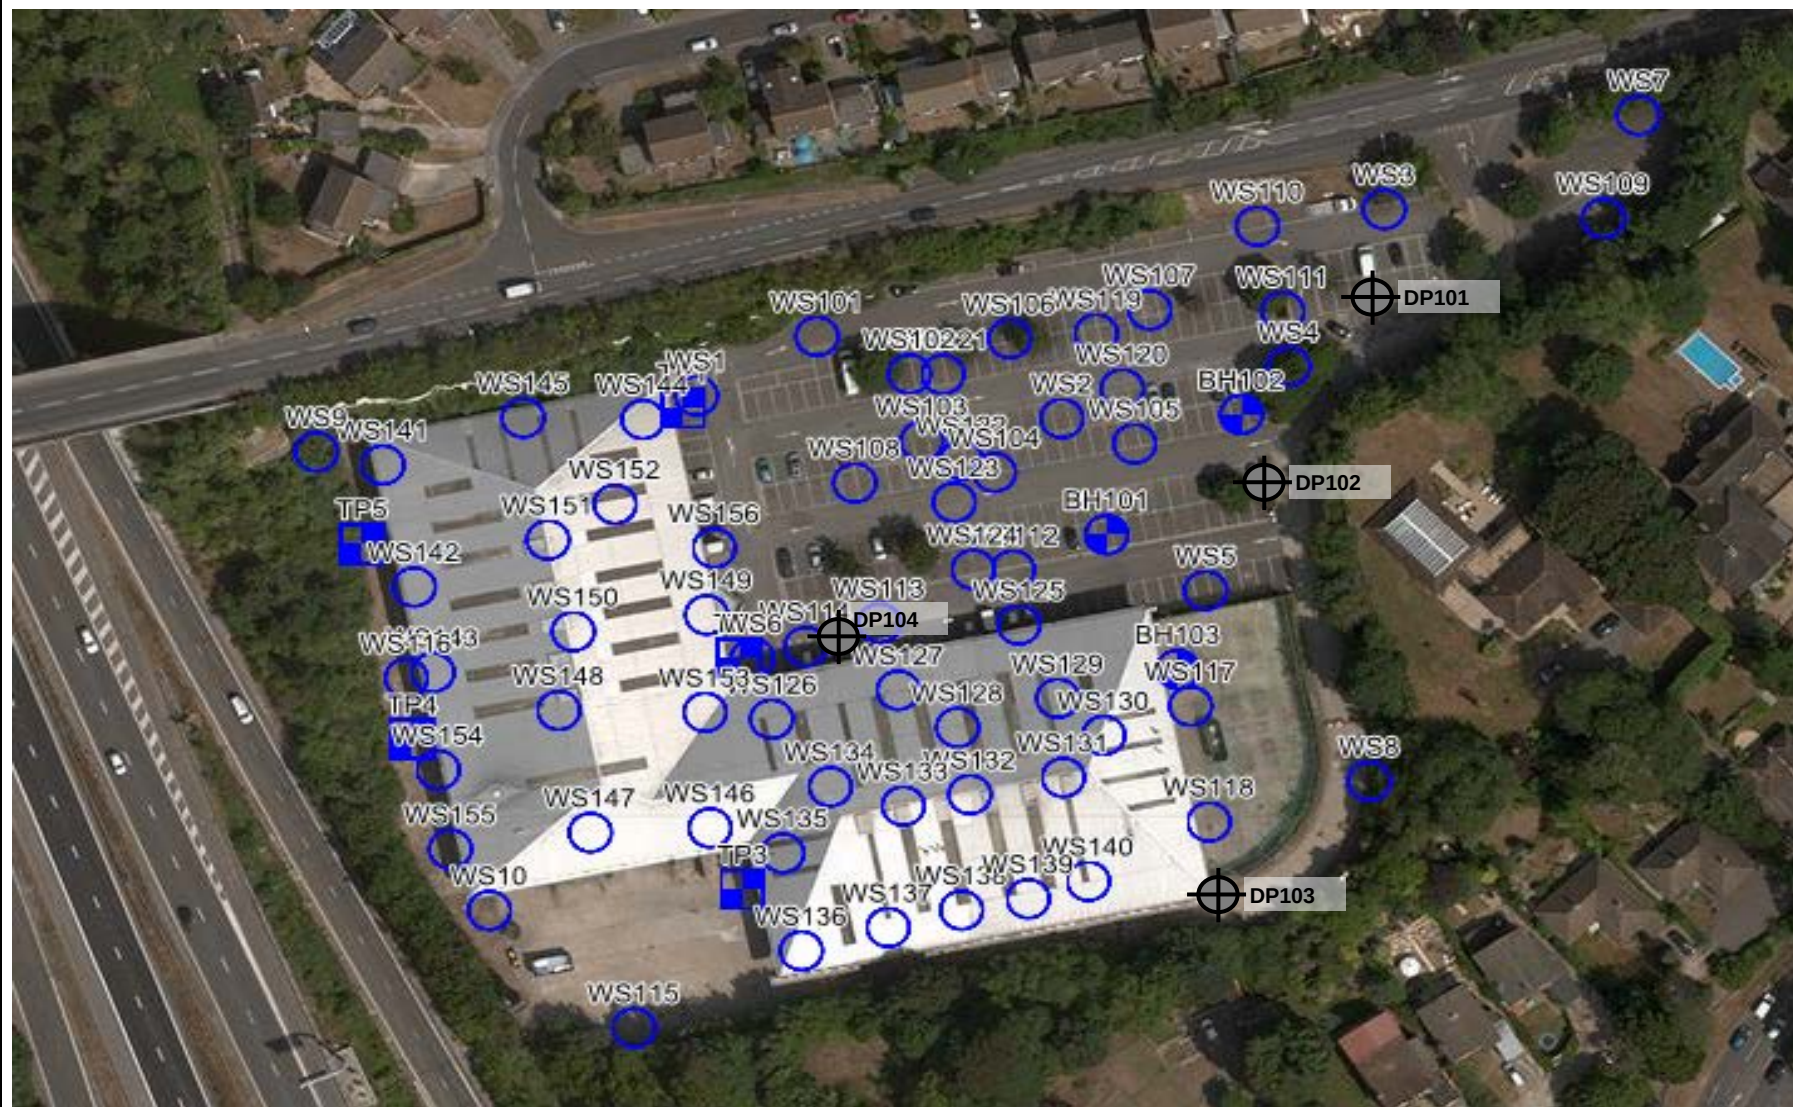
| <b>Project:</b> | Havant Retail Park, Portsdown Hill Road PO9 3NA | | | <b>Title</b> | Exploratory Hole Location Plan (current site layout) | | |

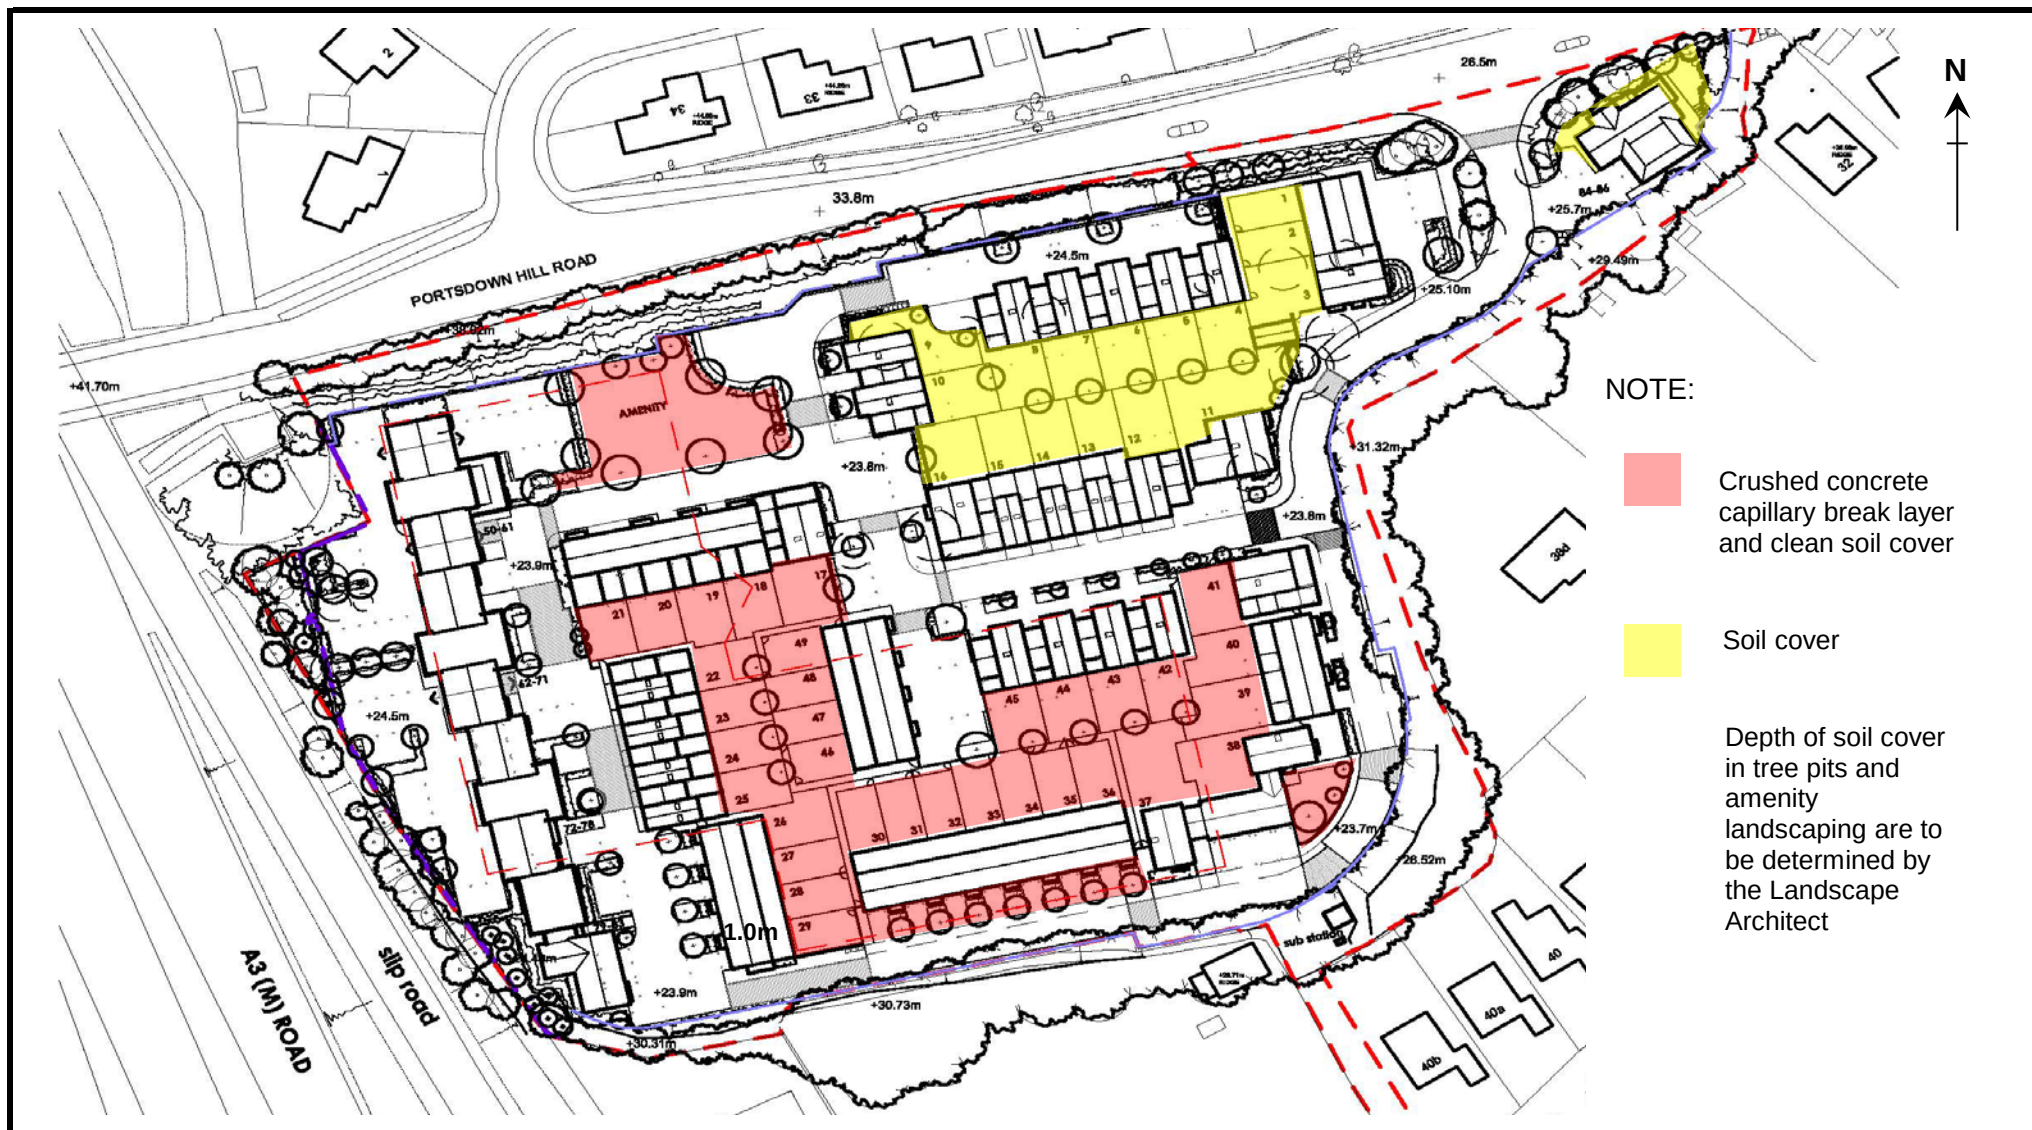
Figure 12 shows the gardens and soft landscaping where the above measures should be applied.

- Removal of hardstanding for off-site disposal or crushing (concrete) to reveal the top of the Made Ground;
- Lay a basal geotextile separator to prevent cover system mixing with Made Ground;
- Place 0.15m thick layer of crushed concrete to act as a capillary break layer and physical dig barrier;
- Lay a second geotextile separator over the crushed concrete to prevent infiltration by subsoil;
- Place subsoil (certified uncontaminated subsoil only) to a minimum thickness of 0.15m;
- Finish to ground level with certified uncontaminated (chemically and physically) Topsoil with a minimum thickness of 0.15m.

In the event that Chalk is encountered directly beneath the current hardcover, then placement of a clean soil cover solution (as described for Plots 1-16 and 84-86) would be considered appropriate.

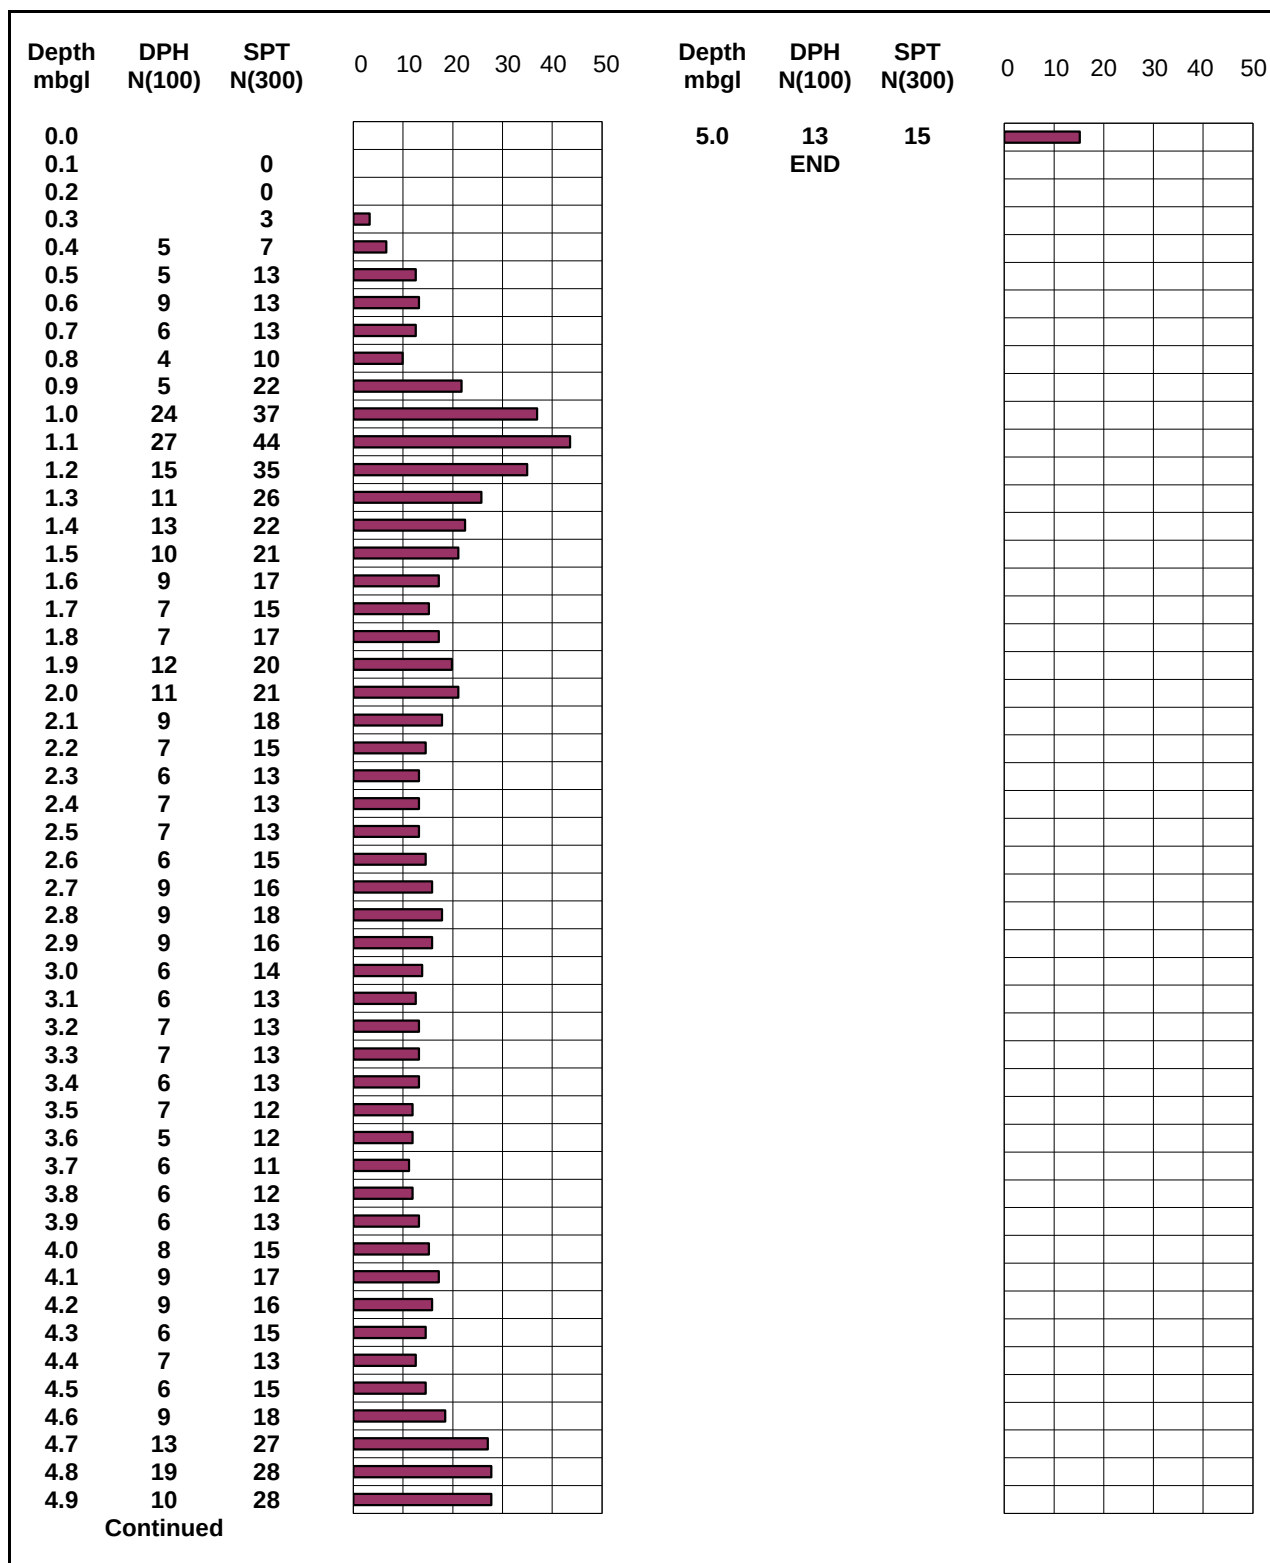
| <b>Project:</b> | Havant Retail Park | | | <b>Title:</b> | DP101 |

Note: DPH 'N(100)' converted to SPT 'N(300)' by using factor of 0.66. Average taken over 300mm

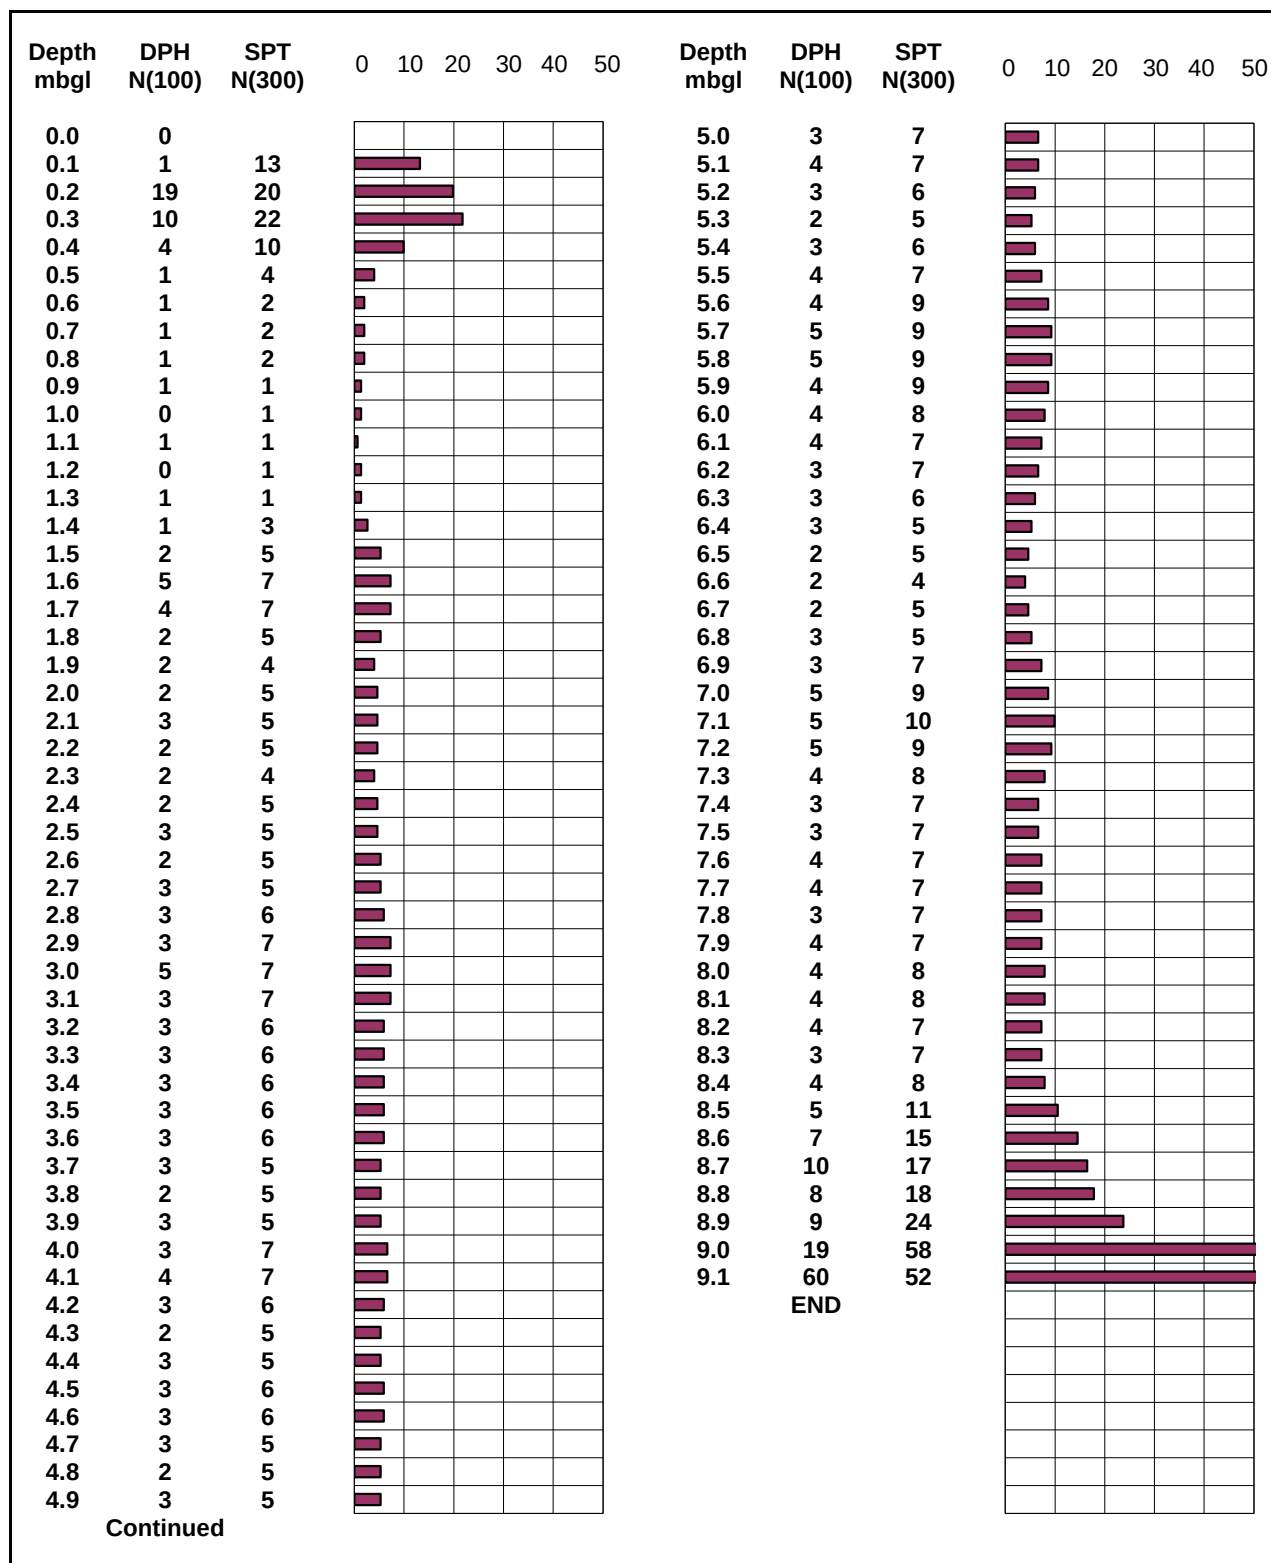
| <b>Project:</b> | Havant Retail Park | | | <b>Title:</b> | DP 102 | |

Note: DPH 'N(100)' converted to SPT 'N(300)' by using factor of 0.66. Average taken over 300mm

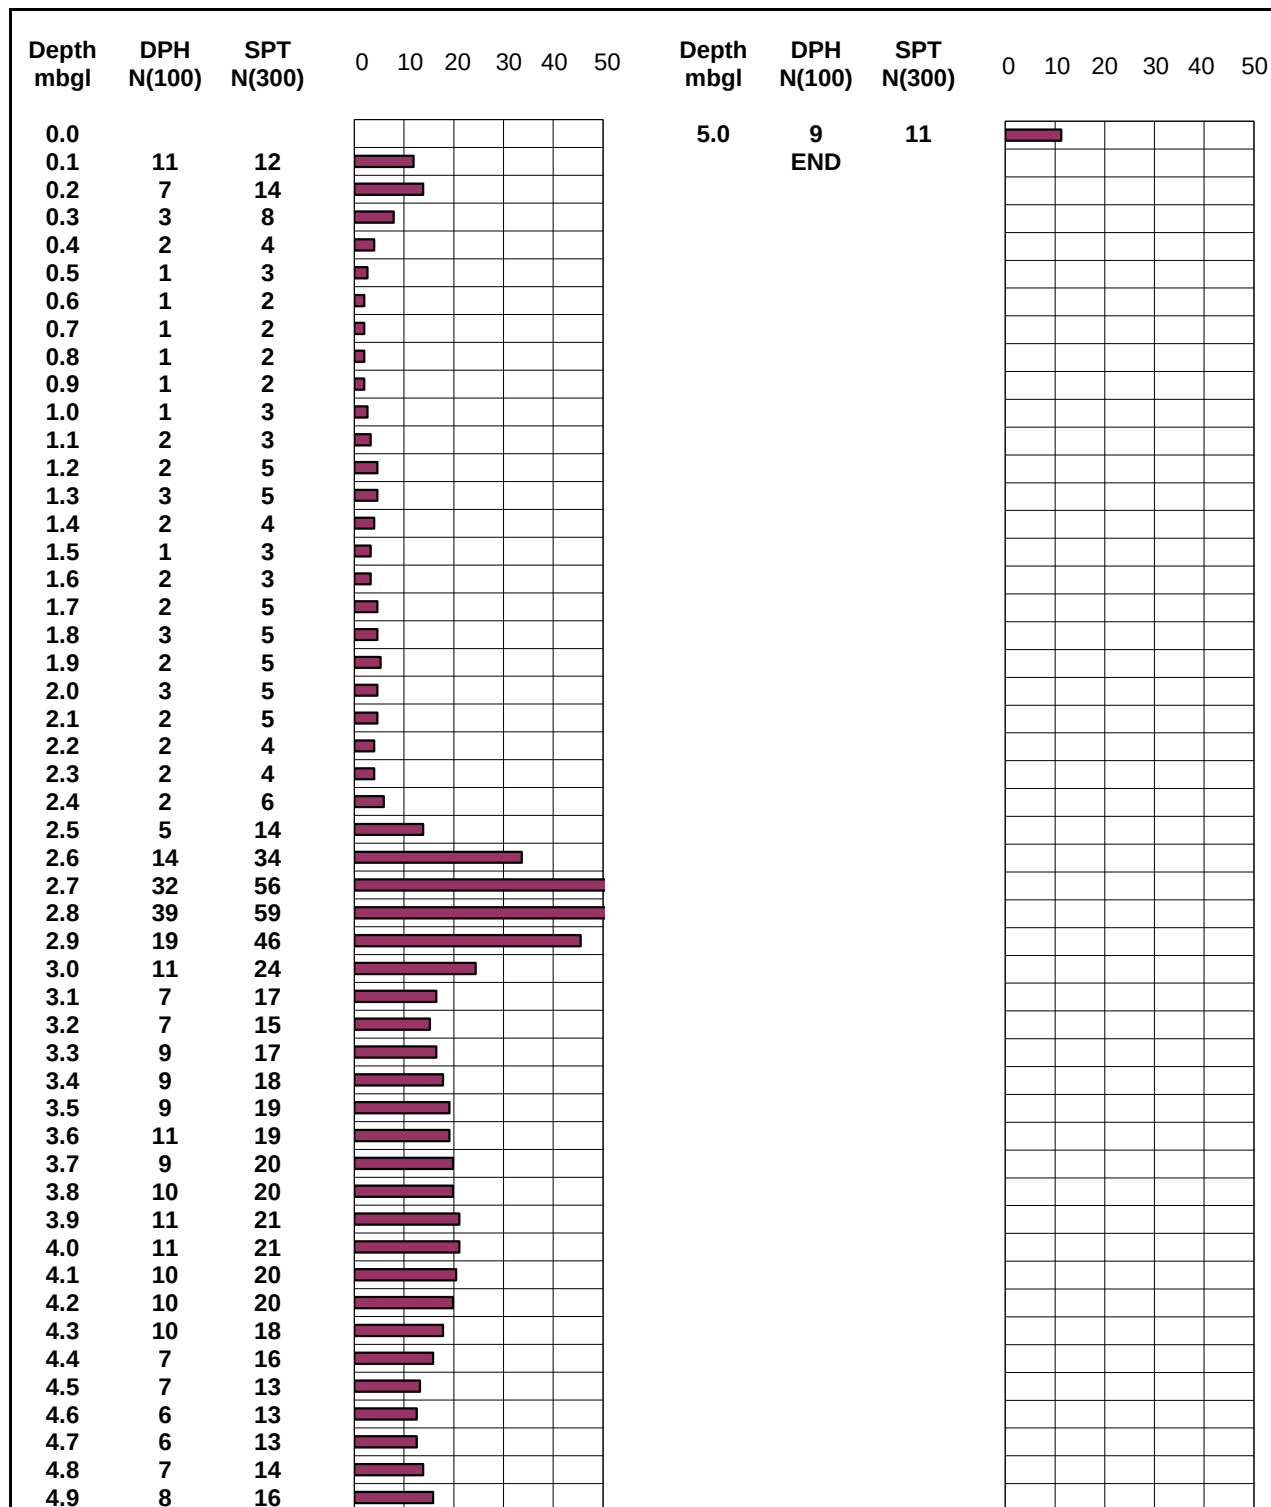
| <b>Project:</b> | Havant Retail Park | | | <b>Title:</b> | DP103 |

Note: DPH 'N(100)' converted to SPT 'N(300)' by using factor of 0.66. Average taken over 300mm

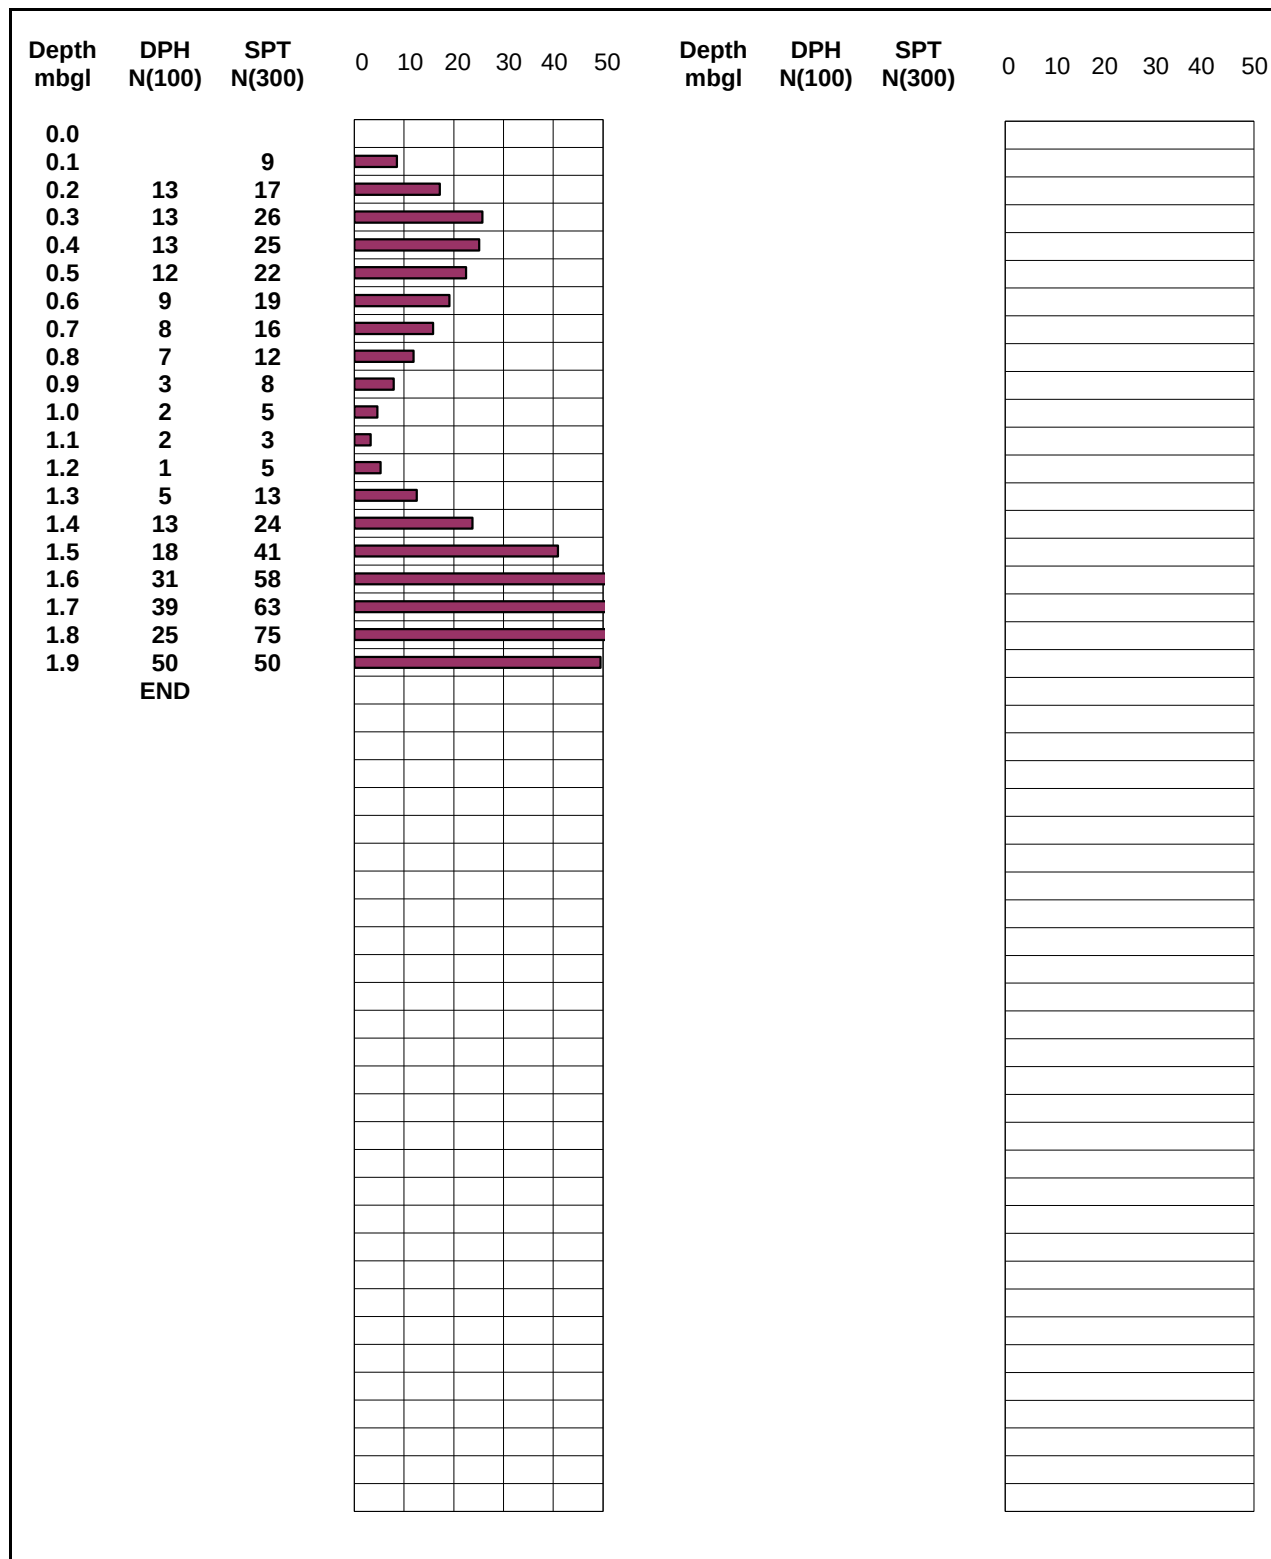
| <b>Project:</b> | Havant Retail Park | | | <b>Title:</b> | DP104 |

Note: DPH 'N(100)' converted to SPT 'N(300)' by using factor of 0.66. Average taken over 300mm
