## **Bat Scoping Survey: 40 Bath Road, Emsworth, Hampshire.**

**Author: Ryan Walker**

**26th April 2014**

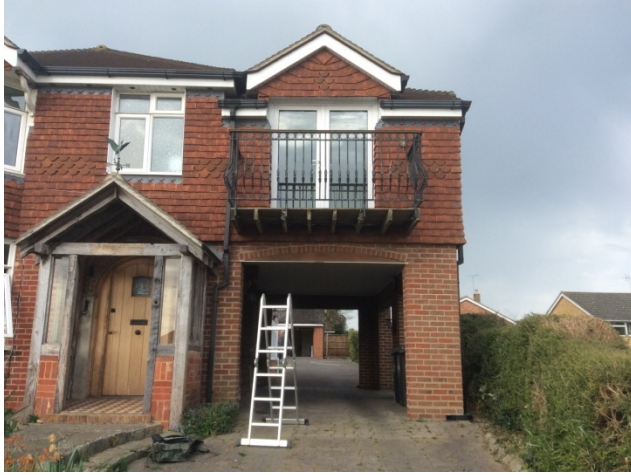
fitting, modern concrete roof tiles and appears to be devoid of gaps suitable for supporting crevice roosting bats (Fig. 2), such as the pipistrelle species, commonly associated with roosting upon the extremities of buildings. The roof void is timber framed and lined with bitumen roofing felt, with an approximate floor space of 10x10m (Fig. 3). There is no evidence to suggest that bats have used the roof void as roosting space within the recent past. The PVC soffits throughout the building are tightly fitted (Fig. 4) and all other similar external aspects of the building within the eastern facing aspect proposed to be affected by the works are in good condition, with no gaps suitable for crevice roosting bats. The upper sections of the building are clad in modern, largely well fitting hanging tiles (Fig. 2, 4 & 5). The gaps between these hanging tiles upon the eastern elevation proposed to be affected by the works were checked for evidence of crevice roosting bats with an endoscope. There is no evidence to suggest that crevice roosting bats have been using the hanging tiles upon this section of the property.

**Figure 2.** East facing aspect of 40 Bath Road, with the area proposed for alteration above the car port and to the right of the porch.

The results of the scoping survey suggest that the eastern facing elevation of the property (proposed to be affected as part of the proposed works to 40 Bath Road) has a negligible potential to support roosting bats and no signs of use by bats was identified during the assessment. No further surveys or mitigation works are recommended. However, there was evidence to suggest that areas of the hanging tiles upon the north facing aspect of the property may support small numbers of crevice roosting bats, as a single dropping was found below a gap between a hanging tile. Therefore if plans change and other parts of the structure of the building are to be altered it maybe necessary to undertake further surveying and mitigation works with regards to roosting bats. It is essential that this part of the building is not disturbed in any way during any of the proposed work.

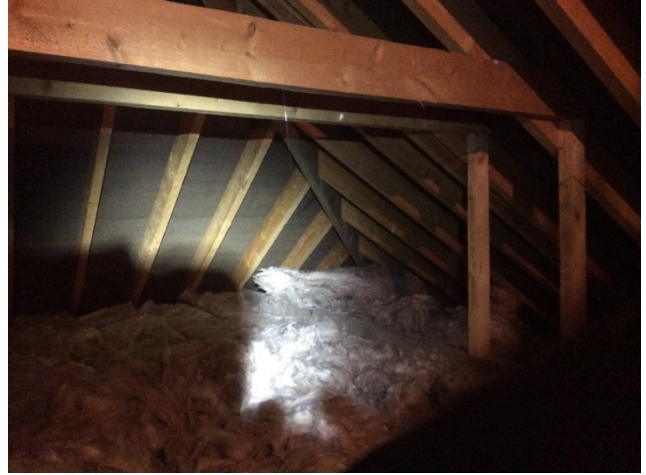
**Figure 3.** The roof void within 40 Bath Road, timber framed with bitumen roofing felt.

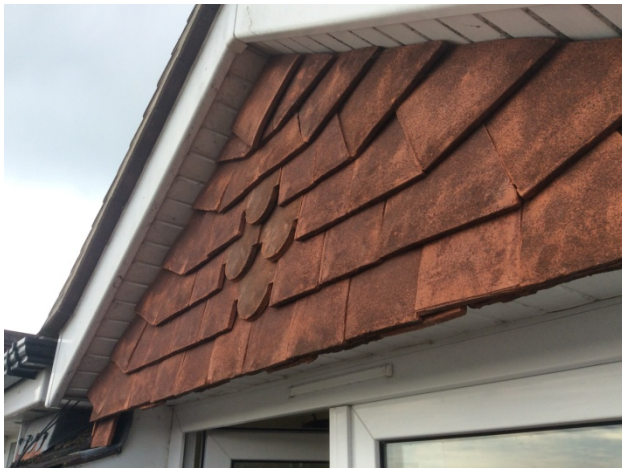
**Figure 4.** The tight fitting PVC soffits devoid of potential bat roosting gaps upon the eastern elevation of 40 Bath Road.

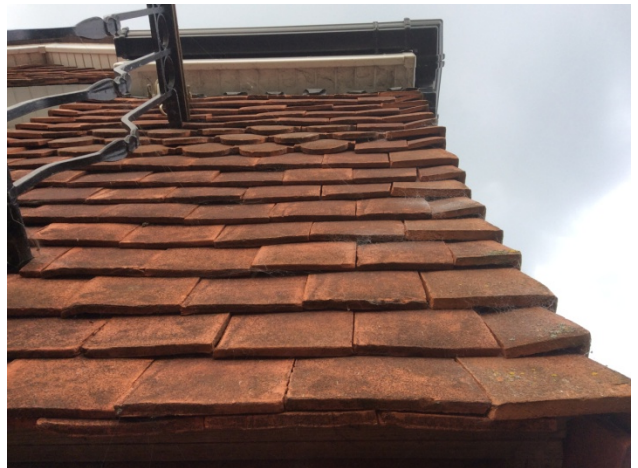
**Figure 5.** The hanging tiles devoid of evidence to suggest the use by crevice roosting bats roosting upon the eastern elevation of 40 Bath Road.
