**PURBROOK PARK SCHOOL, PARK AVENUE, WATERLOOVILLE,  
HAMPSHIRE**

**EXTENDED PHASE 1 ECOLOGICAL ASSESSMENT**

January 2014

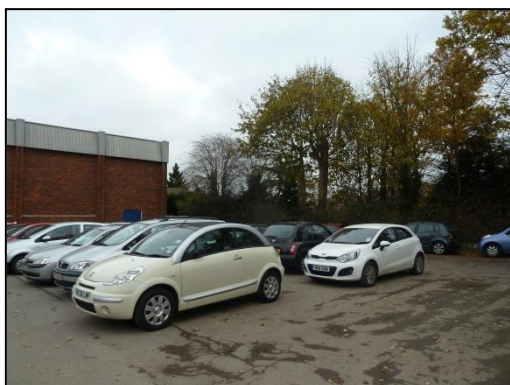
The majority of the site is composed of buildings and hardstanding. School buildings of a variety of designs and ages dominate the site. Hardstanding areas in the form of car parks and concrete pathways are scattered across the site (**Figure 1** and **Figure 2**). On-site buildings are described further in Paragraph 3.5.1 below.

**Figure 1** Facing north-east showing hardstanding car park close to eastern edge of site

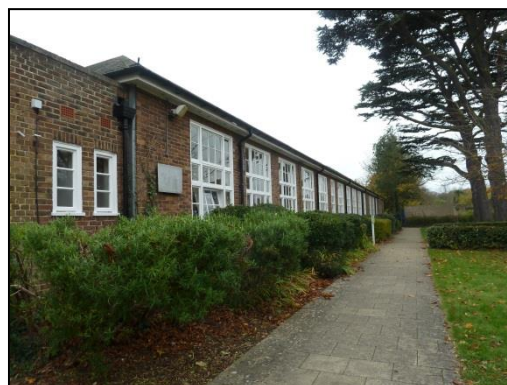
**Figure 2** Facing south-east showing hardstanding pathway close to western boundary of site with introduced shrub

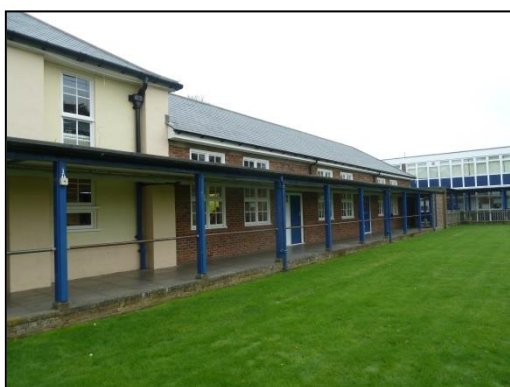
The courtyard in the centre of the site contains a substantial patch of amenity grassland (**Figure 3**). A further area of amenity grassland is present in an open area to the east of the main courtyard (**Figure 4**). Smaller patches are also located along the southern edge of the surveyed area in association with the playing fields. All areas have low species diversity with abundant perennial rye-grass *Lolium perenne*. Other species recorded at lower abundances included dove-foot cranes-bill *Geranium molle*, daisy *Bellis perennis*, red clover *Trifolium pratense*, dandelion *Taraxacum* aggregate (agg.) and common bent *Agrostis capillaris*.

**Figure 3** Facing north-west showing amenity grassland courtyard and surrounding buildings

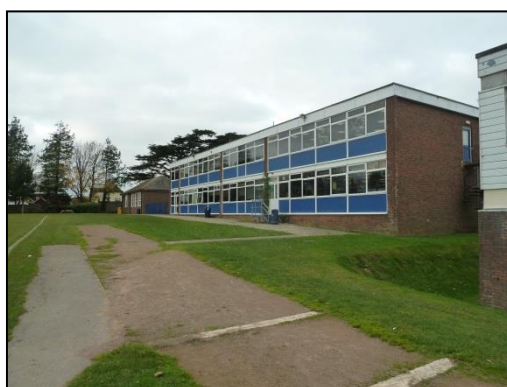
**Figure 4** Facing north showing amenity grassland to the east of the main courtyard and surrounding buildings

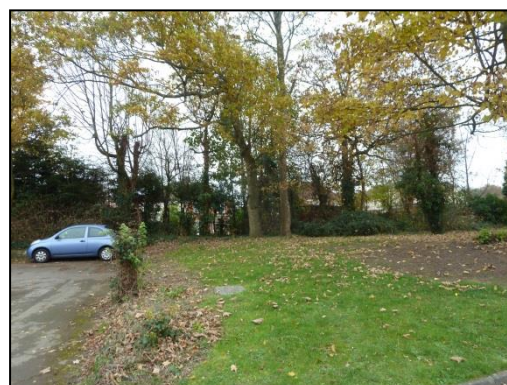
**Figure 6** Facing east showing treeline along eastern boundary

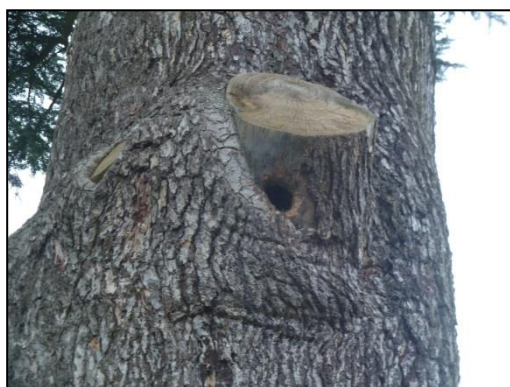
There are currently no plans to remove any trees from the site as part of the proposed works. However, it was noted that the two cedar specimens in the west of the site contained features that would provide suitable roosting locations for bats. The northern tree contained a woodpecker hole around three metres from the ground on the eastern elevation (**Figure 7**). The southern tree also contained a natural cavity also on the eastern elevation (**Figure 8**).

**Figure 7** Eastern elevation of cedar in west of the site showing woodpecker hole suitable for roosting bats

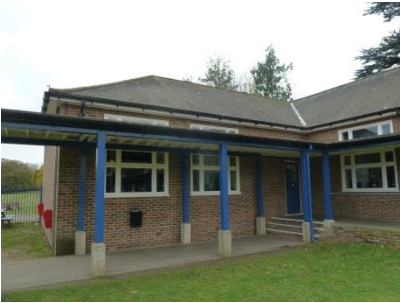
| Surveyed Feature | Figure | Building Description | Description of Potential Bat Roost Features | Evidence of Bat Roost Activity and Location | Assessment of Bat Roost Potential |
|---|---|---|---|---|---|
| Building A | <p><b>Figure 9</b> Eastern elevation of Building A</p> | <p>Building A is a brick built single pitch, single storey structure (<b>Figure 9</b>). It has a hipped slate tiled roof with angled hip and ridge tiles. Soffits and fascias are wooden.</p> <p>Internally there is a roof void. This was not accessible due to the presence of asbestos.</p> <p><b>Figure 9</b> shows the section of Building A to be remodelled / refurbished.</p> | The building was well sealed and contained no features suitable for roosting bats externally. | No direct evidence of roosting bats was recorded. | Negligible |

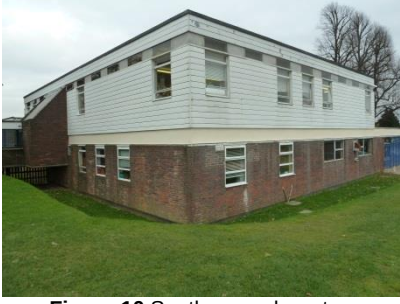
| Surveyed Feature | Figure | Building Description | Description of Potential Bat Roost Features | Evidence of Bat Roost Activity and Location | Assessment of Bat Roost Potential |
|---|---|---|---|---|---|
| Building B | <p><b>Figure 10</b> Southern and western elevation of Building B</p> | <p>Building B is a flat roofed roughly rectangular shaped two-storey building with bitumen felt roof (<b>Figure 10</b>). The lower half of the building is brick built and the upper half is clad with white plastic slats. A flat roofed single storey section is attached to the eastern elevation.</p> <p><b>Figure 10</b> shows the section of Building B to be remodelled / refurbished. The eastern single storey section is to be rebuilt.</p> | A small crevice is present around the exterior of the building where the bitumen felting ties into the plastic cladding. This feature provides limited space for roosting bats and was well covered by spider webs in all those areas that were easily viewable. | No direct evidence of roosting bats was recorded. | Low/Negligible |

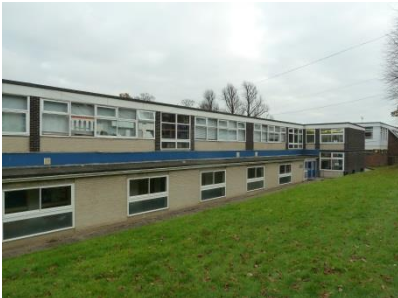
| Surveyed Feature | Figure | Building Description | Description of Potential Bat Roost Features | Evidence of Bat Roost Activity and Location | Assessment of Bat Roost Potential |
|---|---|---|---|---|---|
| Building C | <p><b>Figure 11</b> Western elevation of Building C</p> | <p>Building C is a one and two-storey flat roofed structure (<b>Figure 11</b>). The roof is lined with bitumen felting and the walls are composed of a mixture of brick pillars, windows and prefabricated boarding. No roof void is present internally.</p> <p>Building C attaches to Building D at its northern end.</p> <p>This building is to be part refurbished and partly demolished. The northern end of the building will form part of the new Block B in the east of the site.</p> | <p>As with Building B, where the bitumen felting ties into the plastic cladding a small crevice is present around the exterior of the building. This feature provides limited space for roosting bats and was well covered by spider webs in all those areas that were easily viewable.</p> | <p>No direct evidence of roosting bats was located.</p> | <p>Low/Negligible</p> |

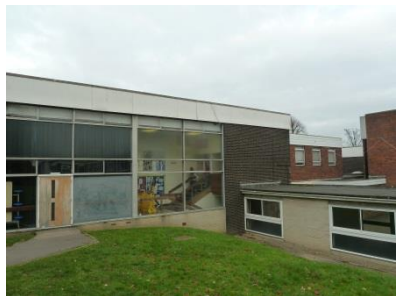
| Surveyed Feature | Figure | Building Description | Description of Potential Bat Roost Features | Evidence of Bat Roost Activity and Location | Assessment of Bat Roost Potential |
|---|---|---|---|---|---|
| Building D | <p><b>Figure 12</b> Southern elevation of Building D</p> | <p>Building D is a large structure that is used as the main school hall. It is a flat roofed brick built and metal framed building with a concrete asbestos roof (<b>Figure 12</b>). No roof void is present internally.</p> <p>This section of the school is to be refurbished / remodelled as part of plans for the site.</p> | <p>The building is in good condition and well-sealed in those accessible areas.</p> | <p>No direct evidence of roosting bats was located.</p> | <p>Negligible</p> |

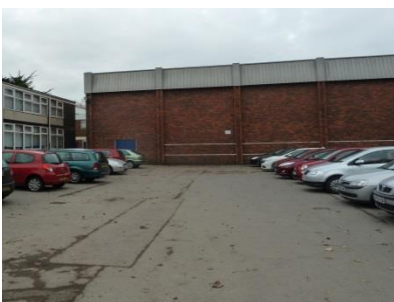
| Surveyed Feature | Figure | Building Description | Description of Potential Bat Roost Features | Evidence of Bat Roost Activity and Location | Assessment of Bat Roost Potential |
|---|---|---|---|---|---|
| Building E | <p><b>Figure 13</b> Southern elevation of Building E</p> | <p>Building E is a large two-part structure that consists of the sports hall and gym (<b>Figure 13</b>). The building is brick built with a metal clad roof. No roof void is present.</p> <p>The building is to remain intact as part of the proposed works. However, the new Block B and Block C will tie into the southern and eastern elevation respectively.</p> | <p>No features were recorded that would provide suitable bat roosting features. The building is in extremely good condition. Furthermore, the roof structure will not be affected by the proposed works.</p> | <p>No direct evidence of roosting bats was located.</p> | <p>Negligible</p> |

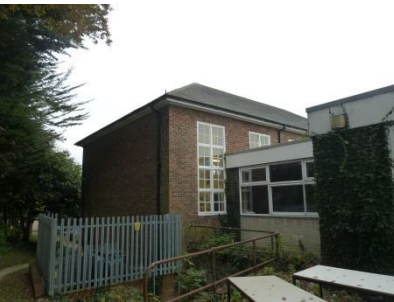
| Surveyed Feature | Figure | Building Description | Description of Potential Bat Roost Features | Evidence of Bat Roost Activity and Location | Assessment of Bat Roost Potential |
|---|---|---|---|---|---|
| Building F | <p><b>Figure 14</b> Western and northern elevation of Building F</p> | <p>Building F is a brick built gable-ended structure with a large internal space (<b>Figure 14</b>). The roof is a clad with slate tiling. The building is surrounded on its western, southern and eastern elevation by single storey sections of Building G.</p> <p>A roof void is present but was not accessible due to the height of the loft hatch (over 3m).</p> <p>This building is to be remodelled / refurbished as part of the proposed works.</p> | <p>The Phase 1 investigation revealed that the building was in a good state of repair. No potential bat roosting features were recorded.</p> <p>It should be noted that it was not possible to view the whole exterior of the property because of the surrounding buildings.</p> | <p>No direct evidence of roosting bats was located.</p> | <p>Negligible</p> |

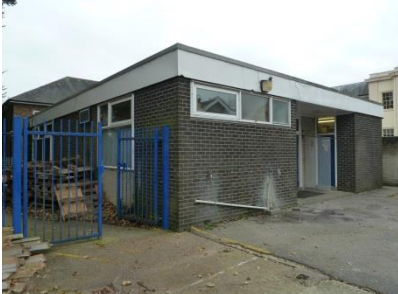
| Surveyed Feature | Figure | Building Description | Description of Potential Bat Roost Features | Evidence of Bat Roost Activity and Location | Assessment of Bat Roost Potential |
|---|---|---|---|---|---|
| Building G | <br><b>Figure 15</b> Western section of Building G | Building G is an area of single storey brick built buildings currently used as a kitchen ( <b>Figure 15</b> ). The building is flat roofed with wooden barge boarding. No roof void is present. | A wide gap under the barge boarding was wide and limited in extent. It was considered that this area would not be suitable for crevice roosting species. | No direct evidence of bats was recorded during the Phase 1 survey. | Negligible |

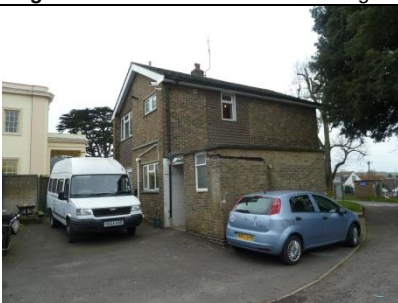
| Surveyed Feature | Figure | Building Description | Description of Potential Bat Roost Features | Evidence of Bat Roost Activity and Location | Assessment of Bat Roost Potential |
|---|---|---|---|---|---|
| Building H | <br><b>Figure 16</b> Northern and eastern elevation of Building H | Building H is a detached two-storey building with a single pitch gable ended roof. The roof is clad with thick concrete tiles and a single brick chimney is present on the northern pitch. The fascias and soffits are plastic.<br><br>There are hexagonal hanging clay tiles around windows on the northern, eastern and western elevations.<br><br>The roof void was not accessed during survey. This building is to be demolished as part of the proposals for the site. | Three of the hanging tiles have broken on the northern elevation but this has not created any crevices suitable for roosting bats. The roof, fascias and soffits boarding are well sealed. | No direct evidence of bats was recorded during the Phase 1 survey. | |

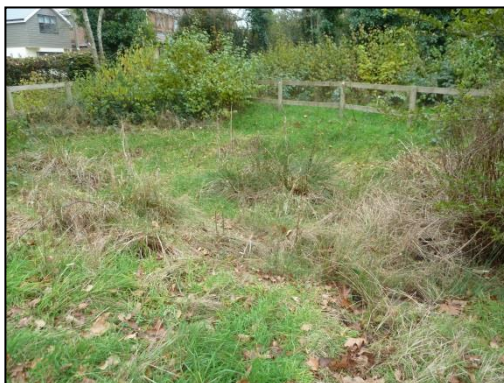
The site does not contain any waterbodies. Ordnance Survey mapping and Aerial Photography did not reveal any waterbodies within 500m of the site. Investigation when on site revealed a dry pond located within the school grounds approximately 130m south-east of the site (**Figure 17**). Information from the caretaker indicated that this had been dry for well over a year. The interior of the pond was beginning to be dominated by coarse grasses such as cock's-foot *Dactylis glomerata*. Therefore, great crested newts are not breeding on site and it is unlikely that the species would visit the site during its terrestrial phase. The site is considered to offer **negligible potential** for supporting great crested newts in either their aquatic or terrestrial phases.

**Figure 17** Former pond off site to the south-east
