**RE: Bartons Road, Havant**

Further to your instruction, we write to present the findings of the preliminary ground investigation and assessment on this site.

| <b>Project:</b> | | Bartons Road, Havant | | <b>Title</b> | | Trial Pit Location Plan | |

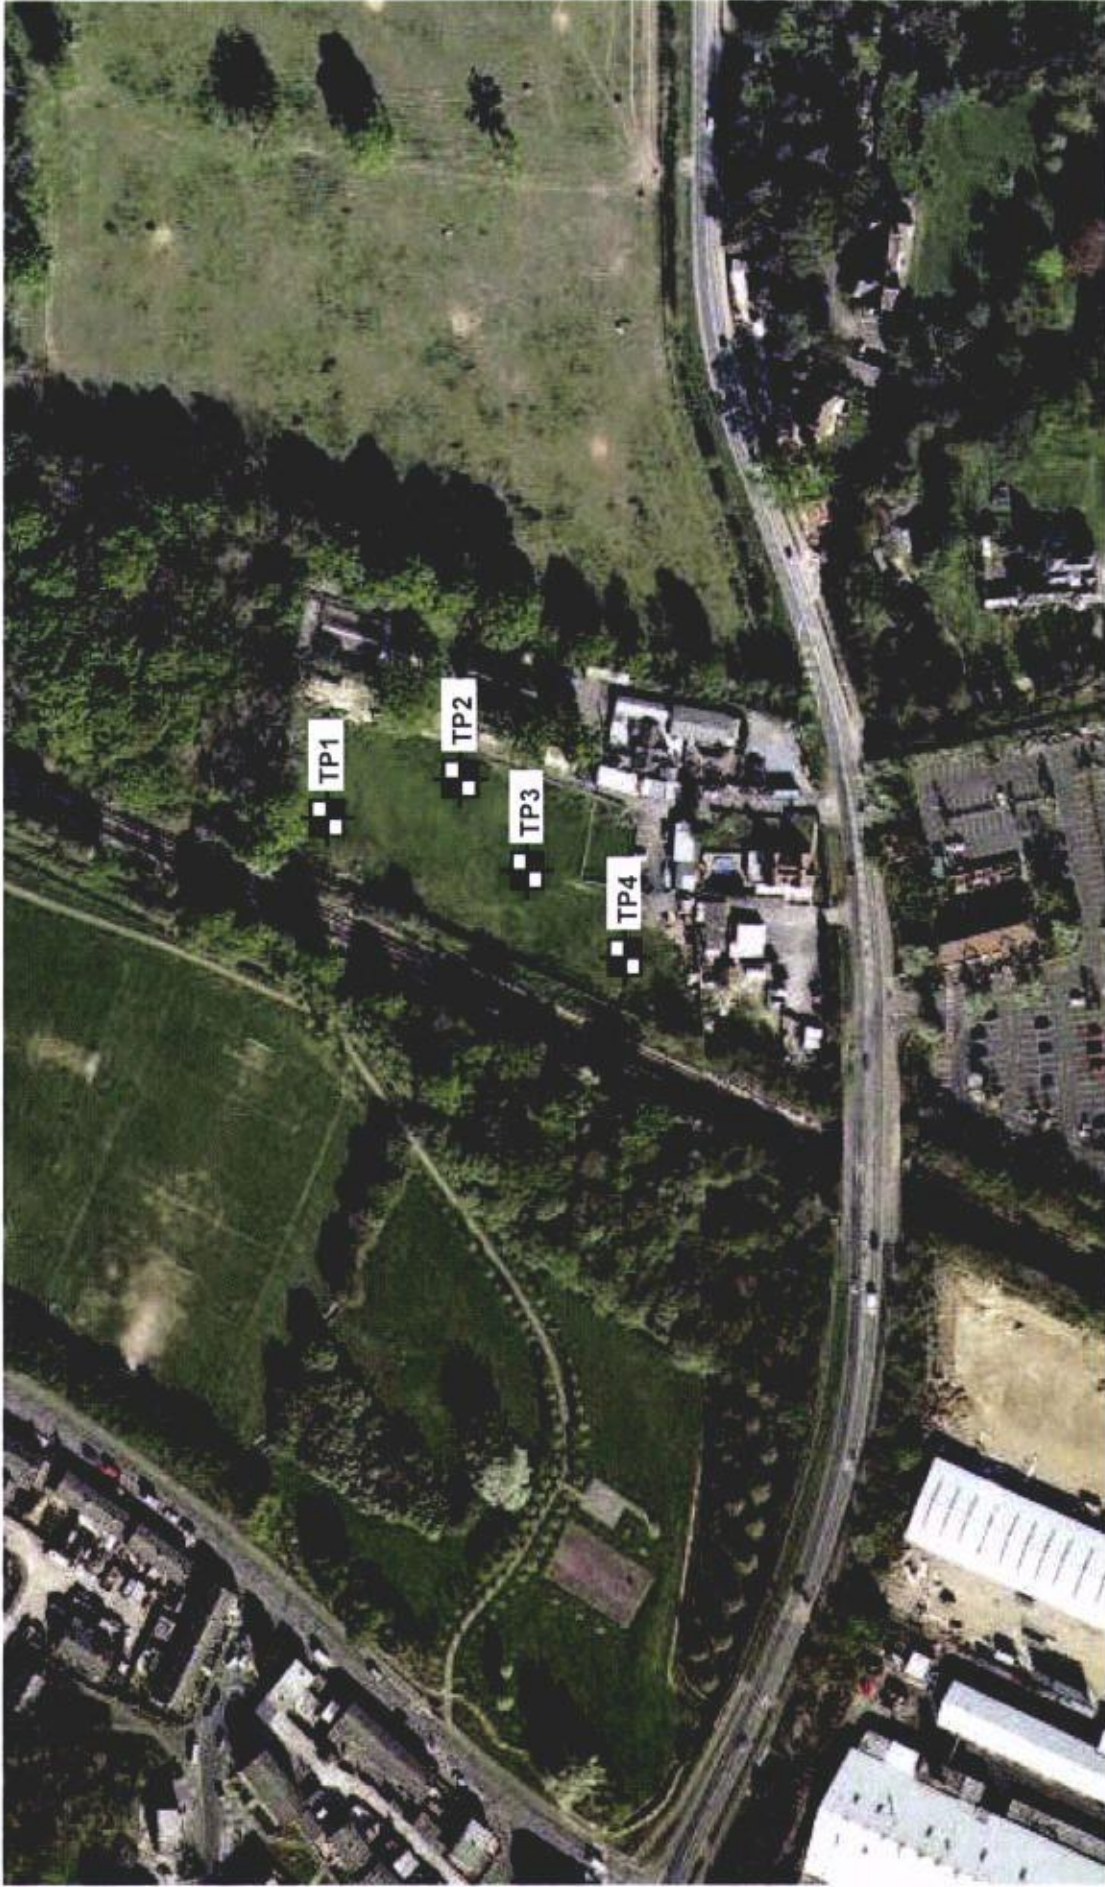
| <b>Figure:</b> | | 2 | | <b>Scale:</b> | | Not To Scale | |

Trial pits were excavated at locations across the site as shown in Figure 2, enclosed, and encountered a general profile of Topsoil overlying Head Deposits and London Clay Formation. In addition, Made Ground was encountered to a depth of 1.2m bgl, overlying Head Deposits, in TP4.
