**David Leach Ecology Ltd.  
Environmental Consultants**

**70 Jubilee Road  
Waterlooville  
Hampshire**

**Protected Species Survey**

**Date: February 2015**

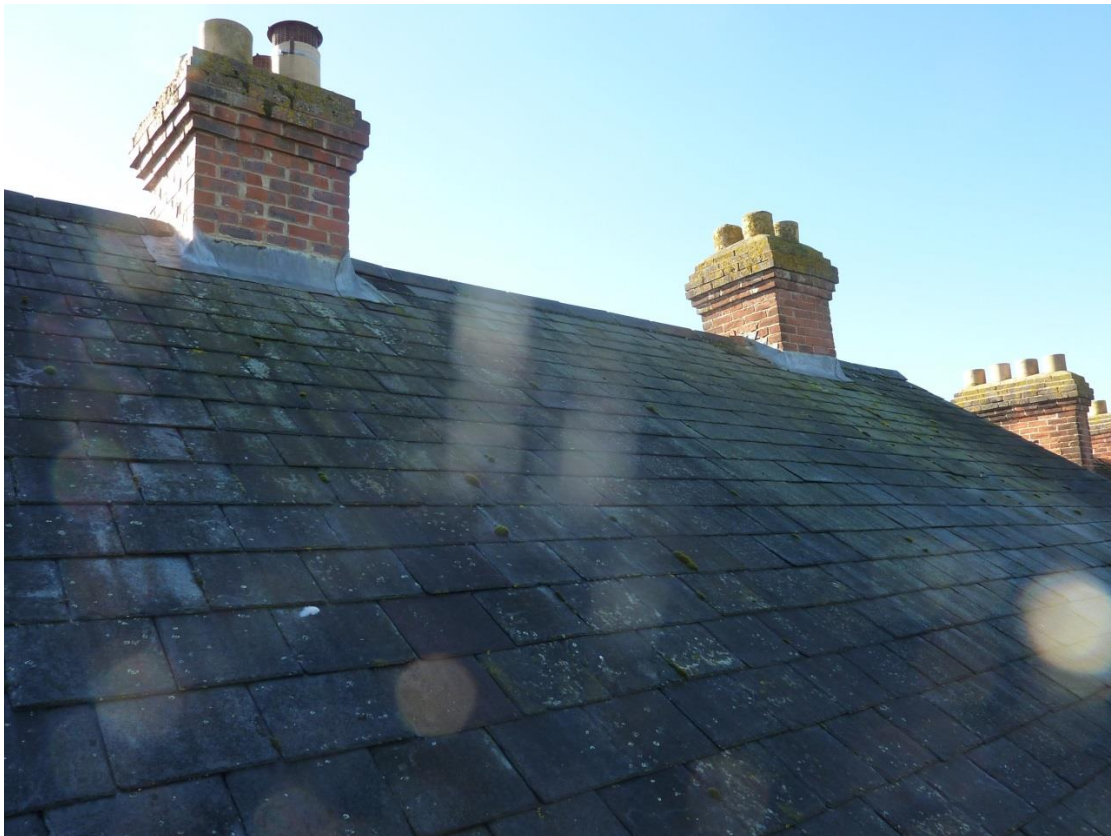
- The semi-detached house had brick walls and a slate roof with wooden soffits and bargeboards. The slates were tightly fitted with no potential access points for bats. There was no warped or rotten timber work around the roof but all areas of wood had peeling paint and were in need of decoration. There were no gaps around the wooden sash window frames.

Rear roof with closely fitted slates.

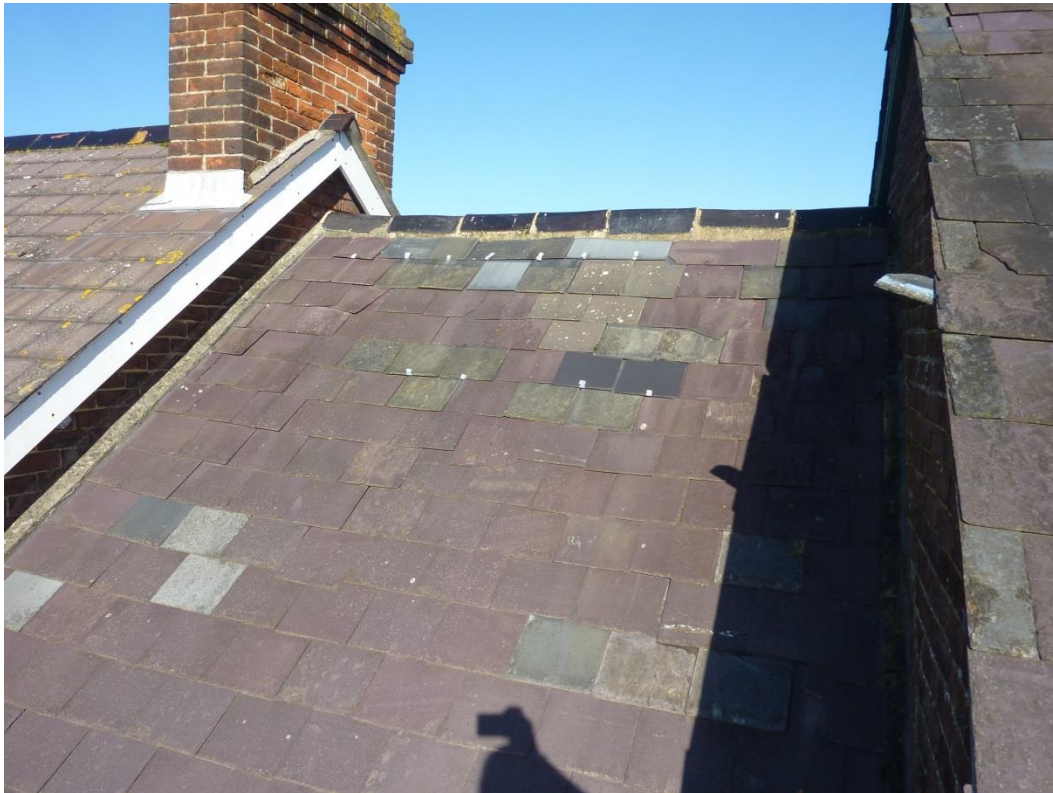
- There was a single integral garage with rooms above. The ceilings in this section were vaulted with no roof void.
- The roof void of the main house had bitumen felt under the slates and fiberglass insulation between the joists. There were thick cobwebs over most the timber of the roof and around the brickwork of the gable walls and the two chimneys.

View of roof above first floor over garage.

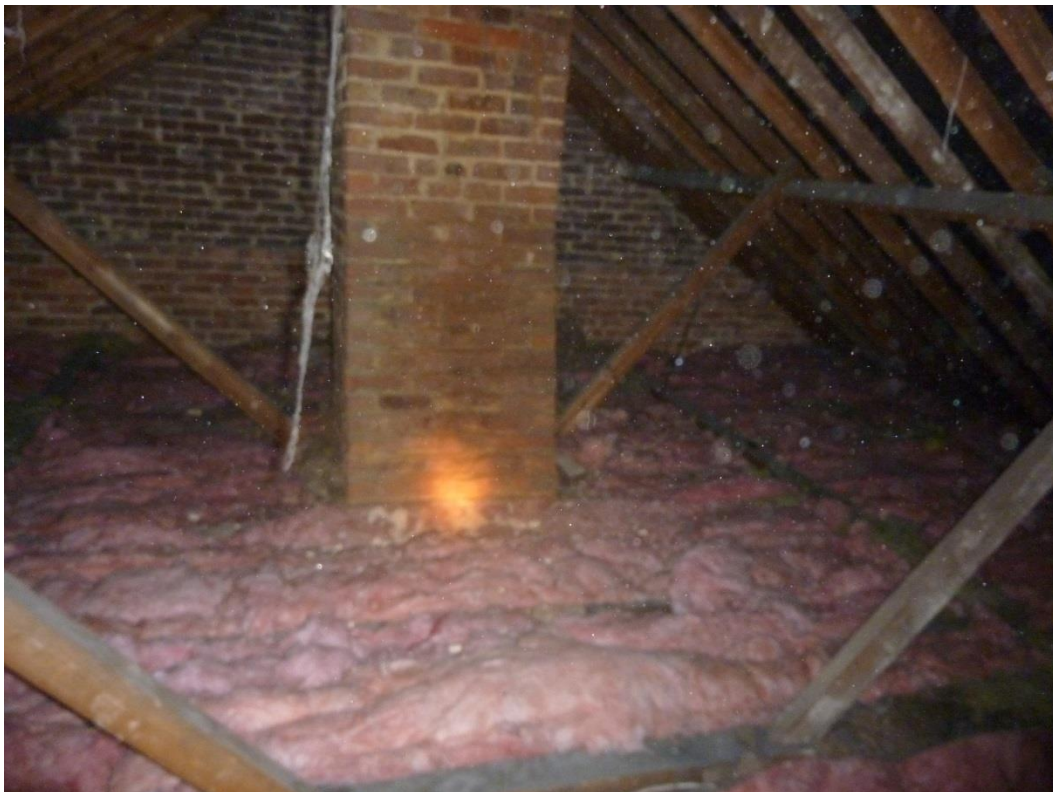
- No signs of bats were found but there were a few rat droppings scattered around the void.
- There was a small garden area at the front of the property which was laid to gravel with small flower borders. At the side and rear of the property the garden was laid to lawn with a few small areas of shrubs and flower beds. There was a paved patio area immediately behind the house. At the rear boundary of the property there was a large Oak and a few ornamental conifers. There was also a small Sequoia at the rear of the property

Roof void with hanging cobwebs .

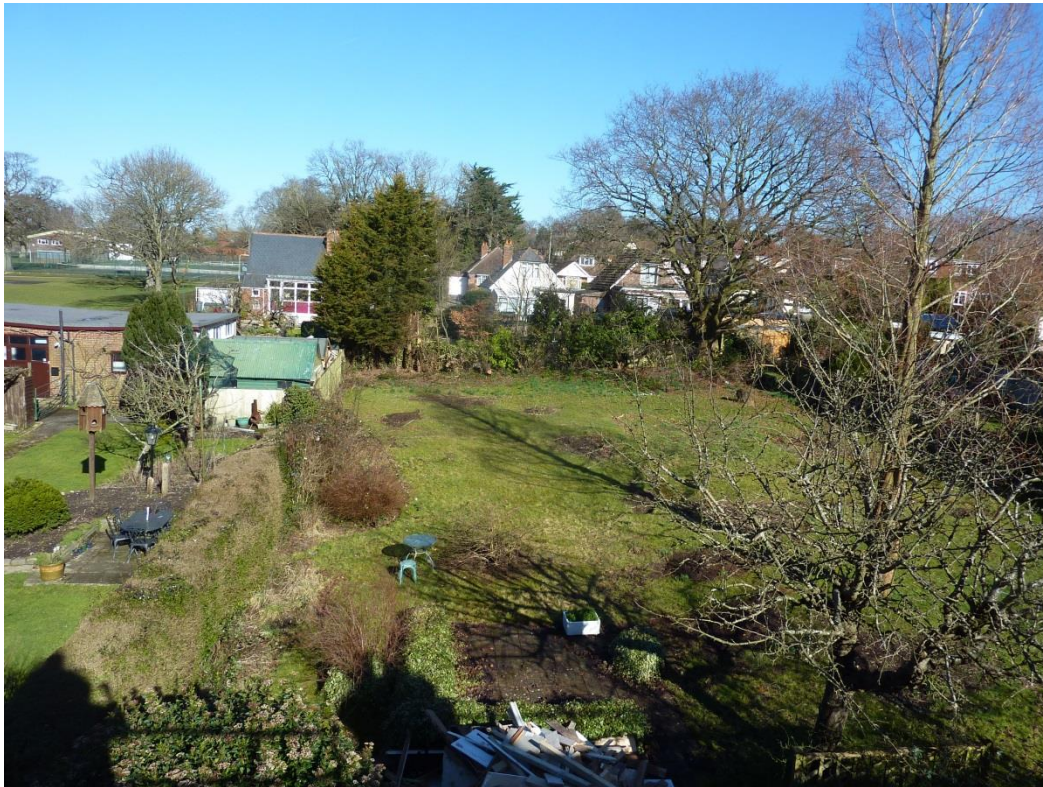
Rear garden

Herras fencing should be set up to create a root protection zone around the trees for the duration of the site development.

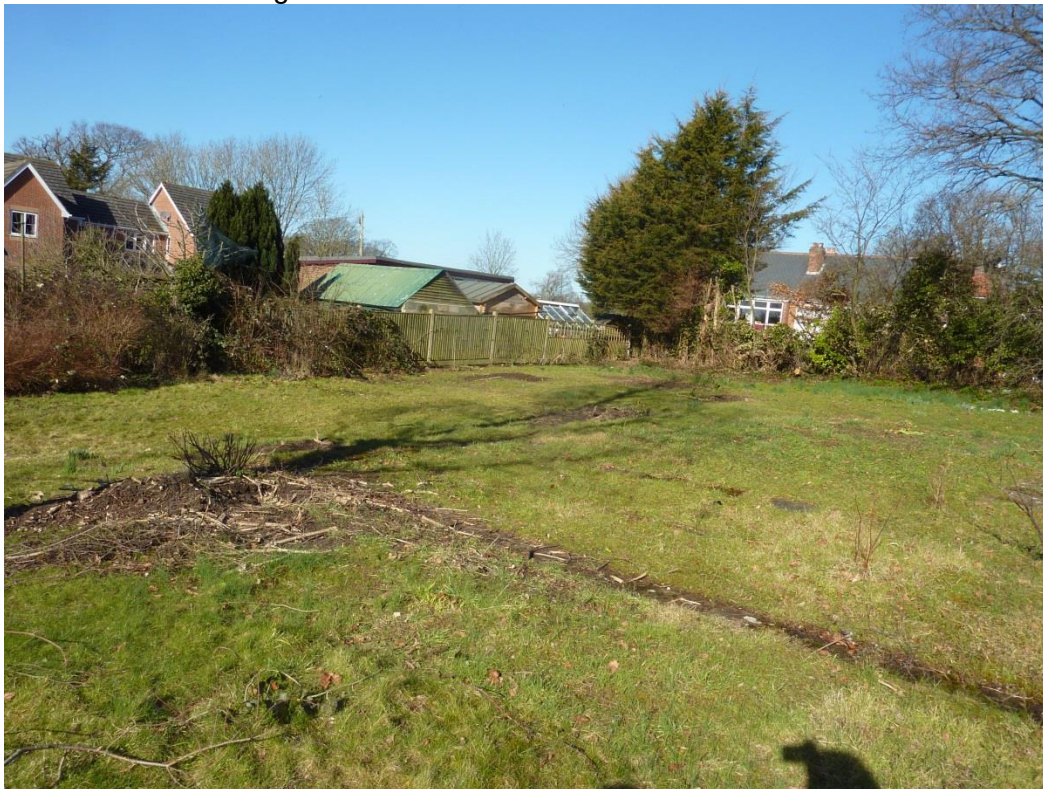
Area where new bungalow will be constructed.

It is recommended that the vegetation around the site that will be impacted by the proposed development is kept short (below 50mm) to keep the habitat sub-optimal for reptiles. The vegetation around the plot should be cleared over the winter period.

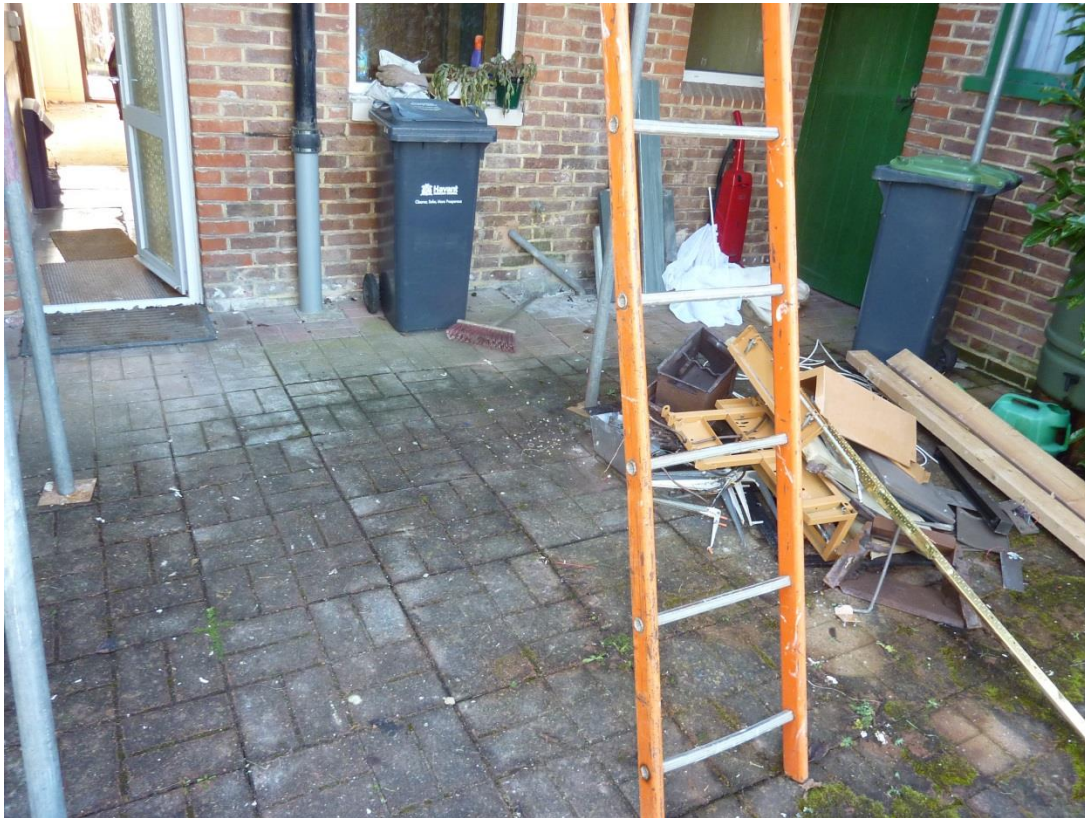
Area where new extension will be built

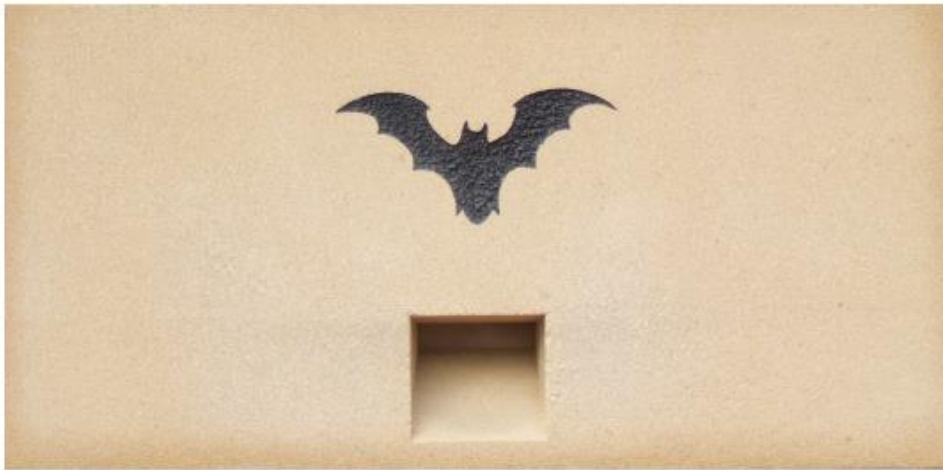
## Product Information – Bat Box

- The Forticrete Bat Box has been developed to be used in new build construction or renovation work where there is a requirement to provide a habitat for Pipistrelle bats.
- The box is made of a conventional cast stone front face but is backed with high grade plywood which is sawn and roughened internally to provide a haven for bats.
- The Bat Box is maintenance free due to the bottom entrance.
- The Bat Box illustrated is available from Forticrete's 'Stone in Stock' range although bespoke boxes can be designed and made for any application.

Two Forticrete bat boxes or Schweglar 1FF bat tubes should be fitted to the gable end of the new building.

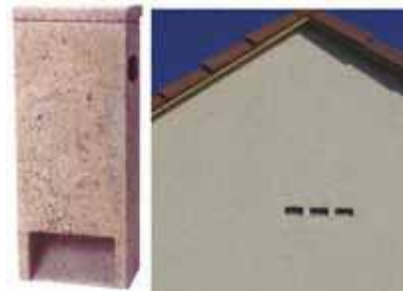
### **Schwegler 2FR Bat Tube**

The same design as the 1FR but with holes in the sides. This allows multiple tubes to be placed next to each other to form a much larger bat roost.

These boxes are maintenance-free as the entrance slit is at the bottom.

Woodcrete (75% wood sawdust, concrete and clay mixture)

Width: 20cm, Height: 47cm, Depth: 12.5cm, Weight: 13kg

Entrance Width: 15cm, Entrance Depth: 2cm
