## **PHASE I & PHASE II GEO-ENVIRONMENTAL SITE INVESTIGATION**

**Former works at 59 – 61 West Street  
West Street  
Havant  
PO9 1LN**

**REC Report: 20586 v1.1 DRAFT  
Issued: February 2014**

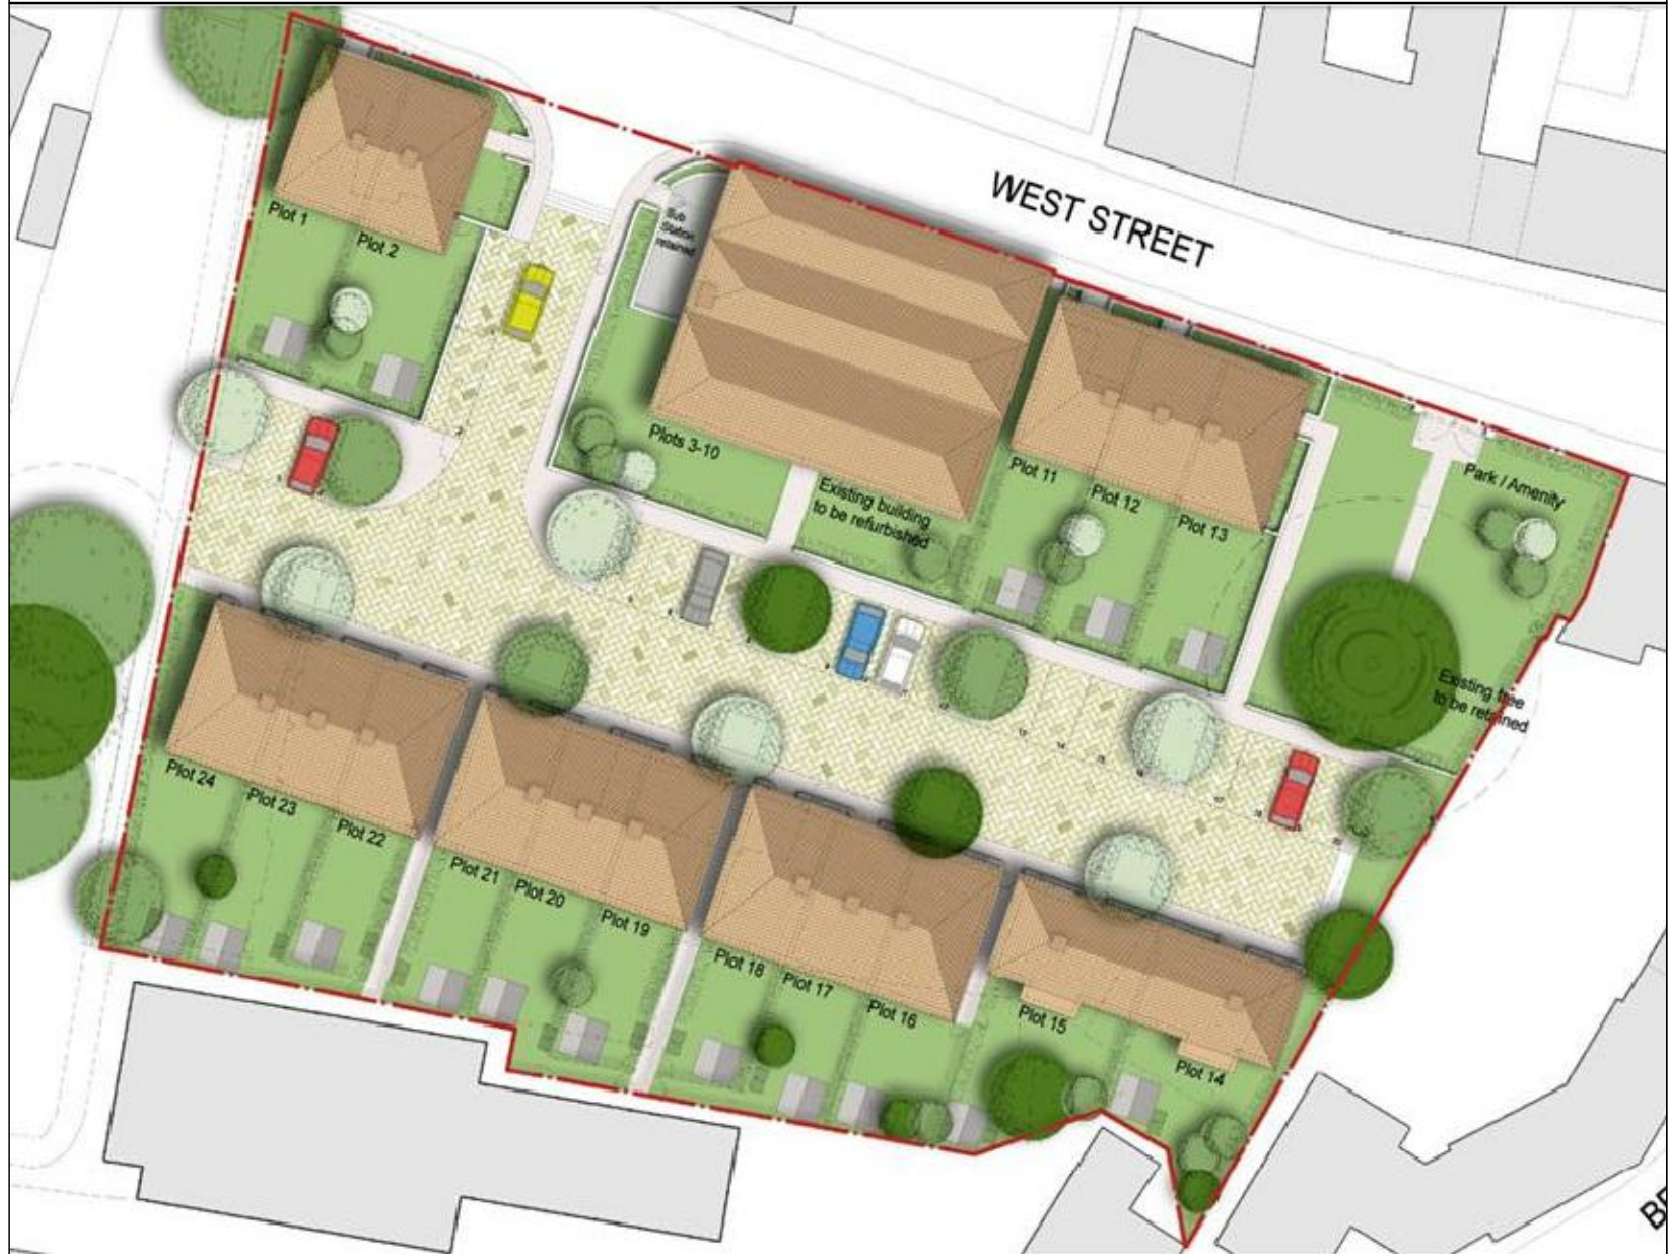
Hand pits were excavated to 1.2 m bgl to retrieve environmental samples and check for shallow services. The exploratory hole locations are illustrated in Figure 3 (Appendix III). The ground conditions encountered and details of monitoring well response zones are indicated on the exploratory hole logs which are provided in Appendix V.

- ⊙ WS101    Approximate Window Sample Probehole Location
- ⊠ TP101    Approximate Trial Pit Location
- ⊠ HP101    Approximate Hand Dug Pit Location
- Site Location
