**HARTS FARM WAY, HAVANT**

**Proposed Permanent Use of Utilities  
Storage Depot for Recycling**

**Transport Statement**

**NSTP/14/2238  
November 2014**

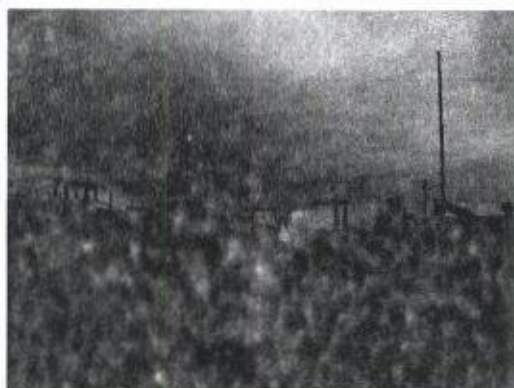
**Figure 3.1:** Site access off the southern side of Harts Farm Way

- 3.3.2 As shown on **Drawing No. 2014/2238/001** and **Figure 3.2** visibility from the existing access is generally good with splays measuring 2.4 x 57 metres (leading direction) and 2.4 x 51.8 metres (trailing direction), based on the actual recorded vehicular speeds along Harts Farm Way being achievable.

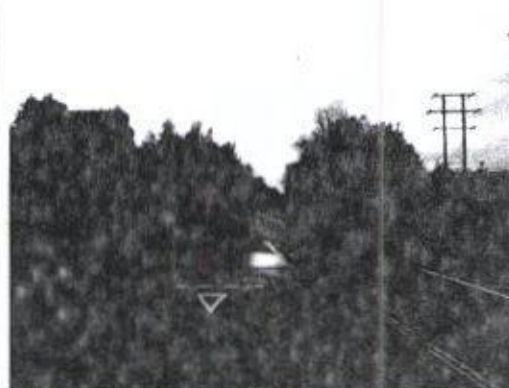
**Figure 3.2:** View of site access along Harts Farm Way

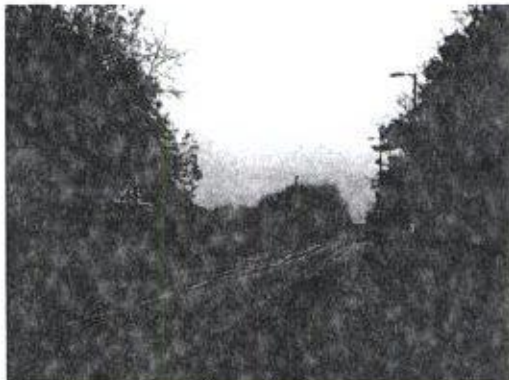
**Figure 3.3:** Shared foot / cycleway infrastructure along the southern side of Harts Farm Way

- 3.5.3 With regards to existing cycling infrastructure, the application site benefits from the provision of a shared foot / cycleway along the southern side of Harts Farm Way. Give-way markings are present at the access points / crossovers of neighbouring industrial units along Harts Farm Way, to prevent cyclists from overrunning the junctions.

- 3.5.4 The shared foot / cycleway forms part of National Cycle Network (NCN) Route 22 and on a local level connects the site to Drayton, Hilsea and Portsmouth to the south-west and Havant, Leigh Park and Rowlands Castle to the north-east. At the junction of the A259 Emsworth Road and East Street, NCN Route 22 connects with Route 2, which heads in a southerly direction towards Hayling Island and westwards to the nearby settlements of Emsworth and Southbourne.

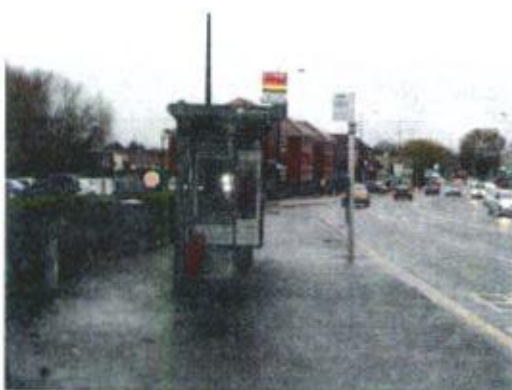
Figure 3.6: B2149 Park Road South Bus Stop (Northbound)

- 3.6.2 As shown in Figure 3.6, the northbound bus stop benefits from the provision of sheltered seating and up-to date timetable information.

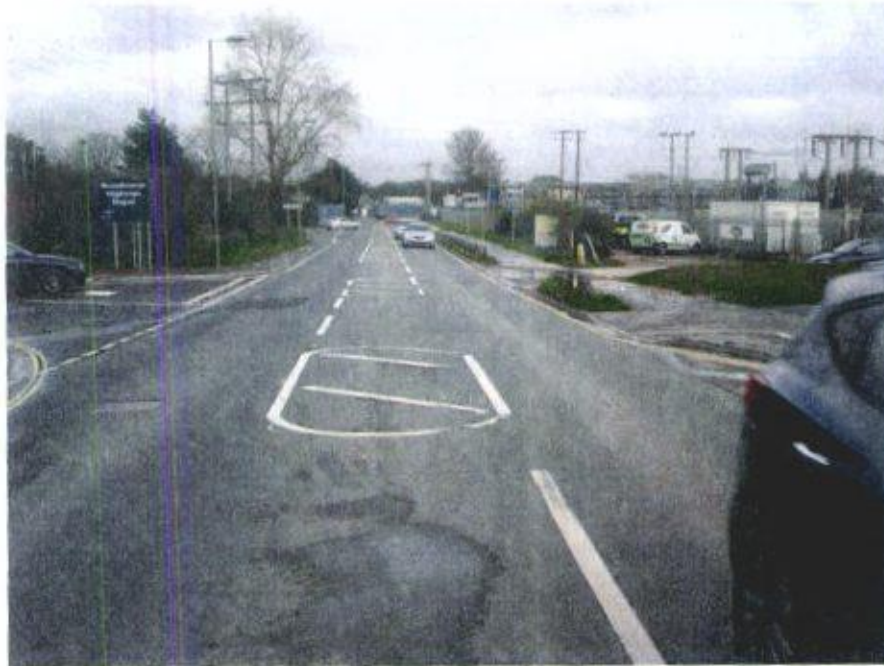
- 4.1 The drawings show an arrangement of road markings on Harts Farm Way that no longer exists. At the time of the site visit, the left turn lane is now the running lane for northeast-bound traffic and the previous running lane has a series of short hatched ghost islands. These are shown on the above photograph. The Audit Team have assumed that there are no proposals to change the current arrangement of road markings.

| Observation | In response to the auditor's comment regarding the arrangement of road markings on Harts Farm Way, Drawing No. 2014/2238/001 has been amended. |
