**PURBROOK PARK SCHOOL, PARK AVENUE, WATERLOOVILLE,  
HAMPSHIRE**

**EXTENDED PHASE 1 ECOLOGICAL ASSESSMENT**

**Final Document**

**January 2014**

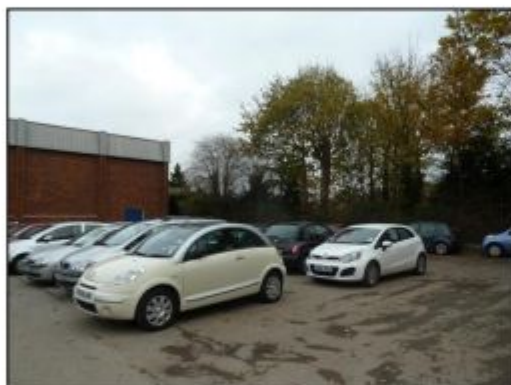
**Figure 1** Facing north-east showing hardstanding car park close to eastern edge of site

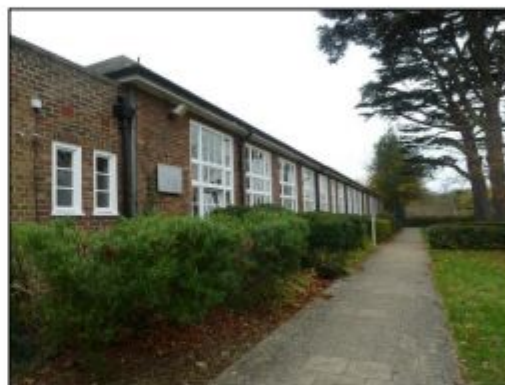
**Figure 2** Facing south-east showing hardstanding pathway close to western boundary of site with introduced shrub

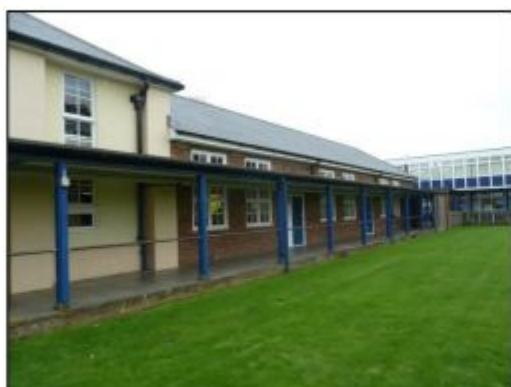
The courtyard in the centre of the site contains a substantial patch of amenity grassland (**Figure 3**). A further area of amenity grassland is present in an open area to the east of the main courtyard (**Figure 4**). Smaller patches are also located along the southern edge of the surveyed area in association with the playing fields. All areas have low species diversity with abundant perennial rye-grass *Lolium perenne*. Other species recorded at lower abundances included dove-foot cranes-bill *Geranium molle*, daisy *Bellis perennis*, red clover *Trifolium pratense*, dandelion *Taraxacum* aggregate (agg.) and common bent *Agrostis capillaris*.

**Figure 3** Facing north-west showing amenity grassland courtyard and surrounding buildings

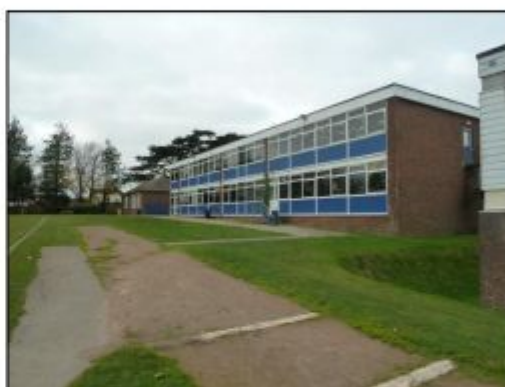
**Figure 4** Facing north showing amenity grassland to the east of the main courtyard and surrounding buildings

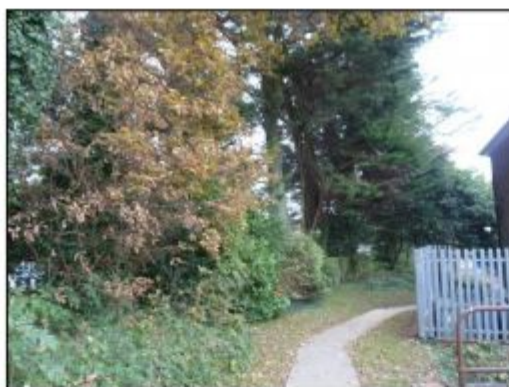
The northern and western boundaries of the site are composed of broken treelines containing a variety of native and non-native species (**Figure 5**). Most of the specimens were immature or semi-mature. Species recorded included sycamore *Acer pseudoplatanus*, conifer sp. *Pinopsida* sp. and pedunculate oak.

**Figure 5** Facing east showing treeline along northern site boundary

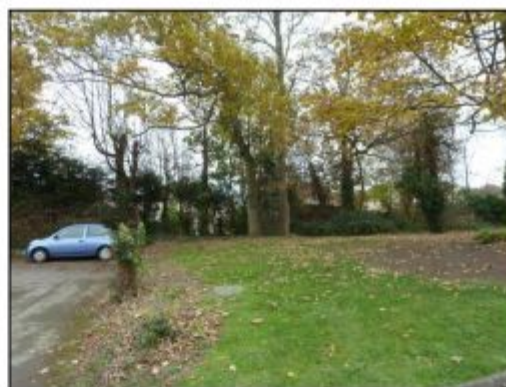
**Figure 6** Facing east showing treeline along eastern boundary

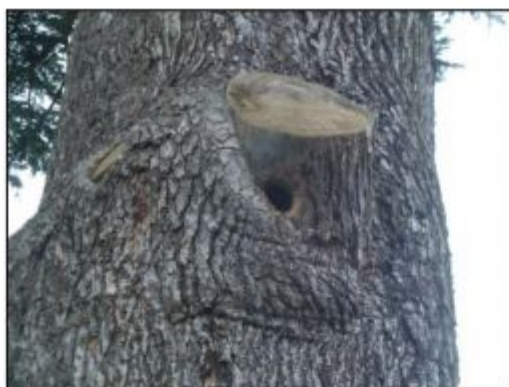
There are currently no plans to remove any trees from the site as part of the proposed works. However, it was noted that the two cedar specimens in the west of the site contained features that would provide suitable roosting locations for bats. The northern tree contained a woodpecker hole around three metres from the ground on the eastern elevation (**Figure 7**). The southern tree also contained a natural cavity also on the eastern elevation (**Figure 8**).

**Figure 7** Eastern elevation of cedar in west of the site showing woodpecker hole suitable for roosting bats

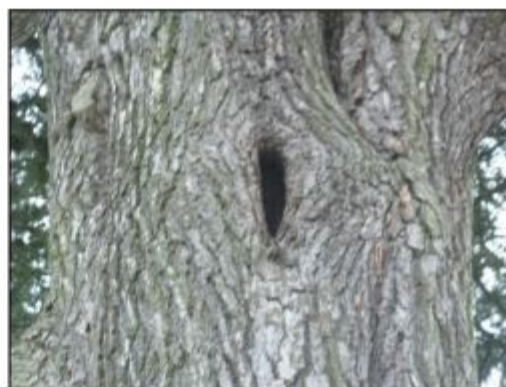
**Figure 8** Eastern elevation of second cedar showing natural cavity suitable for roosting bats

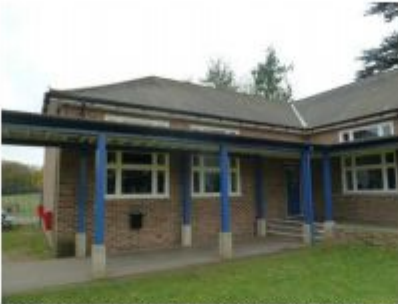
| Surveyed Feature | Figure | Building Description | Description of Potential Bat Roost Features | Evidence of Bat Roost Activity and Location | Assessment of Bat Roost Potential |
|---|---|---|---|---|---|
| Building A | <p><b>Figure 9</b> Eastern elevation of Building A</p> | <p>Building A is a brick built single pitch, single storey structure (<b>Figure 9</b>). It has a hipped slate tiled roof with angled hip and ridge tiles. Soffits and fascias are wooden.</p> <p>Internally there is a roof void. This was not accessible due to the presence of asbestos.</p> <p><b>Figure 9</b> shows the section of Building A to be remodelled / refurbished.</p> | The building was well sealed and contained no features suitable for roosting bats externally. | No direct evidence of roosting bats was recorded. | Negligible |

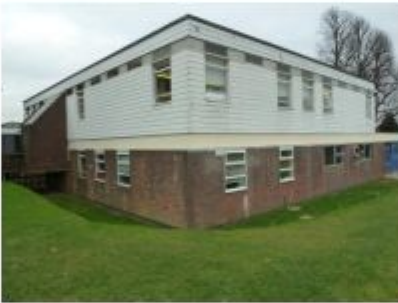
| Surveyed Feature | Figure | Building Description | Description of Potential Bat Roost Features | Evidence of Bat Roost Activity and Location | Assessment of Bat Roost Potential |
|---|---|---|---|---|---|
| Building B | <p><b>Figure 10</b> Southern and western elevation of Building B</p> | <p>Building B is a flat roofed roughly rectangular shaped two-storey building with bitumen felt roof (<b>Figure 10</b>). The lower half of the building is brick built and the upper half is clad with white plastic slats. A flat roofed single storey section is attached to the eastern elevation.</p> <p><b>Figure 10</b> shows the section of Building B to be remodelled / refurbished. The eastern single storey section is to be rebuilt.</p> | A small crevice is present around the exterior of the building where the bitumen felting ties into the plastic cladding. This feature provides limited space for roosting bats and was well covered by spider webs in all those areas that were easily viewable. | No direct evidence of roosting bats was recorded. | Low/Negligible |

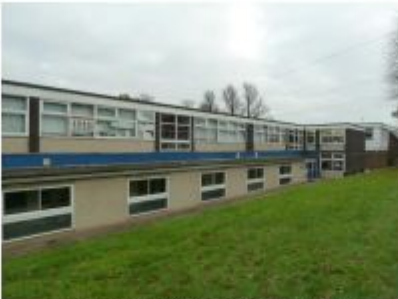
| Surveyed Feature | Figure | Building Description | Description of Potential Bat Roost Features | Evidence of Bat Roost Activity and Location | Assessment of Bat Roost Potential |
|---|---|---|---|---|---|
| Building C | <p><b>Figure 11</b> Western elevation of Building C</p> | <p>Building C is a one and two-storey flat roofed structure (<b>Figure 11</b>). The roof is lined with bitumen felting and the walls are composed of a mixture of brick pillars, windows and prefabricated boarding. No roof void is present internally.</p> <p>Building C attaches to Building D at its northern end.</p> <p>This building is to be part refurbished and partly demolished. The northern end of the building will form part of the new Block B in the east of the site.</p> | <p>As with Building B, where the bitumen felting ties into the plastic cladding a small crevice is present around the exterior of the building. This feature provides limited space for roosting bats and was well covered by spider webs in all those areas that were easily viewable.</p> | <p>No direct evidence of roosting bats was located.</p> | <p>Low/Negligible</p> |

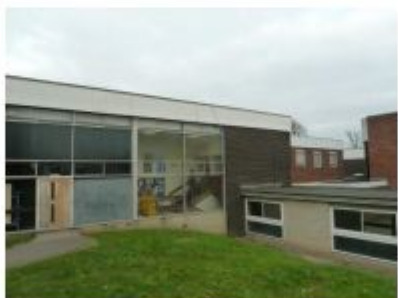
| Surveyed Feature | Figure | Building Description | Description of Potential Bat Roost Features | Evidence of Bat Roost Activity and Location | Assessment of Bat Roost Potential |
|---|---|---|---|---|---|
| Building D | <p><b>Figure 12</b> Southern elevation of Building D</p> | <p>Building D is a large structure that is used as the main school hall. It is a flat roofed brick built and metal framed building with a concrete asbestos roof (<b>Figure 12</b>). No roof void is present internally.</p> <p>This section of the school is to be refurbished / remodelled as part of plans for the site.</p> | <p>The building is in good condition and well-sealed in those accessible areas.</p> | <p>No direct evidence of roosting bats was located.</p> | <p>Negligible</p> |

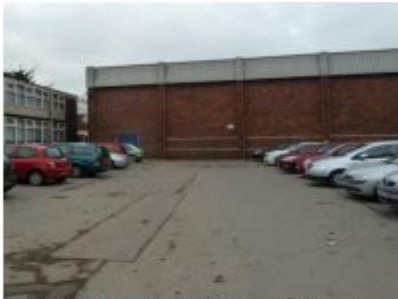
| Surveyed Feature | Figure | Building Description | Description of Potential Bat Roost Features | Evidence of Bat Roost Activity and Location | Assessment of Bat Roost Potential |
|---|---|---|---|---|---|
| Building E | <p><b>Figure 13</b> Southern elevation of Building E</p> | <p>Building E is a large two-part structure that consists of the sports hall and gym (<b>Figure 13</b>). The building is brick built with a metal clad roof. No roof void is present.</p> <p>The building is to remain intact as part of the proposed works. However, the new Block B and Block C will tie into the southern and eastern elevation respectively.</p> | <p>No features were recorded that would provide suitable bat roosting features. The building is in extremely good condition. Furthermore, the roof structure will not be affected by the proposed works.</p> | <p>No direct evidence of roosting bats was located.</p> | <p>Negligible</p> |

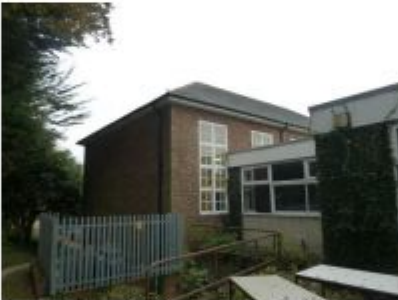
| Surveyed Feature | Figure | Building Description | Description of Potential Bat Roost Features | Evidence of Bat Roost Activity and Location | Assessment of Bat Roost Potential |
|---|---|---|---|---|---|
| Building F | <p><b>Figure 14</b> Western and northern elevation of Building F</p> | <p>Building F is a brick built gable-ended structure with a large internal space (<b>Figure 14</b>). The roof is a clad with slate tiling. The building is surrounded on its western, southern and eastern elevation by single storey sections of Building G.</p> <p>A roof void is present but was not accessible due to the height of the loft hatch (over 3m).</p> <p>This building is to be remodelled / refurbished as part of the proposed works.</p> | <p>The Phase 1 investigation revealed that the building was in a good state of repair. No potential bat roosting features were recorded.</p> <p>It should be noted that it was not possible to view the whole exterior of the property because of the surrounding buildings.</p> | <p>No direct evidence of roosting bats was located.</p> | <p>Negligible</p> |

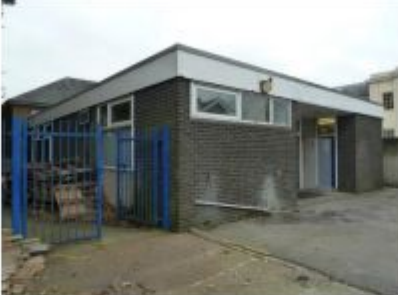
| Surveyed Feature | Figure | Building Description | Description of Potential Bat Roost Features | Evidence of Bat Roost Activity and Location | Assessment of Bat Roost Potential |
|---|---|---|---|---|---|
| Building G | <br><b>Figure 15</b> Western section of Building G | Building G is an area of single storey brick built buildings currently used as a kitchen ( <b>Figure 15</b> ). The building is flat roofed with wooden barge boarding. No roof void is present. | A wide gap under the barge boarding was wide and limited in extent. It was considered that this area would not be suitable for crevice roosting species. | No direct evidence of bats was recorded during the Phase 1 survey. | Negligible |

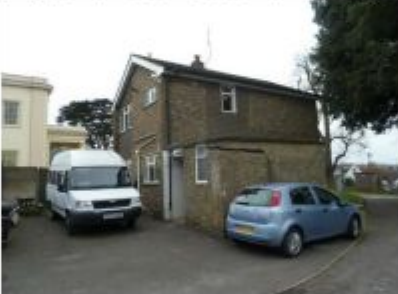
| Surveyed Feature | Figure | Building Description | Description of Potential Bat Roost Features | Evidence of Bat Roost Activity and Location | Assessment of Bat Roost Potential |
|---|---|---|---|---|---|
| Building H | <br><b>Figure 16</b> Northern and eastern elevation of Building H | Building H is a detached two-storey building with a single pitch gable ended roof. The roof is clad with thick concrete tiles and a single brick chimney is present on the northern pitch. The fascias and soffits are plastic.<br><br>There are hexagonal hanging clay tiles around windows on the northern, eastern and western elevations.<br><br>The roof void was not accessed during survey. This building is to be demolished as part of the proposals for the site. | Three of the hanging tiles have broken on the northern elevation but this has not created any crevices suitable for roosting bats. The roof, fascias and soffits boarding are well sealed. | No direct evidence of bats was recorded during the Phase 1 survey. | |

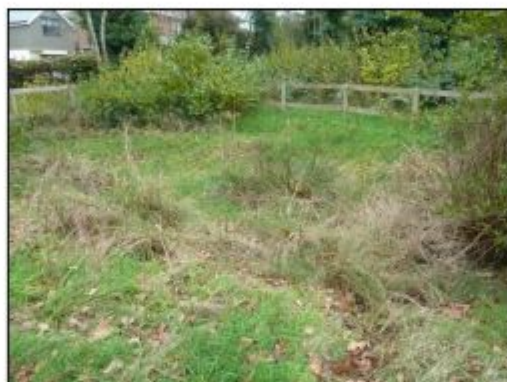
The site does not contain any waterbodies. Ordnance Survey mapping and Aerial Photography did not reveal any waterbodies within 500m of the site. Investigation when on site revealed a dry pond located within the school grounds approximately 130m south-east of the site (**Figure 17**). Information from the caretaker indicated that this had been dry for well over a year. The interior of the pond was beginning to be dominated by coarse grasses such as cock's-foot *Dactylis glomerata*. Therefore, great crested newts are not breeding on site and it is unlikely that the species would visit the site during its terrestrial phase. The site is considered to offer **negligible potential** for supporting great crested newts in either their aquatic or terrestrial phases.

**Figure 17** Former pond off site to the south-east
