## **PHASE I GEO-ENVIRONMENTAL SITE ASSESSMENT & PRELIMINARY PHASE II GEOTECHNICAL SITE INVESTIGATION**

**Field at the junction of:  
Southleigh Road  
&  
Horndean Road,  
Emsworth,  
Hampshire,  
PO10 7PU**

**REC Report: 20568  
Issued: November 2013**

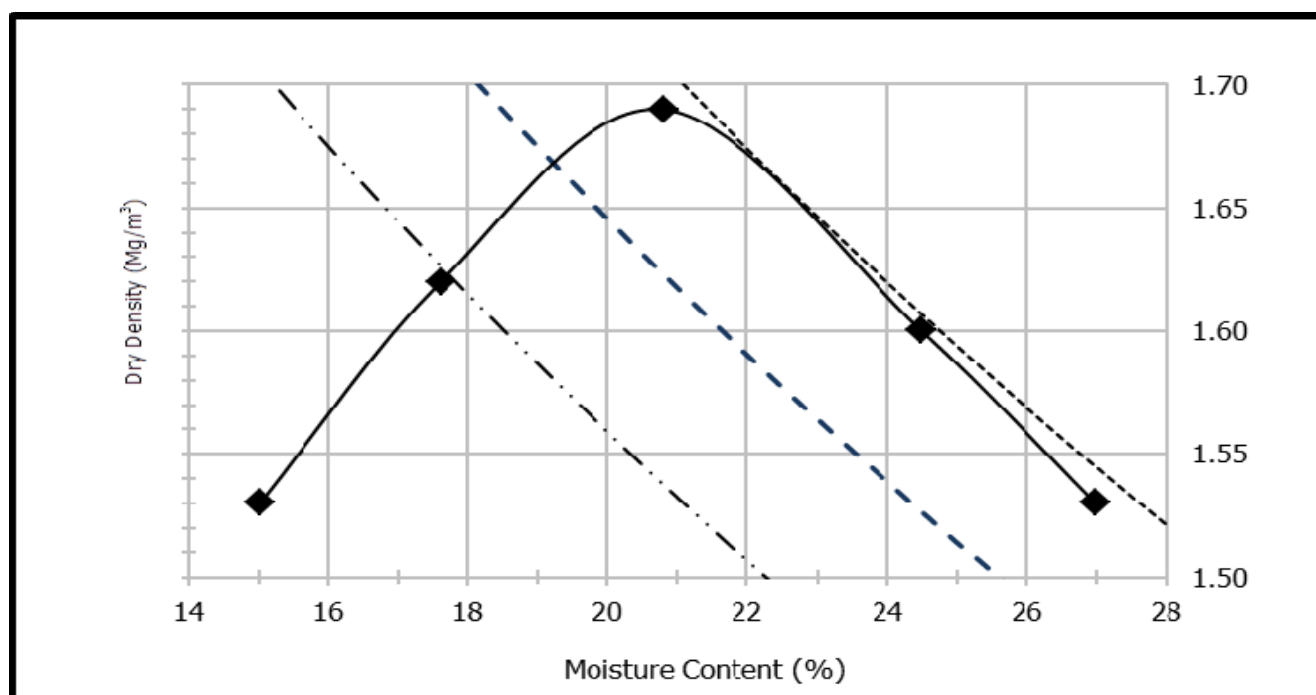
**OPTIMUM MOISTURE CONTENT (%):** 20.8

**MAXIMUM DRY DENSITY ( $\text{Mg/m}^3$ ):** 1.69

Comments: Air Voids Lines plotted at 0%, 5% and 10% Values

Compaction tests carried out using the 4.5kg hammer give maximum dry densities in the range of 1.52 to 1.69 Mg/m<sup>3</sup>. The corresponding optimum moisture contents are in the range of 20.8 to 26.5 %.

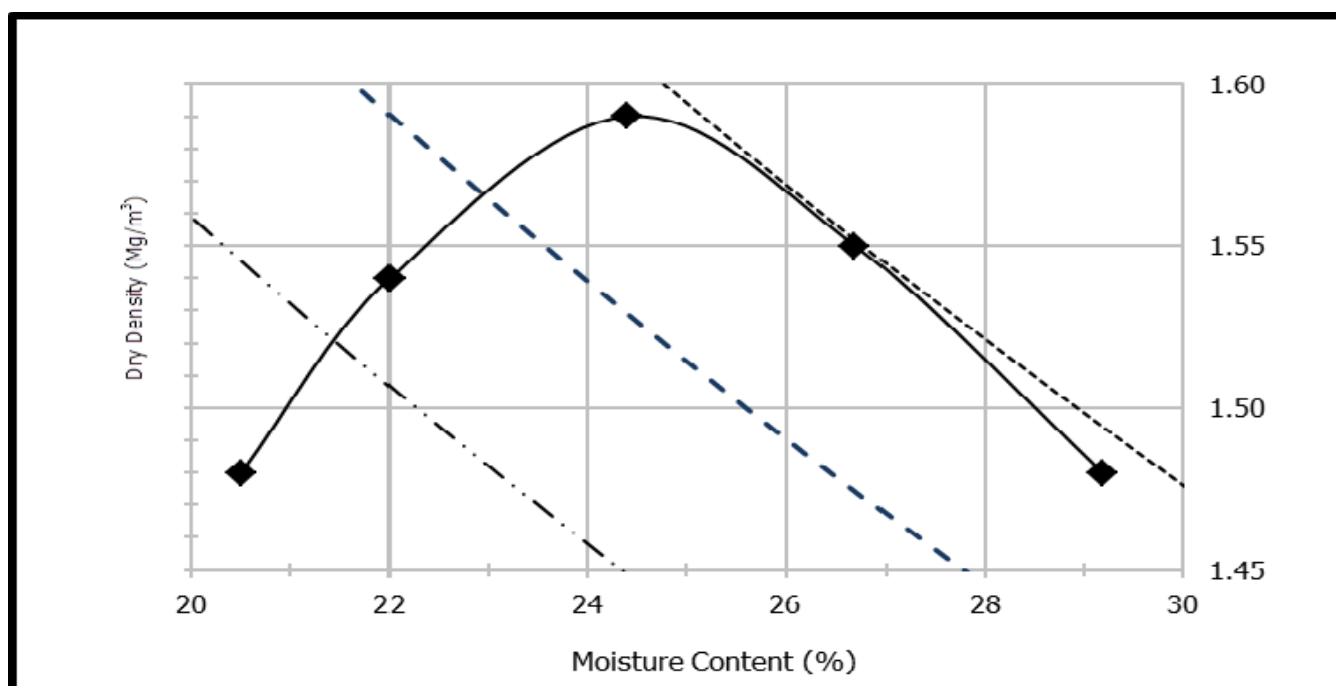
**OPTIMUM MOISTURE CONTENT (%):** 20.8

**MAXIMUM DRY DENSITY ( $\text{Mg/m}^3$ ):** 1.69

Comments: Air Voids Lines plotted at 0%, 5% and 10% Values

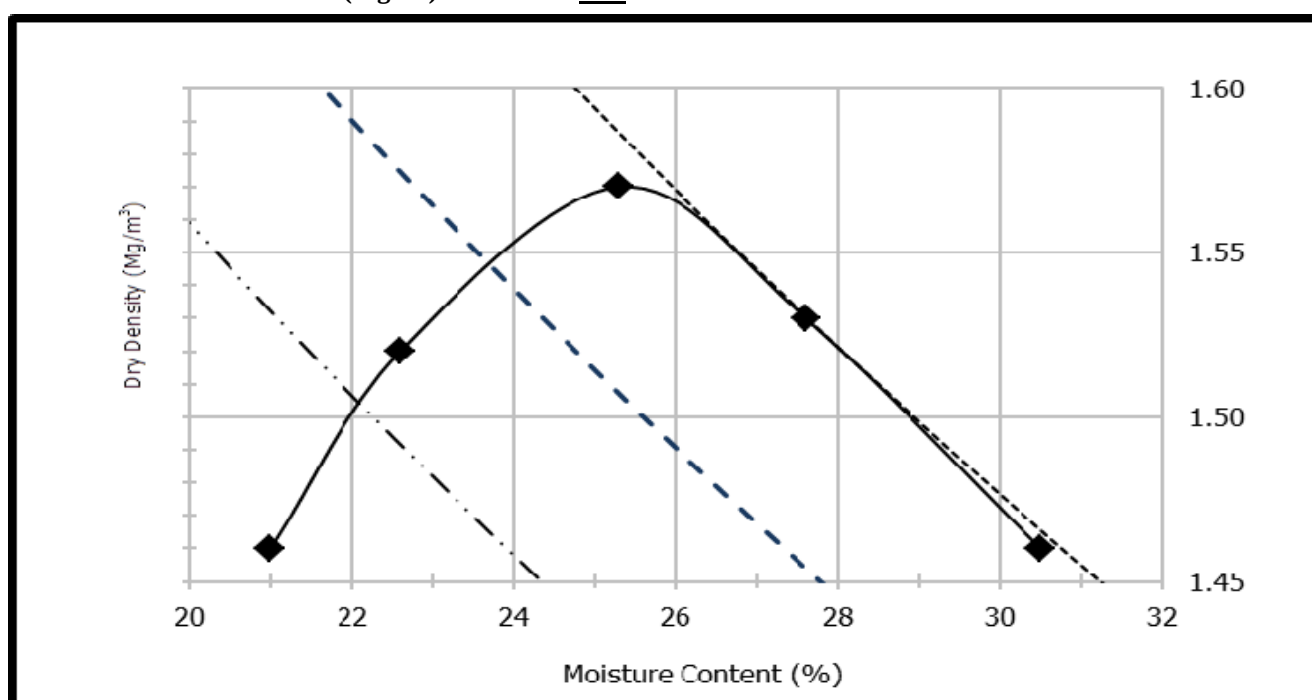
**OPTIMUM MOISTURE CONTENT (%):** 25.3

**MAXIMUM DRY DENSITY ( $\text{Mg/m}^3$ ):** 1.57

Comments: Air Voids Lines plotted at 0%, 5% and 10% Values

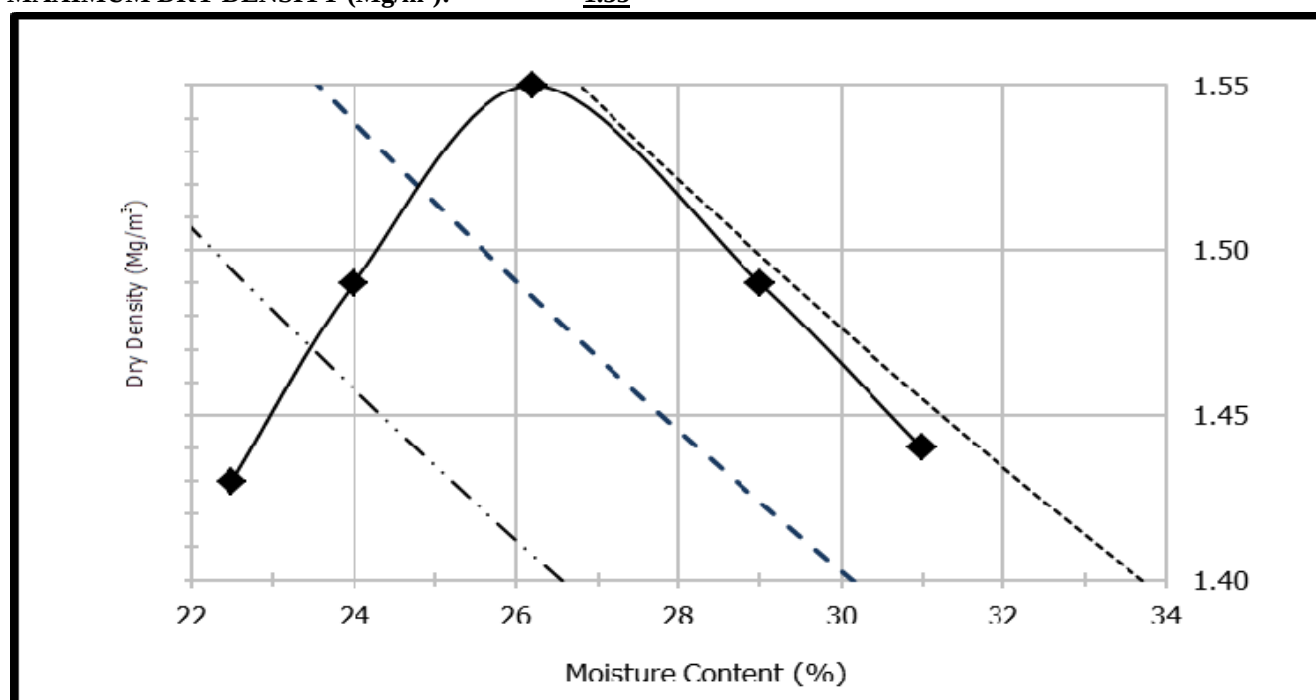
**OPTIMUM MOISTURE CONTENT (%):** 26.2

**MAXIMUM DRY DENSITY ( $\text{Mg/m}^3$ ):** 1.55

Comments: Air Voids Lines plotted at 0%, 5% and 10% Values

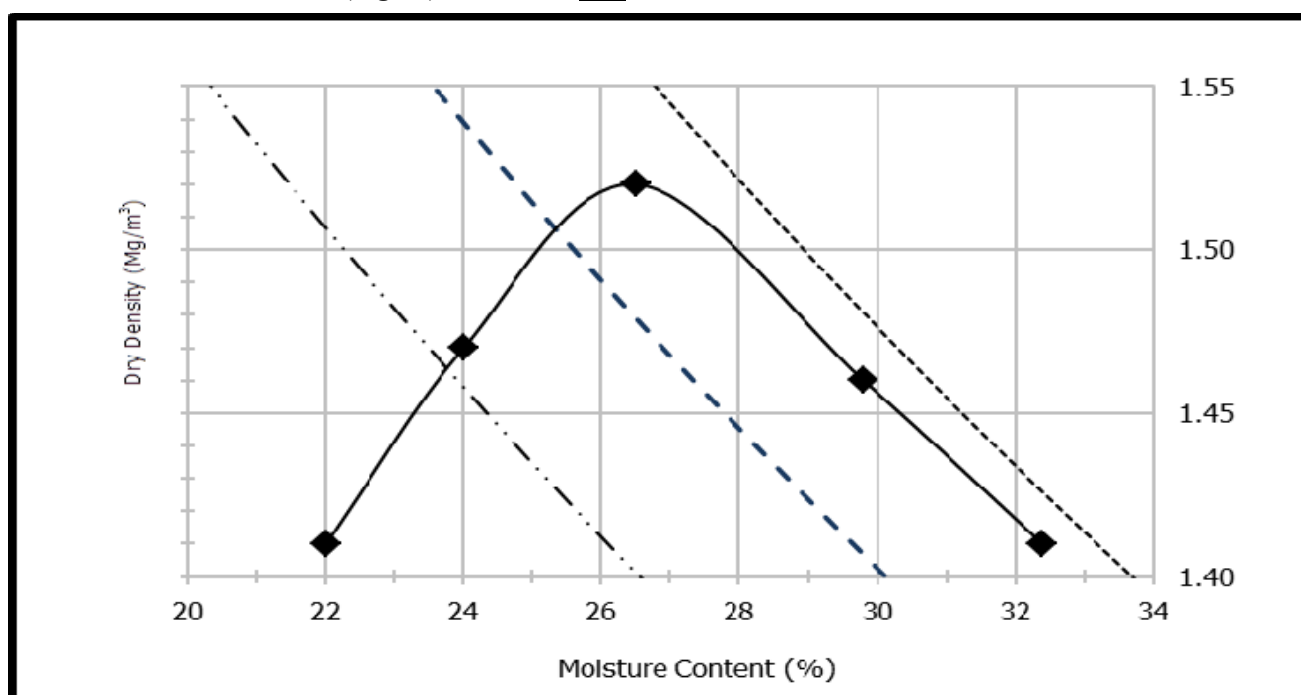
**OPTIMUM MOISTURE CONTENT (%):** 26.5

**MAXIMUM DRY DENSITY ( $\text{Mg/m}^3$ ):** 1.52

Comments: Air Voids Lines plotted at 0%, 5% and 10% Values

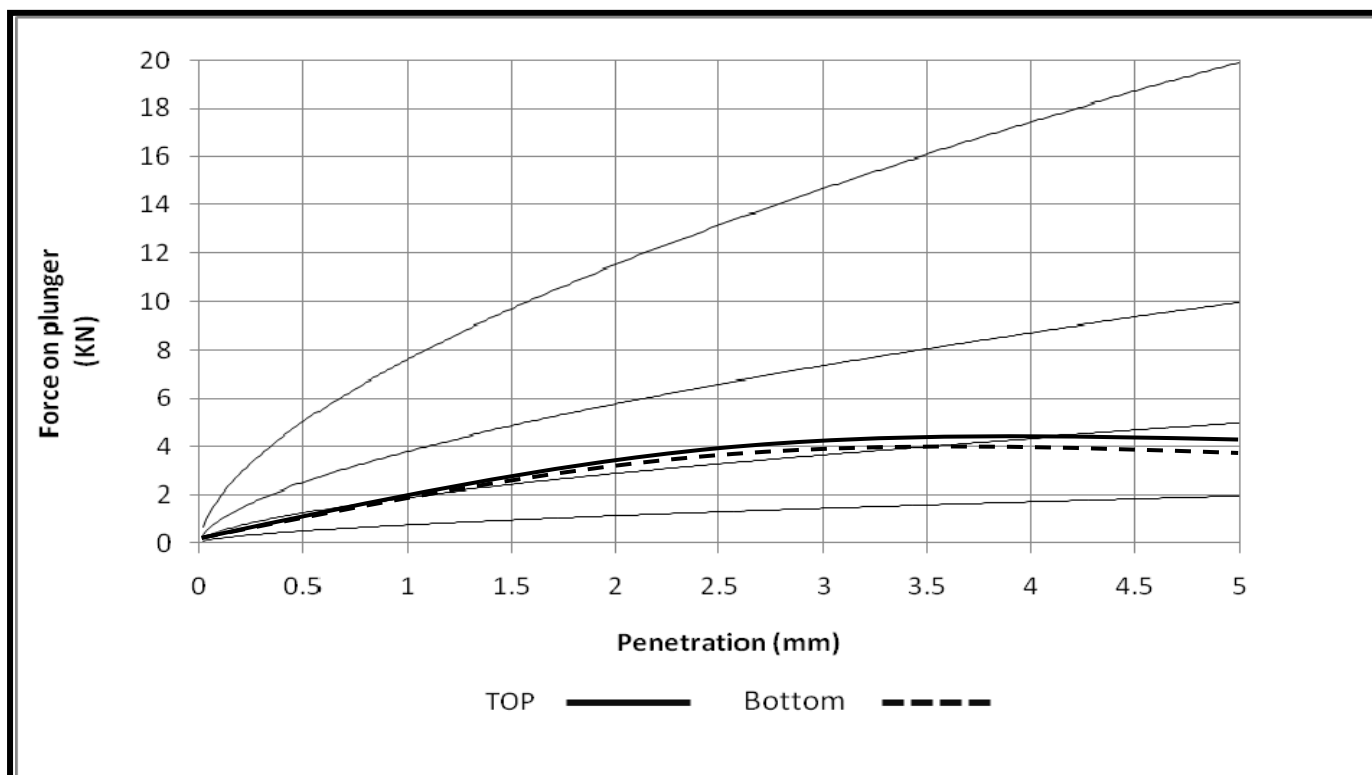
| INITIAL SAMPLE CONDITIONS | | TEST CONDITIONS | | Method of compaction: | |
|---|---|---|---|---|---|
| Dry Density (measured) Mg/m <sup>3</sup> : | 1.72 | Swelling mm: | - | Sample Bottom | 27.8 |
| Percentage retained on 20mm BS test sieve: | 16 | Remarks: Tested in accordance with BS1377: 1990 Part 4<br>Sample preparation method 2.5kg rammer | | | |

Sample Preparation: In accordance with BS 1377-4: 1990 : Clause 7.2.4.4. Moisture Content determined in accordance with BS 1377-2: 1990 Clause 3.2.  
CBR Tested in accordance with BS 1377-4: 1990 Clause 7

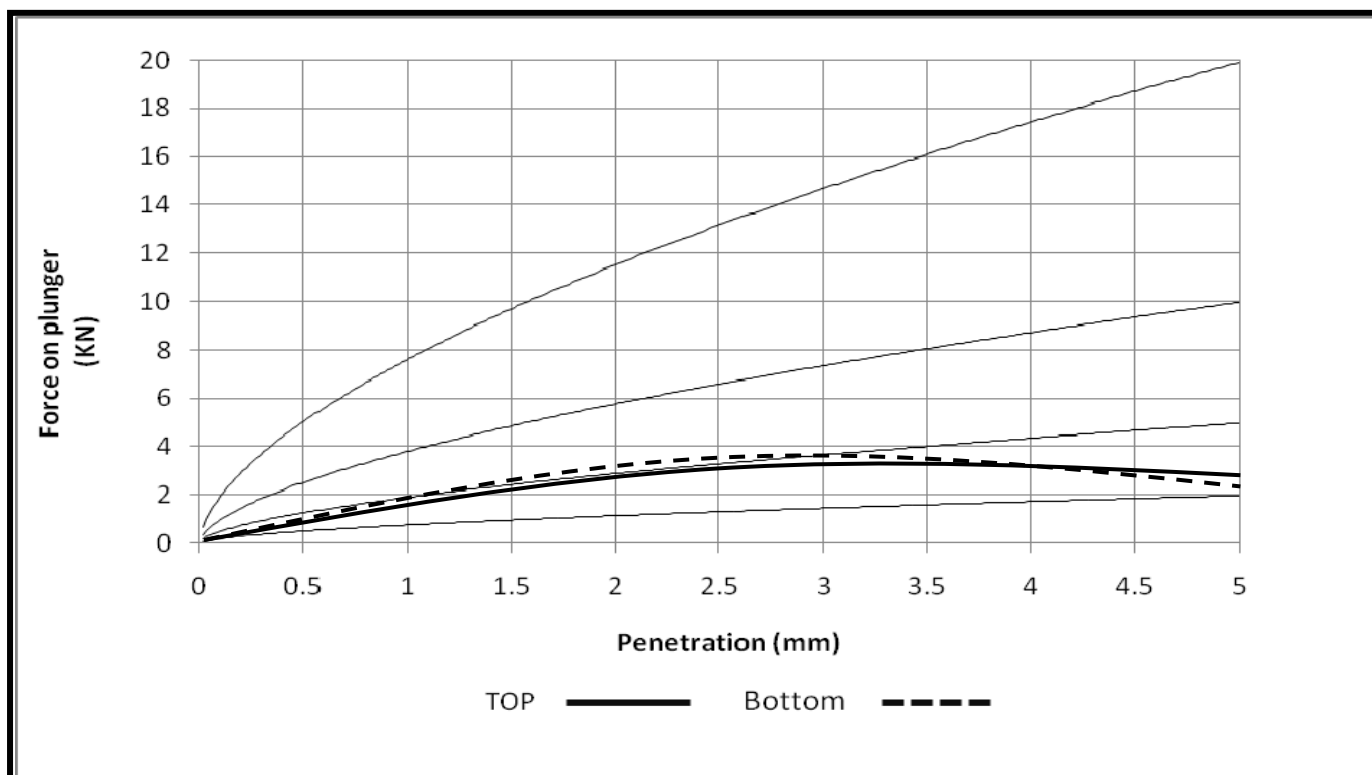
| INITIAL SAMPLE CONDITIONS | | TEST CONDITIONS | | Method of compaction: | |
|---|---|---|---|---|---|
| Dry Density (measured) Mg/m <sup>3</sup> : | 1.70 | Swelling mm: | - | Sample Bottom | 30.5 |
| Percentage retained on 20mm BS test sieve: | - | Remarks: Tested in accordance with BS1377: 1990 Part 4<br>Sample preparation method 2.5kg rammer | | | |

Sample Preparation: In accordance with BS 1377-4: 1990 : Clause 7.2.4.4. Moisture Content determined in accordance with BS 1377-2: 1990 Clause 3.2.  
CBR Tested in accordance with BS 1377-4: 1990 Clause 7

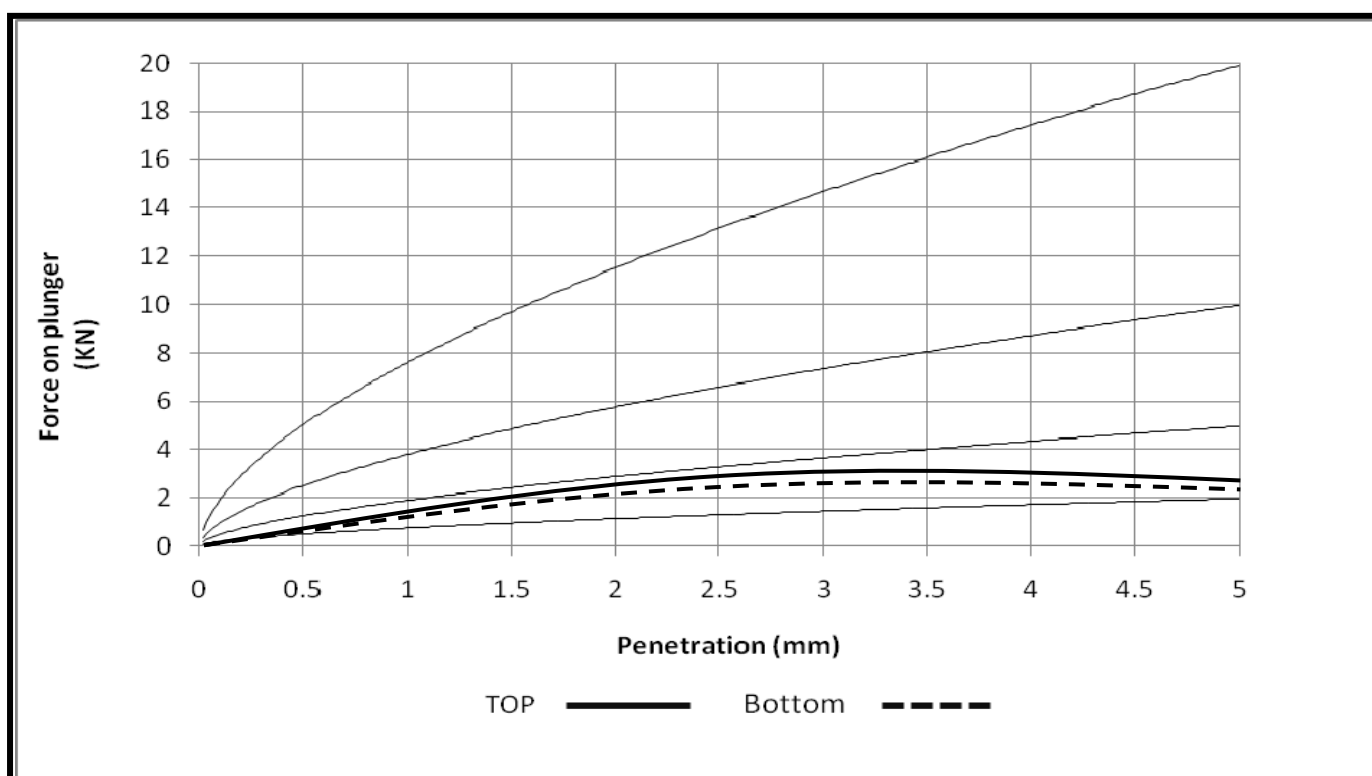
| INITIAL SAMPLE CONDITIONS | | TEST CONDITIONS | | Method of compaction: | |
|---|---|---|---|---|---|
| Dry Density (measured) Mg/m <sup>3</sup> : | 1.70 | Swelling mm: | - | Sample Bottom | 31.5 |
| Percentage retained on 20mm BS test sieve: | - | Remarks: Tested in accordance with BS1377: 1990 Part 4<br>Sample preparation method 2.5kg rammer | | | |

Sample Preparation: In accordance with BS 1377-4: 1990 : Clause 7.2.4.4. Moisture Content determined in accordance with BS 1377-2: 1990 Clause 3.2.  
CBR Tested in accordance with BS 1377-4: 1990 Clause 7

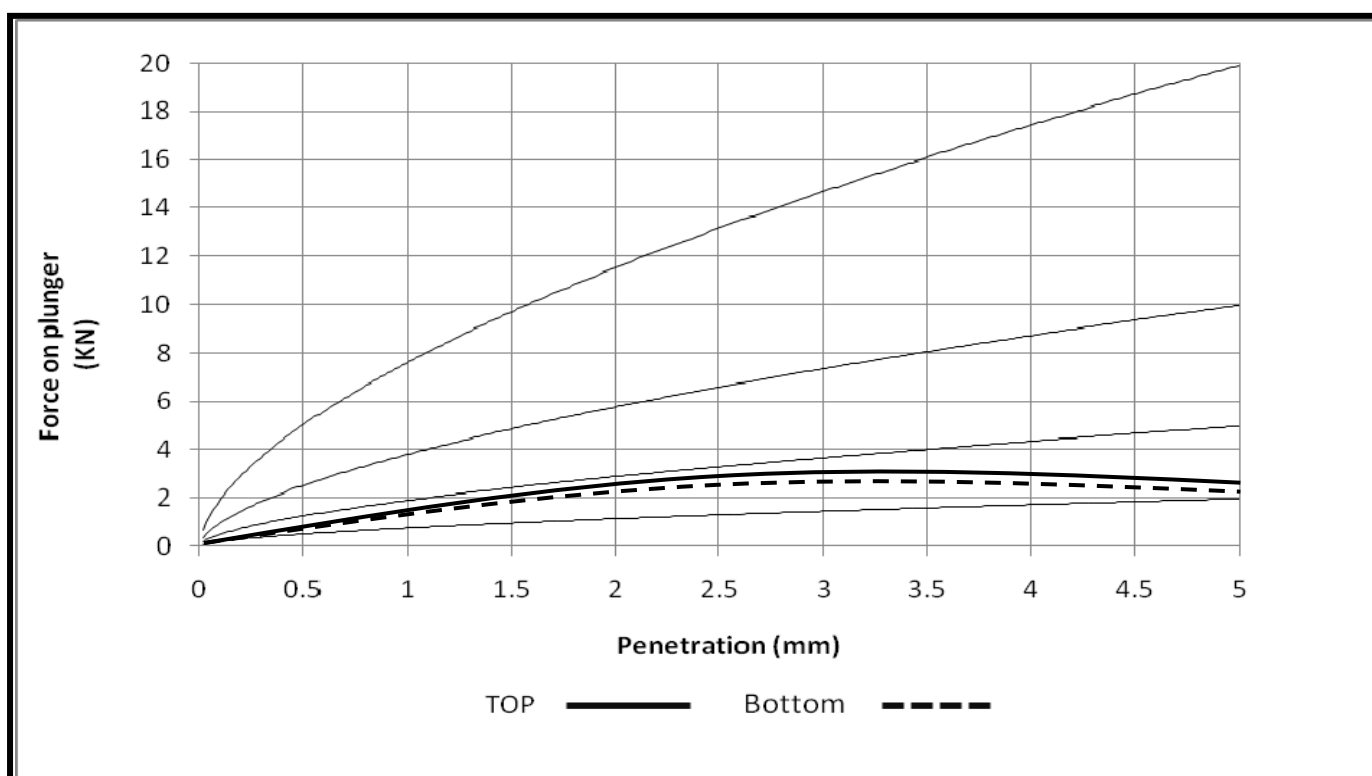
| INITIAL SAMPLE CONDITIONS | | TEST CONDITIONS | | Method of compaction: | |
|---|---|---|---|---|---|
| Dry Density (measured) Mg/m <sup>3</sup> : | 1.71 | Swelling mm: | - | Sample Bottom | 30.9 |
| Percentage retained on 20mm BS test sieve: | - | Remarks: Tested in accordance with BS1377: 1990 Part 4<br>Sample preparation method 2.5kg rammer | | | |

Sample Preparation: In accordance with BS 1377-4: 1990 : Clause 7.2.4.4. Moisture Content determined in accordance with BS 1377-2: 1990 Clause 3.2.  
CBR Tested in accordance with BS 1377-4: 1990 Clause 7

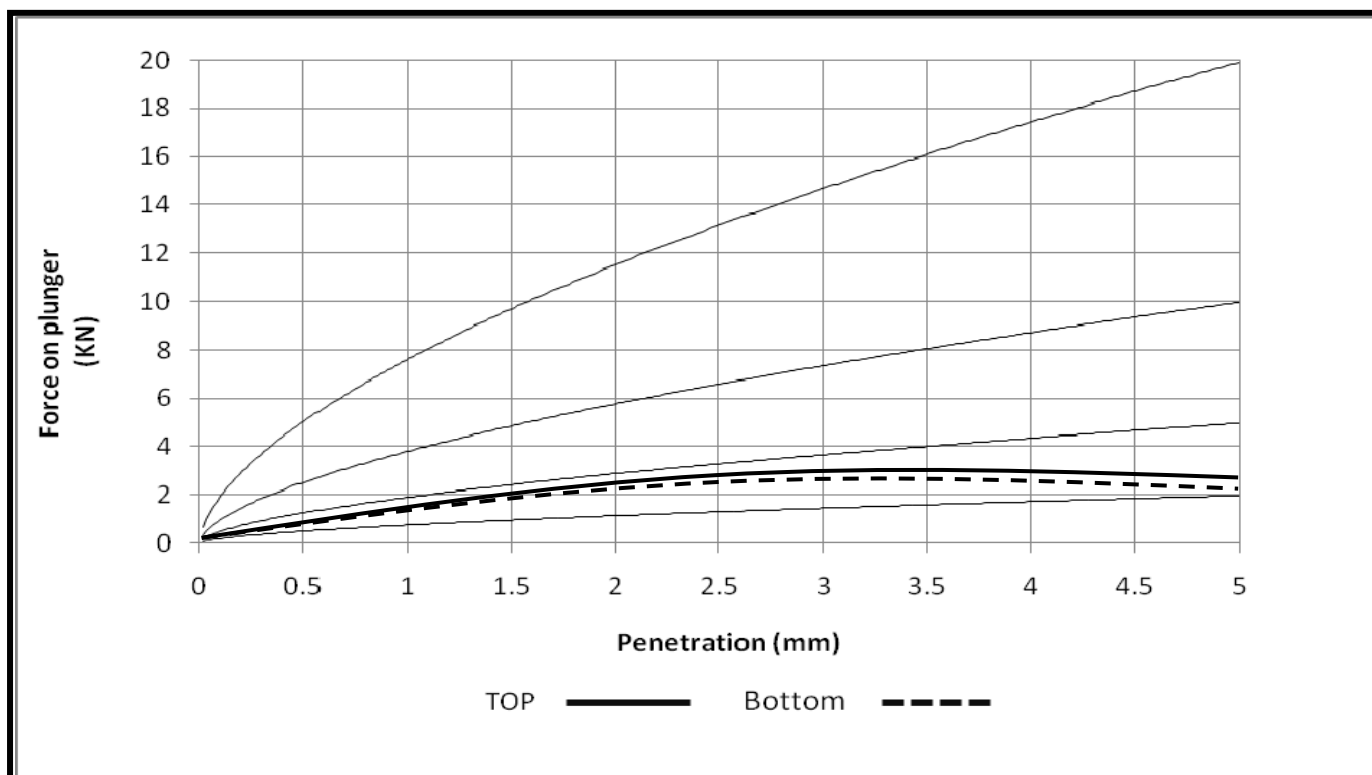
| INITIAL SAMPLE CONDITIONS | | TEST CONDITIONS | | Method of compaction: | |
|---|---|---|---|---|---|
| Dry Density (measured) Mg/m <sup>3</sup> : | 1.71 | Swelling mm: | - | Sample Bottom | 32.4 |
| Percentage retained on 20mm BS test sieve: | - | Remarks: Tested in accordance with BS1377: 1990 Part 4<br>Sample preparation method 2.5kg rammer | | | |

Sample Preparation: In accordance with BS 1377-4: 1990 : Clause 7.2.4.4. Moisture Content determined in accordance with BS 1377-2: 1990 Clause 3.2.  
CBR Tested in accordance with BS 1377-4: 1990 Clause 7

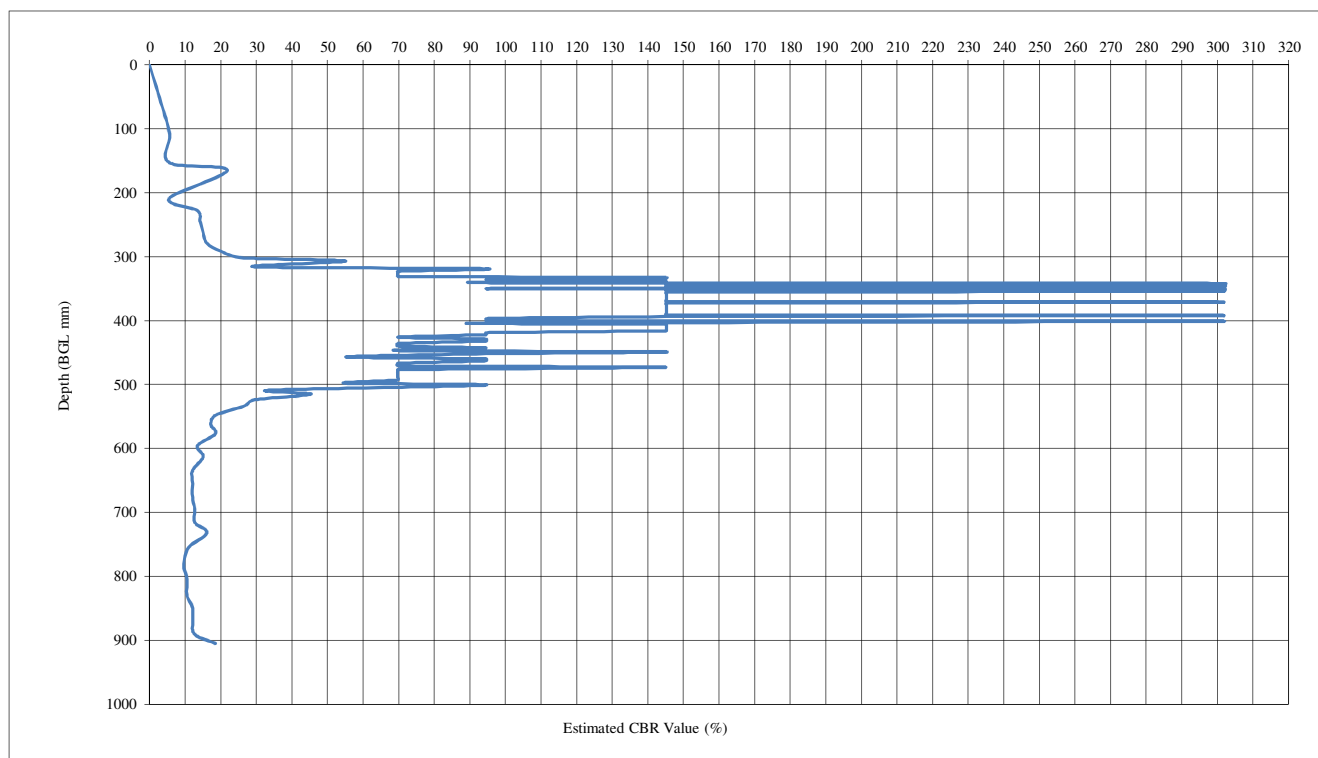
#### Estimated California Bearing Ratio Graph

| Start Depth (mm) BGL | Finish Depth (mm) BGL | No. of Blows | Blows Per Layer | DCP mm/Blows | Ave Estimated Layer (CBR %) |
| 0 | 209 | 5 | 5 | 41.80 | 6 |

Based on this it is considered that a CBR value of less than 7% is adopted, however it is recommended that this be re-assessed using on site plate load tests on the formation level material.

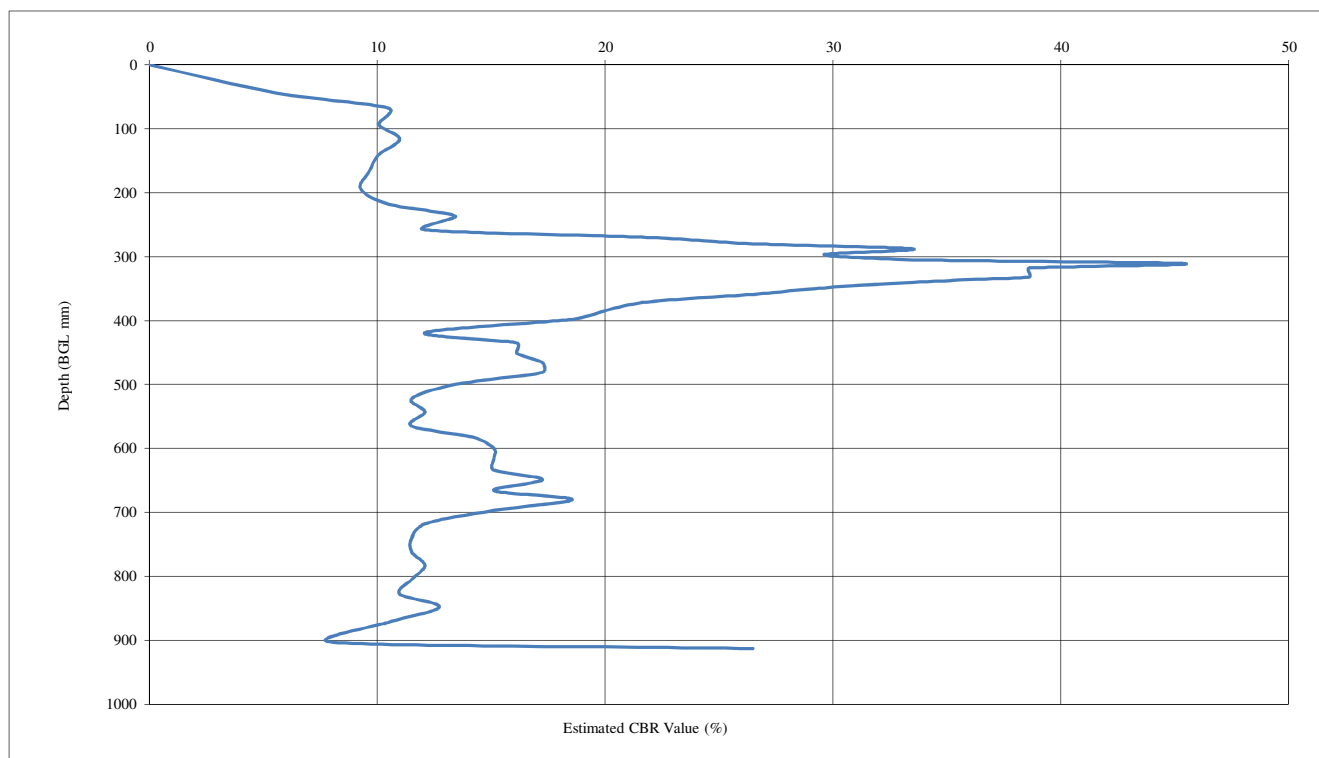
### Estimated California Bearing Ratio Graph

| Start Depth (mm) BGL | Finish Depth (mm) BGL | No. of Blows | Blows Per Layer | DCP mm/Blows | Ave Estimated Layer (CBR %) |
| 0 | 194 | 7 | 7 | 27.71 | 9 |

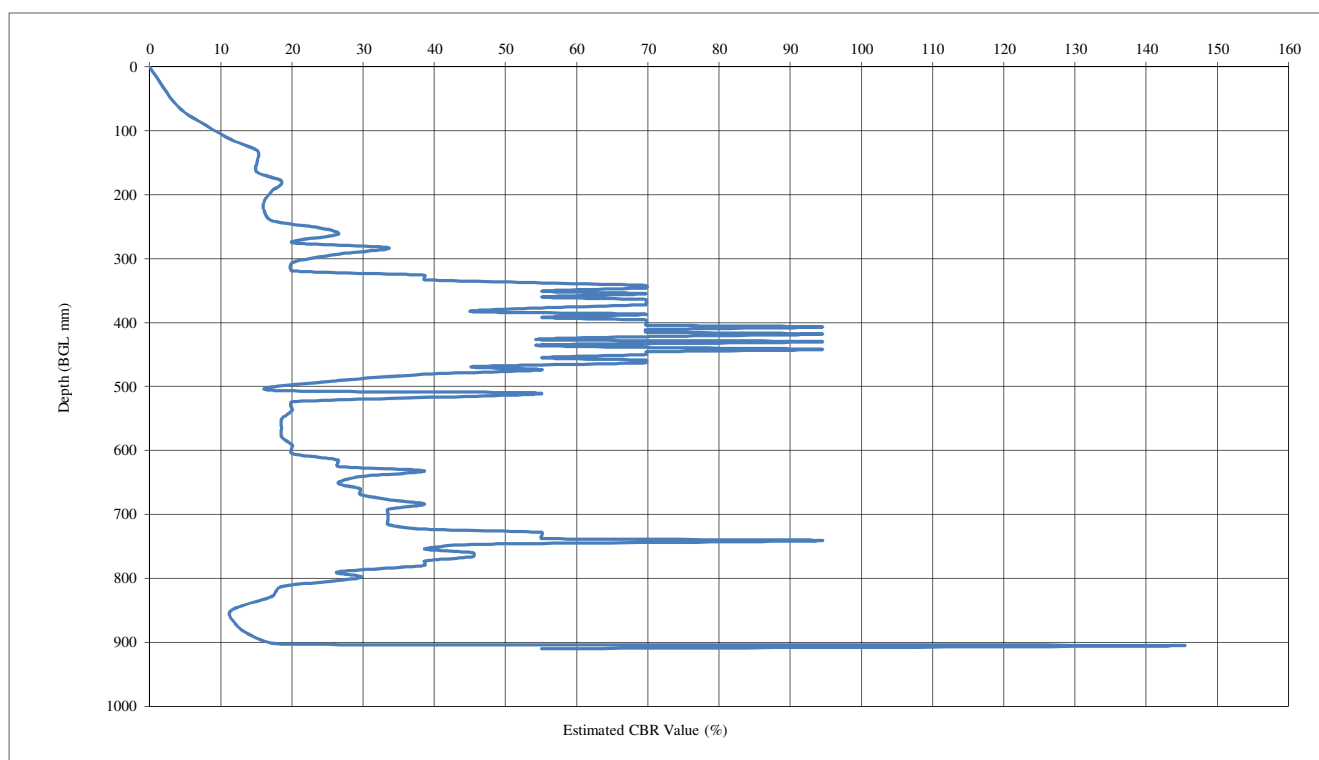
### Estimated California Bearing Ratio Graph

| Start Depth (mm) BGL | Finish Depth (mm) BGL | No. of Blows | Blows Per Layer | DCP mm/Blows | Ave Estimated Layer (CBR %) |
| 0 | 226 | 10 | 10 | 22.60 | 11 |

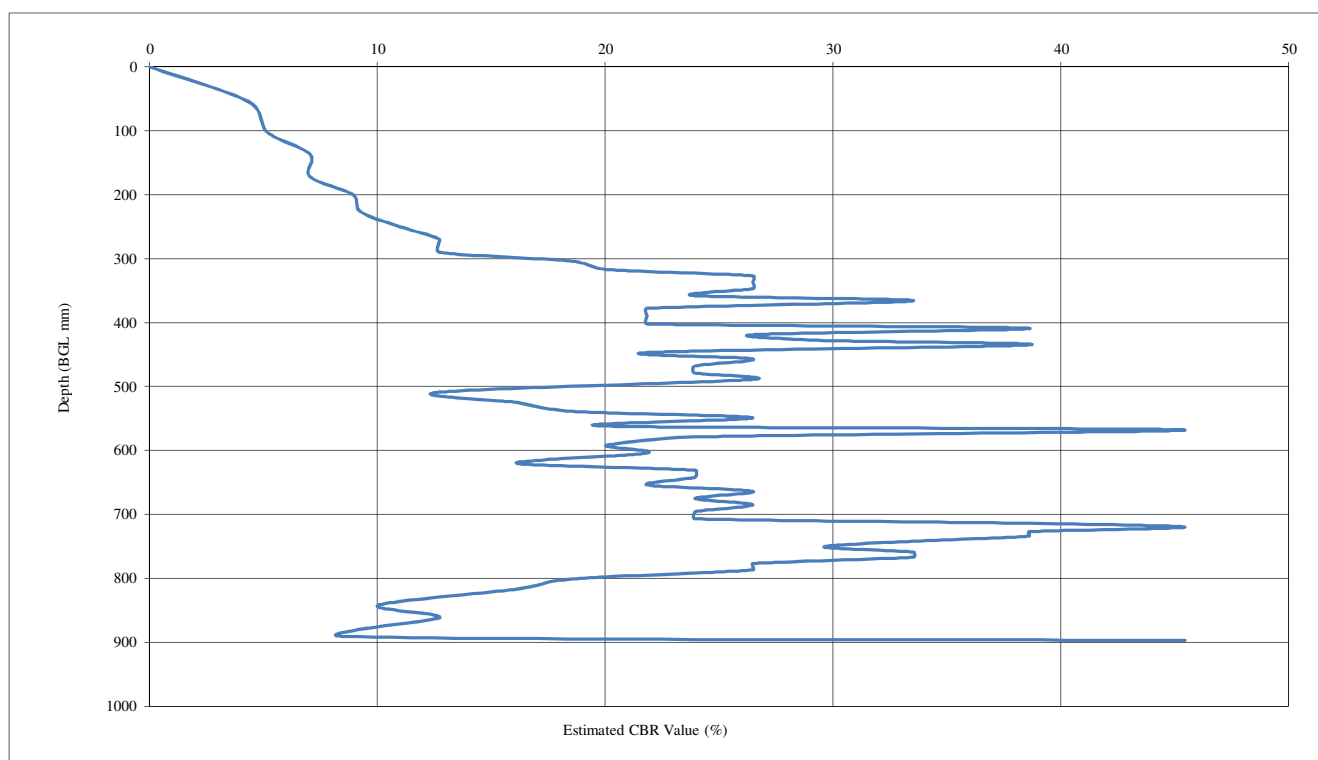
### Estimated California Bearing Ratio Graph

| Start Depth (mm) BGL | Finish Depth (mm) BGL | No. of Blows | Blows Per Layer | DCP mm/Blows | Ave Estimated Layer (CBR %) |
| 0 | 290 | 9 | 9 | 32.22 | 8 |

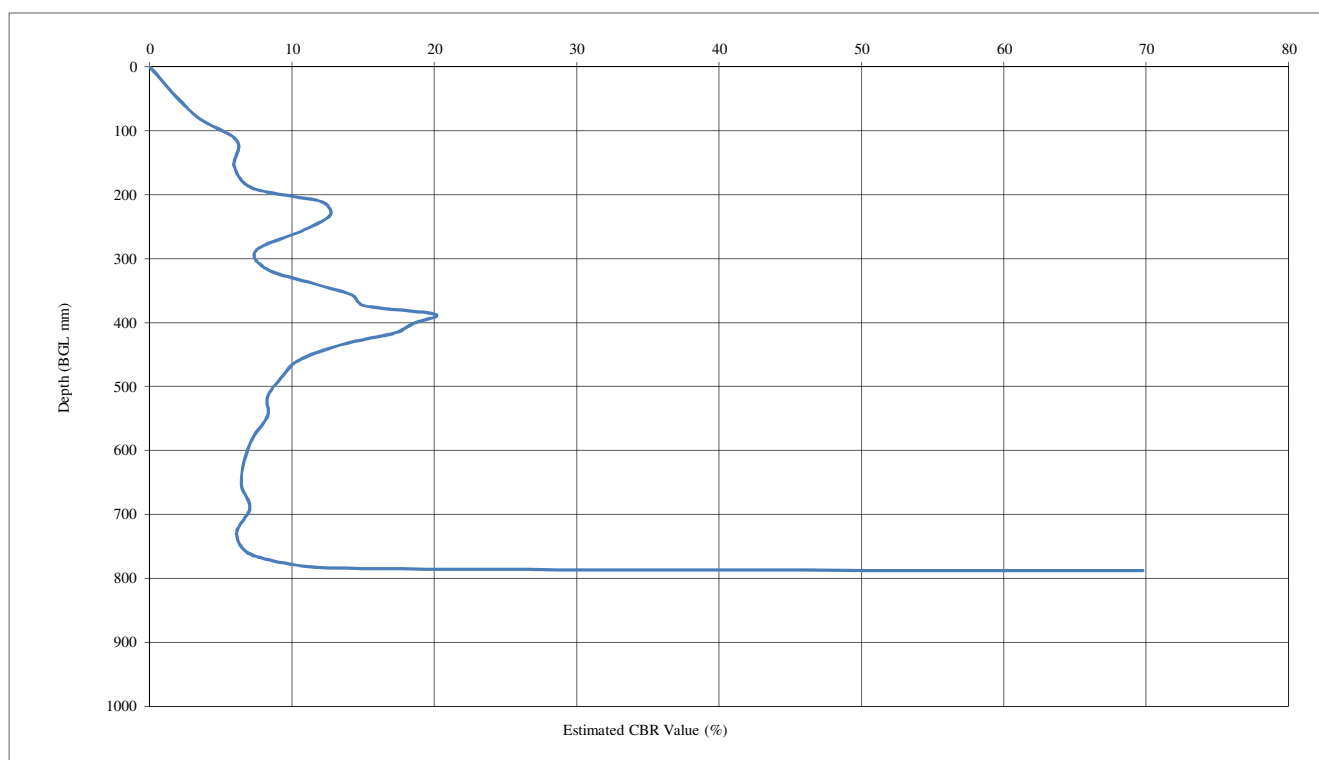
#### Estimated California Bearing Ratio Graph

| Start Depth (mm) BGL | Finish Depth (mm) BGL | No. of Blows | Blows Per Layer | DCP mm/Blows | Ave Estimated Layer (CBR %) |
| 0 | 196 | 3 | 3 | 65.33 | 4 |

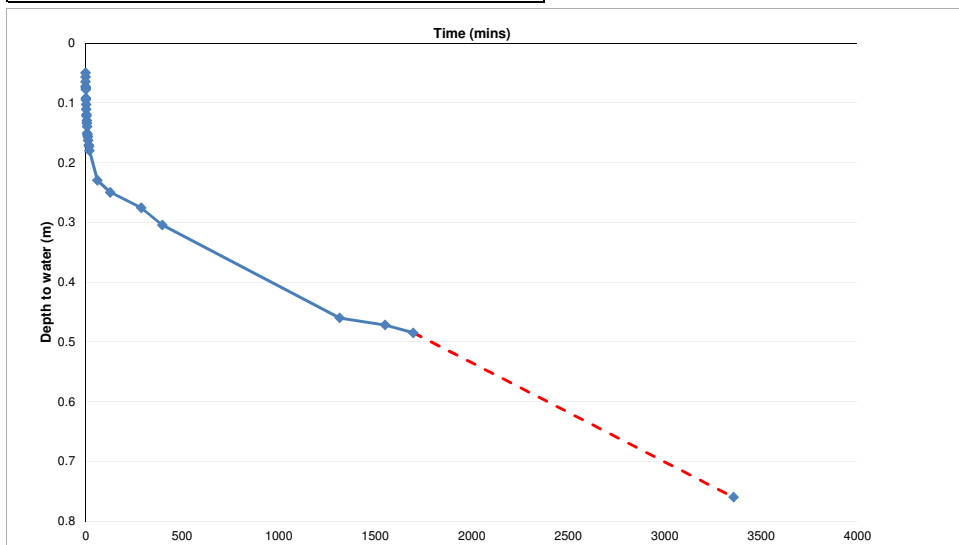
| SOIL INFILTRATION RATE | m/s | 8.96E-07 (extrapolated data) | |

| DESIGN SOIL INFILTRATION RATE, $f$ | 8.96E-07 |

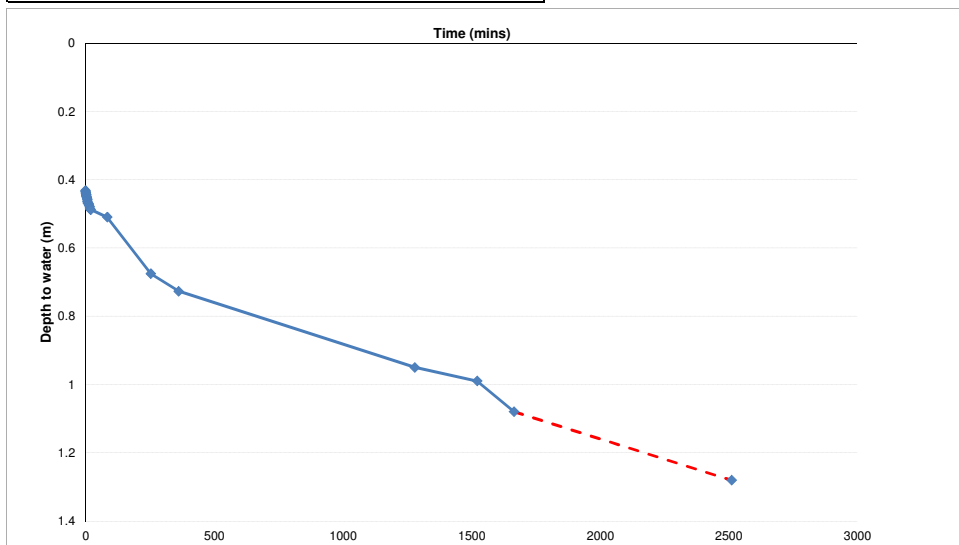
| | | Site <b>Horndean Road, Emsworth</b><br>Job Number <b>20568</b><br>Date of Test <b>03/10/2013</b> | Trial Pit Number <b>TP102</b><br>Length..... <b>2.00</b> m<br>Width..... <b>0.65</b> m<br>Depth..... <b>1.50</b> m<br>Groundwater Level..... <b>n/a</b> |
|---|---|---|---|
| SOIL INFILTRATION RATE | m/s | 1.91E-06 (extrapolated data) | |

| DESIGN SOIL INFILTRATION RATE, $f$ | 1.91E-06 |

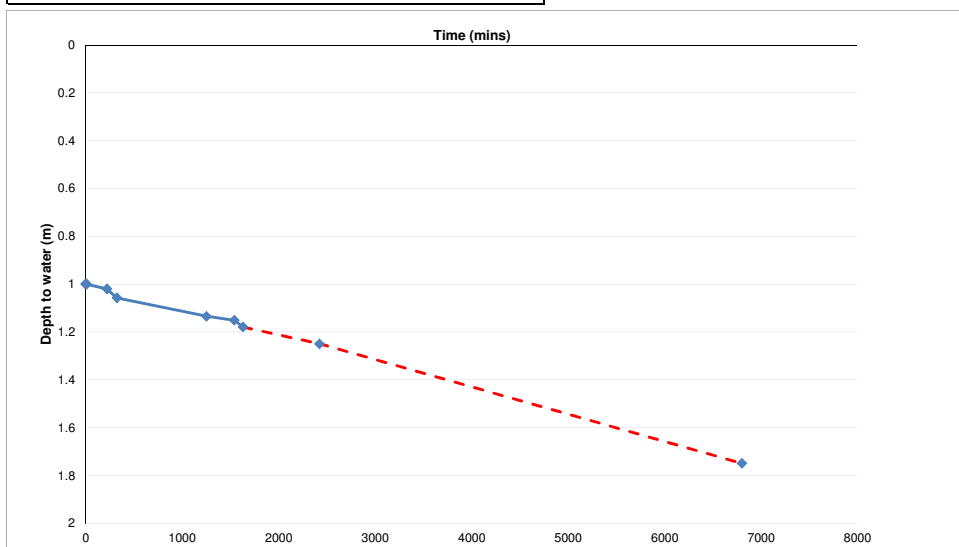
| SOIL INFILTRATION RATE      m/s | 9.51E-07 (extrapolated data) | | |

| DESIGN SOIL INFILTRATION RATE, $f$ | 9.51E-07 |

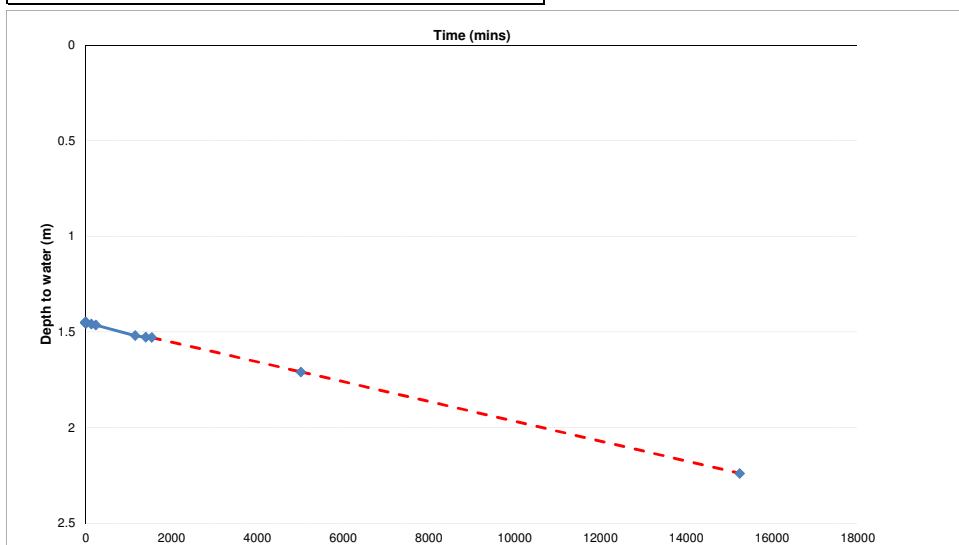
| SOIL INFILTRATION RATE | m/s | 4.07E-07 | (extrapolated data) |

| DESIGN SOIL INFILTRATION RATE, $f$ | 4.07E-07 |

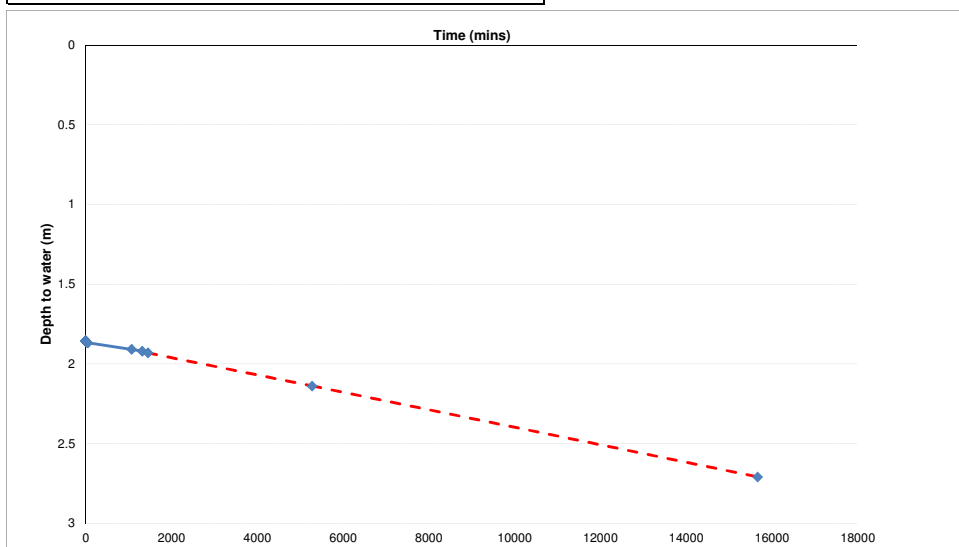
| <div>REC</div> <div>Resource &amp; Environmental Consultants Ltd</div> | | Site<br>Job Number<br>Date of Test | | Horndean Road, Emsworth<br>20568<br>04/10/2013 | | Trial Pit Number<br>Length.....<br>Width.....<br>Depth.....<br>Groundwater Level..... | | TP109<br>1.50 m<br>0.65 m<br>0.50 m<br>n/a | |
| SOIL INFILTRATION RATE | m/s | 1.26E-04 | 9.12E-05 | 7.83E-05 | | | | | |

| DESIGN SOIL INFILTRATION RATE, $f$ | 7.83E-05 |

Soakaway infiltration tests need to be carried out three times in accordance to BRE guidance. This was only able to be completed on one of the positions (TP109) as the first test on all the other trial pits did not reach the 75 percentile for soil infiltration. Five of the tests were fenced and left to run overnight, but still failed to reach the 75 percentile for soil infiltration. The results of the infiltration testing are summarised in Table 8.2 below and full infiltration testing results are presented in Appendix VIII.

The fact that only one of the trial pits (TP109) was able to be run three times, in line with BRE365, indicates that only shallow soakaways may be viable for the site using the gravels as a receiving strata for surface water drainage. The limited infiltration characteristics of the cohesive materials on site indicate that it would be suitable for use off site in the construction of engineered bund walls for a balancing pond feature.

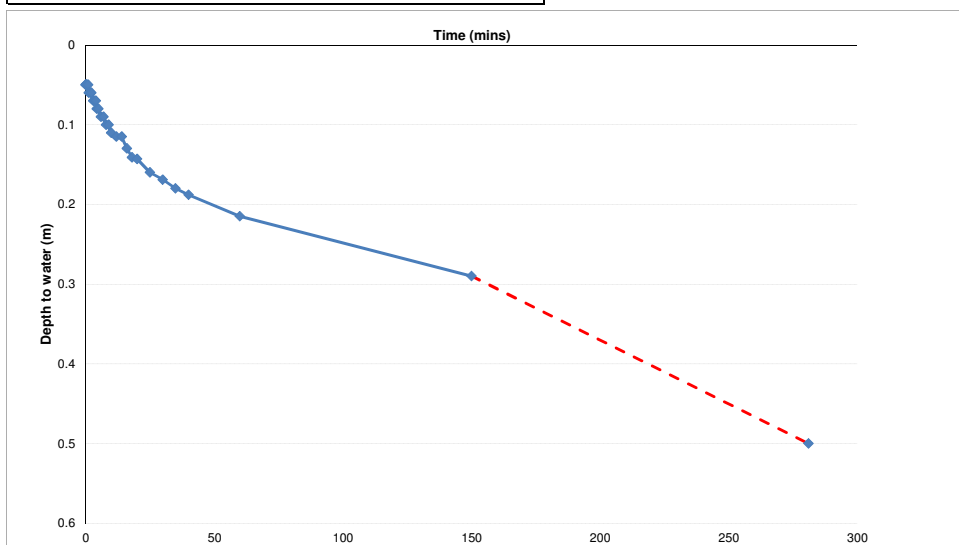
| SOIL INFILTRATION RATE | m/s | 1.59E-05 (extrapolated data) | |

| DESIGN SOIL INFILTRATION RATE, $f$ | 1.59E-05 |
