# **Dunsbury Hill Business Park**

## **Dormouse Licence - Method**

### **Statement Document 1: Background and Supporting Information**

Portsmouth City Council

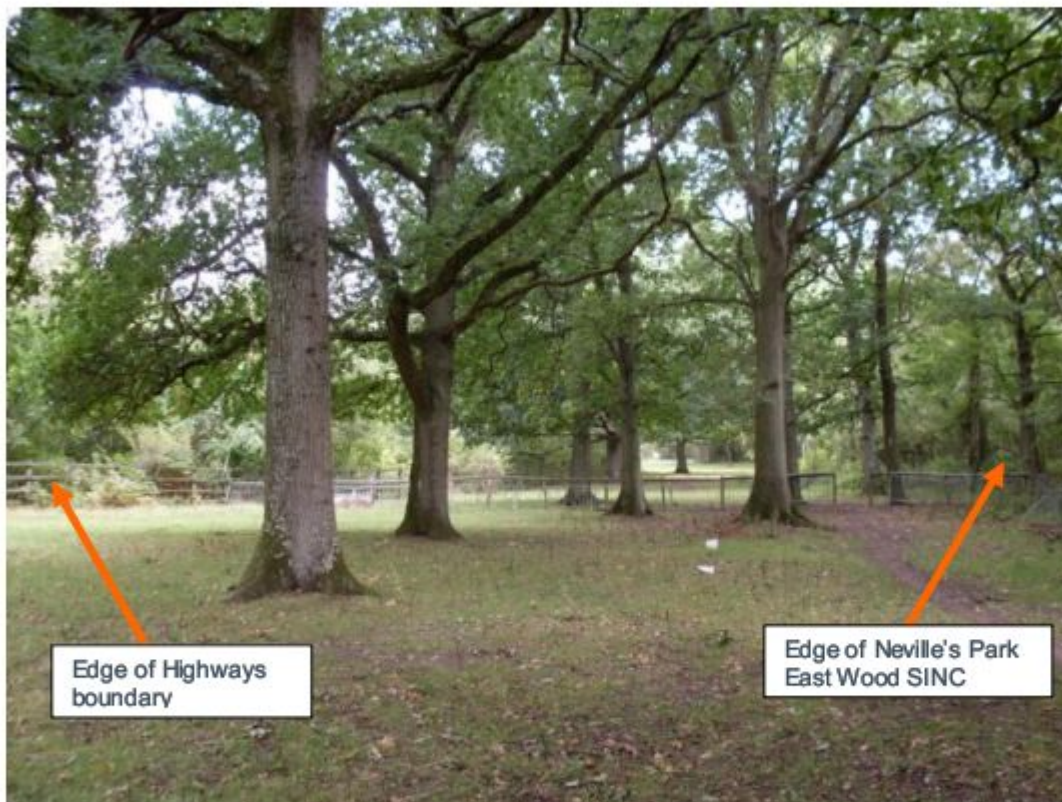
**Photograph 2** – View of trees to be cleared for the link road
