# SUBADRA

Ref : In12963 CL 013

## Verification Groundwater Monitoring Works – Retail Trade Park Phase I, Solent Road, Havant

### 1.3 Verification Monitoring Works – 20<sup>th</sup> August 2014

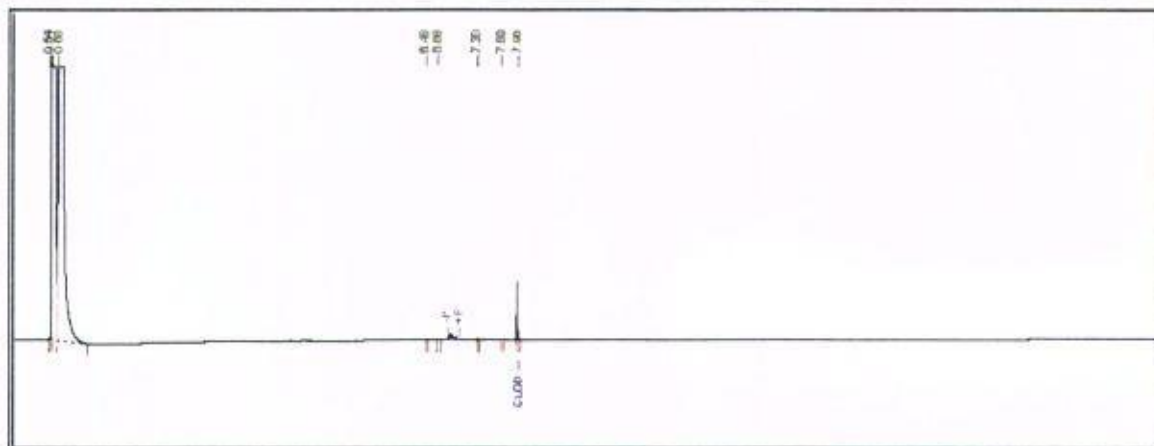
| VES<br>(ml) | MES<br>(g) | CRF | BSV | Results | | | | |
|---|---|---|---|---|---|---|---|---|
| 3 | 124.98 | 0.74 | 0.00 | <10 | <10 | <10 | <10 | <10 |

Gas Chromatogram for Sample
