## ADDITIONAL SITE INVESTIGATION REPORT

**Trade Park - Phase II  
Solent Road, Havant, Hampshire**

Report No: In12963 CL 009

October 2013

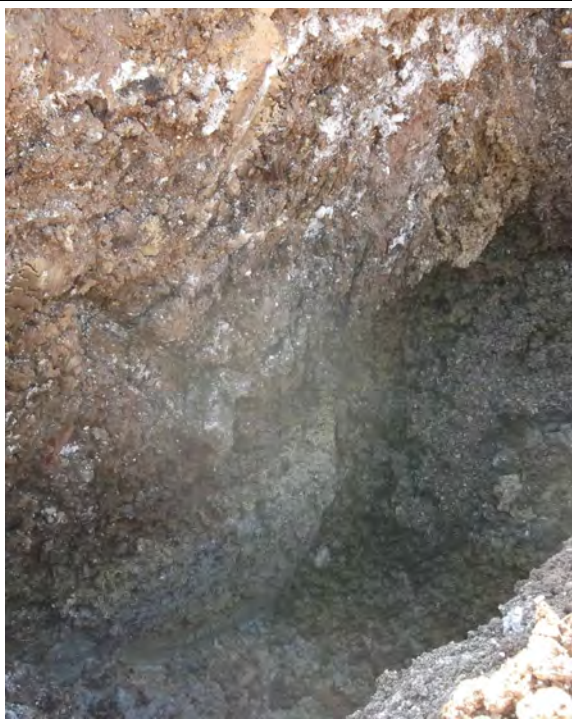
| Location | Item | Description / Comment |
|---|---|---|
| | Geology | 0.0 – 0.7m - Made Ground – Soft to firm brown or beige brown clay with brick and concrete rubble, chalk fragments and flint.<br>0.7 – 1.5m - Alluvium – Soft to firm brown grey sandy clay with frequent flint gravel.<br>1.5 - >2.3m - Alluvium / River Terrace Deposits – loose to medium dense light creamy grey chalky very clayey flint gravel or flint gravely clay. |
| | Observed Contamination | None. No odours or hydrocarbon sheen noted. |
| Photograph One – TP1. Shallow Made Ground and Alluvium | | Photograph Two – TP1. Flint gravelly River Terrace Deposits (?) at ~1.7m. |

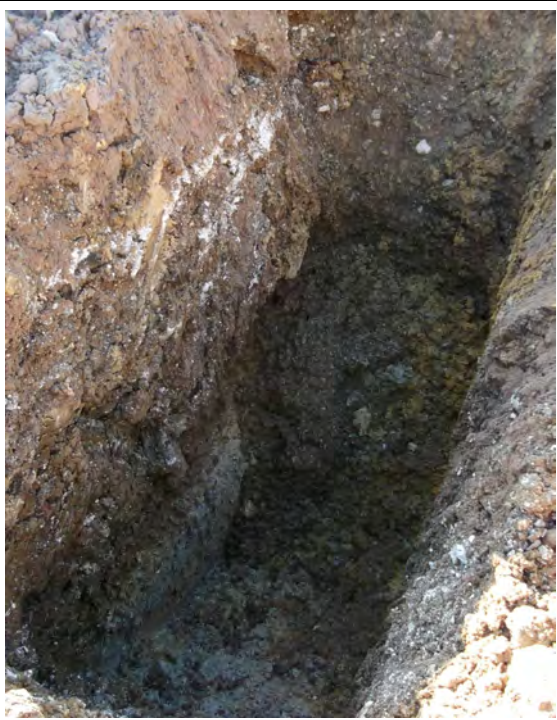
| Location | Item | Description / Comment |
|---|---|---|
| | Groundwater | Groundwater ingress from gravely soils at around 2.0m depths. |

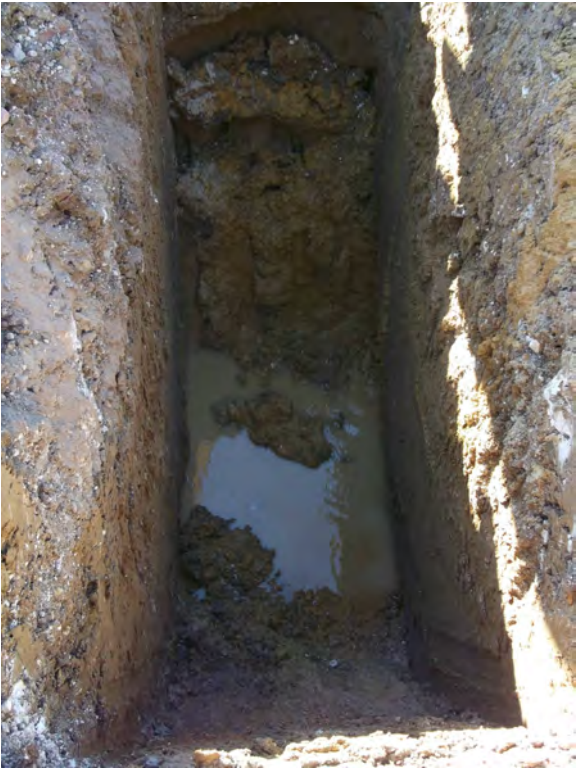
| Location | Item | Description / Comment |
|---|---|---|
| | Groundwater | Groundwater ingress from underlying gravely soils at around 2.0m depths. |
| | Observed Contamination | None noted. No odours or sheens on accumulated groundwater. |
| Photograph Three – TP2. Water ingress noted in the underlying River Terrace Deposits. | | Photograph Four –General view of the south eastern corner of the site. |

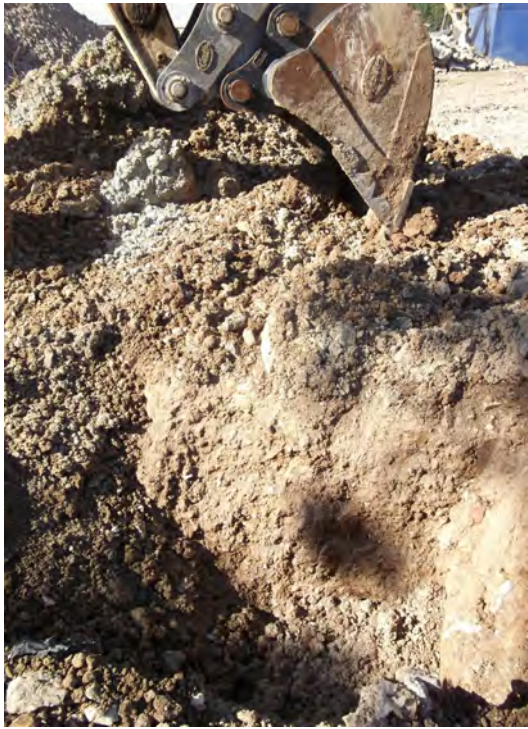
| Location | Item | Description / Comment |
|---|---|---|
| | Geology | 0.0 – 0.8m - Made Ground – Loose brown or beige brown very sandy clayey gravel with brick and concrete rubble, chalk fragments and flint.<br>0.8 – 2.0m – Alluvium? – Loose light brown or creamy brown grey chalky very clayey flint gravel.<br>2.0 – >2.5m - Alluvium – Firm light grey or beige slightly sandy clay with occasional flint gravel. |
| Photograph Five – TP3. Excavating shallow Made Ground | | Photograph Six – Looking northeast across the location of TP3 |

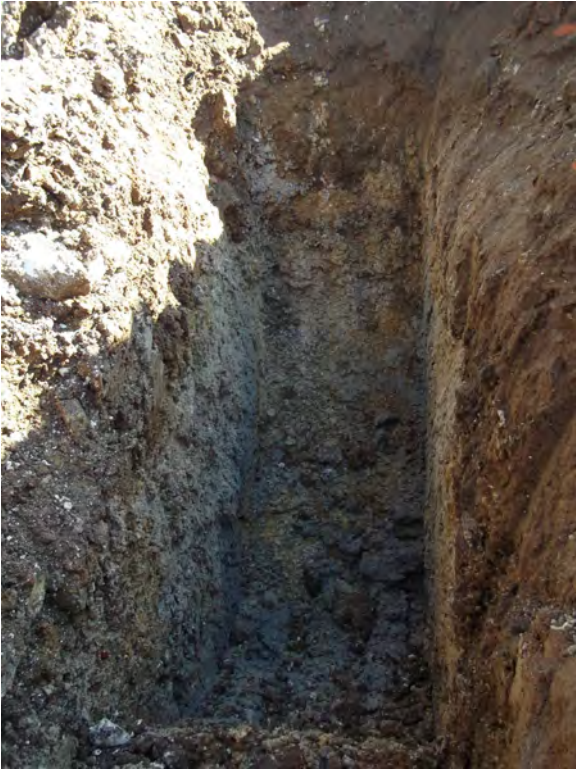
| Location | Item | Description / Comment |
|---|---|---|
| | Geology | 0.0 – 0.7m - Made Ground – Loose brown or beige brown very sandy clayey gravel with brick and concrete rubble, chalk fragments and flint.<br>0.7 – 2.0m – Alluvium? – Loose light brown or creamy brown grey chalky very clayey or chalky flint gravel.<br>2.0 – >2.5m - Alluvium – Firm light grey or beige slightly sandy clay with occasional flint gravel and chalk fragments |
| | Groundwater | No defined water ingress noted. Side walls in the shallow gravel Alluvium generally unstable. |
| Photograph Seven – TP4. Underlying grey alluvial soils exposed. | | Photograph Eight – Looking north / northwest across the location of TP4. |
