## Arboricultural Implications Assessment and Method Statement

**WOODCROFT FARM, WATERLOOVILLE**

Report Ref: **11210 - AIA 2**

Report Date: **12 July 2013**

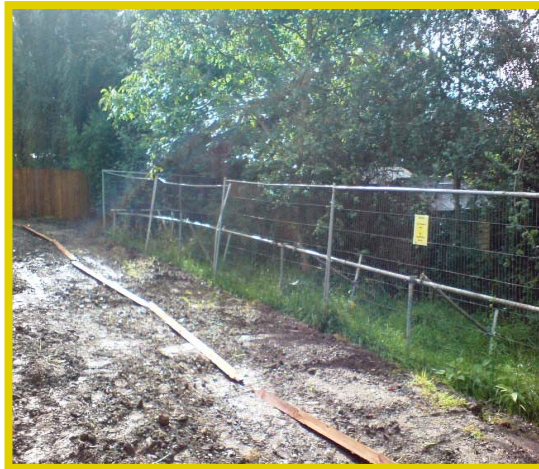
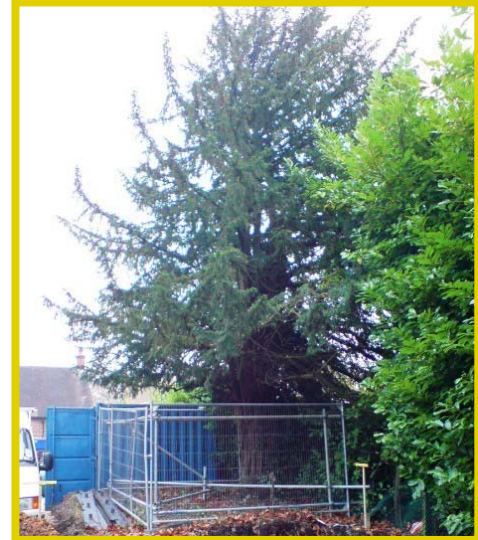
### APPENDIX 3: ILLUSTRATIVE SPECIFICATION FOR TREE PROTECTION BARRIERS

- 1 Standard scaffold poles
- 2 Heavy gauge 2 m tall galvanized tube and welded mesh infill panels
- 3 Panels secured to uprights and cross-members with wire ties
- 4 Ground level
- 5 Uprights driven into the ground until secure (minimum depth 0.6 m)
- 6 Standard scaffold clamps

Illustration taken from British Standard 5837 (2012): Trees in relation to design, demolition and construction – Recommendations.

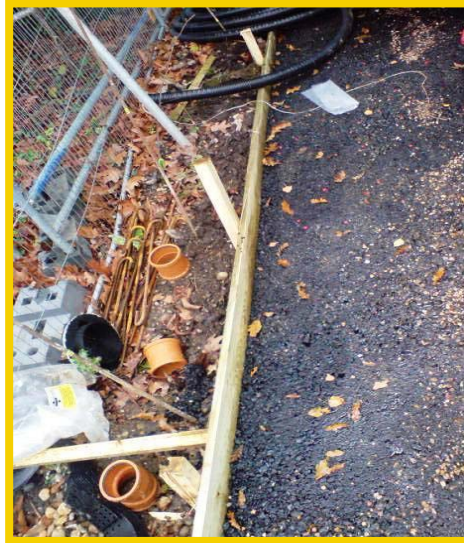
## APPENDIX 4: ILLUSTRATIVE SPECIFICATION FOR 'LOW INVASIVE' TYPE SURFACING IN RPAs

Illustration adapted from original drawings provided by Geosynthetics Ltd.

*Appropriate sub-base options for new hard surfacing include three-dimensional cellular confinement systems. Alternatively, piles, pads or elevated beams can be used to support surfaces to bridge over the RPA or, following exploratory investigations to determine location, to provide support within the RPA while allowing the retention of roots greater than 25 mm in diameter.*

At the current time full engineering drawings for the various new surfacing elements were not available. But, these drawings could be secured by way of a suitably worded planning condition and so could be reviewed by the council prior to implementation. In the meantime, I have provided illustrative specifications for low invasive type surfacing in Appendix 4.
