**The Rose in June  
Hayling Island  
Hampshire**

**Protected Species Survey**

**Date: September 2012**

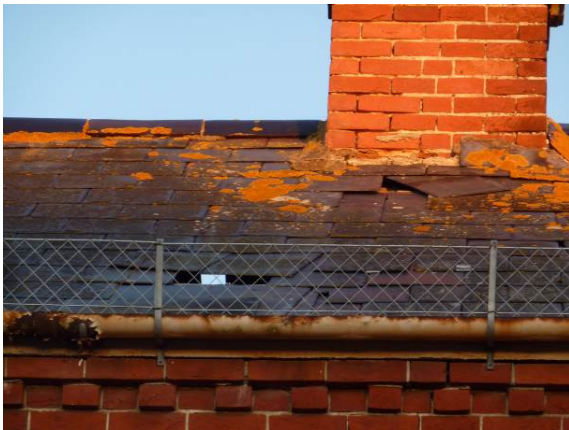
The buildings on site consist of the main public house which is two storey with brick walls and a complex pitched slate covered roof. There were some gaps under ridge tiles and also some slates missing from the east section of the roof. Light could be seen through the roof void showing that slates were missing from areas of the roof which could not be seen from the ground. It also indicated that the roof of the main building did not have a layer of underfelt or sarking boards lining the four sections of roof void. The walls were in good condition with no gaps.

Gaps in main roof

- No bats or other protected species will be affected by the proposed development and no mitigation is required.
- Some of the gaps in the roofs are large enough to allow birds to enter and potentially nest. (feral pigeons were noted on a previous survey). Nesting birds are protected by law (not feral pigeons) and the site should be checked by a competent person prior to work starting. If any active nests are found work should be delayed until the young have fledged.
- If work has not started within 12 months of this report a new bat survey should be undertaken to assess status of the bats and roosts at that time and update the mitigation plan if necessary.

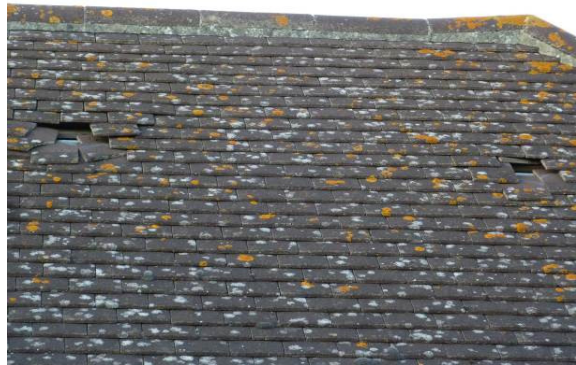
At the rear of the building were a number of modern single storey extensions with brick walls and concrete tiled pitched roofs. There were areas of broken or missing tiles and it could be seen that there was no underfelt or sarking boards lining these roof voids. A number of these gaps were examined with binoculars or endoscope and no signs of bats were found. Many of the gaps under broken tile were covered with cobwebs. The walls were in good condition with no gaps.

Gaps in roof of rear extension

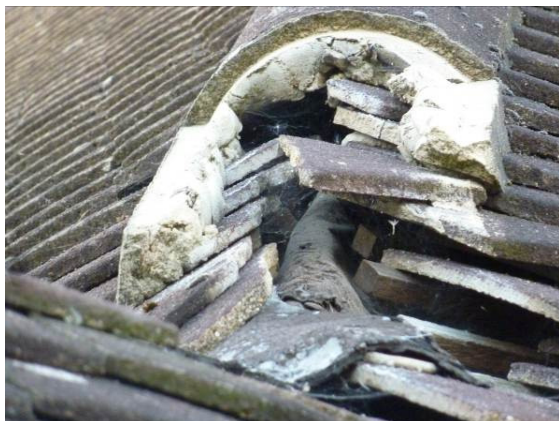
Gaps in roof of rear extension
