# St Michael's Convent, 354 London Road, Waterlooville, PO7 7TF

Method Statement to accompany Natural  
England EPS licence application in respect of  
bats

## Document 2 – Delivery Information

**Method Statement to accompany Natural England EPS licence application in respect of bats**  
**Document 2 – Delivery Information**  
**St Michael's Convent, 354 London Road, Waterlooville, PO7 7TF**  
**for**  
**Linden Homes**

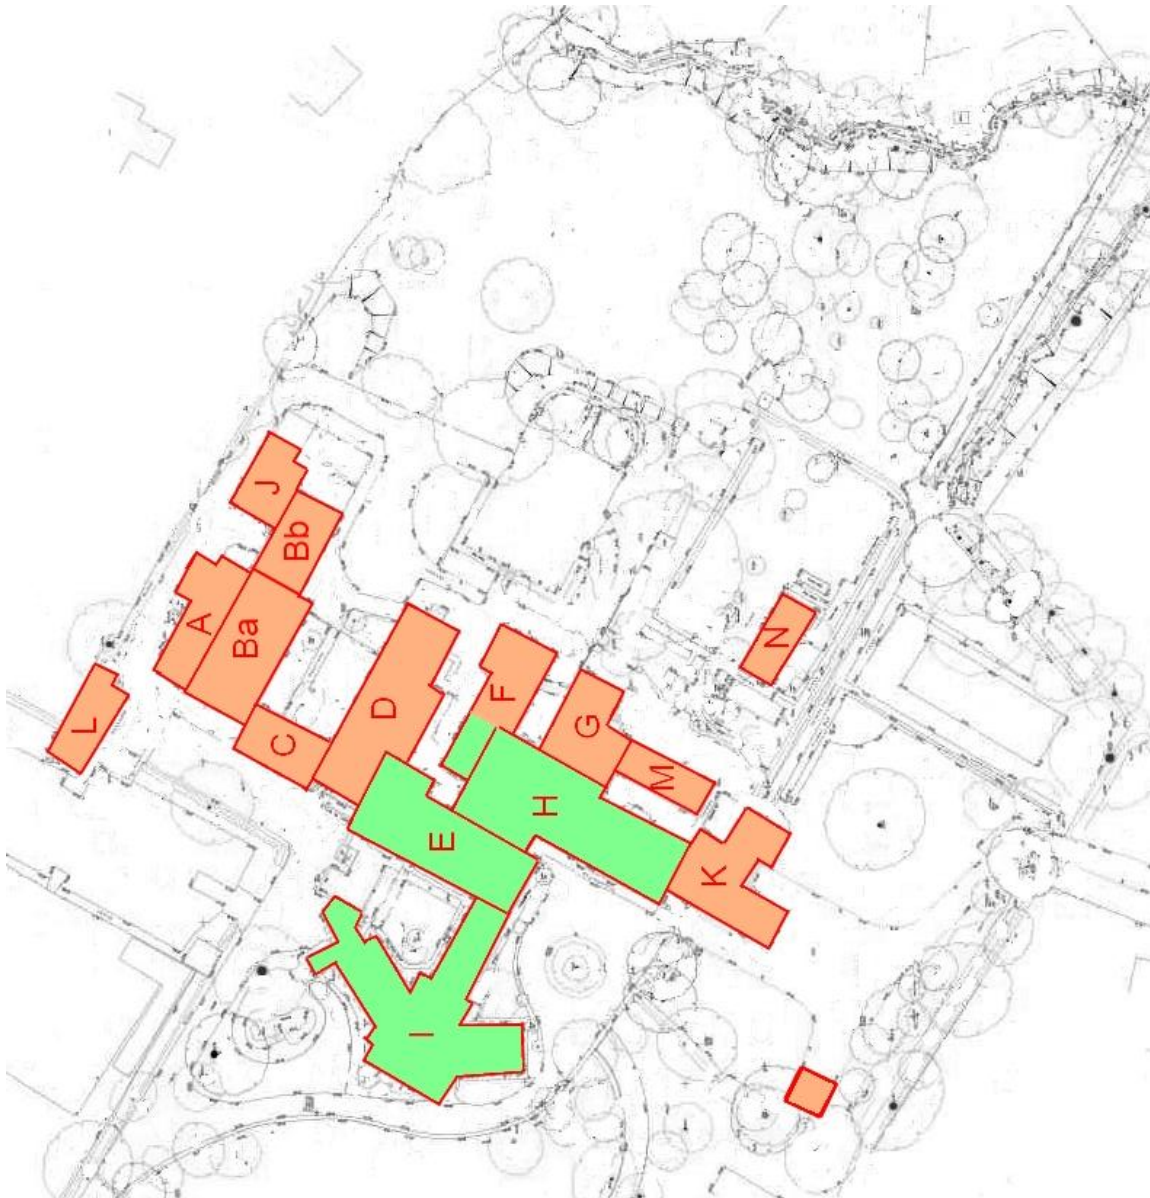
*Figure B.1.2.1. Location of destructive search/ inspection works (highlighted in orange) and retained buildings (highlighted in green).*

It is not considered possible to adequately exclude bats safely. As a result, the strategy for this site is based on careful destructive searching of potential roost areas on the buildings. This will include the roof and hanging tiles and soffit boxes. The destructive search will be carried out by the Licensee Ecologist (John Poland) or his Accredited Agents in order to remove any bats utilising these areas prior to demolition works commencing.

- Roof and hanging tiles will be stripped carefully by hand, supervised by the ecologist, turning each tile over one-by-one allowing the ecologist to search for bats or signs of bats whilst undertaking the work. This ensures that any bats found are unlikely to be harmed.

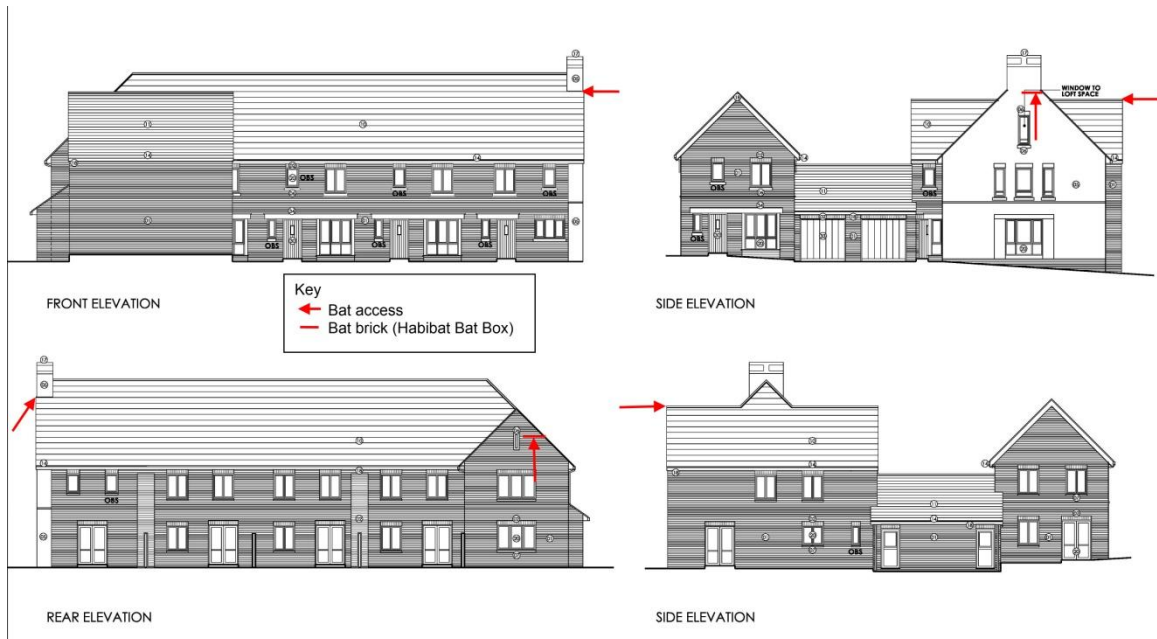
Figure C.1.4.9. Bat mitigation to be installed in Plots 17 & 21 (Block F).

- One bat brick (Habibat Bat Box) will be installed at the top of the gable end in the eastern wall of Plot 17 (Block F). The location is shown in *Figures C.1.4.1., C.1.4.2., and C.1.4.9.*

- One bat brick (Habibat Bat Box) will be installed at the top of the gable end in the southern wall of Plot 21 (Block F). The location is shown in *Figures C.1.4.1., C.1.4.2., and C.1.4.9.*

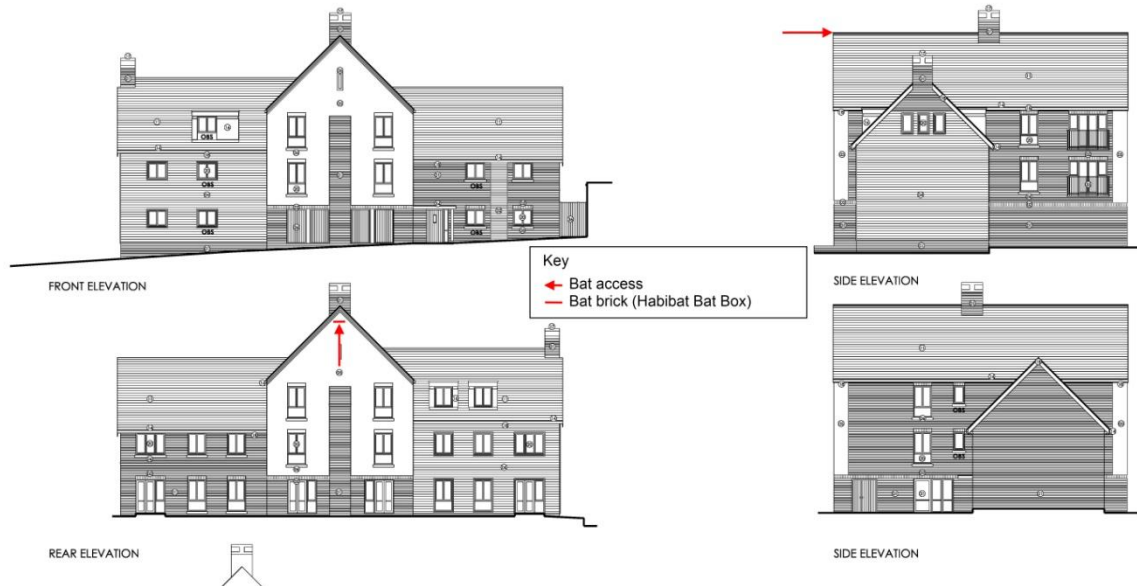
Figure C.1.4.10. Bat mitigation to be installed in the new flats of Plots 22-31 (Block G).

- One bat brick (Habibat Bat Box) will be installed at the top of the gable end in the southern wall of the new block of flats that are Plot 22-31 (Block G). The location is shown in *Figures C.1.4.1., C.1.4.2., and C.1.4.10.*

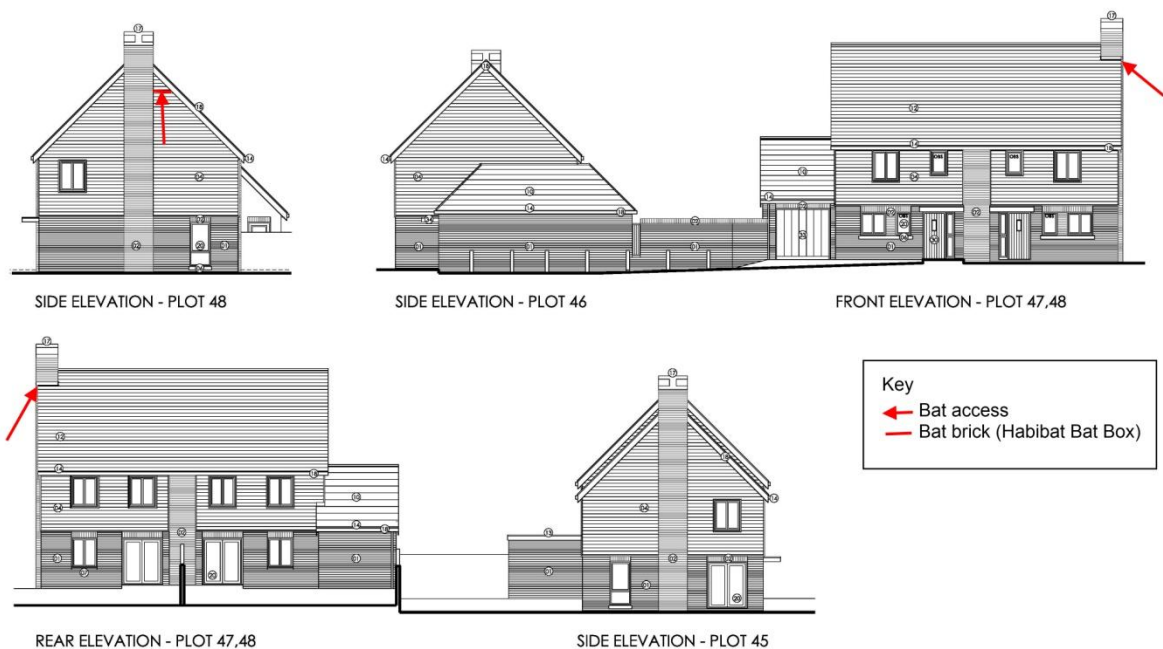
Figure C.1.4.13. Bat mitigation to be installed in Plot 48 (Block K).

- One bat brick (Habibat Bat Box) will be installed at the top of the gable end in the southern wall of Plot 48 (Block K). The location is shown in *Figures C.1.4.1., C.1.4.2., and C.1.4.13.*
