**Proposed Residential  
Development, Woodcroft  
Farm, Waterlooville,  
Hampshire**

**Geoenvironmental and Geotechnical  
Ground Investigation Report**

**Project Ref: 21834/030**

**Doc Ref: R02/rev01**

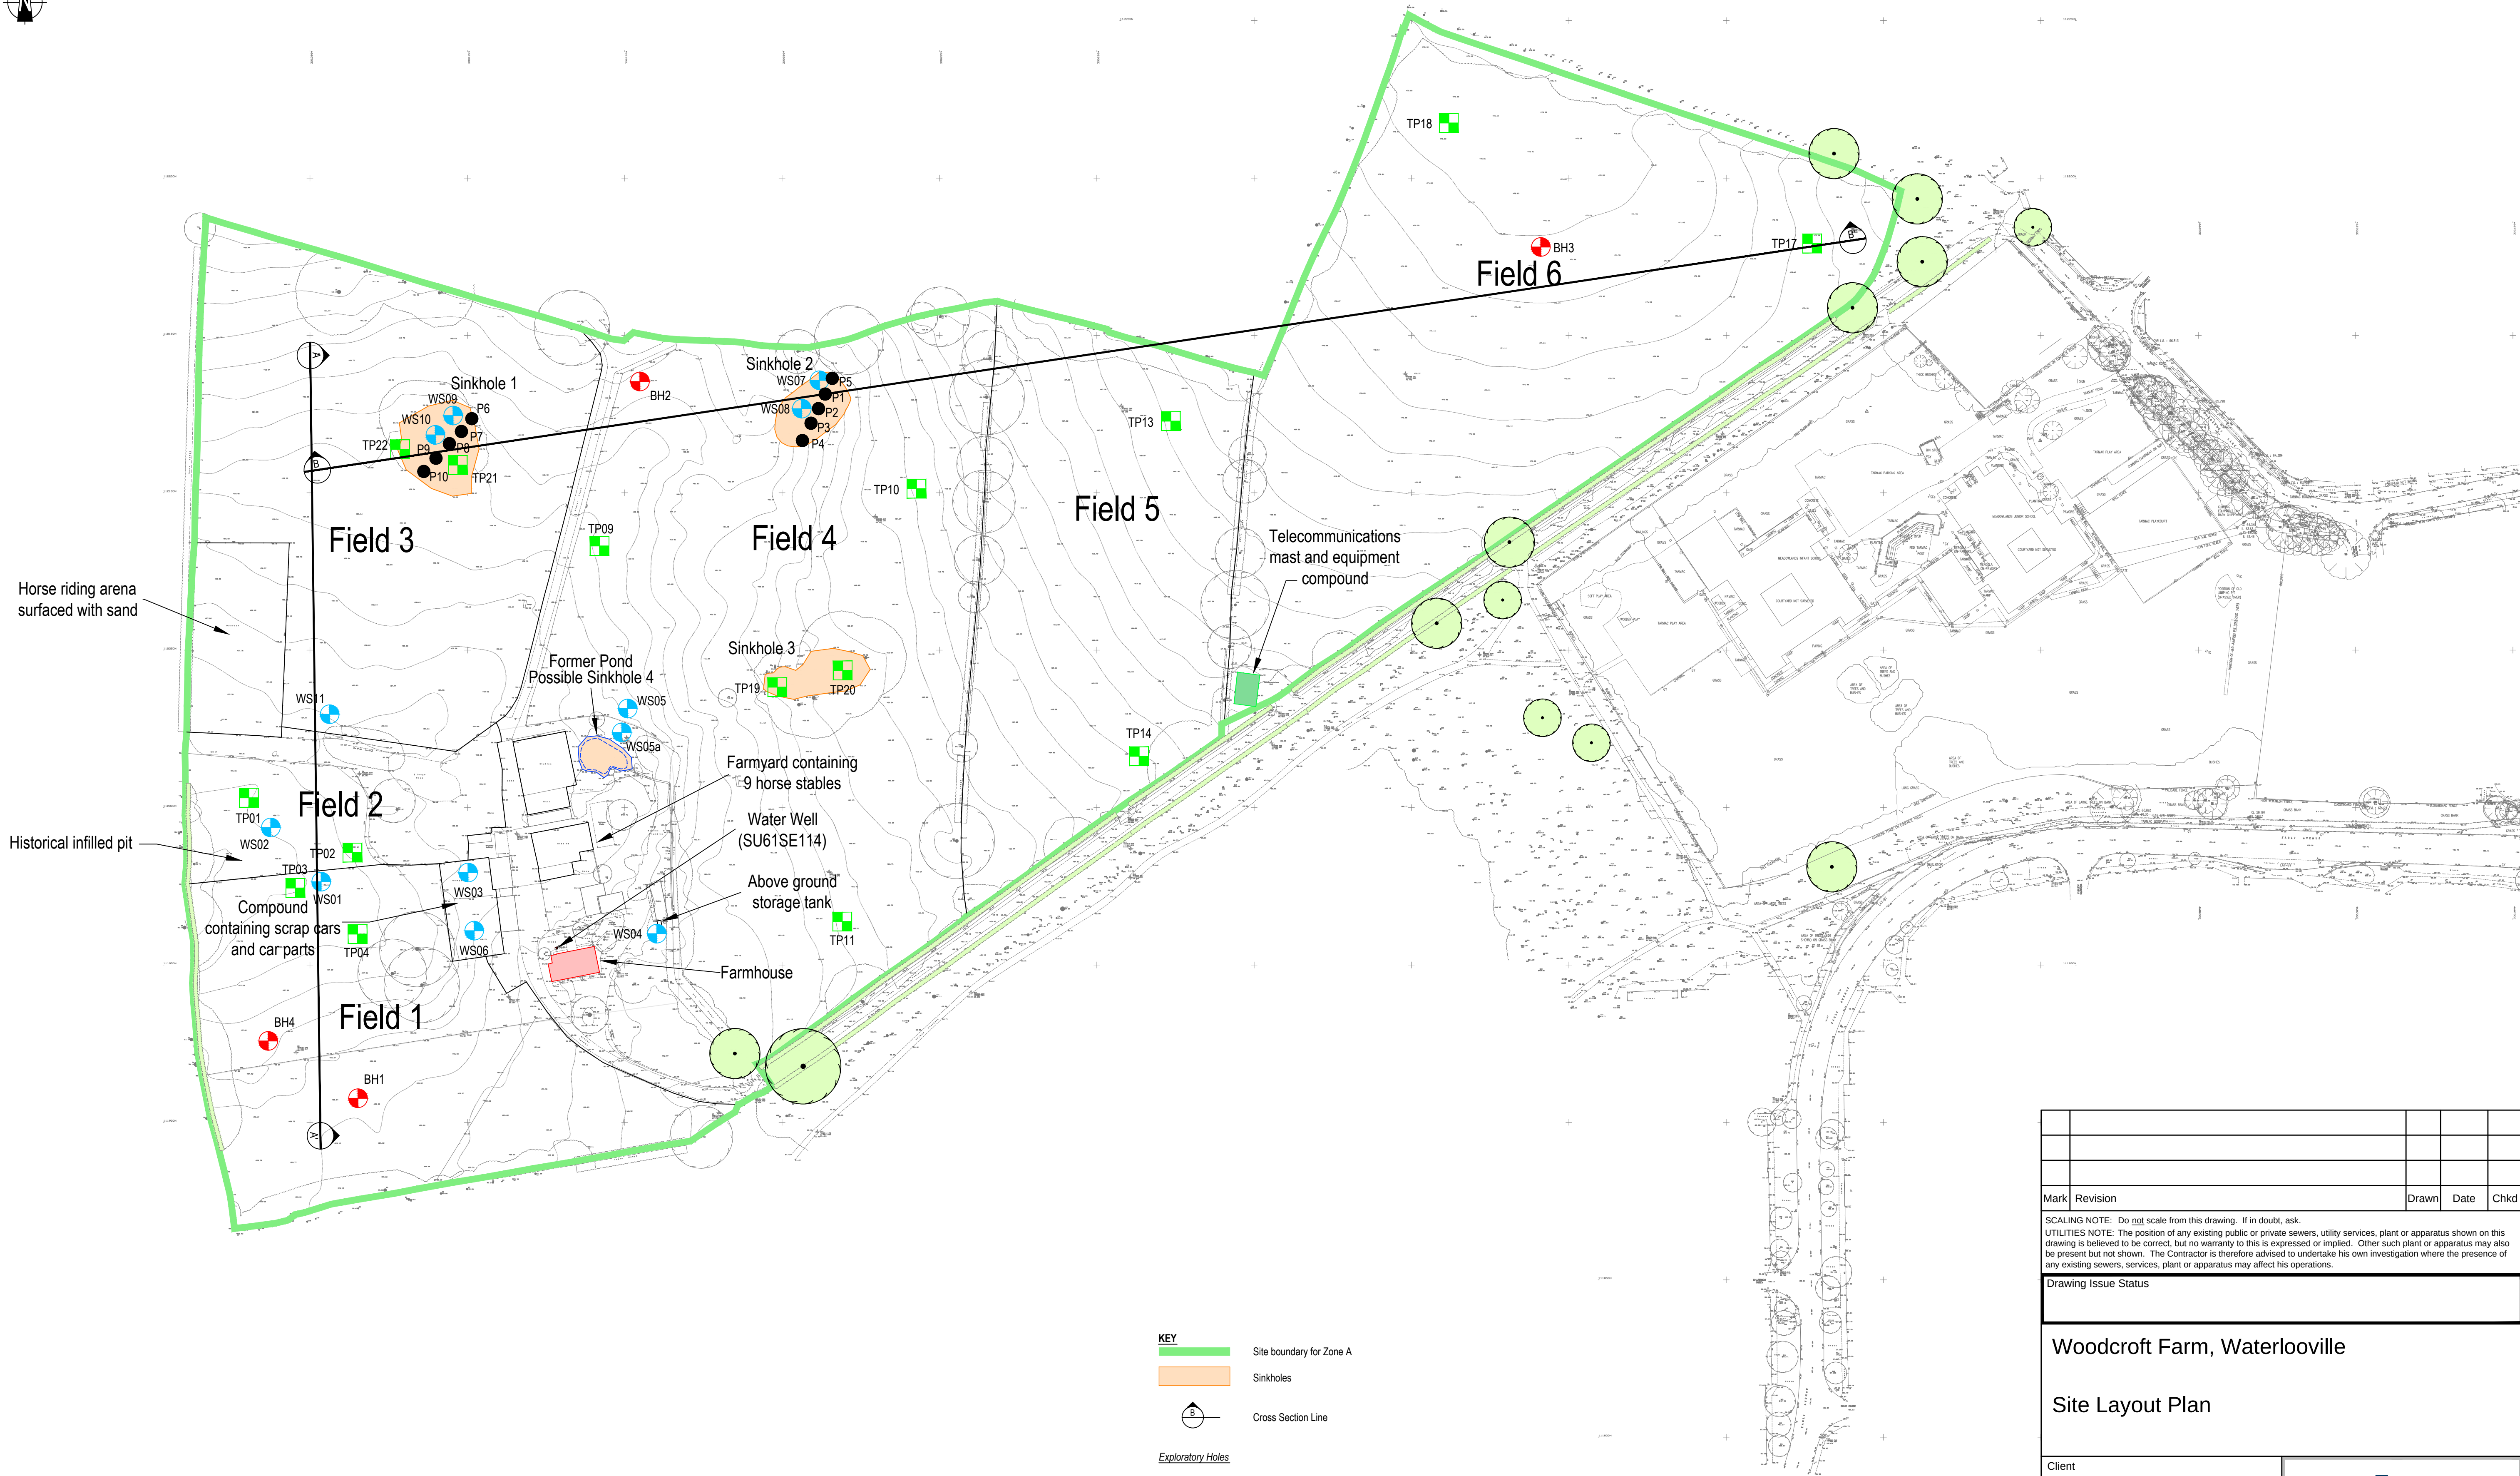
| Drawing Number<br><b>Figure 2</b> | | Revision<br>- | | READING<br>Tel: 0118 950 0761 Fax: 0118 959 7498 | |

Ground subsidence over karstic weathering formed by dissolution of chalk is a consequence of a continuing natural process. The surface depressions created are generally referred to as sinkholes. There are four potential sinkholes that caused by solution features within the Chalk present at the site. For ease of reference from this point in the report the sinkholes at the site are referred to as Sinkhole 1 to Sinkhole 4. The sinkholes are shown and labelled accordingly in **Figure 2**.

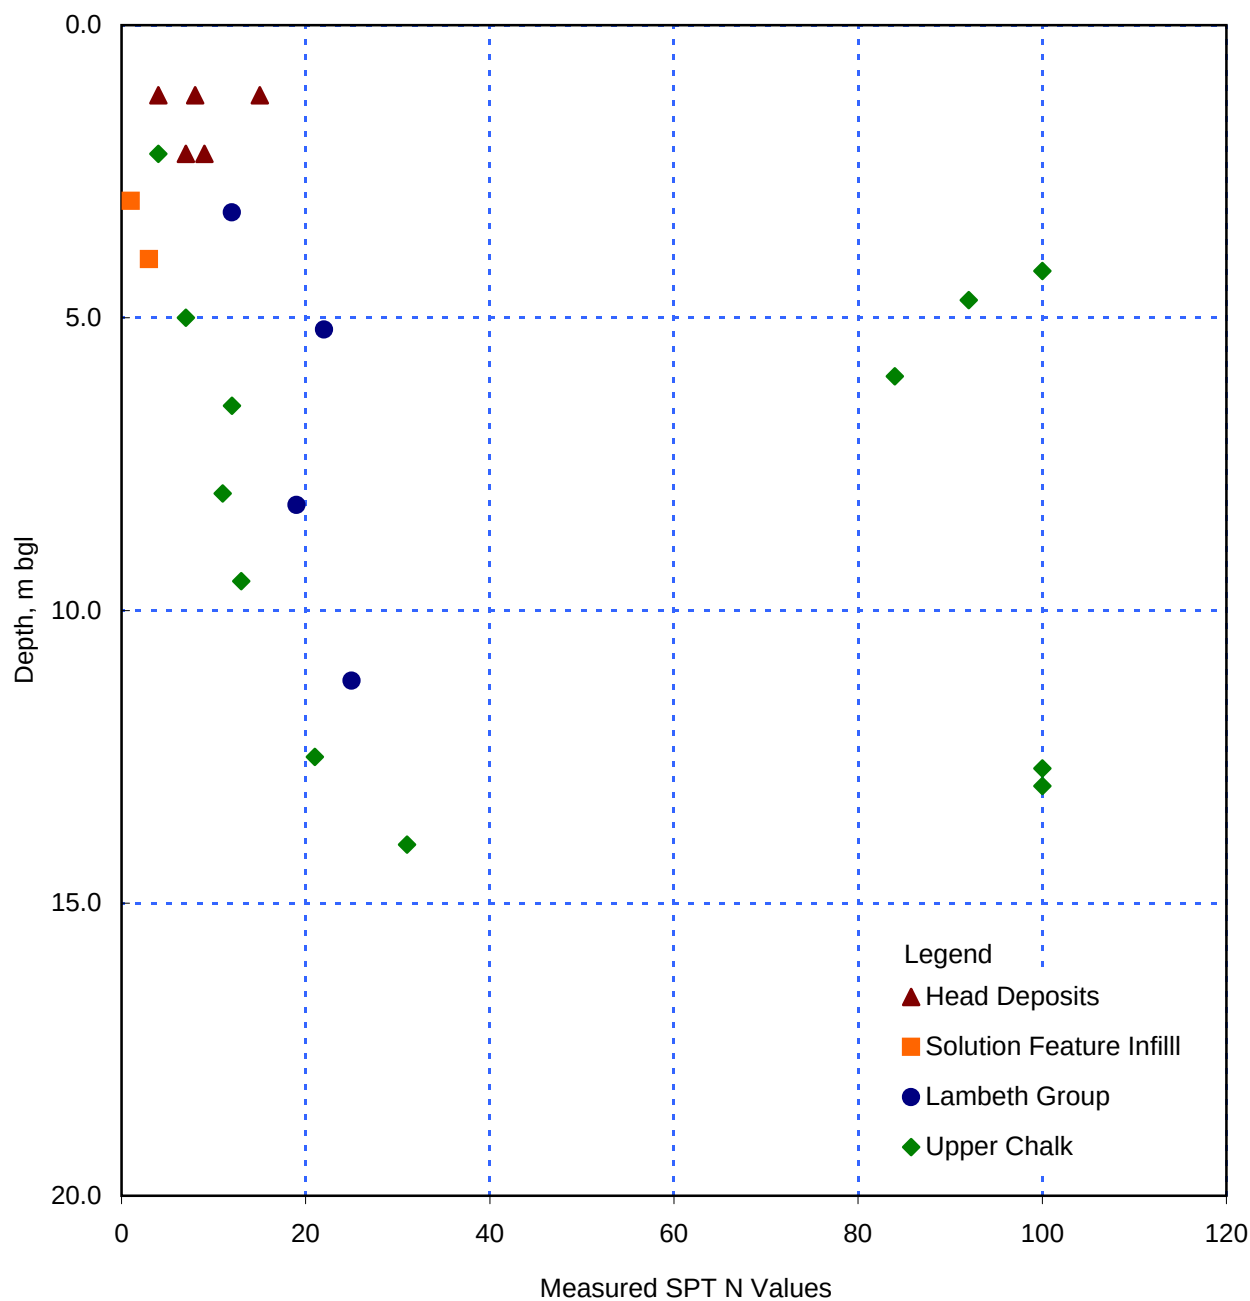
Note: SPT N values have not been corrected for overburden pressure  
SPT N values shown over 50 have been extrapolated using the penetration length

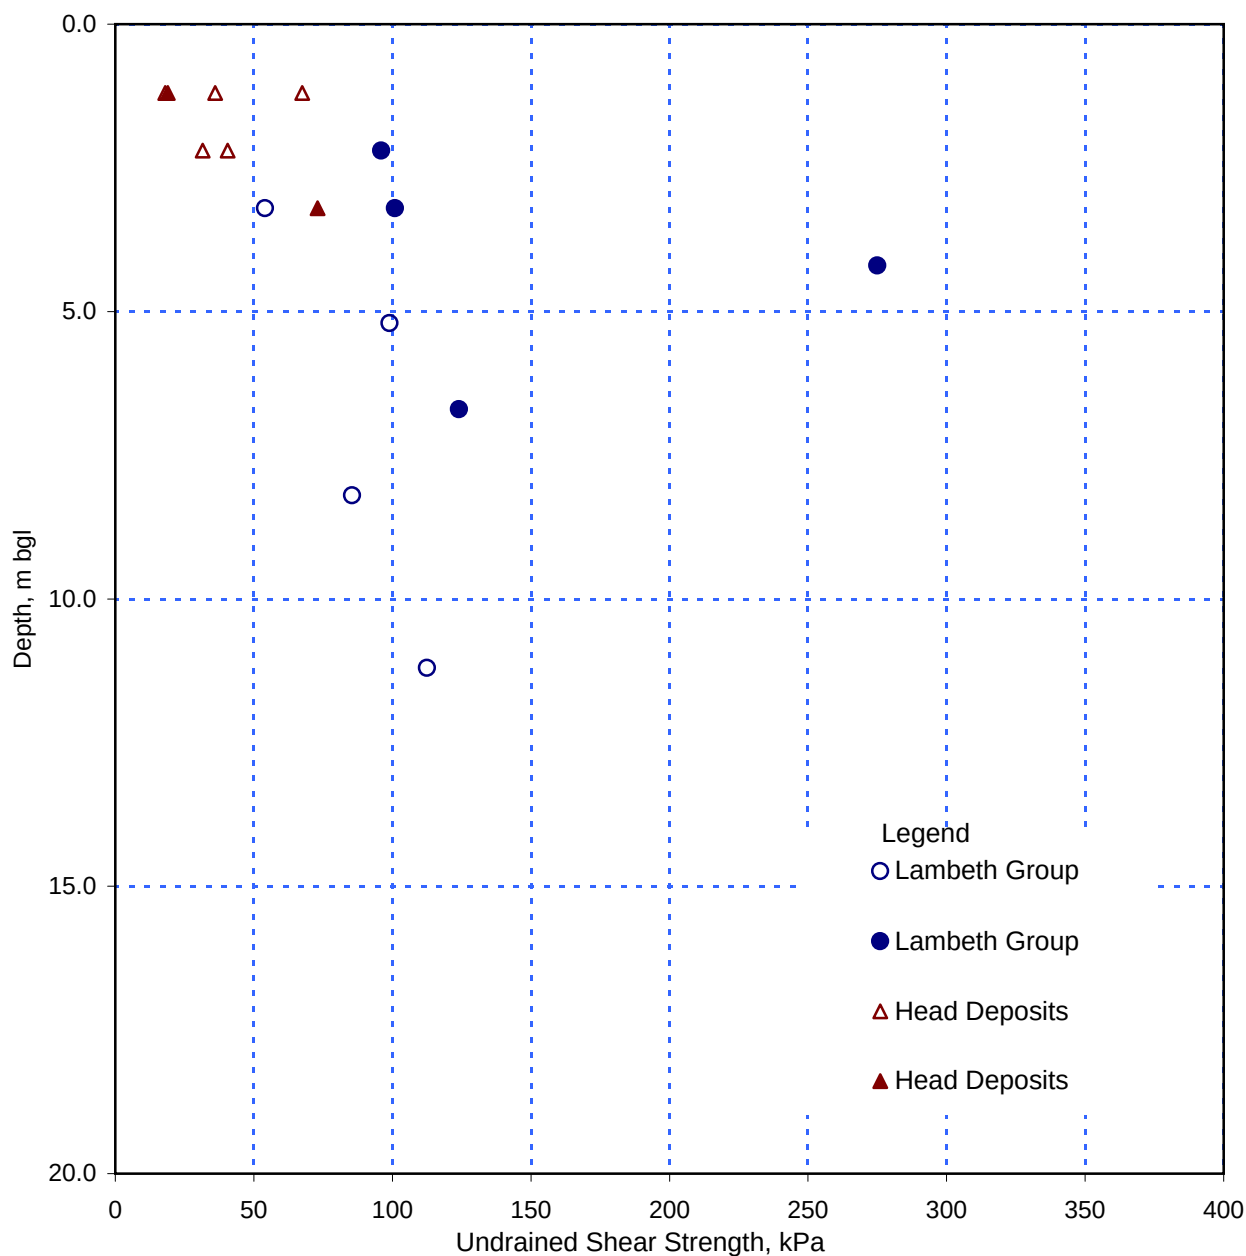
Note: Open symbols denote values of undrained shear strength determined using the empirical correlation with SPT N values (Stroud, 1989) with a factor  $N_c$  of 4.5  
 Closed symbols denote values of undrained shear strength determined by laboratory triaxial testing of UT100 mm diameter specimens

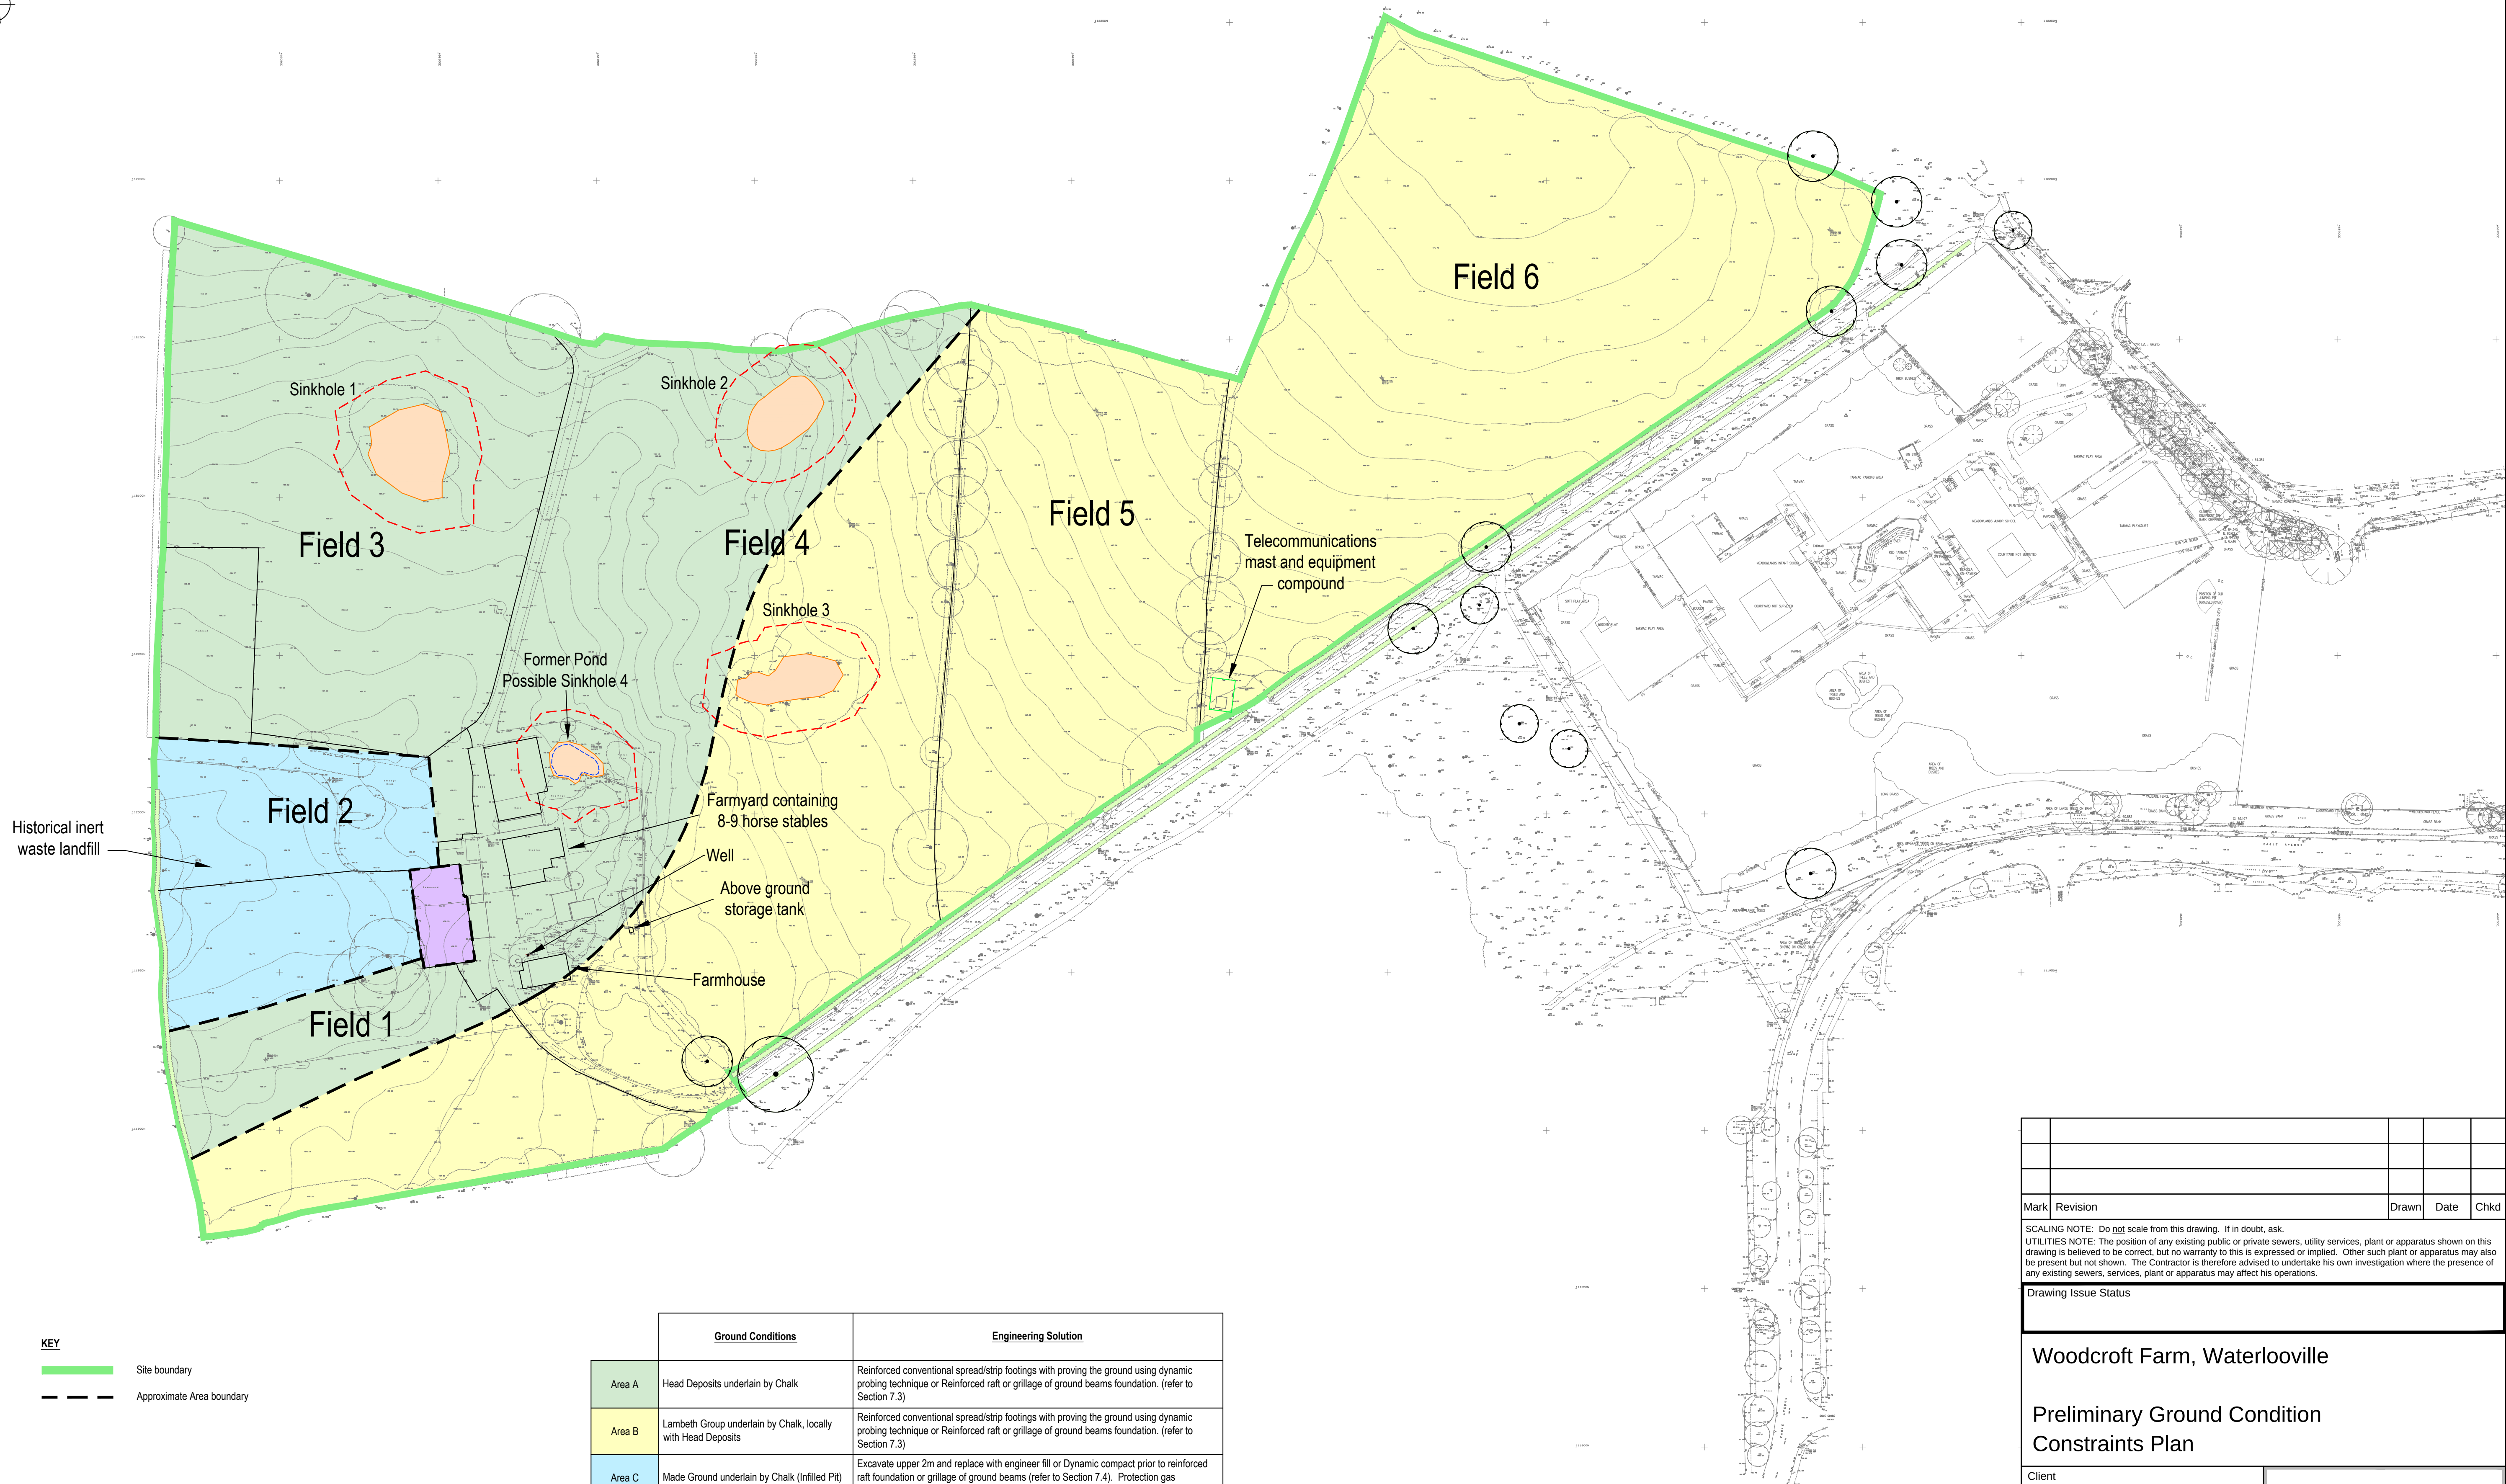
| | Ground Conditions | Engineering Solution |
| Area A | Head Deposits underlain by Chalk | Reinforced conventional spread/strip footings with proving the ground using dynamic probing technique or Reinforced raft or grillage of ground beams foundation. (refer to Section 7.3) |
| Area B | Lambeth Group underlain by Chalk, locally with Head Deposits | Reinforced conventional spread/strip footings with proving the ground using dynamic probing technique or Reinforced raft or grillage of ground beams foundation. (refer to Section 7.3) |
| Area C | Made Ground underlain by Chalk (Infilled Pit) | Excavate upper 2m and replace with engineer fill or Dynamic compact prior to reinforced raft foundation or grillage of ground beams (refer to Section 7.4). Protection gas measures to be incorporated in structures (refer to Section 6.6). |
| Area D | Made Ground underlain by Head Deposits and Chalk (Vehicle Dismantling Yard) | Remove identified impacted soil and use Reinforced conventional spread/strip footings with proving the ground using dynamic probing technique or Reinforced raft or grillage of ground beams foundation. (refer to Section 7.3) |

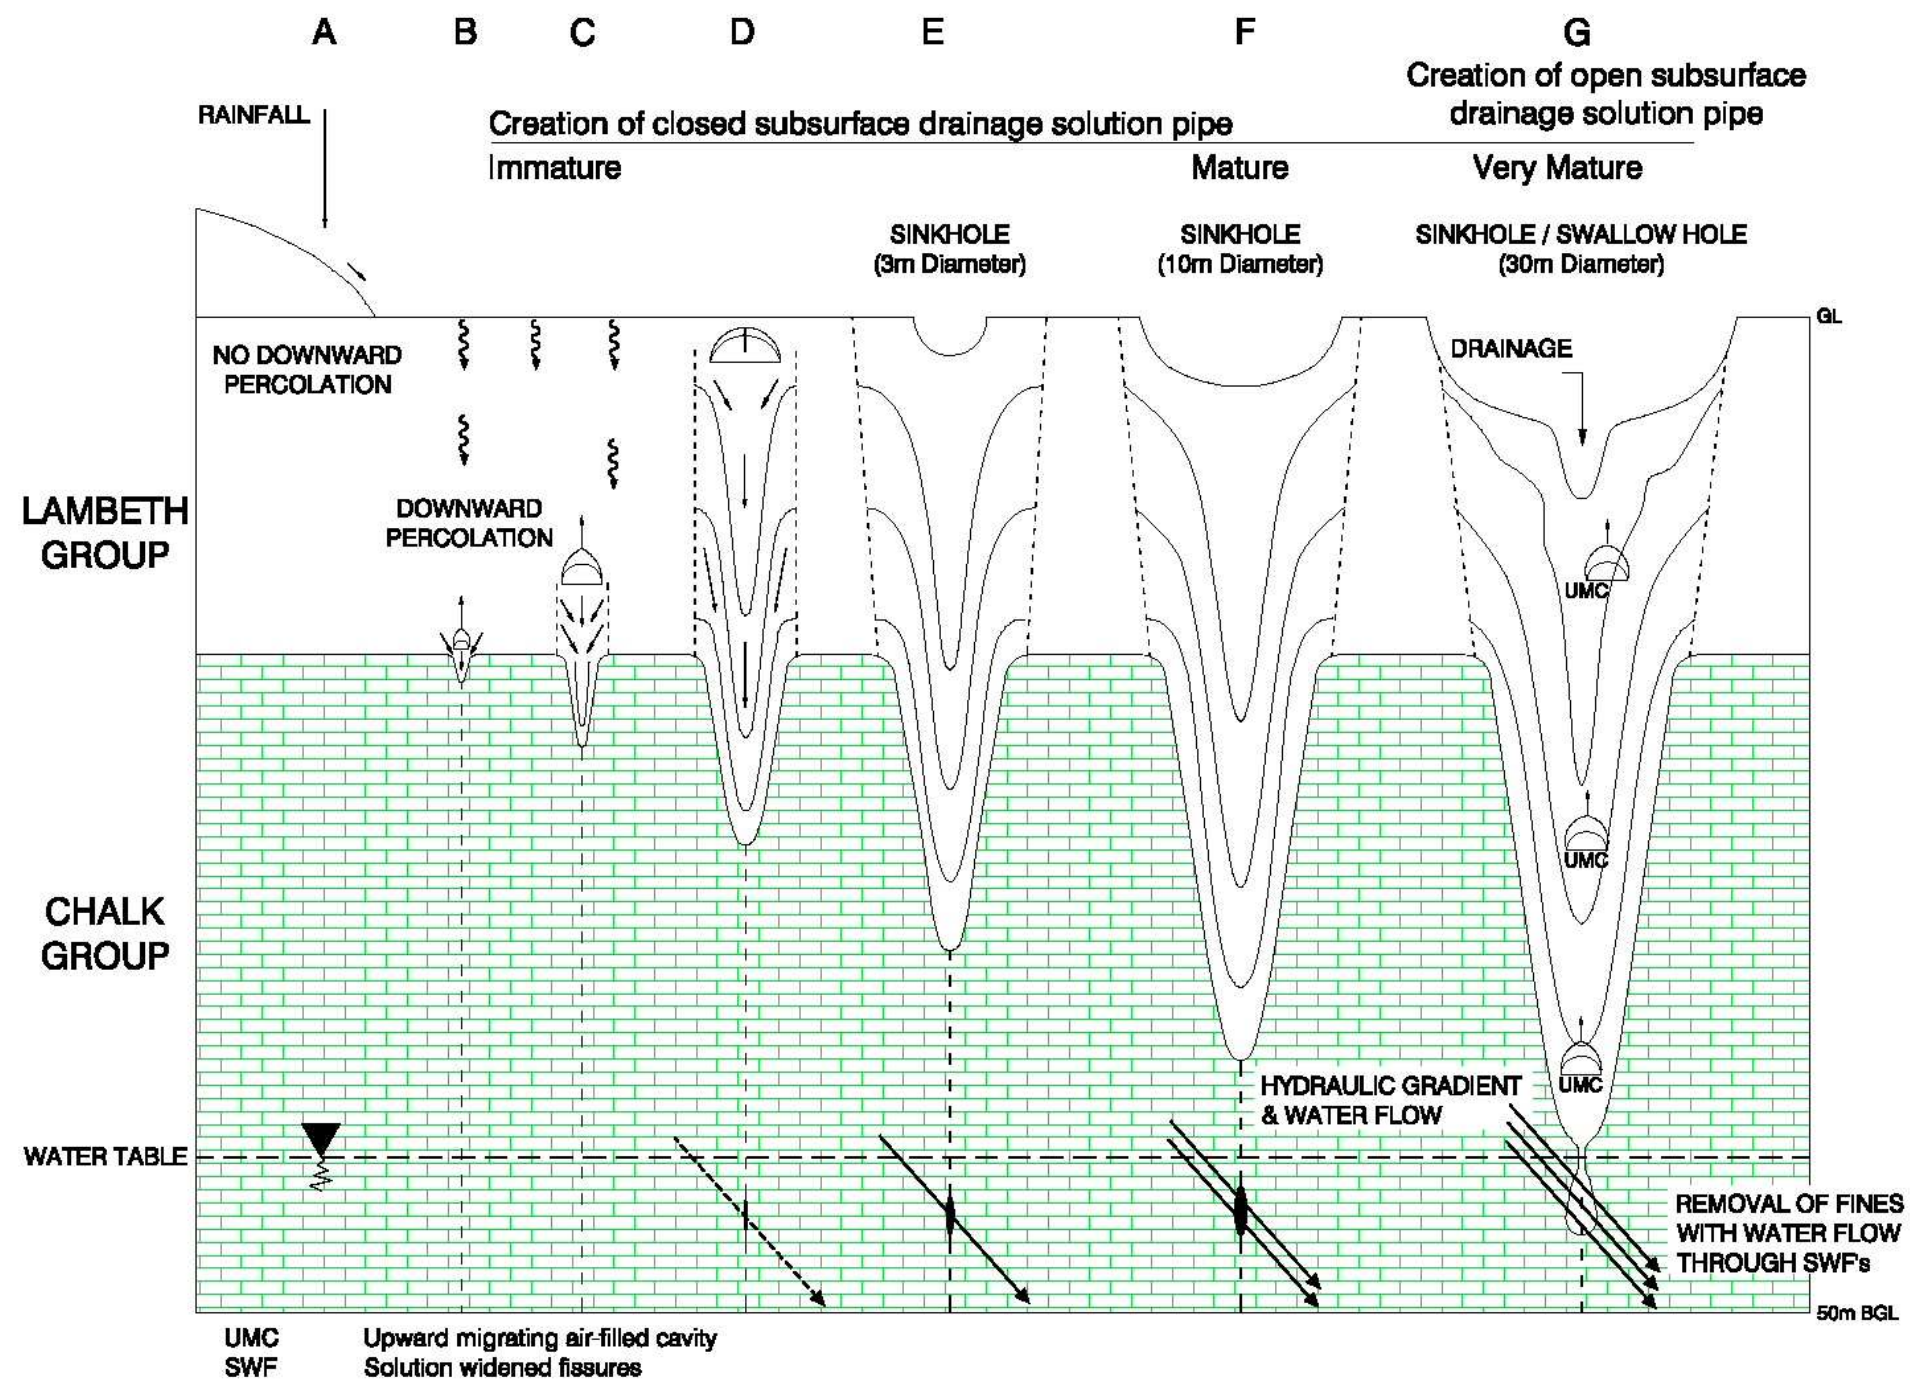
Note  
The figure is reproduced from the paper 'Karst and mining geohazards with particular reference to the Chalk outcrop, England' By C.D. Edmonds. Published in the Quarterly Journal of Engineering Geology and Hydrogeology 2008; v. 41; p. 261-278.
