## **Ecological Walkover Assessment**

**No 12 Wittering Road,  
Hayling Island**

**Paul Whitby**

**3<sup>rd</sup> May 2013**

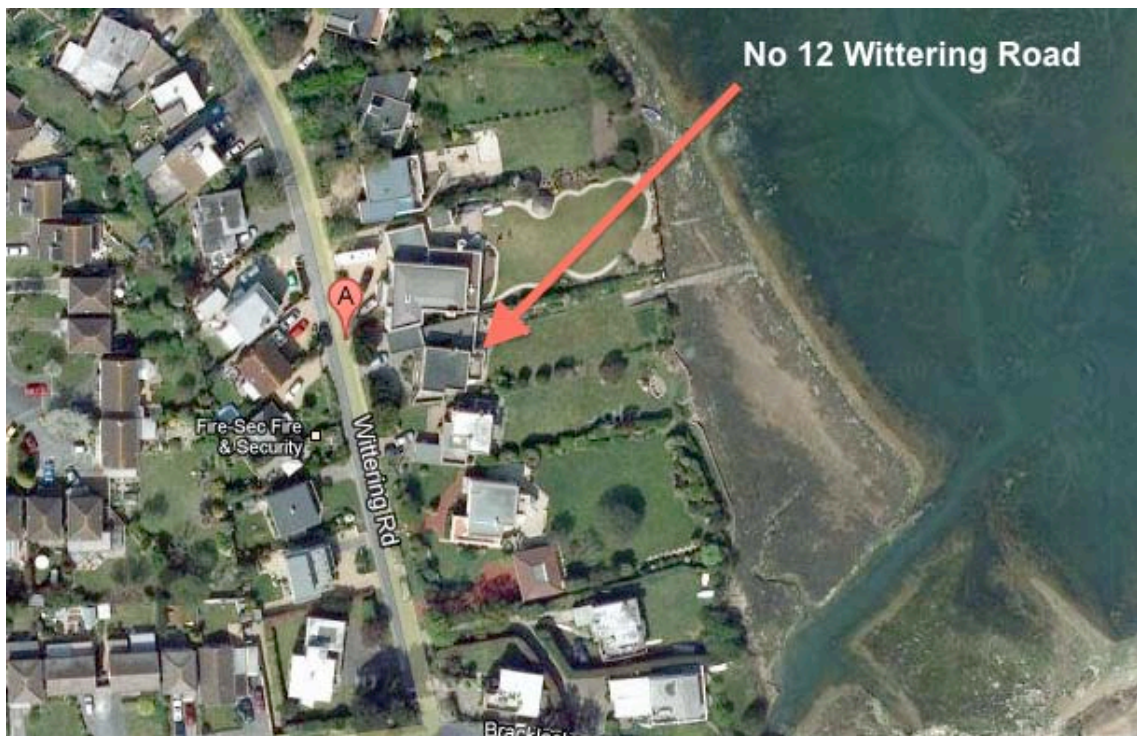
The No 12 property is situated in a residential area in the south eastern part of Hayling Island. The property is bordered to the north and south by neighbouring properties, whilst Wittering road lies along the western boundary and beyond the rear garden to the east is an intertidal inlet (see picture 1 below). The property is a brick-built flat roved summerhouse, which is used by the owners as a weekend/holiday residence. A tarmac parking area borders the front of the building, with an ornamental flower bed including primrose (*Primula vulgaris*), roses (*Rosa spp*) and Spanish bluebells (*Hyacinthoides nonscripta*). A semi-mature yew (*Taxus bacatta*) and Cypress spp form screening along the western boundary, along with a laurel and privet hedge.

**Picture 1** – An aerial picture of the site as shown on Google earth with an arrow indicating the No 12 property.

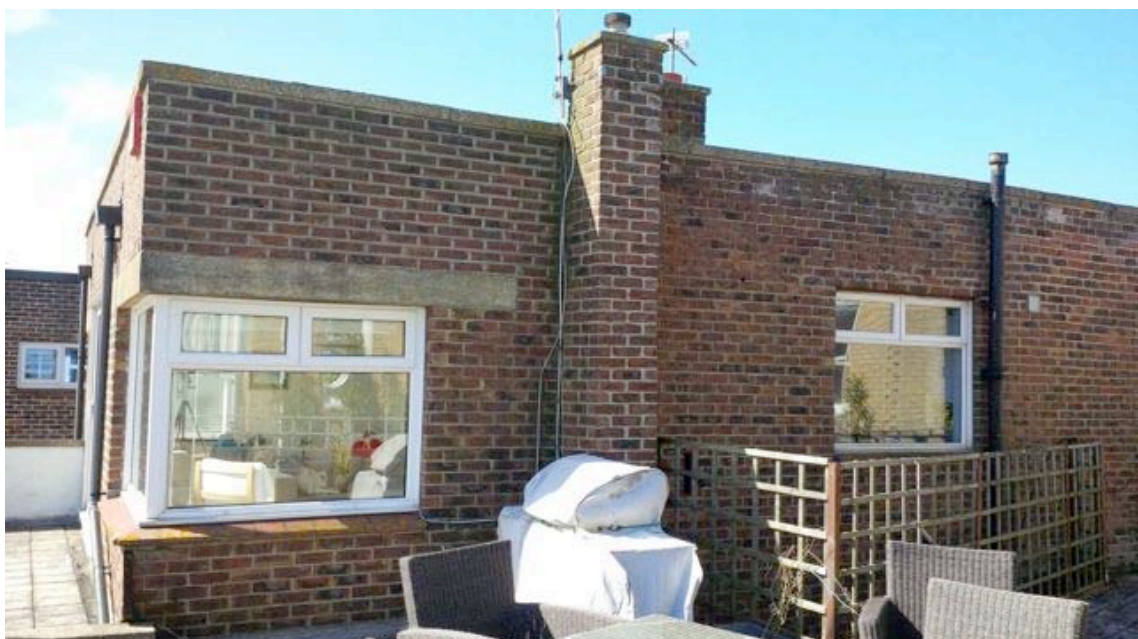
**Picture 2** –The Brick-built property, with a flat roof and simple features.

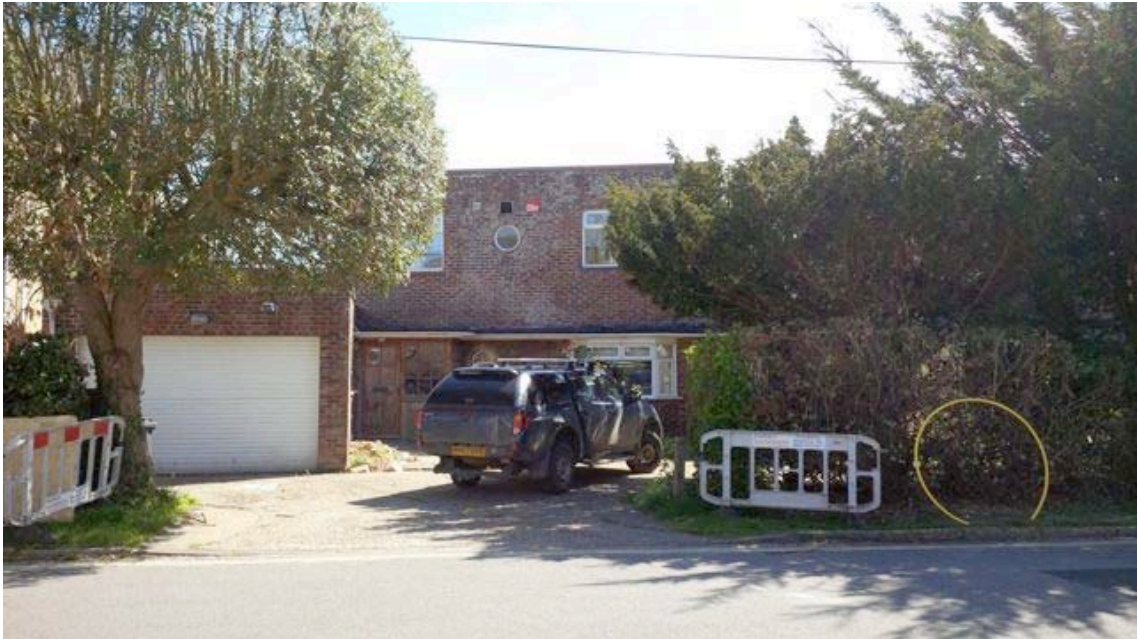
**Picture 3** – The front of the property is partially screened from the road by semi-mature trees and hedging.

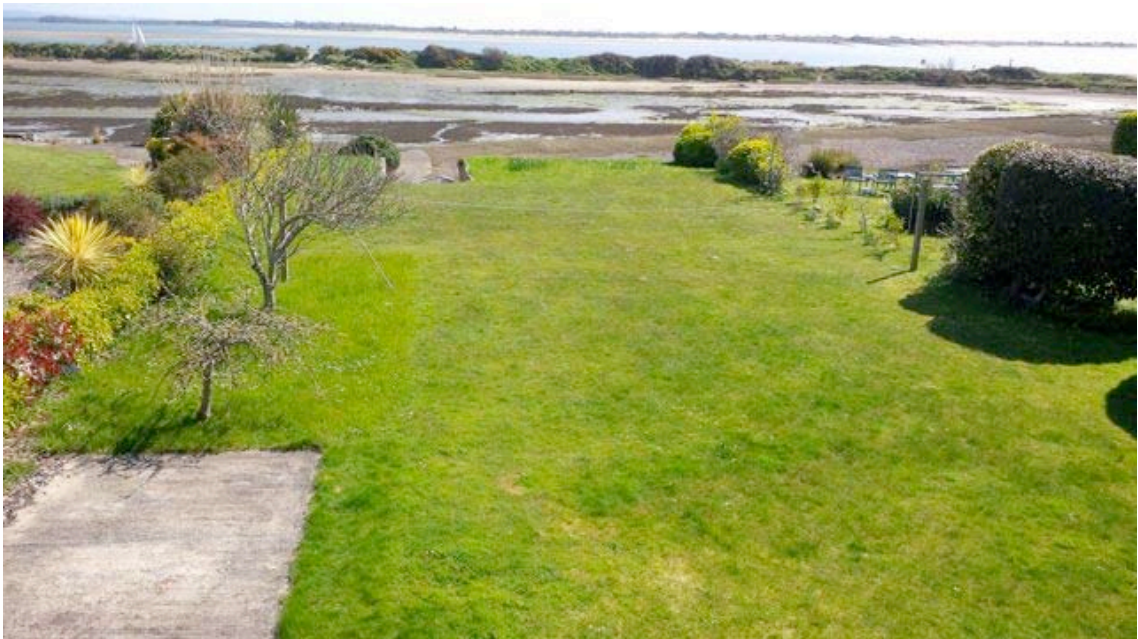
**Picture 4** – The long narrow lawn of the property backs onto the coast, where there is an area of intertidal shingle and mud.

The tidal area at the end of the rear garden should also be protected from disturbance where possible, so that any overwintering or breeding birds are not disturbed. It is recommended that a heras fence with a screening board or netting attached to it is erected half way at least 20 metres from the eastern end of the garden to screen the development during demolition/construction works and discourage construction staff from accessing the shore or storing materials near to the shore. This mitigation is particularly advisable given the statutory protection afforded to the nearby Chichester Harbour.

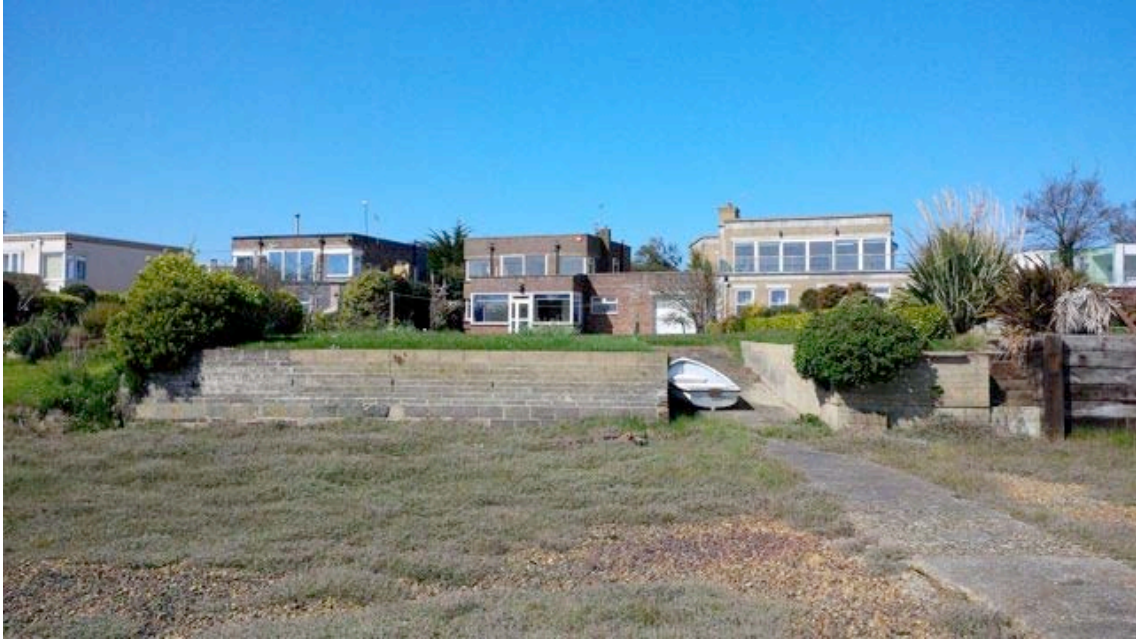
**Picture 5** – The view of the property from the intertidal area beyond the back garden, with a boat launch and retaining wall.

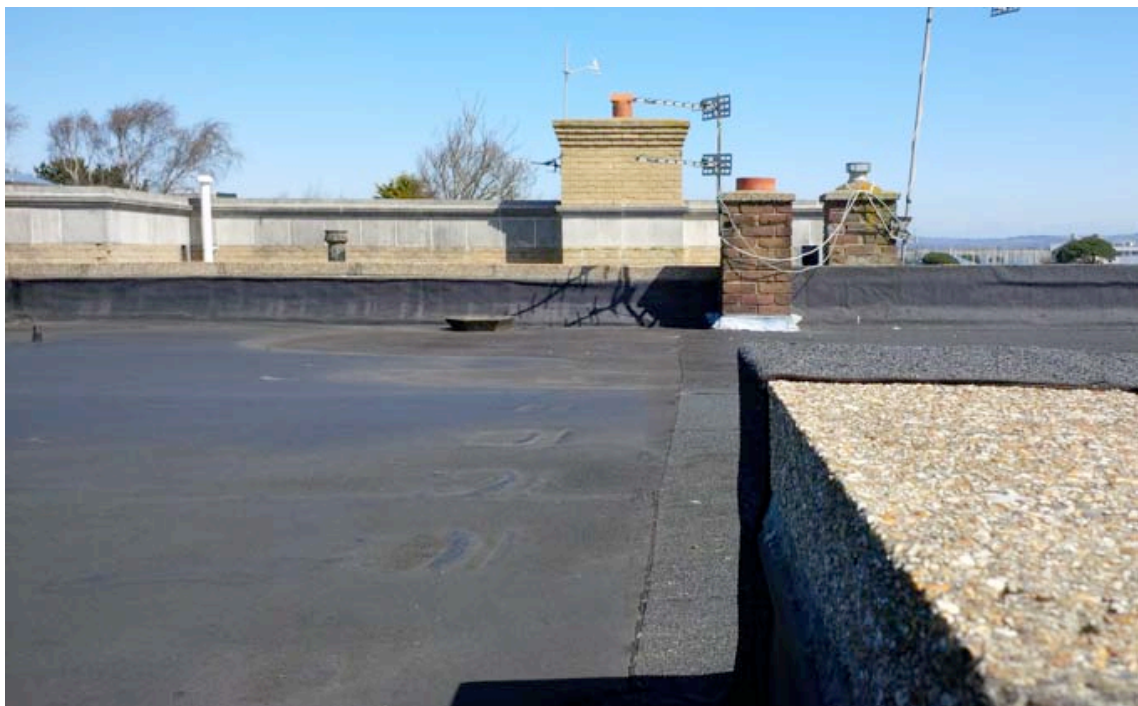
The No 12 property itself does not have any internal loft space or roof void that might be used by bats. Both the property and adjoining garage have flat felt lined roofs, which are tightly sealed with a bitumen layer. No gaps or tears were seen in the bitumen sheeting that might offer roosting potential for bats (see picture 6 below).

No potential roosting opportunities for crevice dwelling bats were seen on the flat roof or any part of the building exterior.

Picture 6 – The bitumen lined flat roof of the No 12 property.

No further surveys or specific mitigation for bats is required during the demolition of the No 12 property, however it is advised that any external lighting is downward facing and shielded by light baffles to minimise light pollution and the effect that external lights can have on foraging bats.
