**GROUND APPRAISAL REPORT**  
for the site at  
**VILLA GARDENS, WATERLOOVILLE**  
on behalf of  
**LINDEN HOMES SOUTHERN LIMITED**

| <b>GE9185\GAR\APR13</b> | | <b>STATUS: FINAL</b> | |
| File reference GE9185-GAR-APR13 | | | |

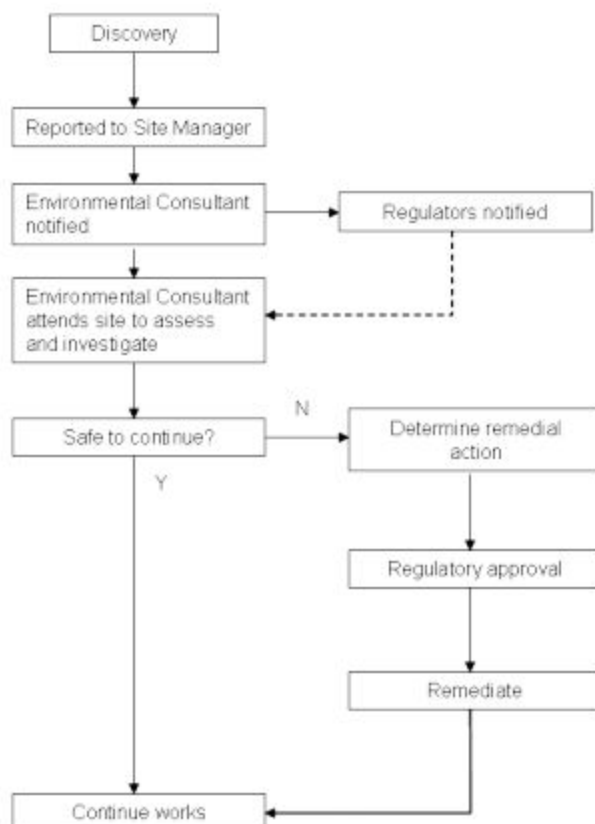
#### Discovery Strategy Process

Should previously undiscovered contamination be encountered during construction, this should be reported to the site manager immediately in order that any necessary inspection and assessment by the Environmental Consultant can be made. Records should be kept, and samples submitted for analysis where conditions encountered are not as anticipated. The results of any such testing should be sent to the relevant planning authority for consultation.

The process is shown below.

A copy of the discovery strategy should be lodged on site, and provisions made to ensure that all workers are made aware of their responsibility to observe, report, and act on any potentially suspicious or contaminated materials they may encounter.
