86/86a WEST STREET, HAVANT,  
HAMPSHIRE

PHASE 1 ECOLOGICAL SURVEY

Draft Document  
March 2010

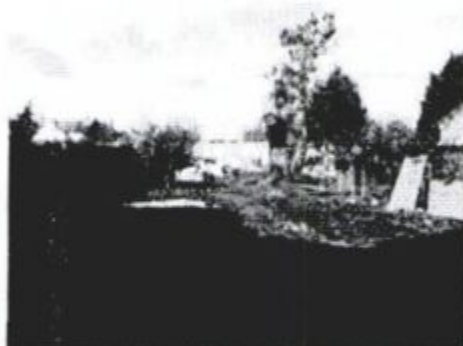
The vegetation on site comprises largely disturbed ground with a few isolated ornamental tree and shrub species. The species recorded include cleavers *Galium aparine*, stinging nettle *Urtica dioica* and a small buddleja *Buddleja davidii*.

Figure 1 Garden to North of Residential Property

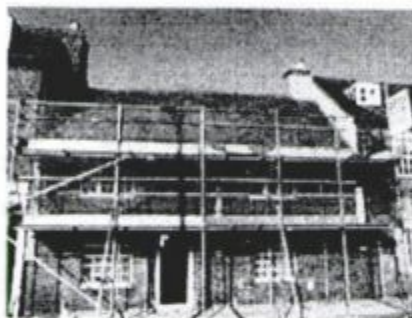
The building comprises a two-storey residential property with brick elevations and a clay tiled roof in a pitched design (Figure 2). The building forms part of a terrace with the main roof ridge running from west to east, two hipped roof sections extend from the northern elevation (Figure 3). The building has three chimneys, one is attached to the rear of the building (northern elevation), the other two extend through the roof at the eastern and western elevations. A wooden fascia is located along the wall plate on the northern elevation.

Figure 2 Southern Elevation of Building

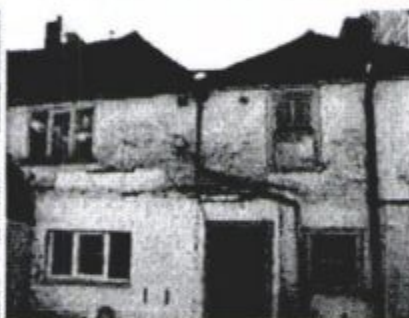
Figure 3 Northern Elevation of Building

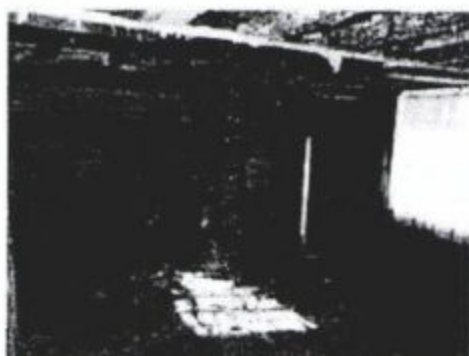
Internally, the building has been fully stripped of all fixtures and fittings (**Figure 4**), but was formerly designed to provide ground and first floor area, with a third floor created but the conversion of a section of roof (**Figure 5**). The first floor ceilings have been removed thereby exposing the underside of the roof, subsequently no roof voids are now present.

Figure 4 Internal View of Ground Floor Figure 5 Internal View of Converted Roof Area

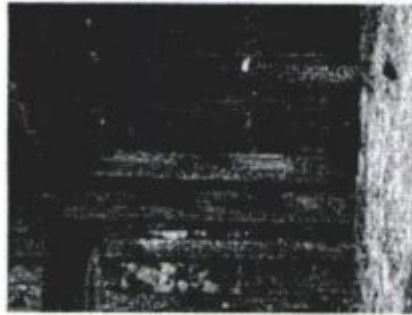
The roof is constructed with peg tiles, which are unlined internally, subsequently it is possible to view into gaps within the ridge tiles (**Figure 6**), and hip joints located within timbers on the underside of the roof. The valley between the two hip sections is leaking, thereby making the roof area in this vicinity wet and draughty.

Figure 6 Gaps within Ridge Tiles

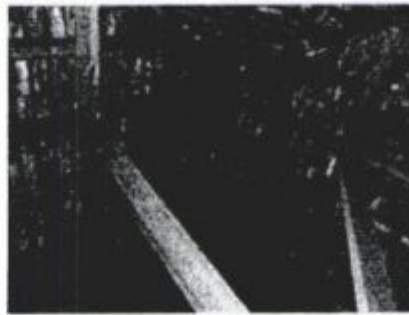
Figure 7 Hip Joints located on Underside of Roof

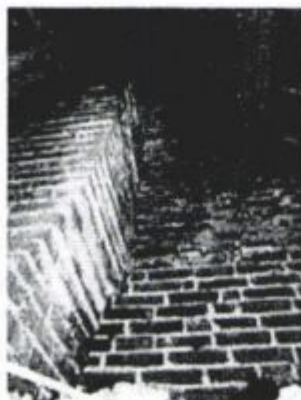
- Small voids are present within the ridge tiles. These could be accessed by bats from outside, where mortar is missing and from internally where obvious gaps are present (Figure 6).
- Sheltered areas are present around the hip joints of the roof (Figure 7).
- A large crack is present where the chimney breast butts against the wall of the adjacent building at the western elevation (Figure 8), and
- Gaps are present beneath the wooded fascia located on the northern elevation (Figure 9).

Figure 8 Gap behind Chimney Breast on Western Elevation Figure 9 Gap behind Wooden Fascia

Given the fact that it is considered to be structurally unsafe, there will be no requirement to carry out detailed Phase 2 bat surveys. However, it is recommended that on the evening prior to the demolition works commencing, a single dusk emergence survey is carried out. Providing no bats are recorded during this survey, the removal of roof and ridge tiles and fascias from the building should proceed under the supervision of a licenced bat ecologist. This is to ensure that, should any bats be recorded roosting within the building, they are removed safely. If bats are recorded either during the emergence survey or during the destructive search then a Natural England European Protected Species Mitigation (EPSM) licence may be required, however, given the condition of the building it is considered that this is an unlikely event.
