86/86a WEST STREET, HAVANT,  
HAMPSHIRE

PHASE 1 ECOLOGICAL SURVEY

March 2010

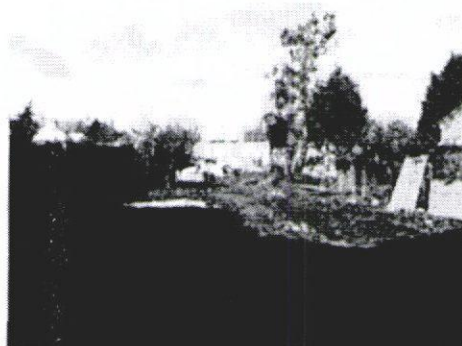
The vegetation on site comprises largely disturbed ground with a few isolated ornamental tree and shrub species. The species recorded include cleavers *Galium aparine*, stinging nettle *Urtica dioica* and a small buddleja *Buddleja davidii*.

Figure 1 Garden to North of Residential Property

Given the lack of any structured vegetation within the site it is considered to be of negligible ecological value for the vegetation present.

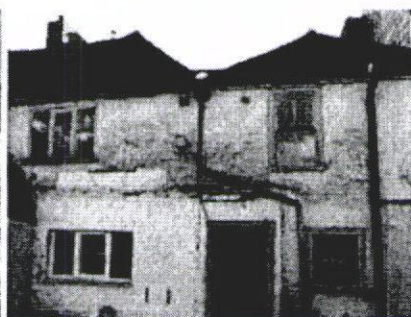
The building comprises a two-storey residential property with brick elevations and a clay tiled roof in a pitched design (Figure 2). The building forms part of a terrace with the main roof ridge running from west to east, two hipped roof sections extend from the northern elevation (Figure 3). The building has three chimneys, one is attached to the rear of the building (northern elevation), the other two extend through the roof at the eastern and western elevations. A wooden fascia is located along the wall plate on the northern elevation.

Figure 3 Northern Elevation of Building

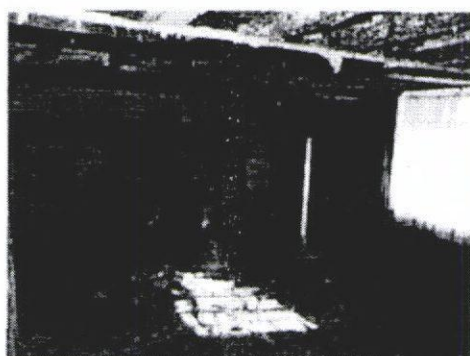
Internally, the building has been fully stripped of all fixtures and fittings (**Figure 4**), but was formerly designed to provide a ground and first floor area, with a third floor created but the conversion of a section of roof (**Figure 5**). The first floor ceilings have been removed thereby exposing the underside of the roof, subsequently no roof voids are now present.

Figure 4 Internal View of Ground Floor Figure 5 Internal View of Converted Roof Area

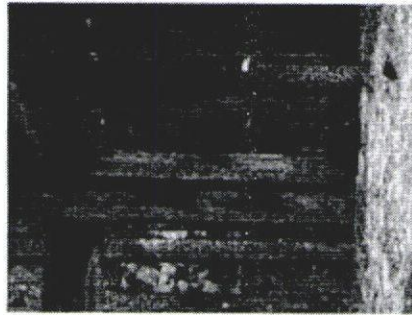
The roof is constructed with peg tiles which are unlined internally, subsequently it is possible to view into gaps within the ridge tiles (**Figure 6**), and hip joints located within timbers on the underside of the roof. The valley between the two hip sections is leaking, thereby making the roof area in this vicinity wet and draughty.

Figure 6 Gaps within Ridge Tiles

- Small voids are present within the ridge tiles. These could be accessed by bats from outside, where mortar is missing and from internally where obvious gaps are present (Figure 6).
- Sheltered areas are present around the hip joints of the roof (Figure 7).
- A large crack is present where the chimney breast butts against the wall of the adjacent building at the western elevation (Figure 8), and
- Gaps are present beneath the wooded fascia located on the northern elevation (Figure 9)

- It is recommended that the removal of the existing roof tiles will be supervised by a suitably qualified ecologist. Following their removal the under-surface of these tiles, and the areas covered by them, will be inspected for the presence of bats and their field signs (droppings, prey remains etc).

Given the fact that it is considered to be structurally unsafe, there will be no requirement to carry out detailed Phase 2 bat surveys. However, it is recommended that on the evening prior to the demolition works commencing, a single dusk emergence survey is carried out. Providing no bats are recorded during this survey, the removal of roof and ridge tiles and fascias from the building should proceed under the supervision of a licenced bat ecologist. This is to ensure that, should any bats be recorded roosting within the building, they are removed safely. If bats are recorded either during the emergence survey or during the destructive search then a Natural England European Protected Species Mitigation (EPSM) licence may be required, however, given the condition of the building it is considered that this is an unlikely event.

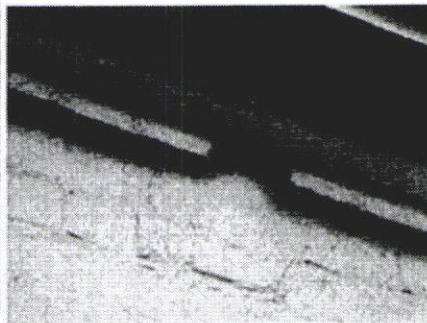
Figure 8 Gap behind Chimney Breast on Western Elevation Figure 9 Gap behind Wooden Fascia
