Dunsbury Hill Farm  
Photographic View 1  
Figure 14.5

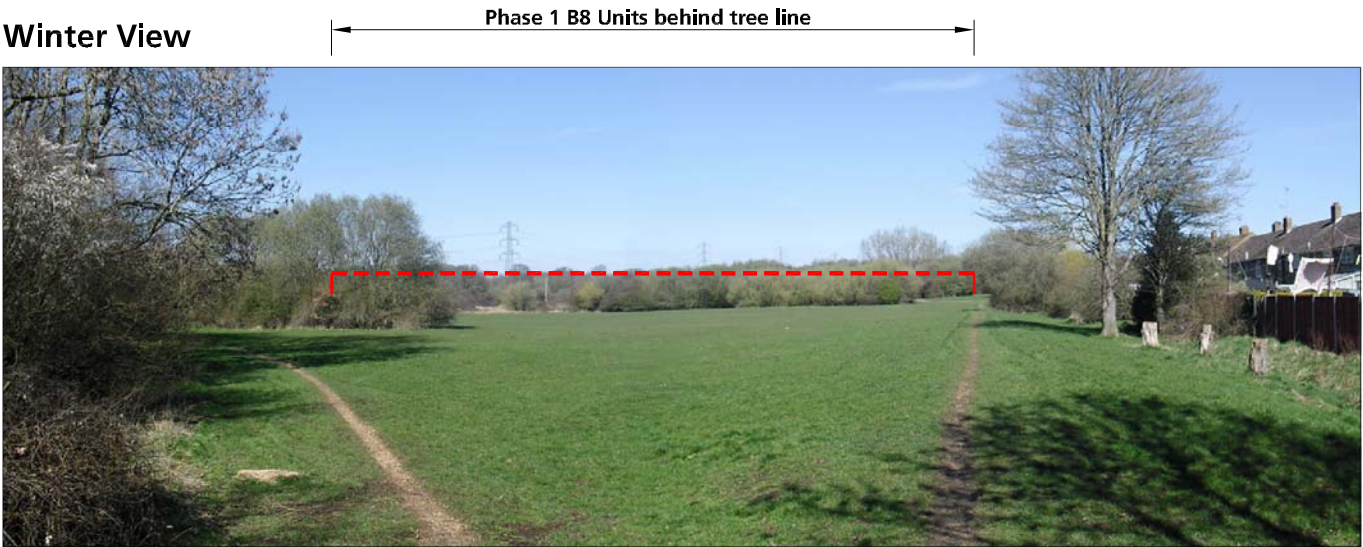
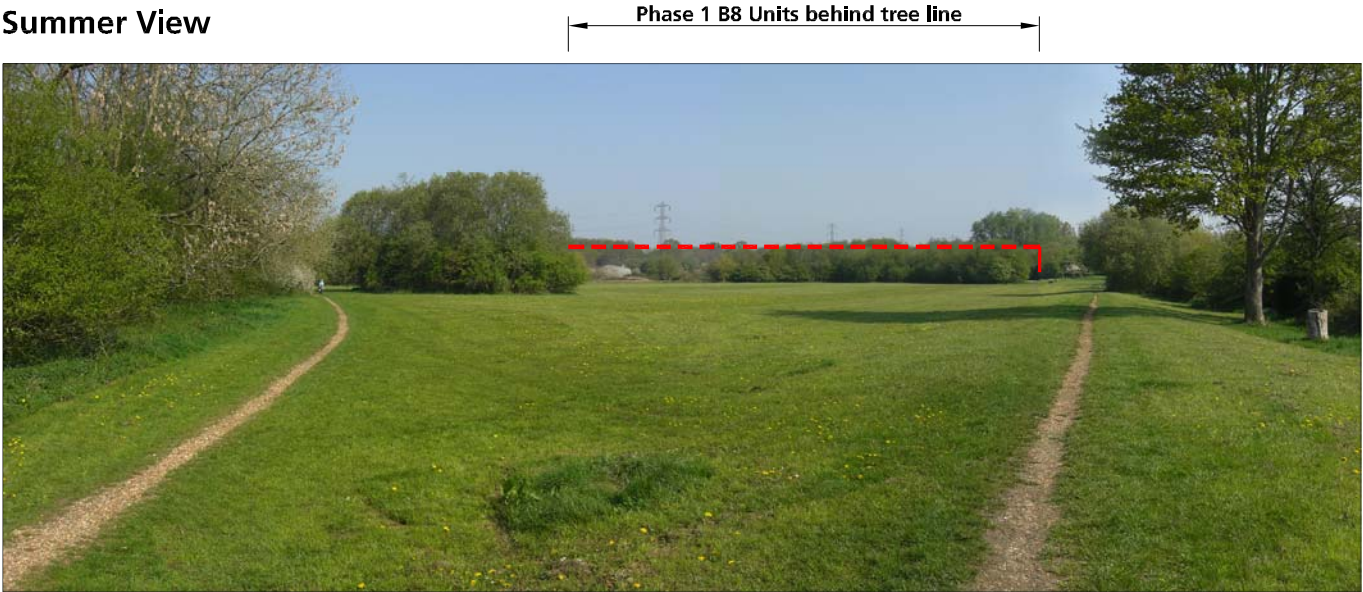
1 View from Footpath 508 adjacent to Hermitage Stream looking north across open grassland used recreationally by local residents. Development would be located to the right of the view beyond and concealed by the mature tree line. Rooflines will not be visible over the existing vegetation following proposed development as indicated by red dashed line.
