# St Michael's Convent, 354 London Road, Waterlooville, PO7 7TF

Method Statement to accompany Natural  
England EPS licence application in respect of  
bats

## Document 1 – Background and Supporting Information

July 2012

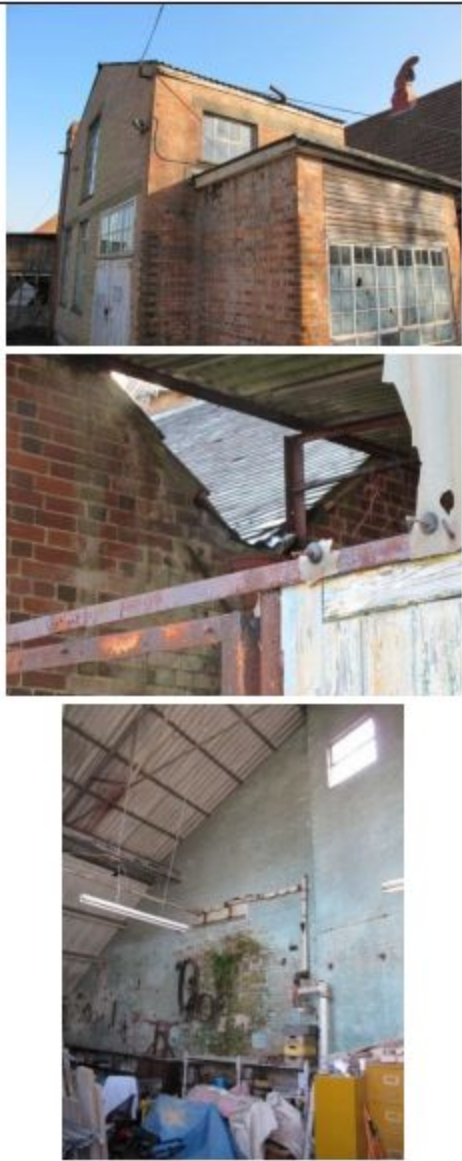
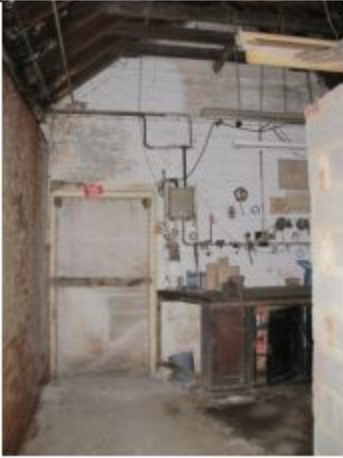
| Building | Photograph | Bat Roost Potential |
|---|---|---|
| <b>A</b> | | <p>Building A is a one-storey brick and breezeblock building with a pitched asbestos sheet roof. There is no internal lining or insulation. A small area of wooden cladding is present on the western elevation. There is an annex on the eastern end, which is constructed from bricks and breezeblocks, with a pitched, tiled roof on timber beams. The roof within the annex is lined with wooden boards.</p> <p>Bargeboards are present around the exterior of the building, and there are several gaps into the interior. A lifted tile on the annex provides entry to the interior of the roof void, whilst the asbestos roof of the main part of the building is raised. There are several loose or missing tiles on the annex (front and side). The interior of the main building is well lit to the roof (approximately 10m high). Mouse droppings are scattered throughout. This building has <b>high bat roost potential</b> which was confirmed by the presence of bat droppings on the floor of the annex. Therefore, <b>this building is a bat roost.</b></p> |

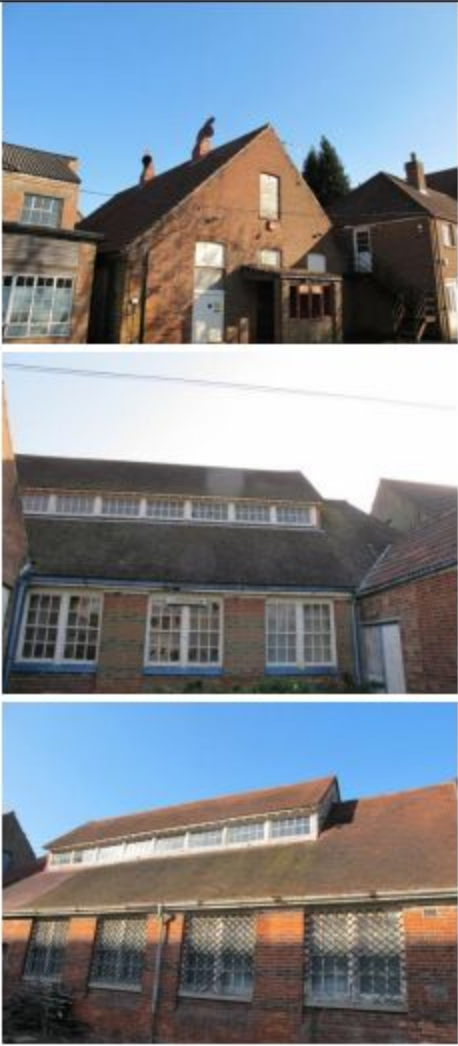
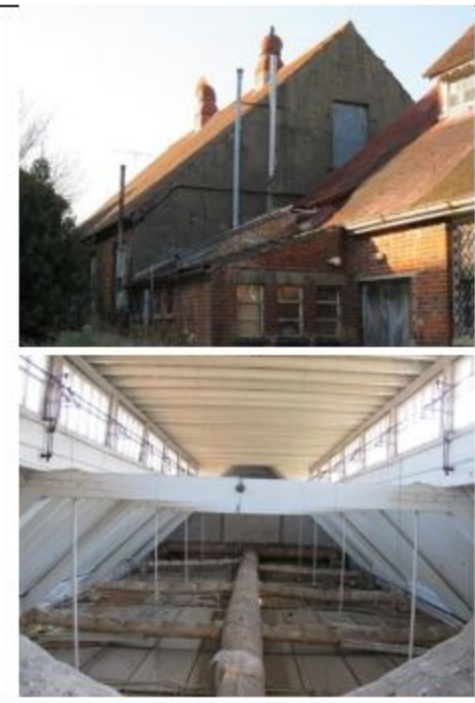
| <p><b>B</b></p> | | <p>A large two-storey brick outbuilding with a pitched tiled roof. There are two voids both of which are lined with wooden boards. The interior has a suspended ceiling. The main void above the suspended ceiling has a row of windows running along the north and south elevations making the interior void very well lit. The frame within the voids is wood with ridge beams present at the apex. There were very few cobwebs within the voids, although no evidence of bats was found. Mouse and rat droppings were scattered throughout the voids and the ground floor of the building. It has several loose or missing tiles that could provide access to bats, as well as a hole in the brickwork on the western elevation. However, the high levels of light in the roof voids means that bats may be disturbed. Therefore, it has <b>moderate bat roost potential</b>.</p> |

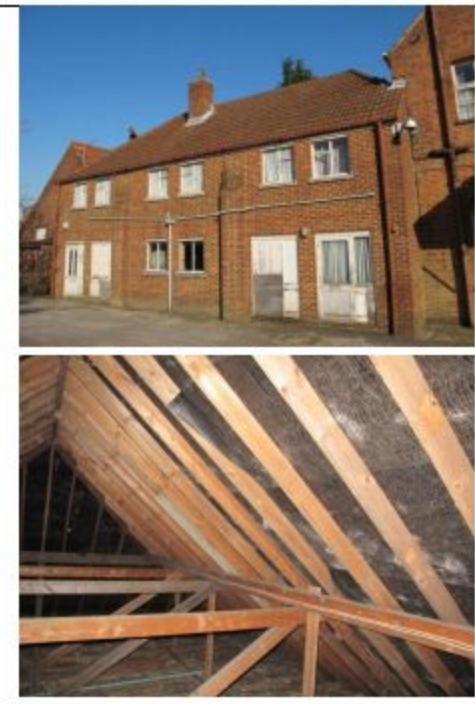
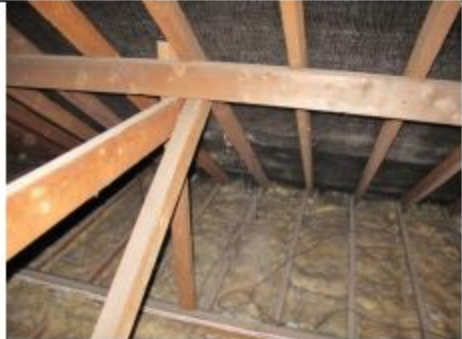
| <b>C</b> | | <p>Building C is a two-storey brick house with a hipped, pitched tiled roof. The roof void is lined with roofing felt and is insulated with fiberglass. The frame is wooden with a wooden ridge beam. The void has a maximum height of approximately 3m. Light enters the void through four large tears in the felt lining. Rodent droppings were found throughout. There were few cobwebs within the void, but no evidence of bats. Bargeboards and a chimney with lead-flashing present on the exterior of the building. There are several lifted tiles on the roof, and an area of lifted lead-flashing on the southern elevation of the chimney. This building has <b>moderate bat roost potential</b>.</p> |

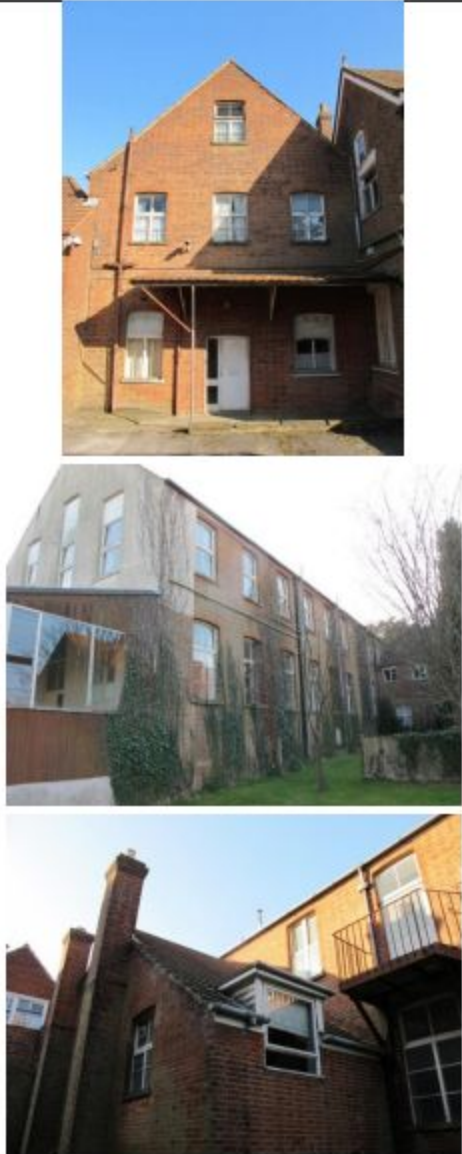
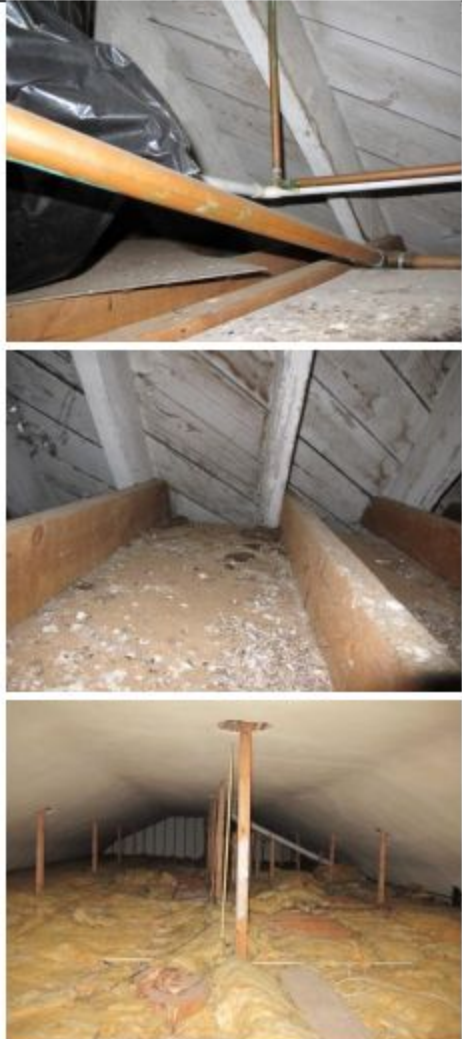
| <p><b>D</b></p> | | <p>A three-storey brick building with a pitched tiled roof. There is an extension with wooden cladding on the east side. Two roof voids are present, one small void containing a water tank on the east and a larger void on the west. The smaller of the two voids is lined with wooden boards. It contains few cobwebs and is well-sealed. The void is filled with pigeon droppings. The larger of the voids has wooden beams, contains fiberglass insulation, and is lined with plasterboard. No evidence of bats was visible at the time of survey, although some rodent droppings were present. There are gaps into the roof void via a hole to the right of the red drain pipe on the west side and via several slipped tiles. Lead-flashing and a porch are present on the exterior of the structure. There are climbing plants including <i>Hedera helix</i> (Ivy) on the northern elevation. This building has <b>moderate bat roost potential</b>.</p> |

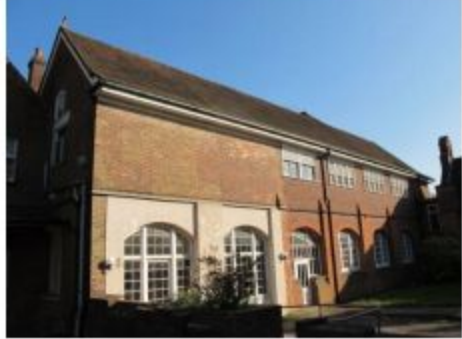
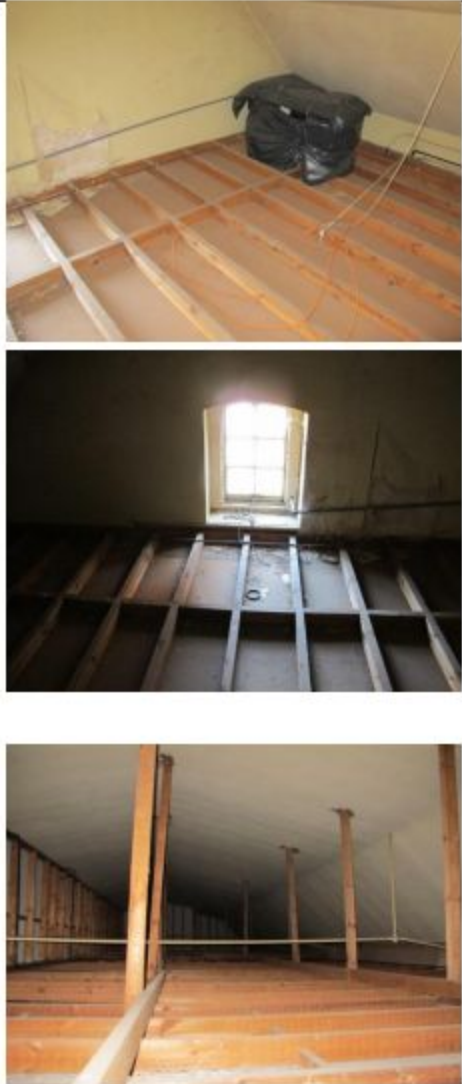
| <p><b>E</b></p> | | <p>A two-storey brick building with a pitched tiled roof. The interior of the void is lined with plaster and devoid of cobwebs. A small area of the north end of the roof void is partitioned off, with an access hole into the main part of the roof void. It has a large window, ensuring much of this area is well lit. Rodent droppings were scattered throughout the void, but no evidence of bats was found. There are several raised tiles on the roof and a gap in the soffits in which birds were nesting at the time of survey. There are bargeboards and soffit boxes around the exterior of the roof, and a chimney with lifted lead-flashing. This building has <b>moderate bat roost potential</b>.</p> |

Buildings E, H, I and part of F will be retained. However, it will be necessary to remove the roofs to inspect the beams and make any necessary repairs. Bat access points into the roof that were identified during the emergence surveys will be retained following reinstatement of the roof. Therefore, any bats using these buildings as a roost will continue to be able to following completion of the works. The impact on bats, on a local scale, is low.

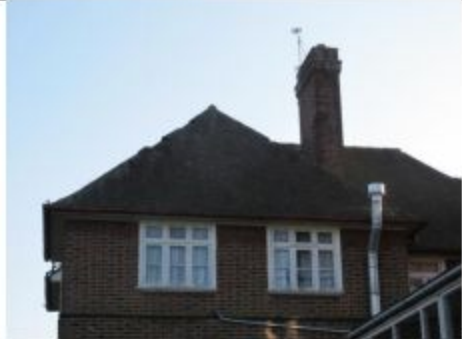
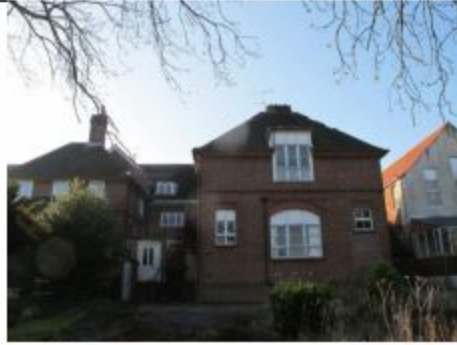
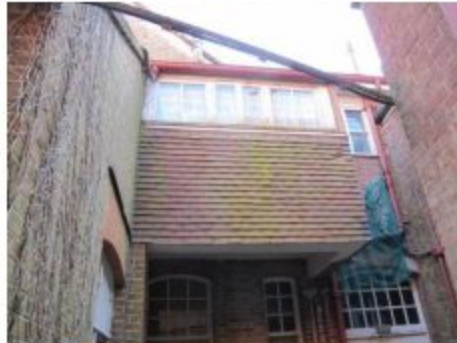
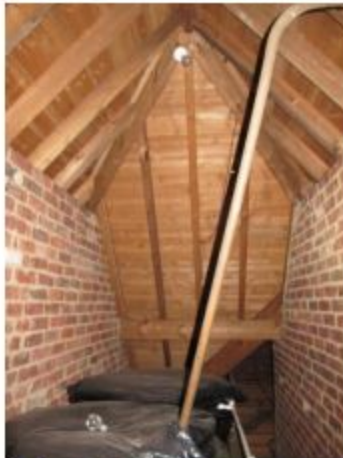
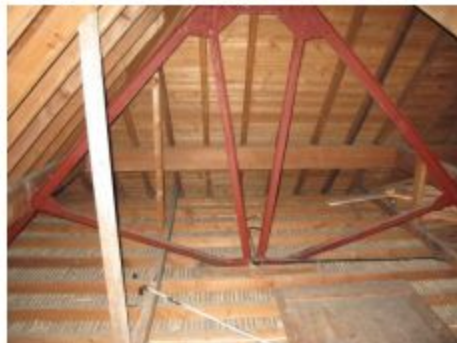
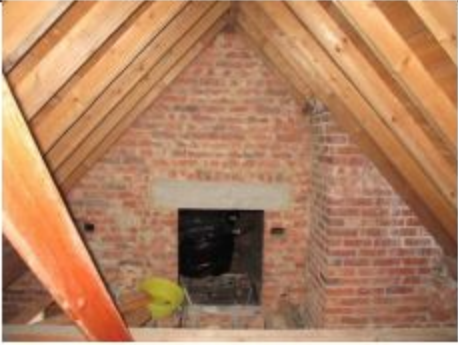
| <b>F</b> | | <p>Building F is an extension to the east of Building E. It is a brick building with a pitched, hipped, tiled roof. The roof void is lined with wooden boards and has a wooden and metal frame. There were few cobwebs within the void. Rodent droppings were scattered throughout but no evidence of bats was found. On the eastern end of the building several hip tiles have and missing and slipped. In addition, there are missing and lifted tiles on the roof and lifted lead-flashing and gaps either side of dormer windows. There is a small area of hanging tiles on the northern side. Bargeboards, soffit boxes, dormers windows, a chimney and</p> |

lead-flashing are present on the exterior of the building. This building has **moderate bat roost potential**.

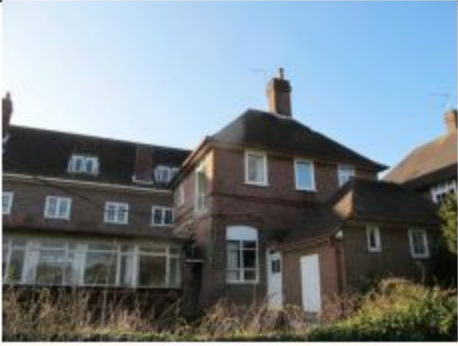
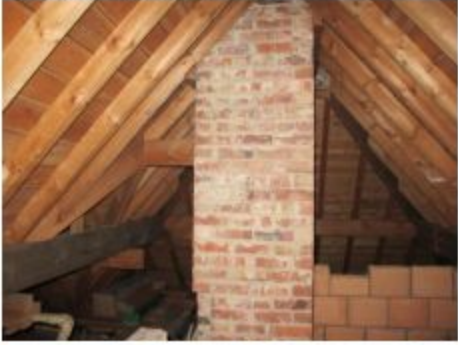
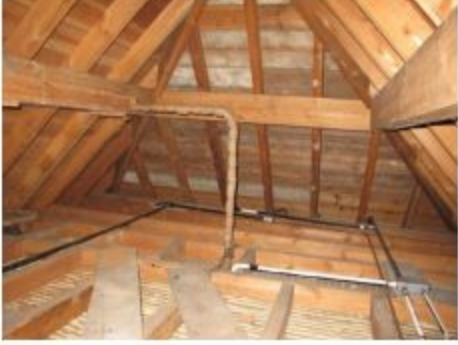
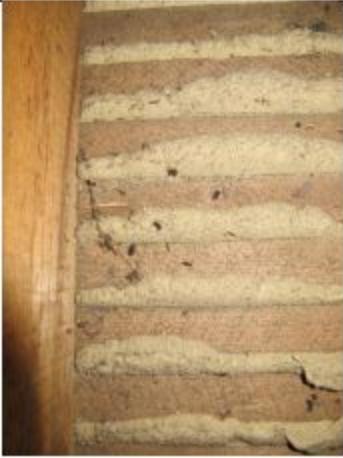
| <b>G</b> | <br><br> | <p>A brick built two-storey building with a pitched, hipped, tiled roof. The roof void is open and lined with wooden boards. There are very few cobwebs. Rodent droppings from rodents were scattered throughout. There are missing and slipped hip tiles on the north and south elevations, slipped and missing tiles on the main slope of the roof and lifted lead-flashing. Bargeboards, soffit boxes and a chimney with lead-flashing are present on the exterior. This building has <b>high bat roost potential</b>. This was confirmed by the presence of bat droppings. Therefore, <b>this building is a bat roost</b>.</p> |

Bat droppings were found scattered in the roof voids of Buildings G and H. The greatest concentrations were located under the ridge beams. Their size, shape and texture were consistent with those of long-eared bats.

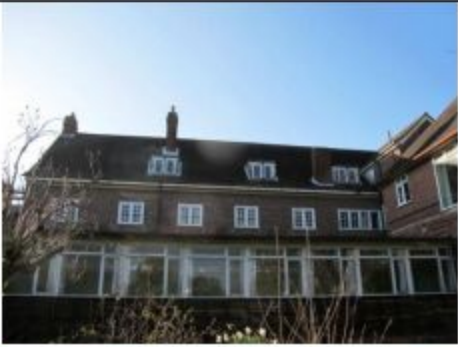
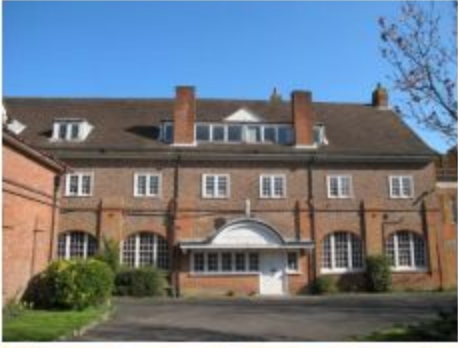
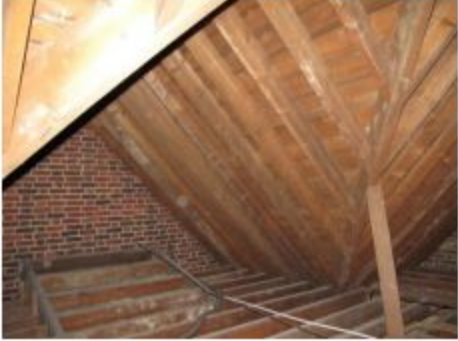
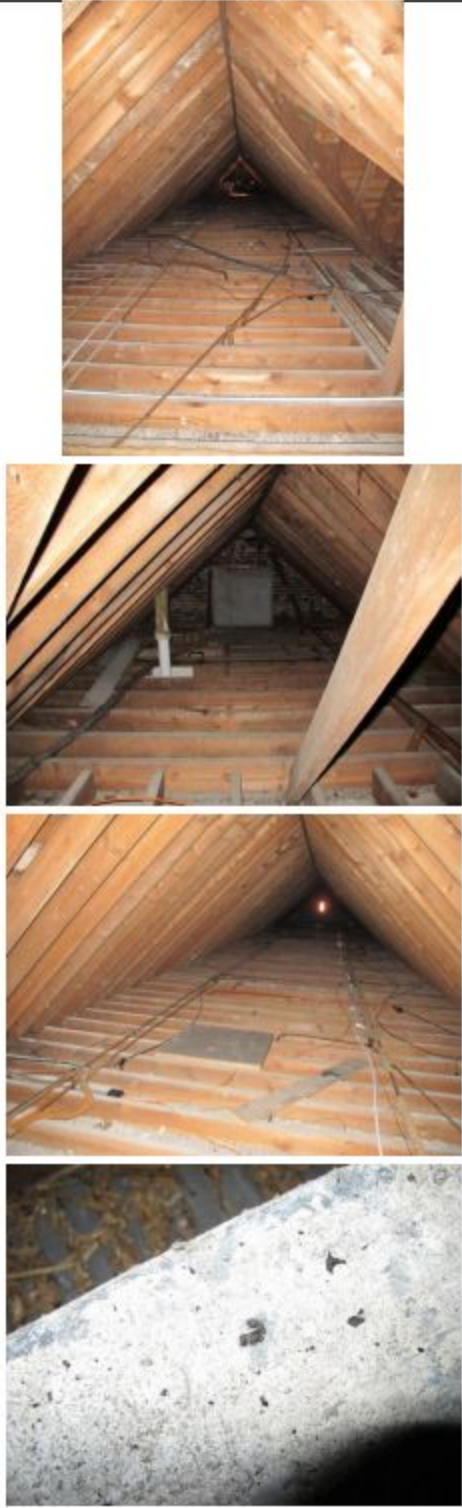
| <b>H</b> | | <p>A brick built two-storey building with a pitched tiled roof. Its roof is constructed from wooden beams with a wooden ridge and is lined with wooden boards. It has an open roof void with no insulation between the joists. Light is visible at the northern end of the void, through a large gap in the bricks (covered in wire). There are few cobwebs within the void. Rodent droppings were scattered throughout. There are several lifted and missing tiles that could provide bat access into the roof void. Also, there are two raised ridge tiles on the southern apex of the building. In addition, there is lifted lead-flashing around the northern dormer on the western elevation and a raised tile on the inner valley of the connection between buildings H and I. There are gaps into the soffits either side of the southern gable end. This building has <b>high bat roost potential</b>. This was confirmed by the presence of bat droppings. Therefore, <b>this building is a bat roost.</b></p> |

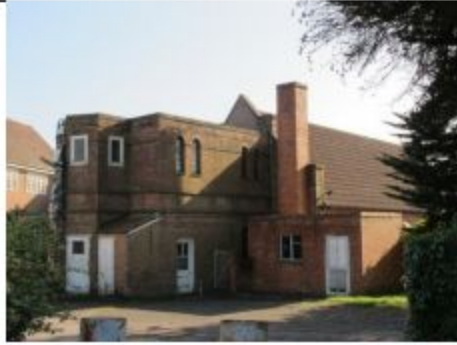
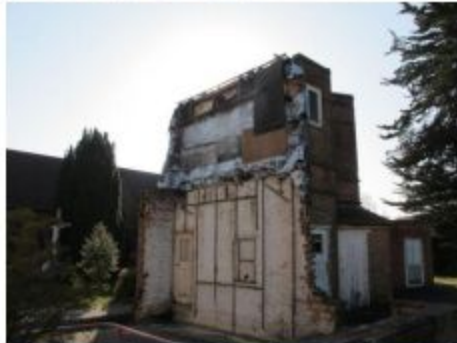
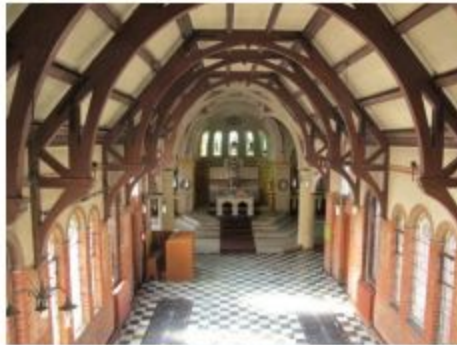
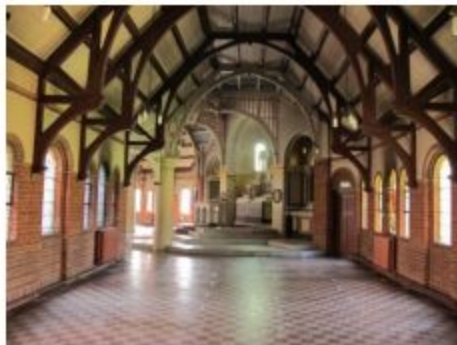
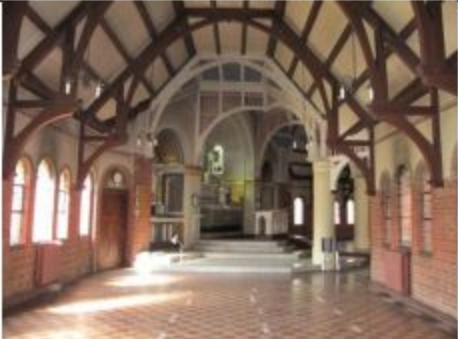
Building I is a brick-built Victorian chapel with a pitched, tiled roof. It was not possible to access the roof void between the roof and the interior plaster of the chapel's ceiling. The exterior is well-sealed, with the exception of gaps under lead-flashing on the gable ends on the north, south and west elevations; and where a connection to the convent has been demolished (northern elevation) and there are multiple gaps into the structure (partially covered by roofing felt). There are also raised tiles on a small lean-to building attached to the chapel. This building has **moderate bat roost potential**.

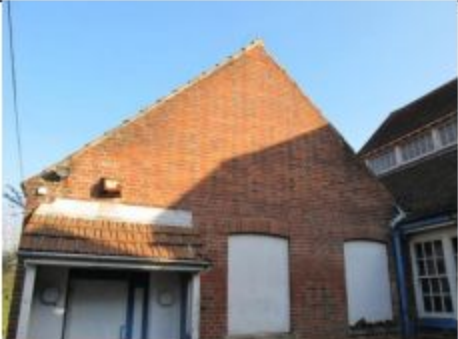
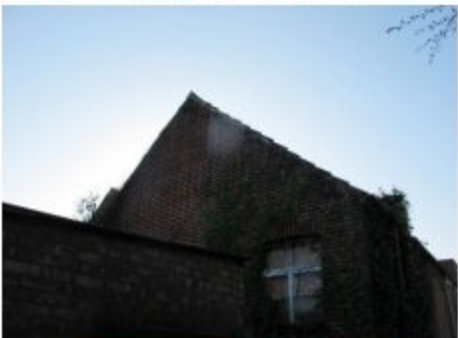
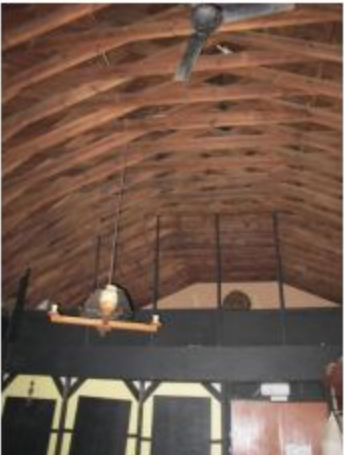
| <p><b>J</b></p> | <br><br> | <p>Building J is brick-built with a pitched, tiled roof. The interior is open to the ceiling, which has a wooden ridge and is paneled with wood. Rodent droppings were scattered throughout. There are several raised tiles including ones at both gable ends where the mortar is missing beneath them. There is a small tiled porch on the western elevation with raised tiles; and bargeboards on the northern and southern elevations. This building has <b>moderate bat roost potential</b>.</p> |

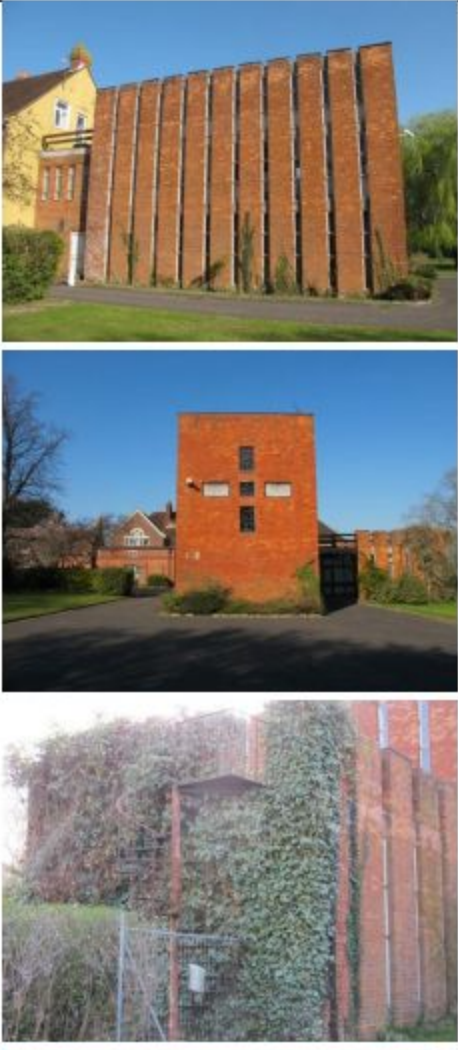
| <p><b>K</b></p> | | <p>Building K is a three-storey extension built circa 1960. The building is made from brick, with a flat roof and lead-flashing. The climber <i>Hedera helix</i> (Ivy) covers the eastern elevation on the ground floor. Some of the brickwork on the western elevation has crumbled and created a gap behind the lead-flashing. This building has <b>low to moderate bat roost potential</b>.</p> |

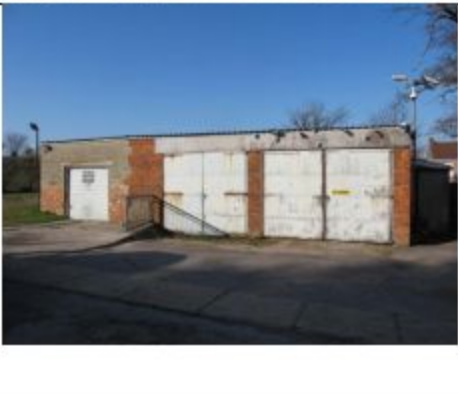
| <p><b>L</b></p> | | <p>Building L is a single-storey, flat roofed garage. It is brick-built with a sheet metal roof. It appears well-sealed. It has <b>negligible bat roost potential</b>.</p> |

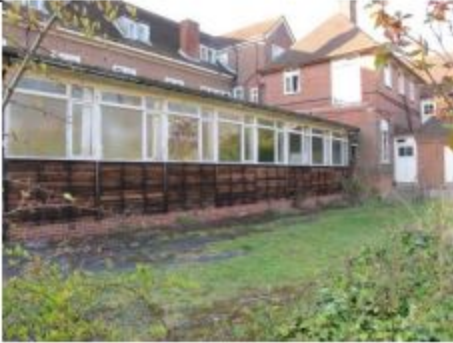
| <b>M</b> | | <p>Building M is a single-storey, flat roofed extension to building H. It is constructed of wood and glass, with a felt roof. The exterior is wooden cladded, although this appears to be well-sealed. It has <b>low bat roost potential</b>.</p> |

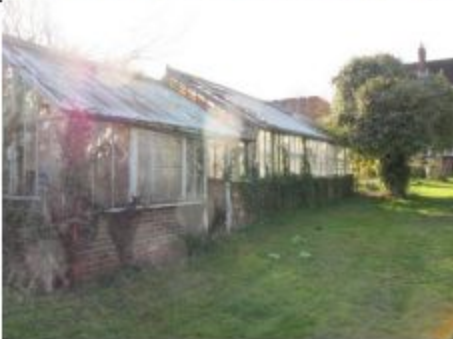
| <b>N</b> | | <p>Building N is a single-storey disused greenhouse. Several of the glass panes are broken, and the interior is filled with <i>Rubus fruticosus</i> agg. (Bramble). It has <b>negligible bat roost potential</b>.</p> |

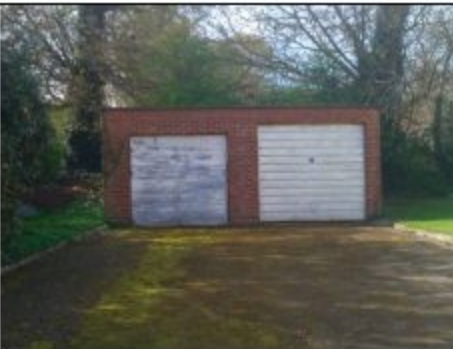
| <b>O</b> | | <p>Building O is a single-storey brick garage with a flat roof covered in roofing felt. It has <b>negligible bat roost potential</b>.</p> |

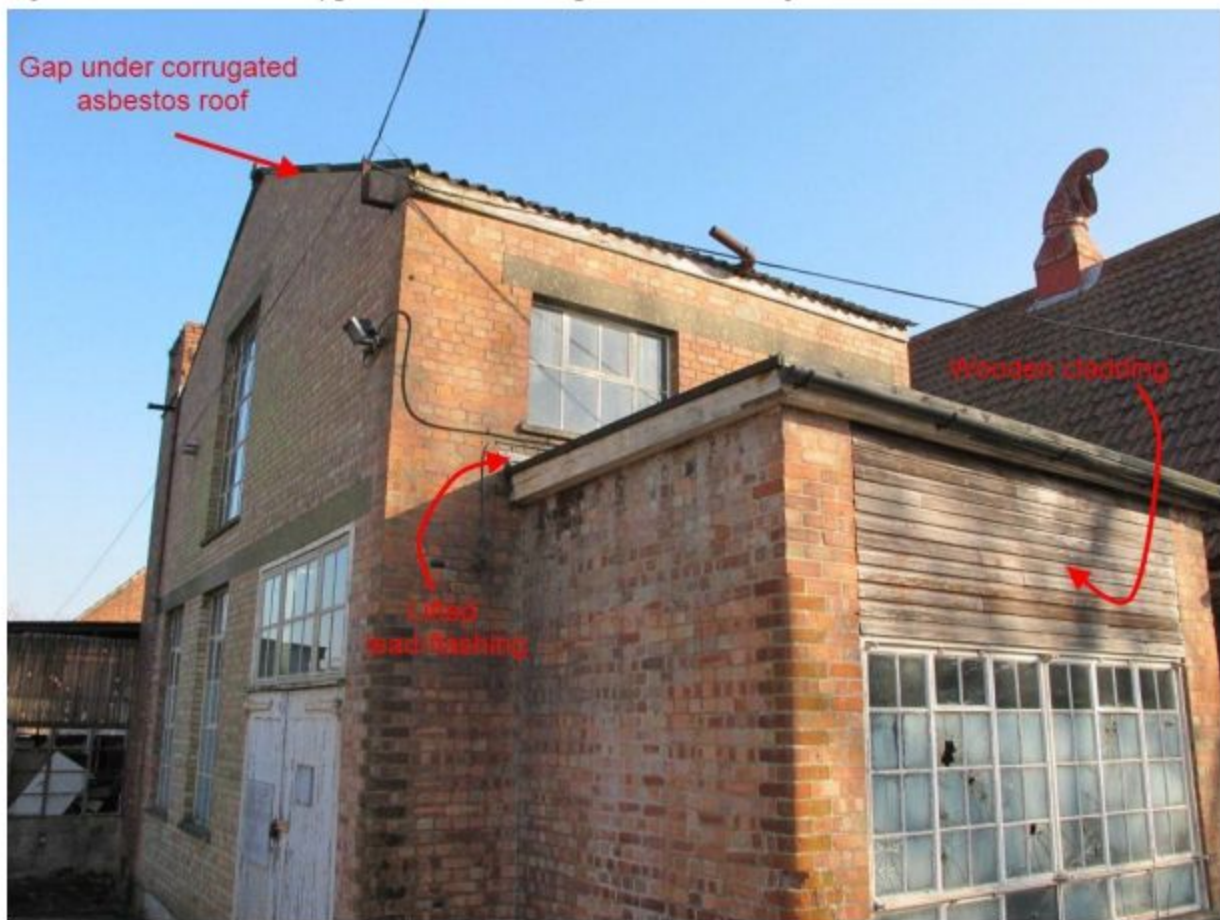
*Figure C.7.1.1. Location of potential bat access points on Building A.*

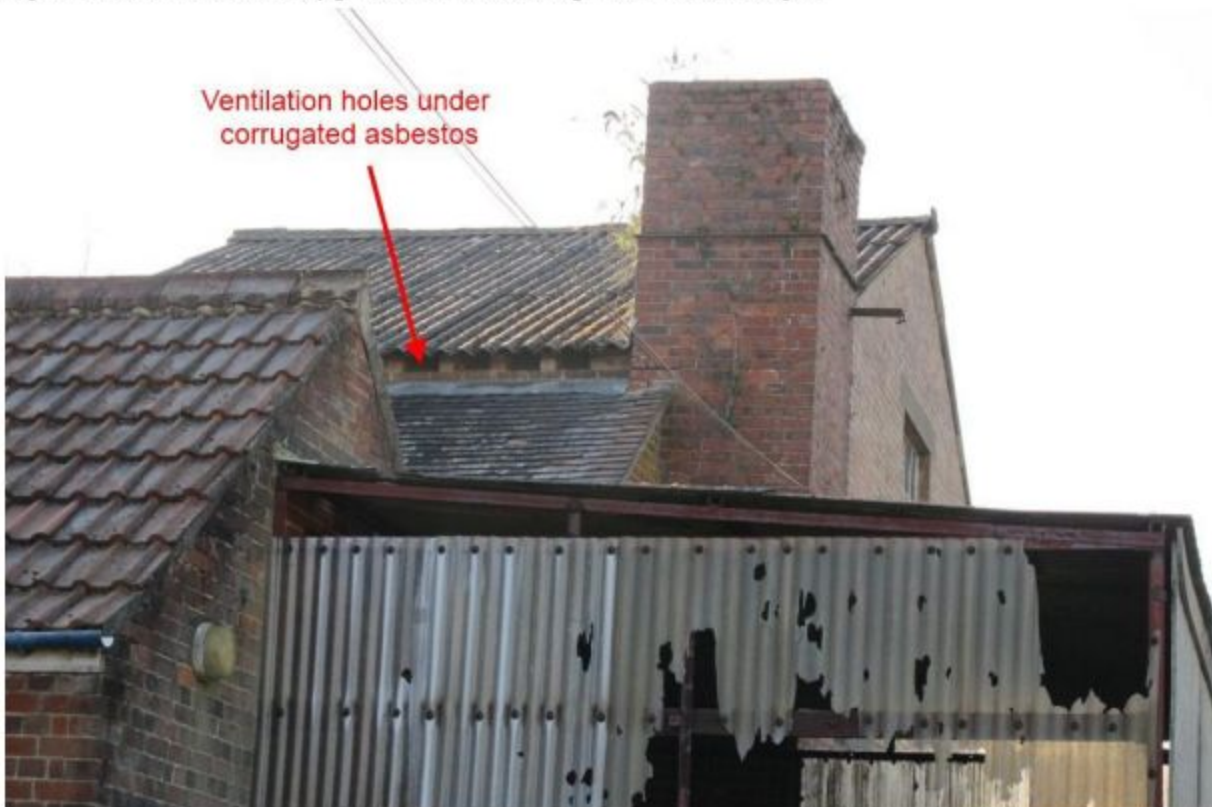
*Figure C.7.1.3. Location of potential bat access points on Building A.*

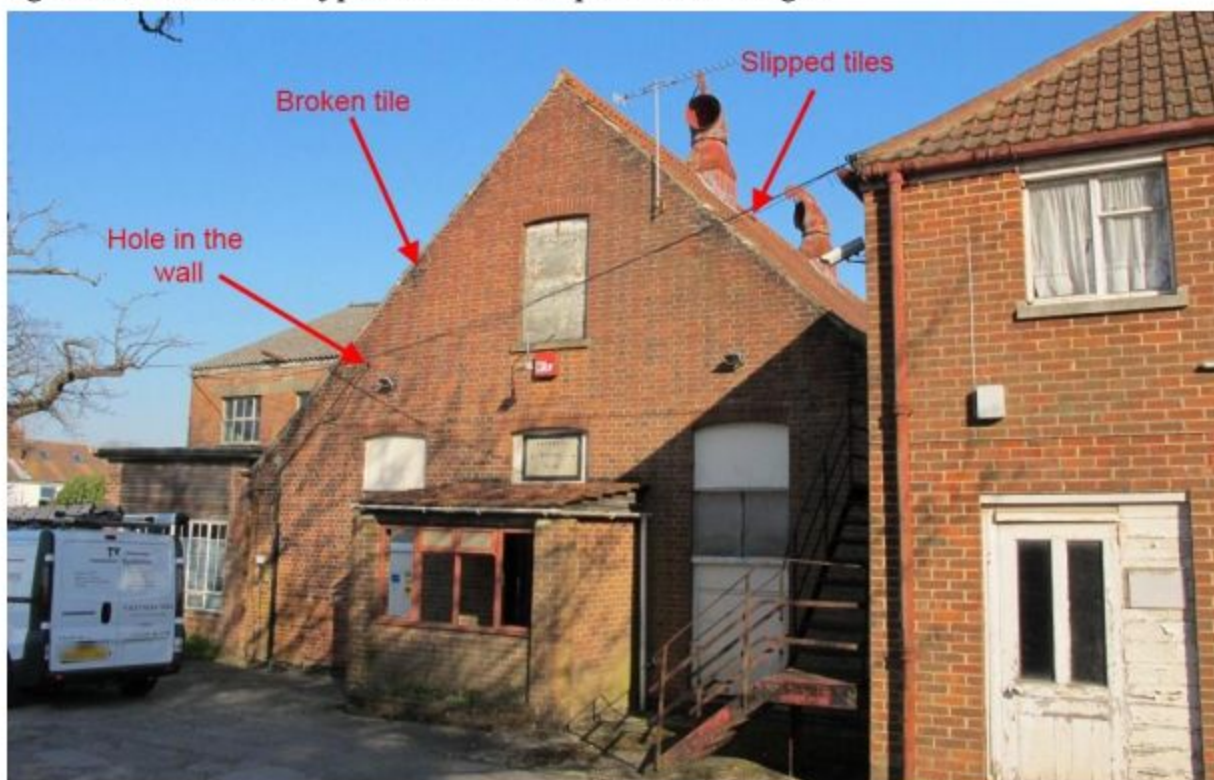
*Figure C.7.1.4. Location of potential bat access points on Building B.*

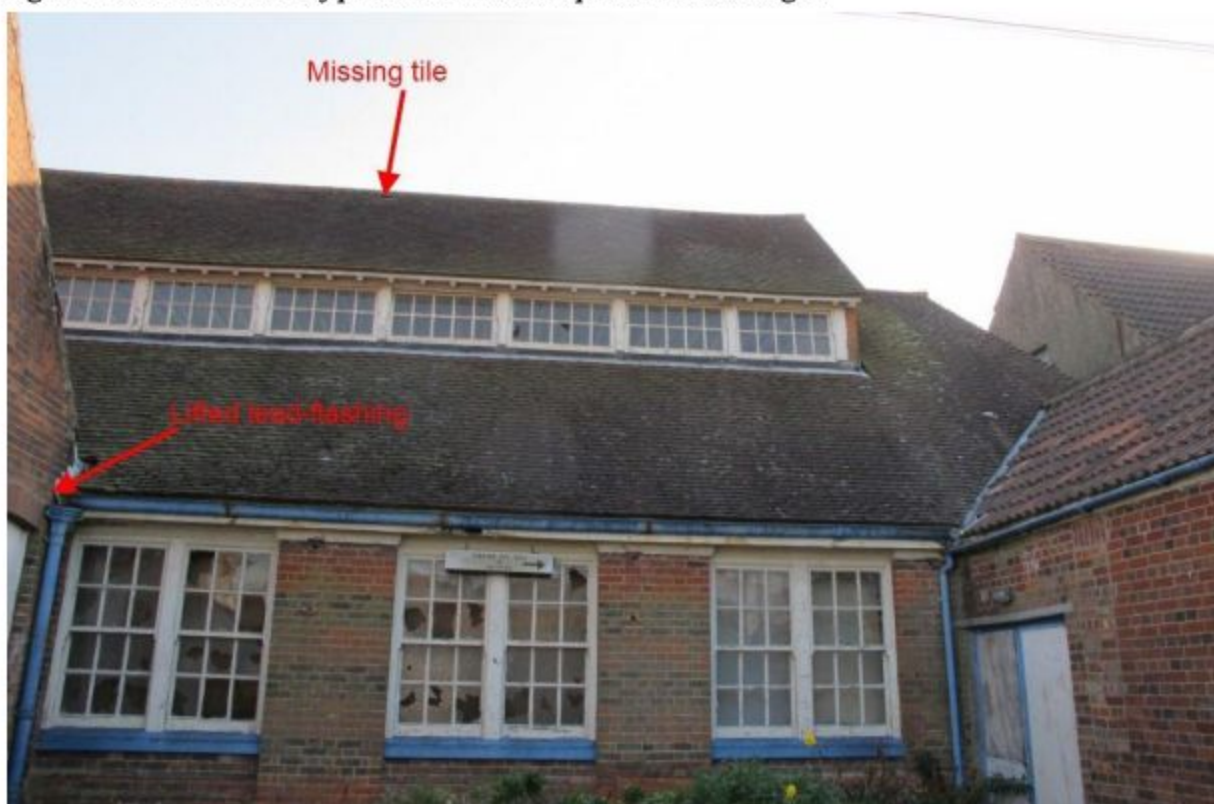
*Figure C.7.1.5. Location of potential bat access points on Building B.*

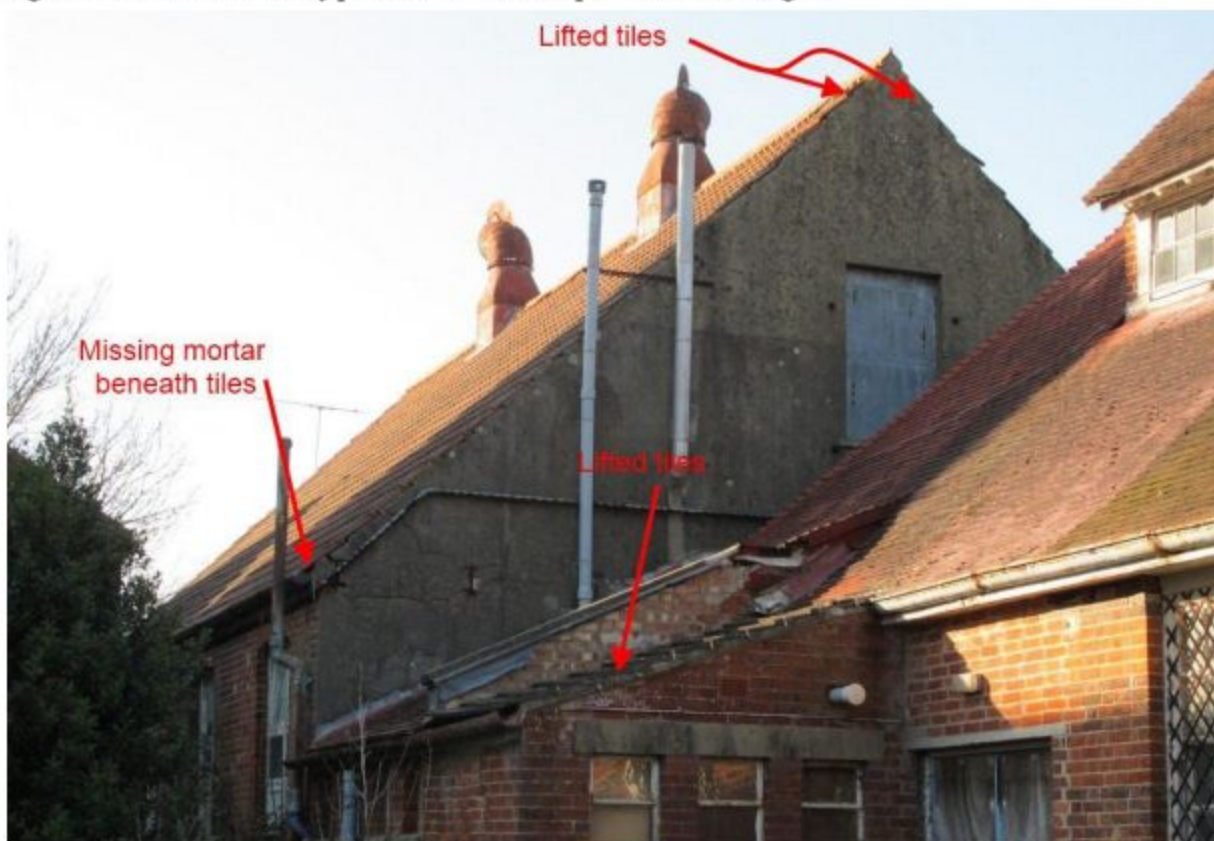
*Figure C.7.1.7. Location of potential bat access points on Building B.*

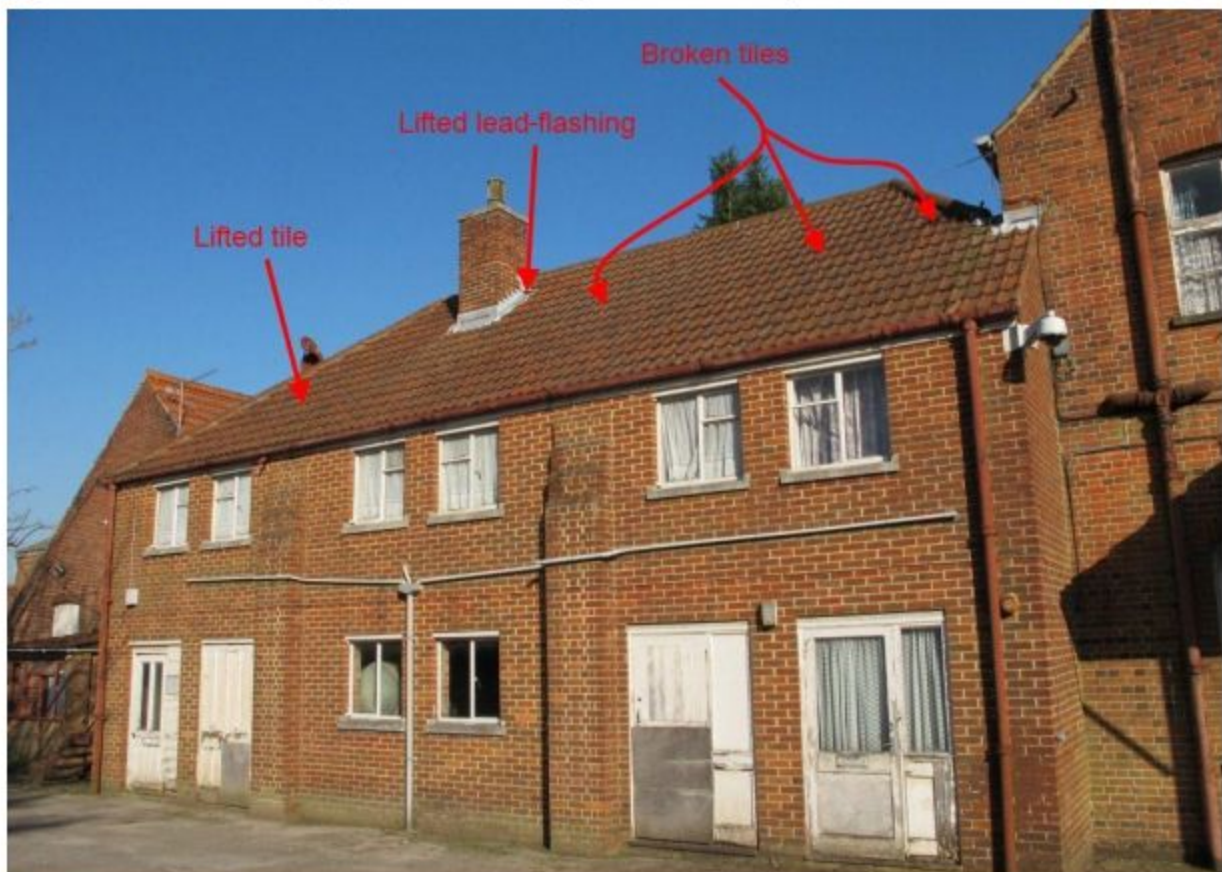
*Figure C.7.1.8. Location of potential bat access points on Building C.*

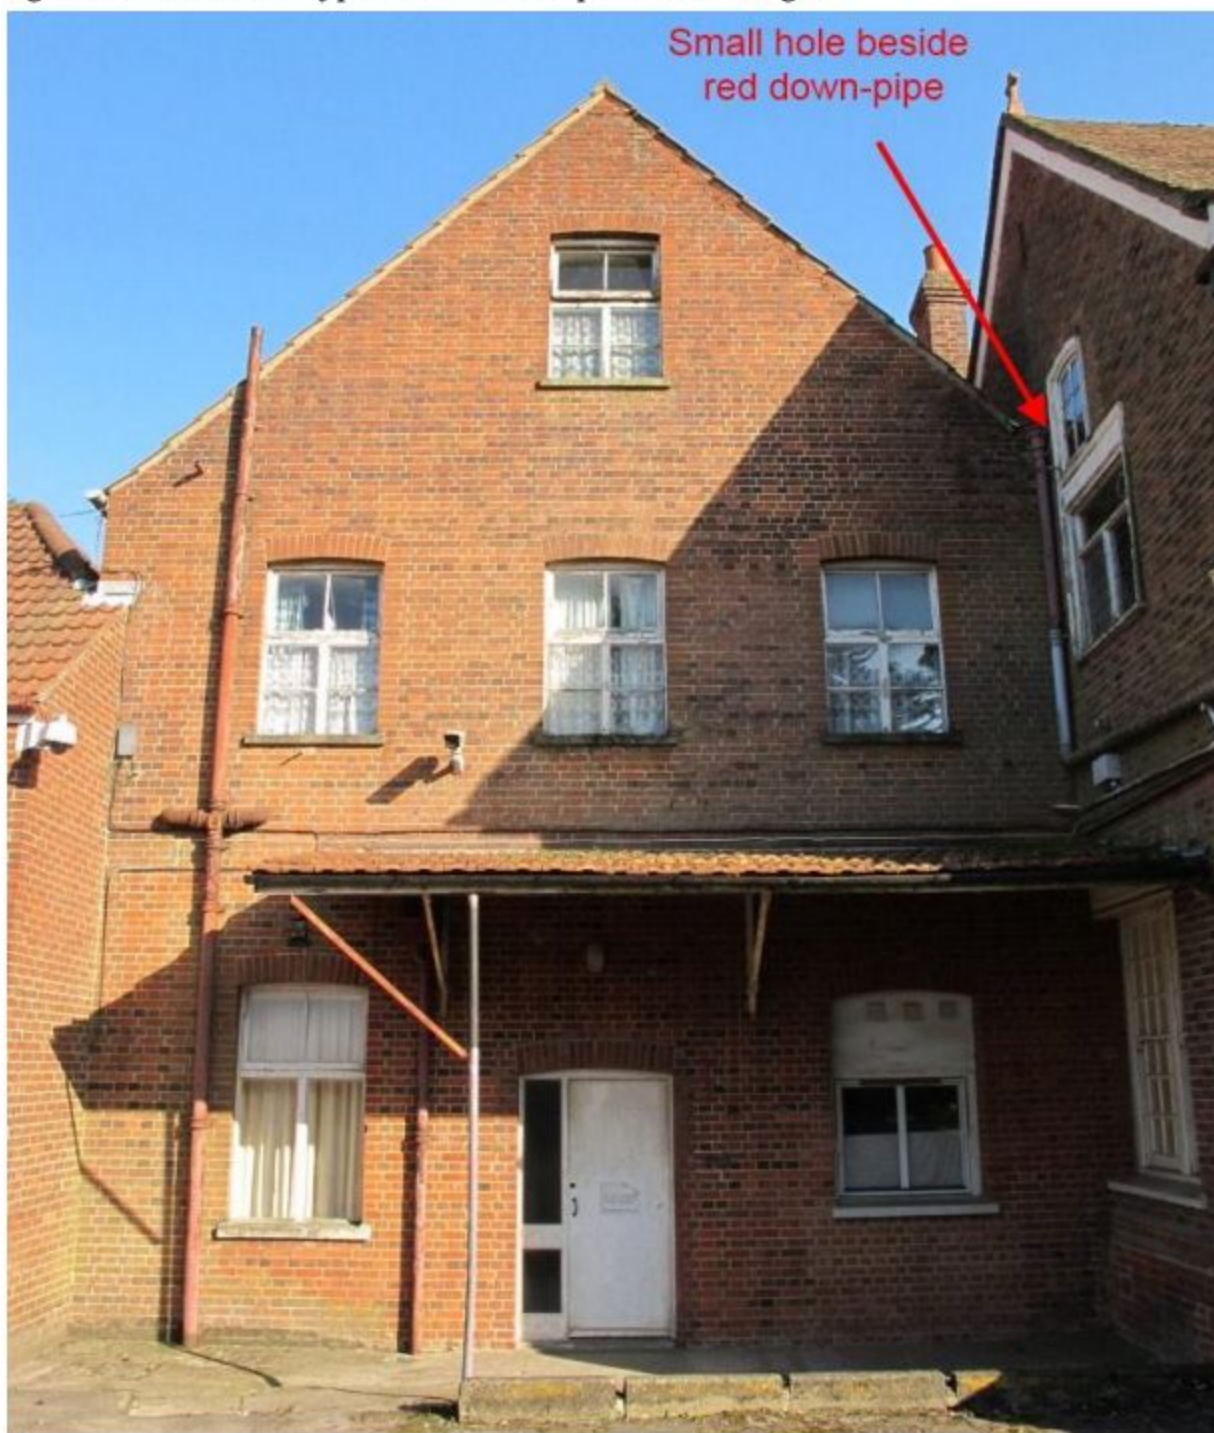
*Figure C.7.1.9. Location of potential bat access points on Building E.*

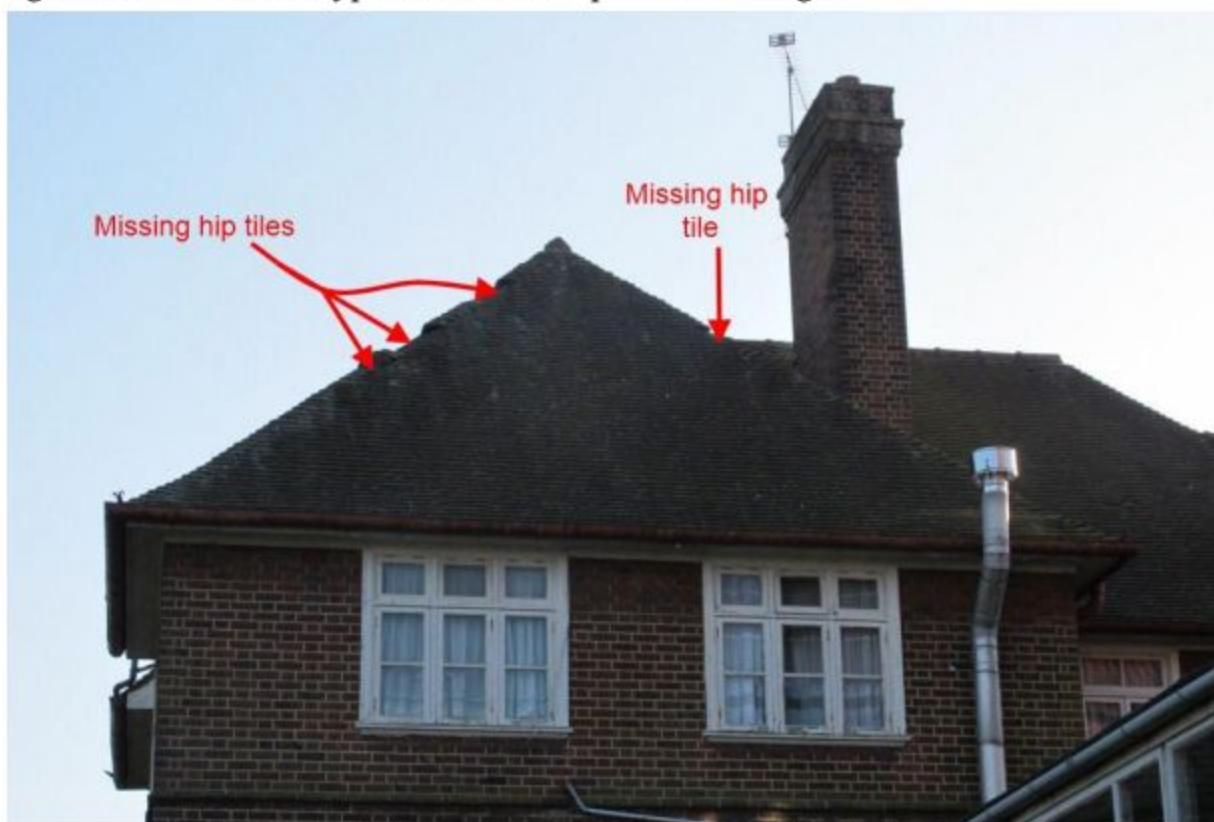
*Figure C.7.1.12. Location of potential bat access points on Building F.*

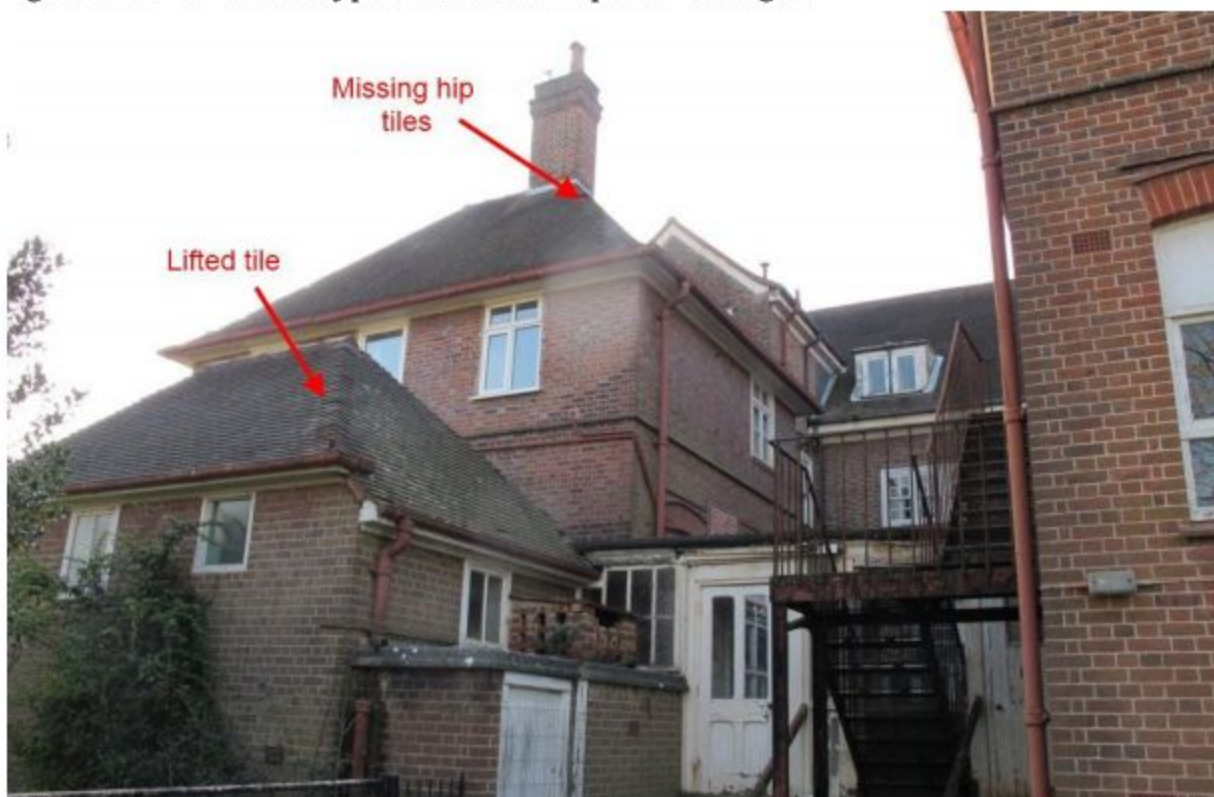
*Figure C.7.1.13. Location of potential bat access points Building G.*

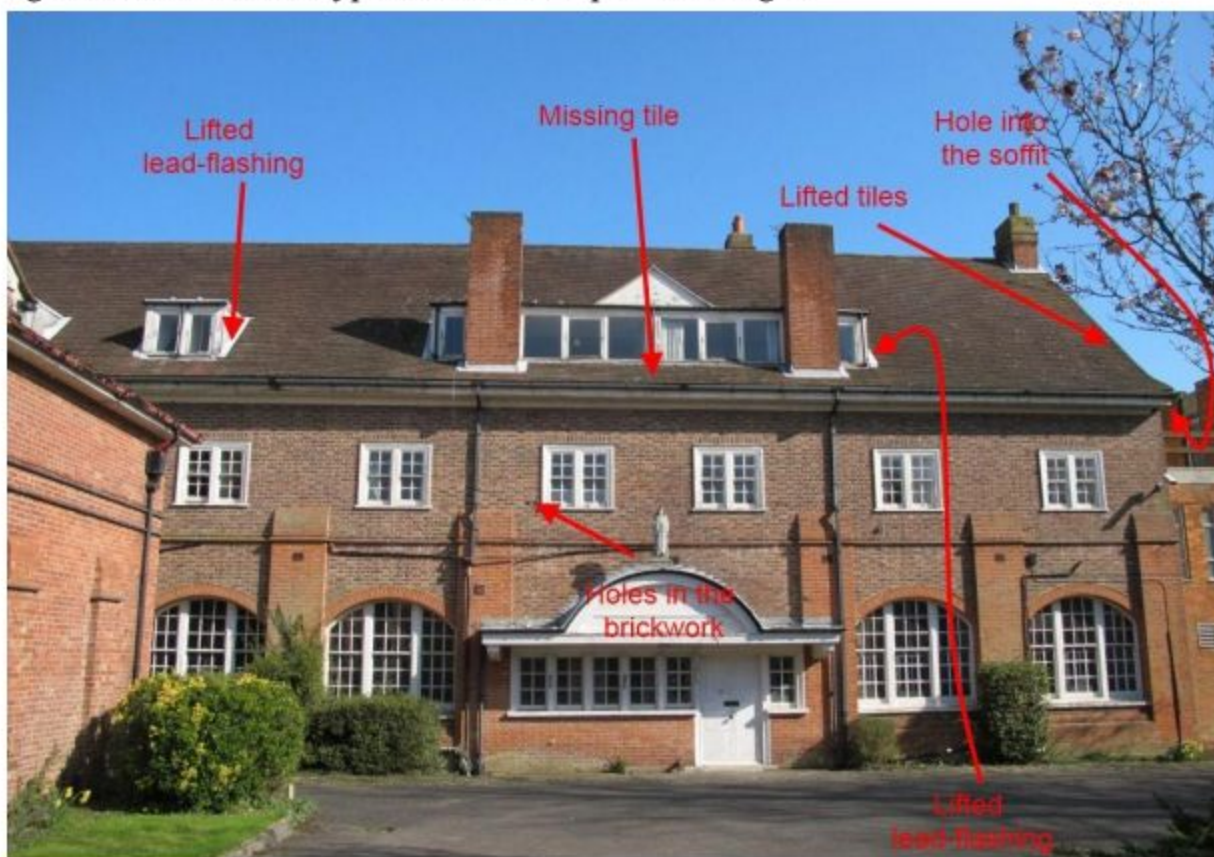
*Figure C.7.1.14. Location of potential bat access points Building H.*
