# St Michael's Convent, 354 London Road, Waterlooville, PO7 7TF

Method Statement to accompany Natural  
England EPS licence application in respect of  
bats

## Document 1 – Background and Supporting Information

July 2012

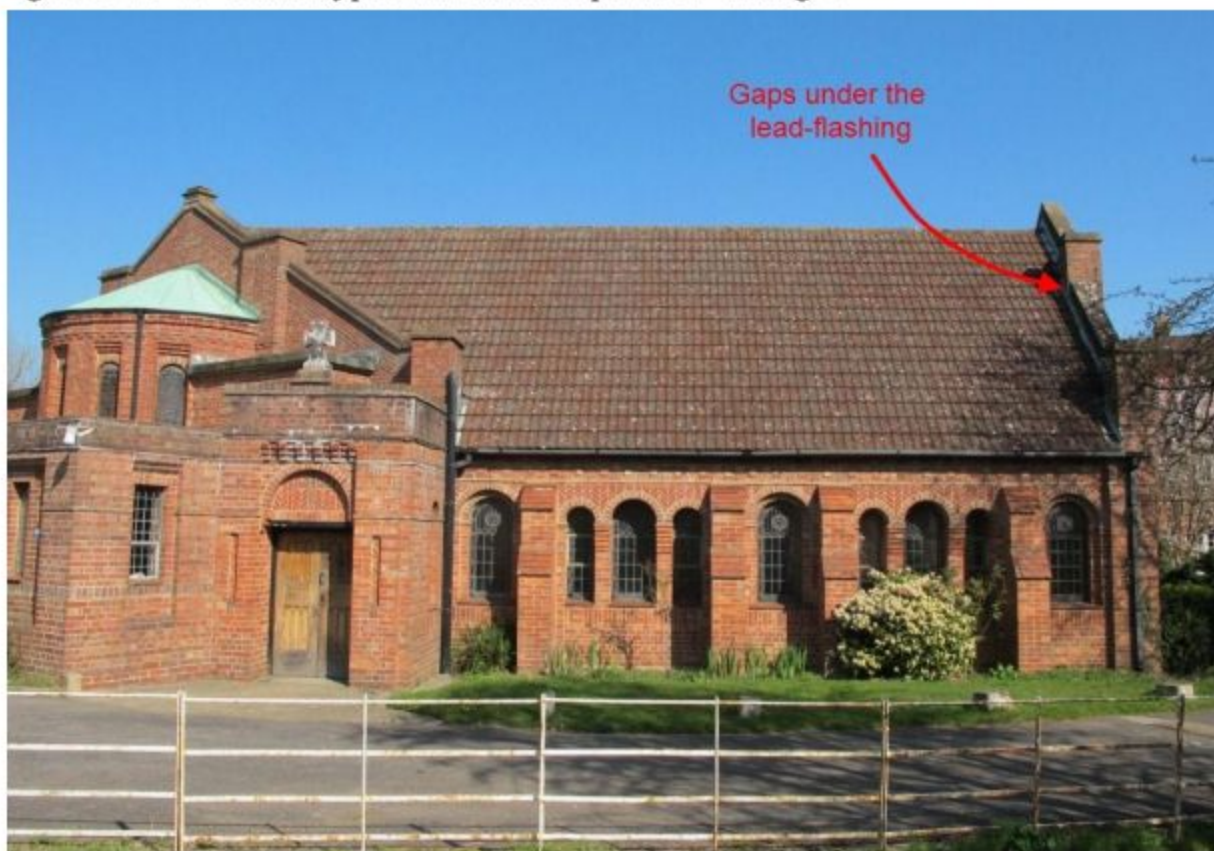
*Figure C.7.1.17. Location of potential bat access points on Building I.*

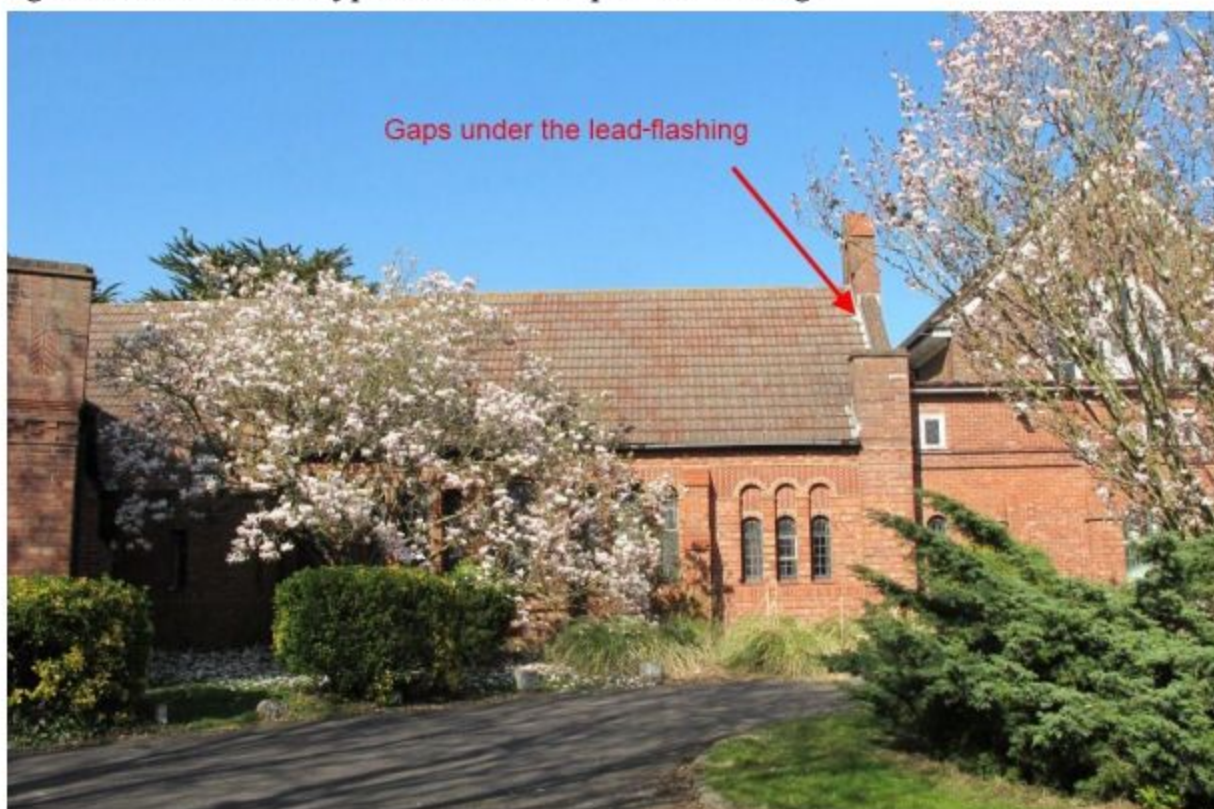
*Figure C.7.1.18. Location of potential bat access points on Building I.*

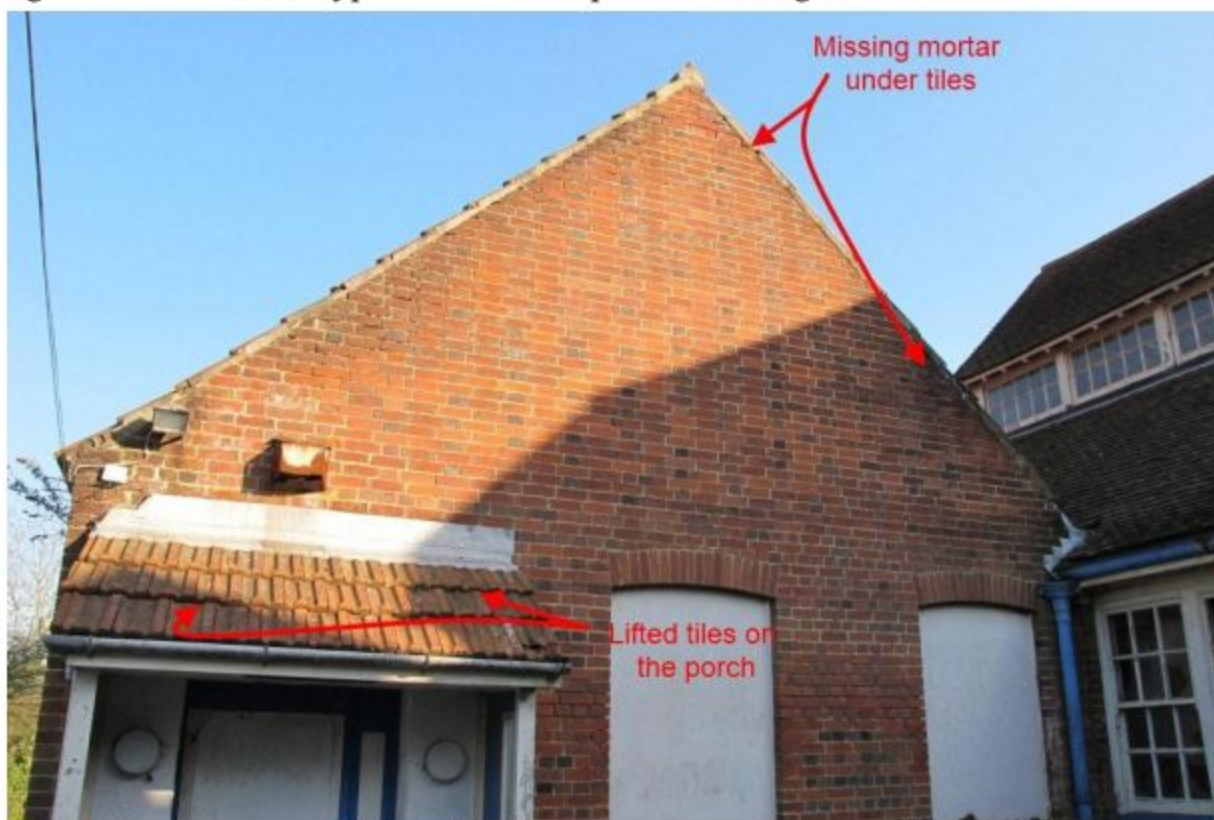
*Figure C.7.1.20. Location of potential bat access points on Building J.*

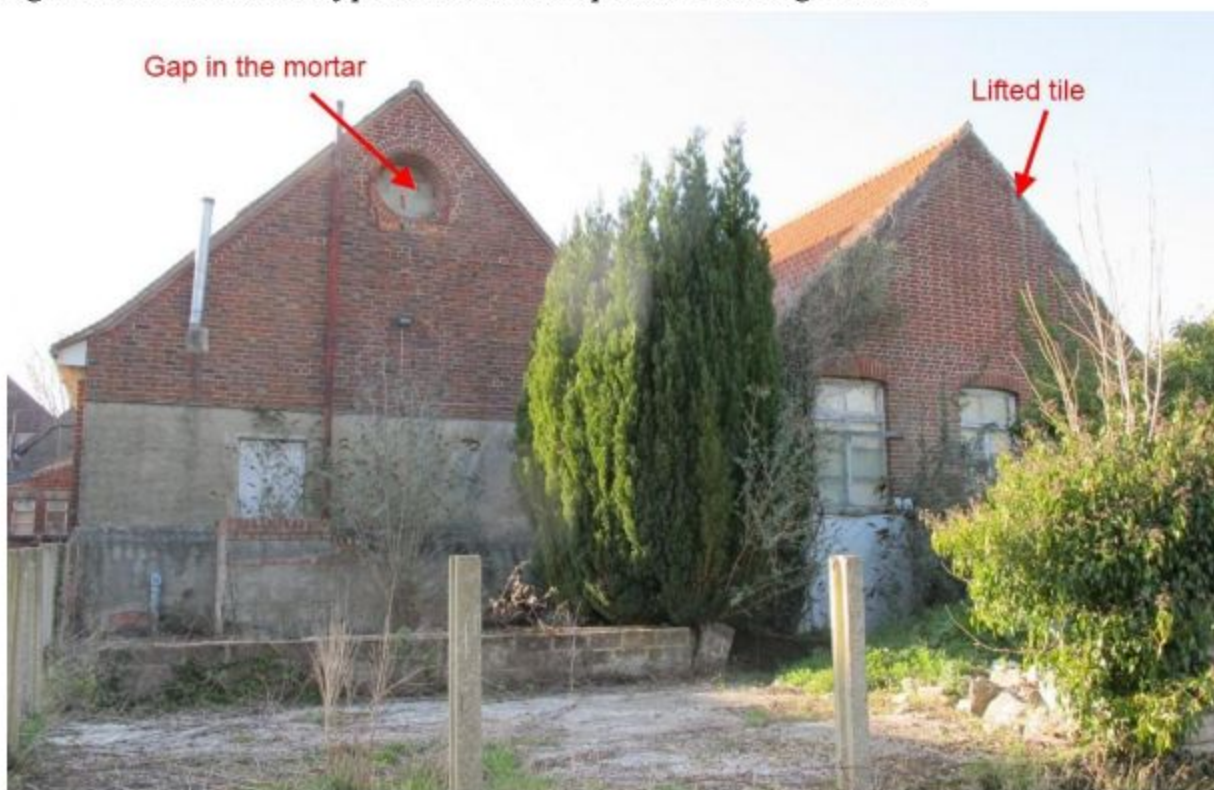
*Figure C.7.1.21. Location of potential bat access points on Buildings B and J.*

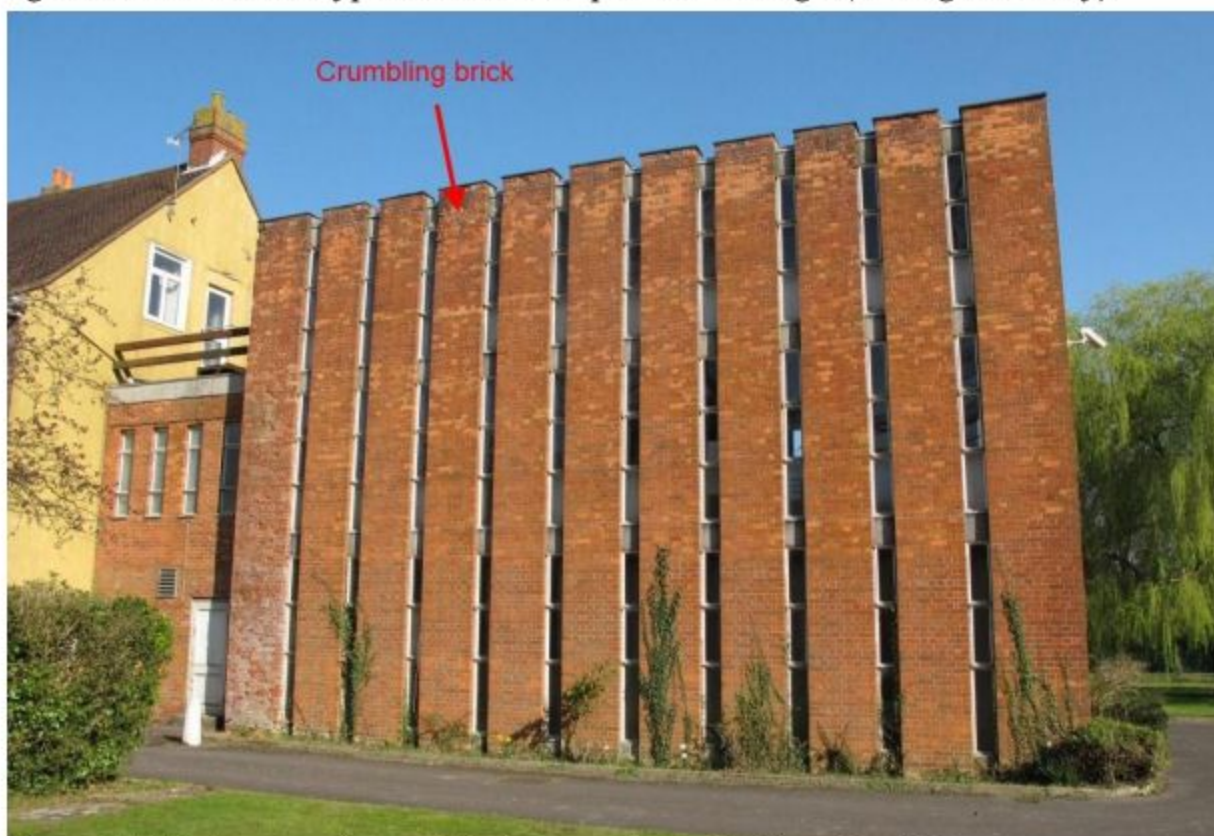
*Figure C.7.1.22. Location of potential bat access points on Building K (Building H to the left).*

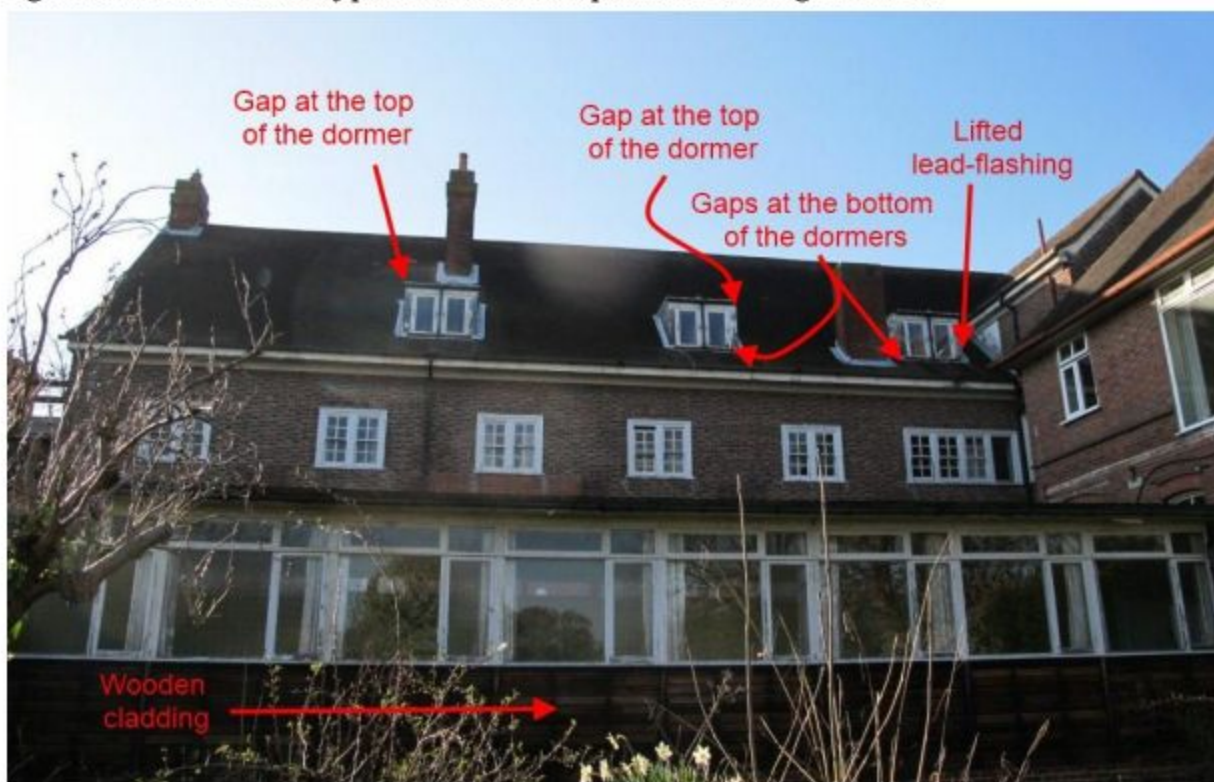
*Figure C.7.1.23. Location of potential bat access points on Buildings H and M.*
